UK AIRPROX BOARD

Analysis of Airprox in UK Airspace

**Report Number 13
July 2004 - December 2004**

Thirteenth Report by the UK Airprox Board:

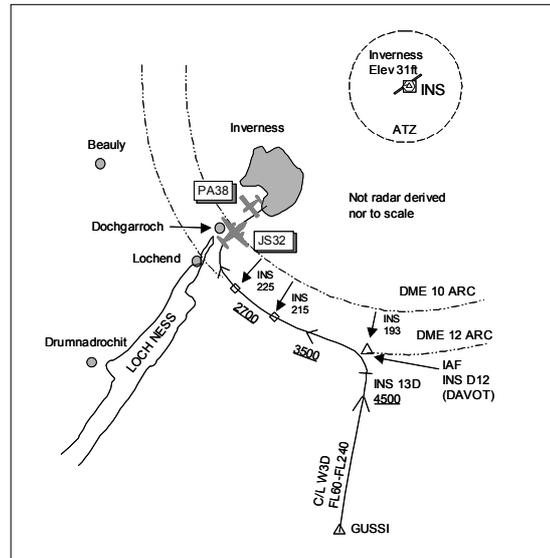
THE JS32 PILOT reports inbound to Inverness IFR via W3D having been cleared by Lossiemouth RADAR for an ILS approach onto RW05 squawking an assigned code with Mode C. The visibility was 30km in VMC and the ac's nav, strobe and landing lights were all switched on. About 20nm from Inverness he was transferred to Inverness TOWER on 122.6MHz and although 'visual' decided to carry out the new ILS procedure for training. The only traffic reported by ATC, he thought, was "a fast moving jet to the south" which was not affecting their flight (Inverness has no radar). Established on the ILS LLZ at 9nm heading 055° at 150kt and 2700ft QNH, the platform altitude, a blue/white PA38 was visually acquired moments before it passed down their LHS about 200m away and above, at between 2700-3000ft. This placed the PA38 on the extended C/L of RW23 and within 300ft vertically. He assessed the risk as high. They had not heard the PA38 pilot call on the radio during the time that they were on the same frequency prior to the Airprox. As far as they are aware, there are no VFR departure/arrival procedures at Inverness, something that in his view could be looked at owing to the increase in commercial traffic using the airport. The PA38 was then found to be on the frequency as the Tower controller asked its pilot "did you see the Jetstream" to which he replied "yes".

Cause: A very late sighting by the JS32 crew and a late sighting by the PA38 pilot.

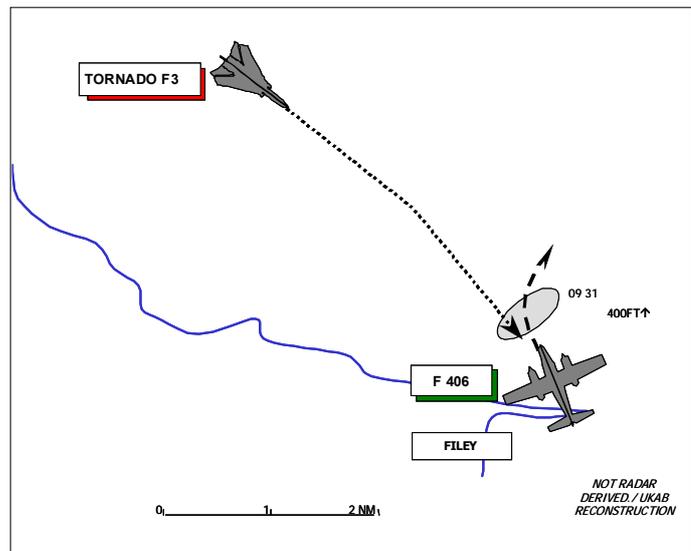
THE F406 PILOT reports flying a Fishery Patrol Flight from Humberside in a blue and white ac with no TCAS but with HISLs selected on, squawking 4100 (on the date of the incident, a Fishery Patrol code) in receipt of a FIS from Humberside. While heading 340° at 140kt following a 100ft pass of a fishing vessel which was operating close inshore and on passing the vessel he initiated a climb to their cruising altitude. When passing 400ft he sighted an ac ¾nm away heading in the opposite direction. He believed the pilot saw them as the other ac climbed and turned R. His major concern was that the other ac was heading S with a cliff face on its right hand side which had limited its ability to turn R when the pilot saw another ac heading in the opposite direction. After passing down his port side he lost sight of the ac however, both his First Officer and Systems Operator saw the ac climbing to approximately 1000ft in the vicinity of Flamborough Head before heading off in a Northerly direction. He commenced a R turn to avoid it and assessed the risk of collision as being medium.

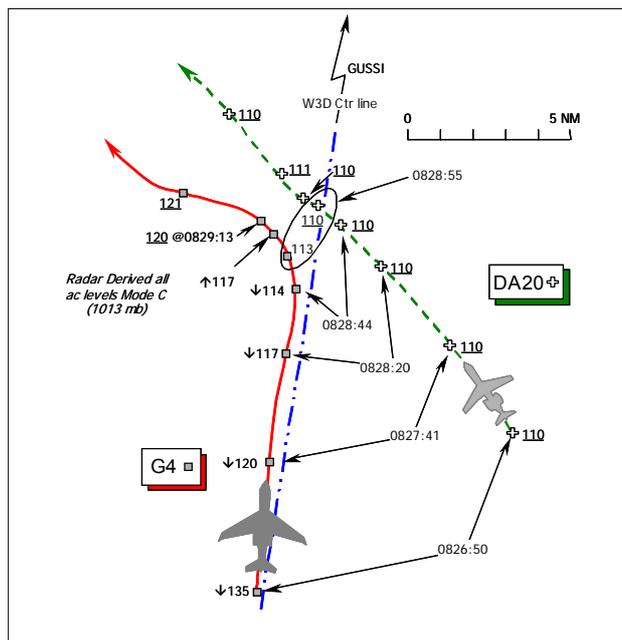
THE ScACC WEST COAST COMBINED TACTICAL & PLANNER CONTROLLER (W COAST SC) reports that the Gulfstream 4 was inbound to Inverness routeing ADR W3D. Just before he transferred the flight to Lossiemouth RADAR he had co-ordinated this ac with ScATCC (Mil) Console 4 (CON 4), to be not below FL120 against their traffic at FL110 tracking northwest – the Falcon 20. This co-ordination was duly passed on to Lossiemouth RADAR and accepted by the controller. The Gulfstream crew was then transferred to Lossiemouth ATC for an ATS approaching GUSSI, after which the Gulfstream's Mode C was observed to descend below FL120 into conflict with ScATCC (Mil)'s Falcon before making an avoiding action turn and climbing back up. STCA was triggered and prescribed separation was eroded, but he did not specify to what degree.

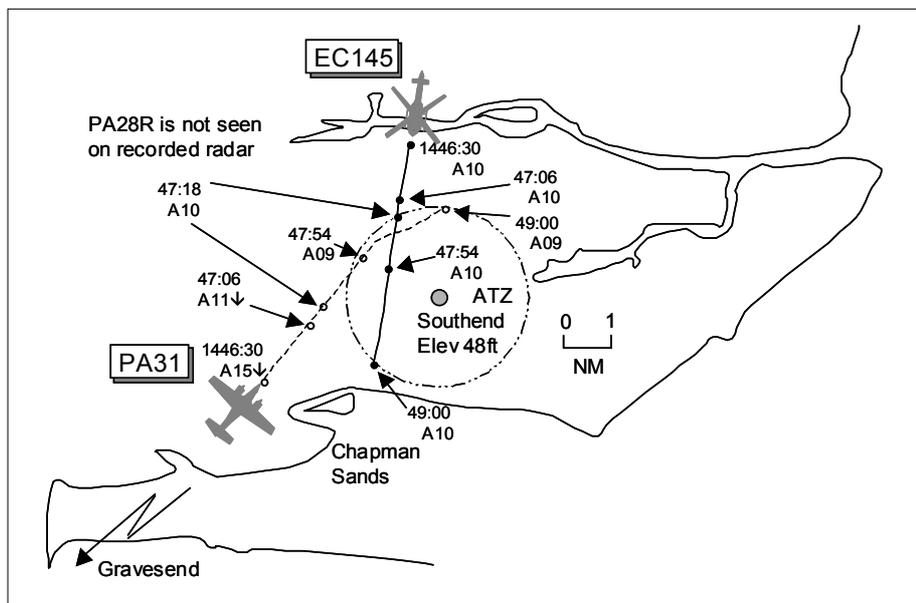
THE SOUTHEND APR reports that unknown traffic was observed on radar approaching the ATZ from the N. One of the 2 contacts was believed to be a PA28 (not the subject ac) on the frequency at 2400ft, but it was not positively identified. The other contact was tracking to pass about 1nm W of the overhead and was about 3nm NNW of the aerodrome when the PA28 pilot reported overhead. He asked the ADC to look out for this unknown traffic. At 1447, coincident with the traffic crossing the ATZ boundary, a call was received from an EC145 pilot, on handover from Stansted routing to Le Touquet at 1000ft. The unknown traffic was seen by the ADC as an EC145 inside the ATZ and in conflict with 2 ac in the visual cct, a PA31 and a PA28R. The PA31 pilot initiated his own avoiding action and the ADC gave avoiding action to the PA28R pilot. When he asked the EC145 pilot to confirm his position, he replied Gravesend although the Direction Finding (DF) trace did correspond with the contact on radar and the helicopter observed from the VCR. He passed TI to the EC145 pilot on the cct traffic and also informed him that he had possibly infringed the ATZ but no response was received and no further RT communication was established, despite trying several times.

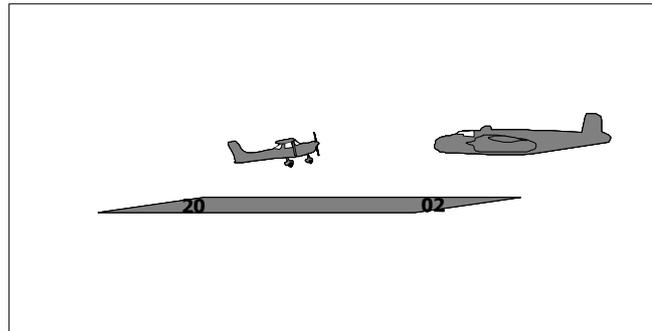
THE C172 PILOT reports flying a dark blue and white ac with strobes selected on from North Weald to a farm strip. Shortly before take off while she was in contact with North Weald Radio, she heard another ac call for joining instructions and call 'Base Leg'. She called ready for departure from RW 20 and shortly after called '*lining up for immediate departure*' and requested a L turn out onto track. As the RW in use was 20, she assumed the other ac was behind her. On take off she saw a twin engined Mitchell Bomber with its landing lights on coming towards her at the far threshold of the opposing RW and the same height. She made a L turn to avoid it, as a R turn would have taken her ac further across the Mitchell's path. It passed down her right side 300yd away, just above, and she assessed the risk of collision as being high.

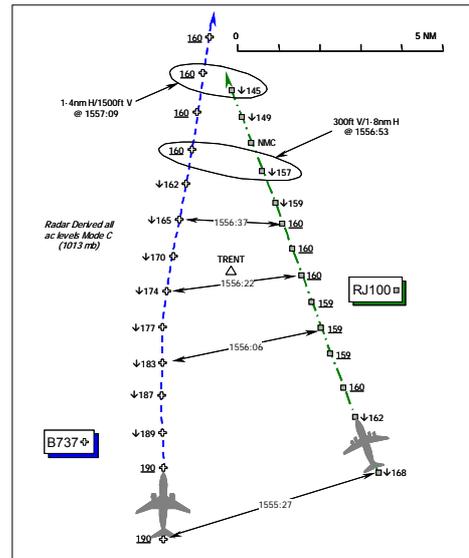
THE RJ100 PILOT reports that he was in descent into Manchester, NNW bound and in receipt of an ATC service from MACC. He was flying in VMC, with scattered cloud at 11,000ft and an in-flight visibility of 50km. In the vicinity of the TNT [TRENT] VOR in a stepped descent at 250kt from FL160 to FL140, a TCAS TA was enunciated on traffic at 10 o'clock - 5nm away, some 500ft above his ac and descending towards them. Upon passing FL150, ATC requested that they increase their rate of descent, whereupon a B737 was acquired visually at 10 o'clock at a range of 3nm. The autopilot & auto throttle was disconnected and the descent rate increased to 3500ft/min; the B737 passed through their 12 o'clock at 1½nm some 300ft above his ac. TCAS did not enunciate an RA. On arrival he discussed the occurrence with the MACC Watch manager. He did not assess the risk.

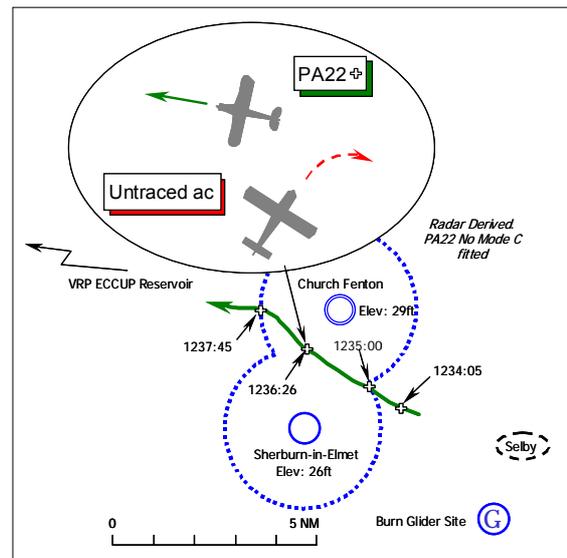
AIRPROX REPORT NO 128/04

THE PIPER PA22 PILOT reports he was flying from Sandtoft to Leeds Bradford Airport in his red & white ac, in level cruise at an altitude of 2200ft Leeds QNH (1013mb), some 1500ft clear below cloud with an in-flight visibility of 30km. Whilst contacting Leeds APPROACH (APP) overhead Selby, North Yorkshire he had taken up a track from North Selby to Eccup Reservoir (VRP) whilst in receipt of a FIS from APP, squawking the code assigned: the ac was not fitted with Mode C at the time of the Airprox. His planned track had consciously bisected the airspace between Sherburn and Church Fenton and he was approaching a position 2nm N of Sherburn Aerodrome at 1230UTC, he thought, heading 285° at 87kt. He opined that this is a busy section of airspace and during his lookout scan he saw a movement in his L peripheral vision. Upon turning his head to the 7o'clock he saw a white low-wing single engined ac – possibly a RANS RV6 or a Europa – passing behind him in a “max rate” turn to starboard with about 75° AOB. The minimum separation was about 50-75m at the same altitude: he added that it was hard to judge but the other ac was at most 100m away. He took no action to avoid the other ac himself as its pilot was turning away: moreover there was no time to do so. He assessed the risk as “very high”.

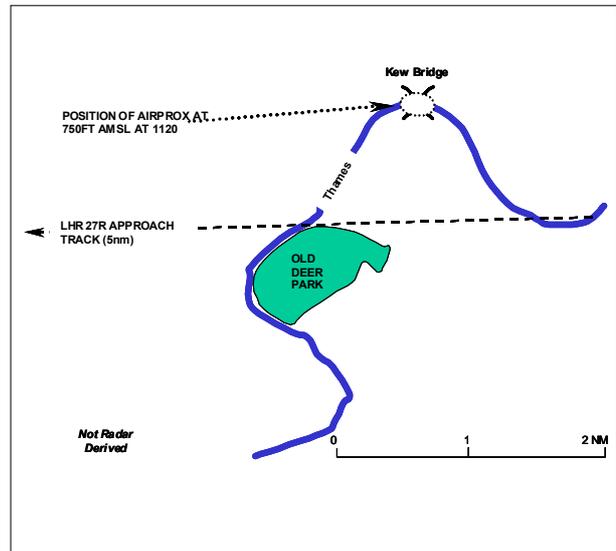
AIRPROX REPORT NO 129/04

THE AS 355 PILOT reports flying a white, blue and gold ac on a non-scheduled passenger sightseeing flight over London in contact with the Heathrow SVFR Controller and squawking as directed. He was flying at 750ft amsl at 125kt and heading 285° approaching Kew Bridge on route H10 when he saw what appeared to be a light fixed wing ac flying on the approach path for LHR 27R. He then realised that it was a radio controlled model ac and that it was very close (100ft away at about the same height) so he initiated a hard L turn to avoid it and tracked it visually as it passed from the front R windscreen past the R chin bubble window. It was close enough for him to make out the engine and sprung nose leg. As soon as it had passed, he turned hard R to avoid conflict with LHR inbounds and to maintain the Helicopter Route. He saw the model descending towards the central point of the river between Kew and Richmond Bridges. Neither he nor any of his 5 passengers, all of whom saw the model, could see any evidence on the ground of radio control activity.

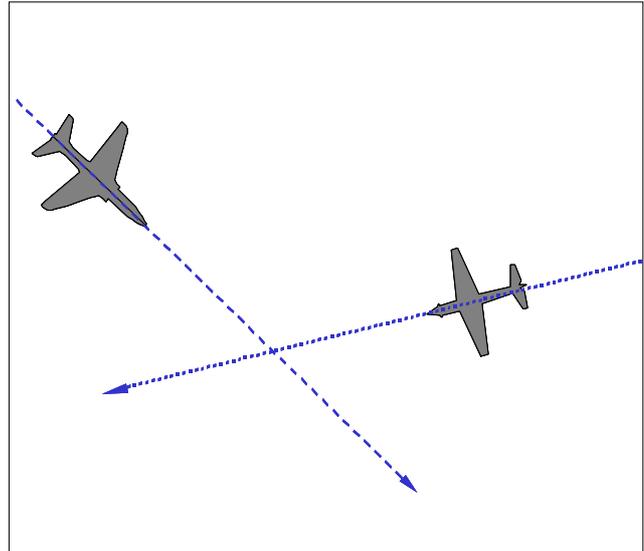
AIRPROX REPORT NO 131/04

THE TUCANO PILOT reports flying a black ac with HISLS and landing lights selected on squawking 7001 on a QFI instructional sortie in the UKDLFS. He was heading 255° at 240kt and as he levelled off at 250ft, having pulled up to cross a ridgeline, he spotted a Hawk in his 2 o'clock 1nm away on a converging heading, and slightly above his level. Because he was already beneath the Hawk and the valley was opening up in front of him, he bunted and the Hawk passed above and behind him. The Hawk appeared to be on a heading of ~140° and remained straight and level throughout the encounter.

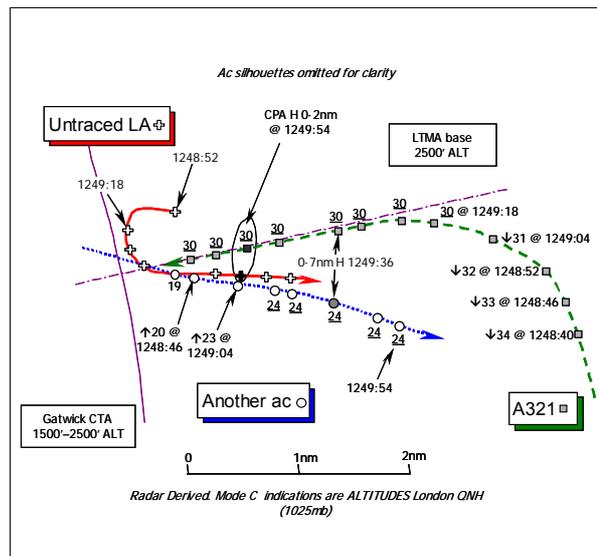
AIRPROX REPORT NO 132/04

Date/Time: 24 Jul 1249 (Saturday)
Position: 5112N 00011E (14nm finals RW26L London Gatwick - elev 196ft)
Airspace: LTMA (Class: A)
Reporting Ac Reported Ac
Type: A321 Untraced Light ac
Operator: CAT NK
Alt/FL: 3000ft NK
(QNH 1025mb) -
Weather VMC CLOC NK
Visibility: NR NK
Reported Separation:
100ft V/1/2nm H NK
Recorded Separation:
0.2nm H

Cause: Perceived conflict with an untraced LA close to the base of the LTMA.

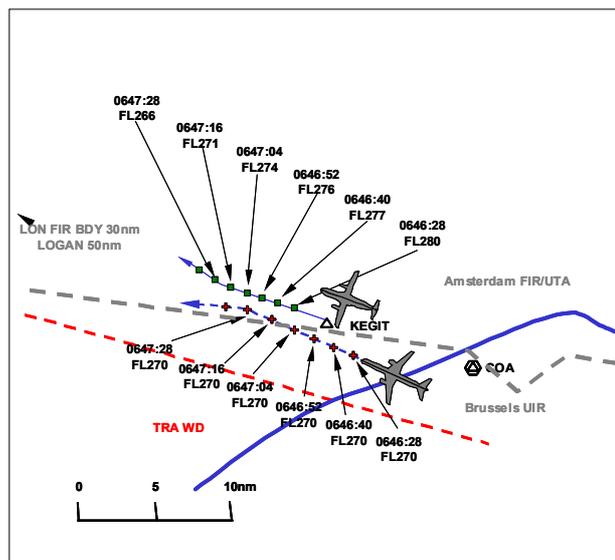
Recorded Separation:

100ft V/Min 2.1nm H. (0 V at 2.5nm)

Cause: The CLN SC descended the Do328 into conflict with the B757.

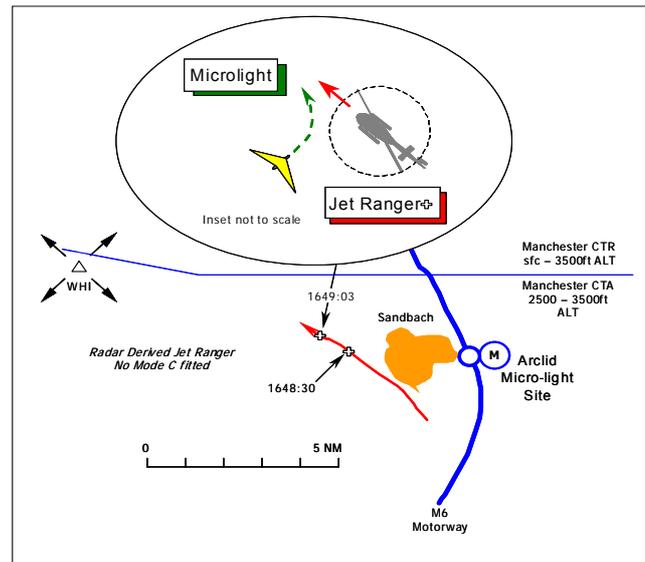
AIRPROX REPORT NO 134/04

Date/Time: 23 Jul 1649
Position: 5309N 00227W
 (2nm W of Sandbach)
Airspace: London FIR (Class: G)
Reporting Ac Reported Ac
Type: Microlight B206
Operator: Civ Trng Civ Trng
Alt/FL: 1500ft 1600ft
 (QNH 1024mb) ALT
Weather VMC CLBC VMC CLBC
Visibility: 20km >10km
Reported Separation:
 150ft V/nil H 200ft V/150m H
Recorded Separation:
 Not recorded

Cause: Late sightings by both pilots, the conflict being resolved by the microlight pilot.

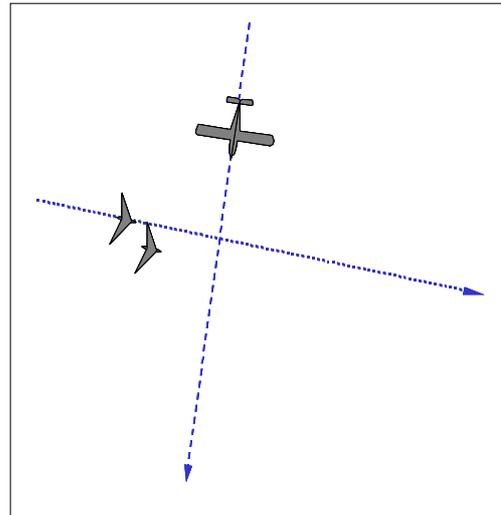
AIRPROX REPORT NO 135/04

Date/Time: 26 Jul 1807
Position: 5151N 00004W (NE of Ware)
Airspace: London FIR (Class: G)
Reporting Ac Reported Ac
Type: Microlight PA32
Operator: Civ Pte Civ Pte
Alt/FL: 1000ft 1200ft
(QNH 1018 mb) (QNH 1017 mb)
Weather VMC CAVOK VMC CAVOK
Visibility: 30km >10km
Reported Separation:
0 VI <100ft H ~700ft V/800ft H
Recorded Separation:
Not recorded

Cause: Non-sighting by the PA32 pilot and late sighting by the Microlight pilot.

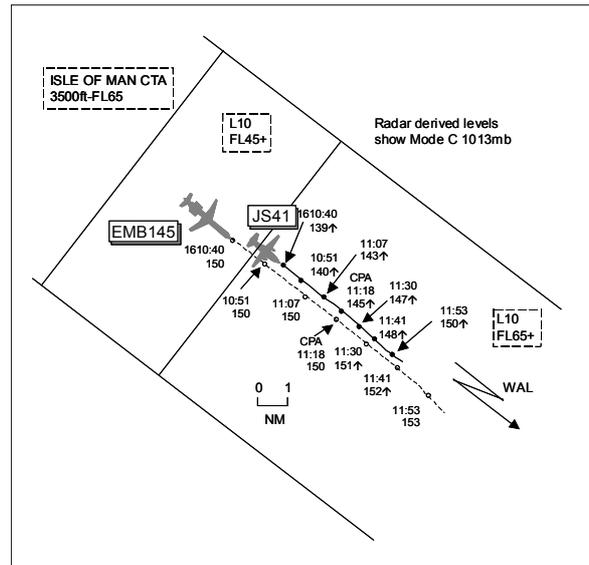
Date/Time: 26 Jul 1611
Position: 5345N 00400W
 (37nm NW WAL)
Airspace: AWY L10 (Class: A)
Reporting Ac Reported Ac
Type: EMB145 JS41
Operator: CAT CAT
Alt/FL: FL150 ↑FL170

Weather VMC CLNC NK
Visibility: >50km NK
Reported Separation:
 400ft V 0.5nm H NR
Recorded Separation:
 500ftV 0.3nm H

Cause: The MACC West/IOM RC did not ensure standard separation between the subject ac.

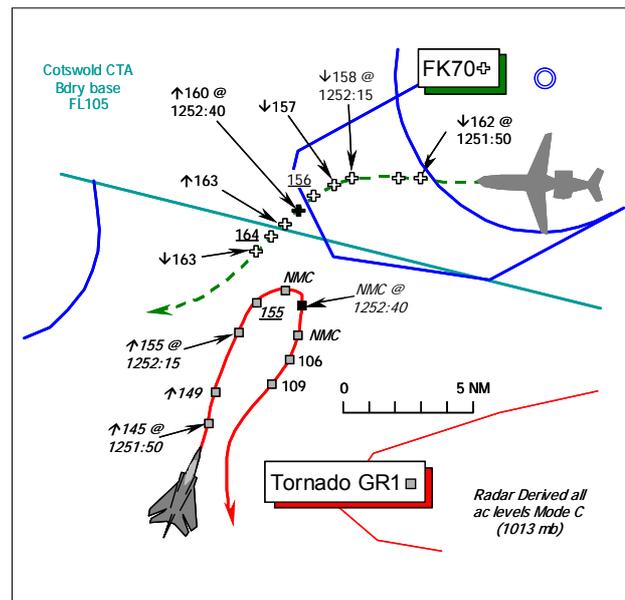
Recorded Separation:

3.7nm H

Cause: Acting on a perception of a possible CAS infringement, the Bristol APR turned the FK70 into conflict with the Tornado GR1.

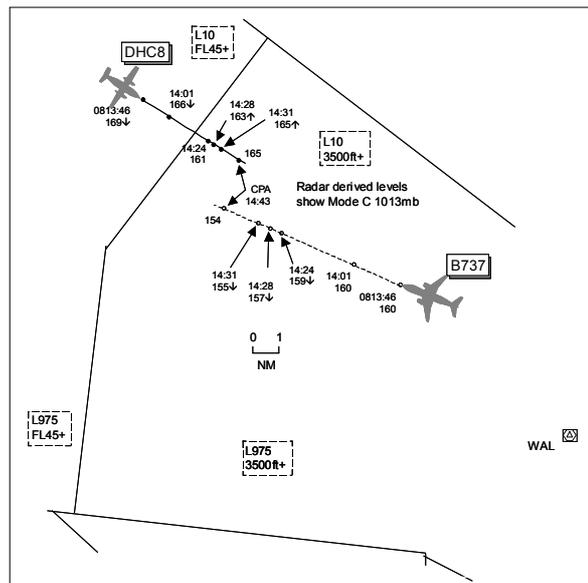
AIRPROX REPORT NO 139/04

Date/Time: 29 Jul 0815
Position: 5333N 00330W (16nm NW WAL)
Airspace: AWY L10/L975 (Class: A)
Reporting Ac Reporting Ac
Type: B737-200 DHC8
Operator: CAT CAT
Alt/FL: FL160 ↓FL110
Weather VMC CLAC VMC CLOC
Visibility: >10km >10km
Reported Separation:
1000ft V/2-5nm H 400ft V/0-25nm H
Reported Separation:
1100ft V 1-9nm H

Cause: The MACC West/IOM RC vectored the DHC8 and B737 into conflict.

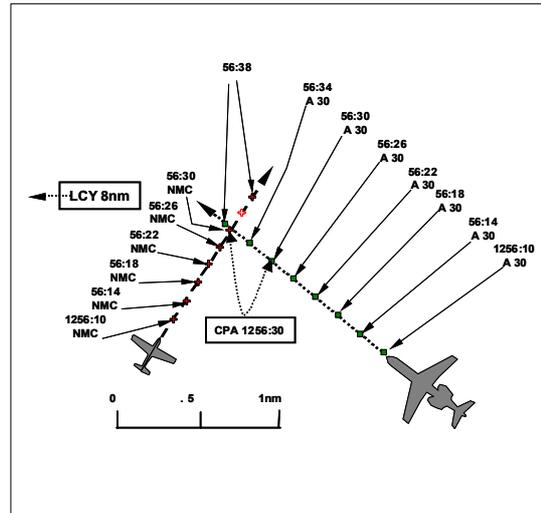
AIRPROX REPORT NO 140/04

Date/Time: 30 Jul 1256
Position: 5130N 00016E(8nm E Lon City)
Airspace: London TMA (Class: A)
Reporting Ac Reported Ac
Type: F900 Zlin 526F
Operator: Civ Exec Civ Pte
Alt/FL: 3000ft NR
 (QNH 1019mb)
Weather VMC CAVOK NR
Visibility: 10km NR
Reported Separation:
 0.2nm H/0ft V not seen
Recorded Separation:
 Not Recorded V/0-35nm H

Cause: The Zlin apparently entered Class A CAS without clearance and flew into conflict with the F900 which he did not see.

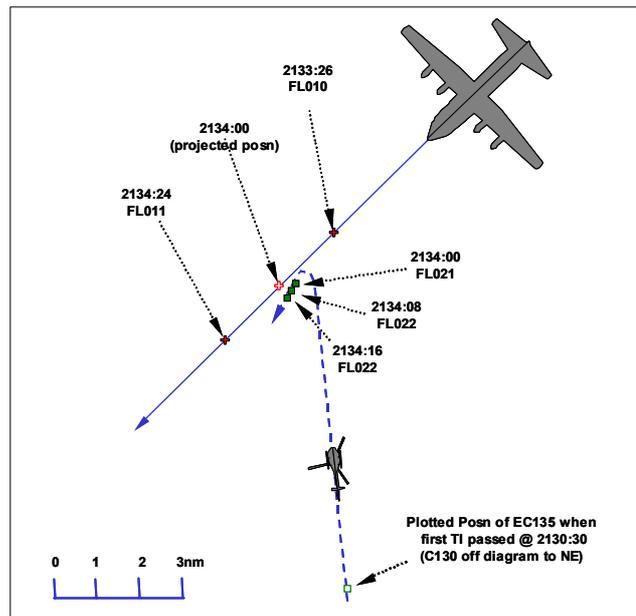
(Estimated from projected positions

1100ft V/ ¼ nm H)

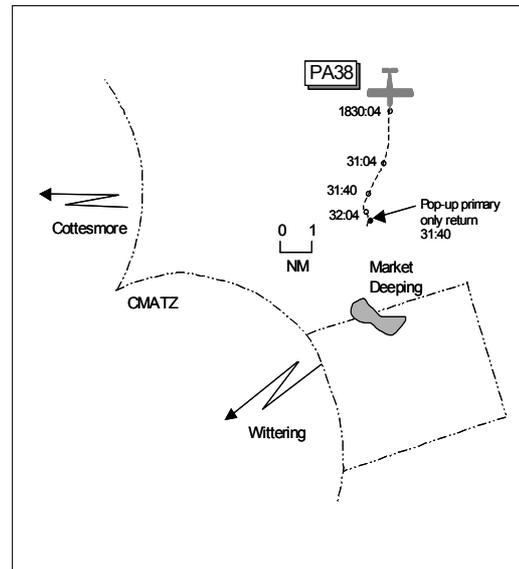
AIRPROX REPORT NO 145/04

Date/Time: 1 Aug 1832 (Sunday)
Position: 5244N 00019W
(3nm N of Market Deeping)
Airspace: LFIR (Class: G)
Reporting Ac Reported Ac
Type: PA38 Aviasud Mistral
Operator: Civ Pte Civ Pte
Alt/FL: 1000ft NR
(QFE 1021mb) NK
Weather VMC HAZE VMC CLNC
Visibility: 5000m >10km
Reported Separation:
Nil V/200m H NR
Recorded Separation:
Not recorded

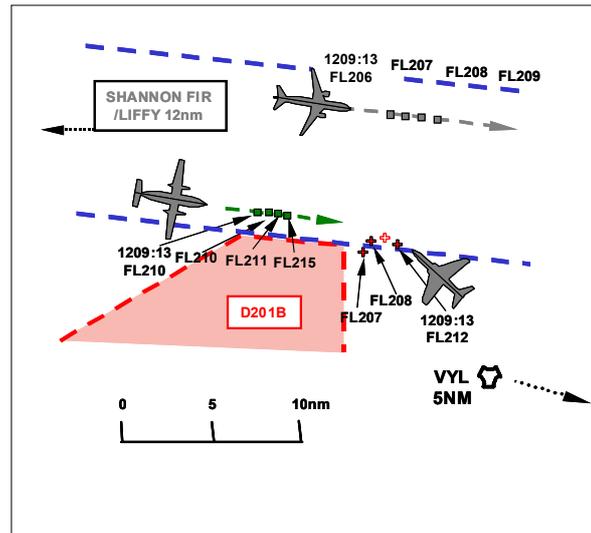
Date/Time: 3 Aug 1210
Position: 5328N 00503W (15nm East LIFFY)
Airspace: Airway L975 (Class: A)
Reporting Ac Reported Ac
Type: Dash 8-300 Hawk
Operator: CAT HQ PTC
Alt/FL: FL210 FL200

Weather VMC VMC CLOC
Visibility: 10km >10km
Reported Separation:
700ft V/5-6nm H Not seen
Recorded Separation:
500ft V/5.2nm H

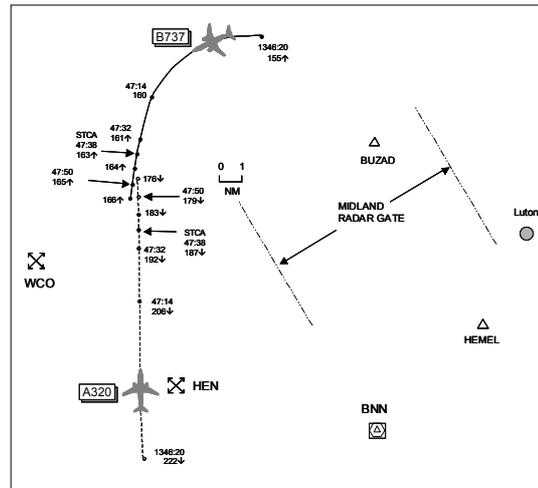
AIRPROX REPORT NO 147/04

Date/Time: 12 Aug 1348
Position: 5153N 00150W (5nm NE WCO)
Airspace: Daventry CTA (Class: A)
Reporting Ac Reported Ac
Type: A320 B737-800
Operator: CAT CAT
Alt/FL: ↓FL170 ↑NR
Weather VMC CLAC VMC CLOC
Visibility: >10km NR
Reported Separation:
600ft V/0.25nm H NR
Recorded Separation:
1200ft V 0.3nm H

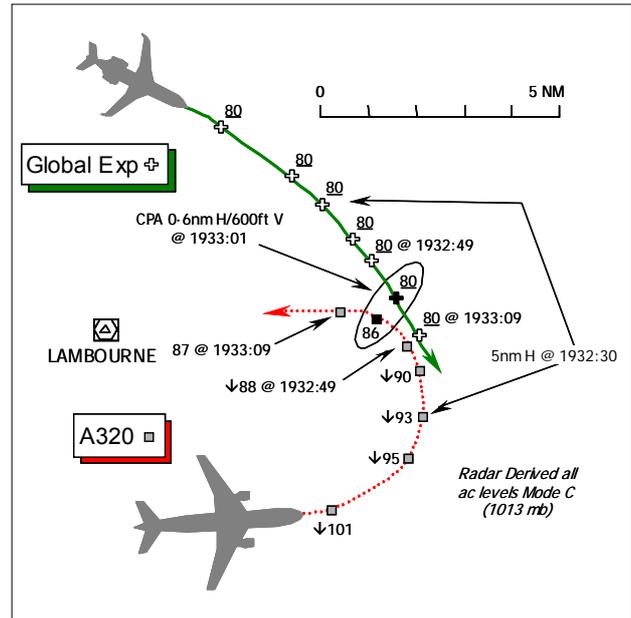
Recorded Separation:

600ft V/0.6nm H

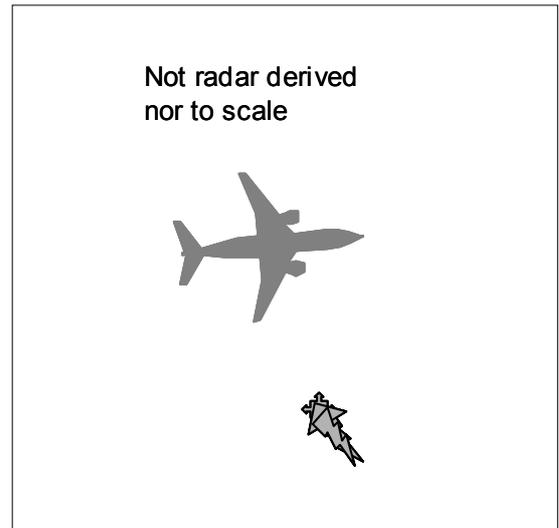
Date/Time: 15 Aug 1605 (Sunday)
Position: 5157N 00033W (8nm NW Luton)
Airspace: AWY L10 (Class: A)
Reporting Ac Reported Ac
Type: B737-300 Untraced Parachutist
Operator: CAT N/K
Alt/FL: FL100 (N/K)

Weather VMC CLOC NK
Visibility: >10km
Reported Separation:
 Nil V <0.5nm H
Recorded Separation:
 NR

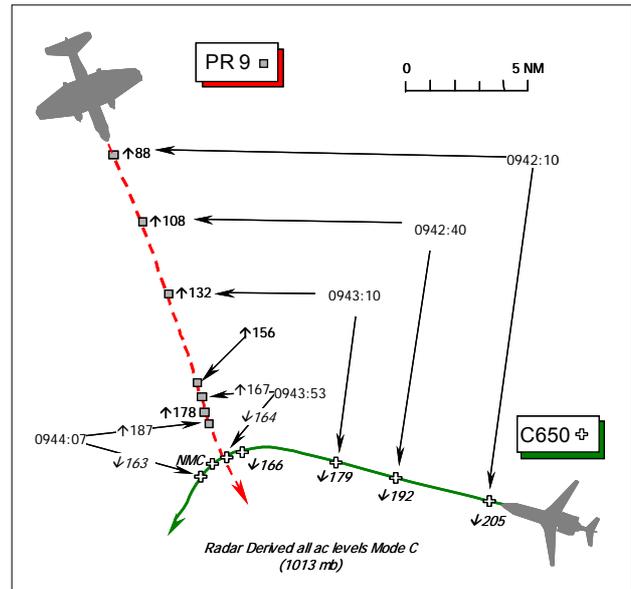
Recorded Separation:

2nm H

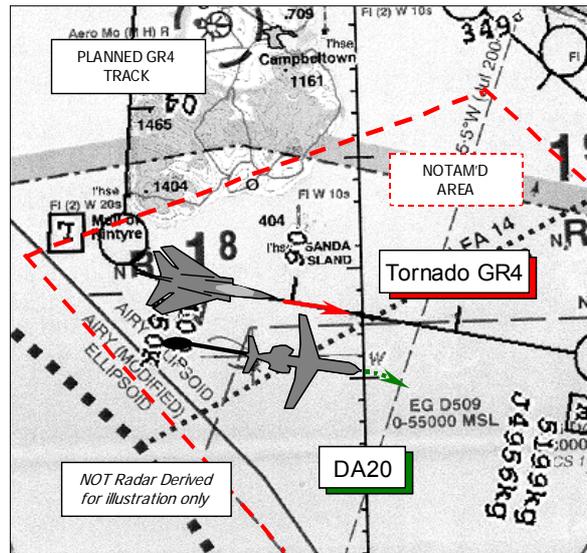
AIRPROX REPORT NO 152/04

Date/Time: 24 Aug 1100
Position: 5511N 00539W (10nm SE of Mull of Kintyre light)
Airspace: Scottish FIR (Class: G)
Reporting Ac Reported Ac
Type: Falcon DA 20 Tornado GR4
Operator: Civ Comm HQ STC
Alt/FL: 1800ft 250-750 ft
 (1004mb) (Rad Alt)
Weather VMC Sky Clear VMC HAZE
Visibility: 30km >15km
Reported Separation:
 1100ft V/2nm H Not seen (3nm)
Recorded Separation:
 Not recorded

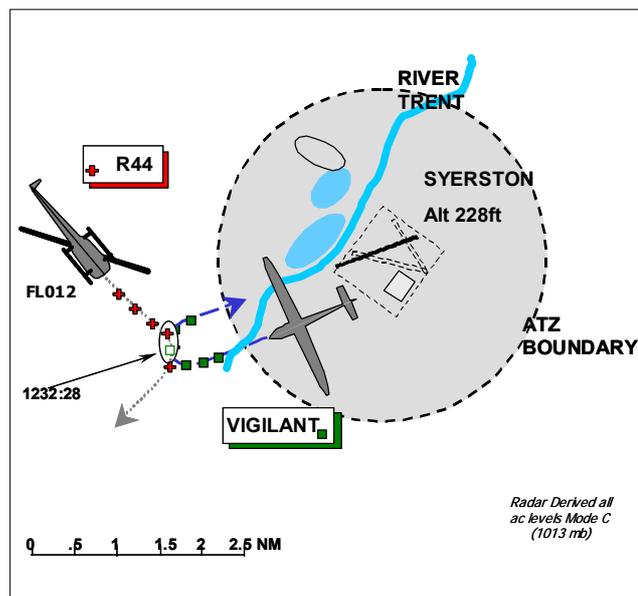
Recorded Separation:

Less than 300m H

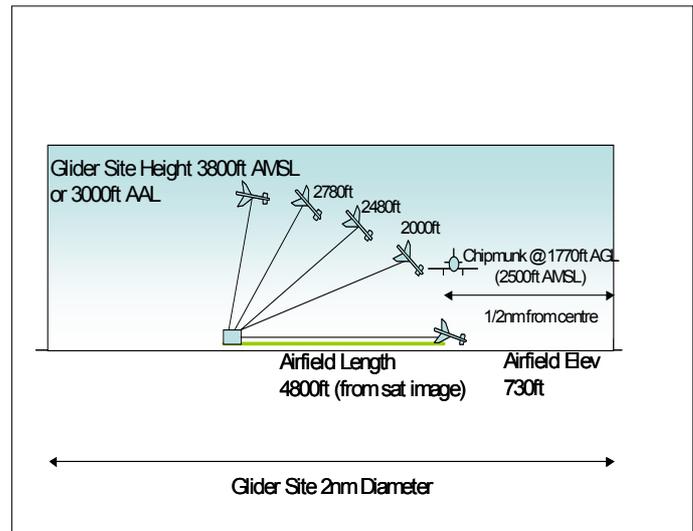
AIRPROX REPORT NO 155/04

Date/Time: 28 Aug 1357 (Saturday)
Position: 5120N 00132W (Rivar Hill Airfield - elev 730 ft)
Airspace: London FIR (Class: G)
Reporting Ac Reported Ac
Type: Astir Glider Chipmunk
Operator: Civ Club Civ Pte
Alt/FL: 800ft 2500ft
(QFE 987 mb) (RPS)
Weather VMC CLOC VMC CAVOK
Visibility: >10km >10km
Reported Separation:
100ft V/O H Not seen
Recorded Separation:
Not recorded

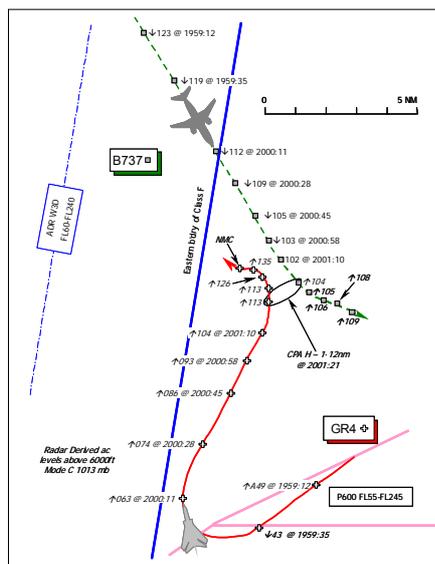
AIRPROX REPORT NO 156/04

Date/Time: 26 Aug 2001 Night
Position: 5622N 00406W (35nm NW of Edinburgh)
Airspace: Scottish FIR (Class: G)
Reporter: Edinburgh APR
First Ac Second Ac
Type: B737-300 Tornado GR4
Operator: CAT HQ STC
Alt/FL: FL100↓ NK
Weather IMC In Cloud NK
Visibility: "0" NK
Reported Separation:
NR Not seen
Recorded Separation:
900ft @ 1.12nm H

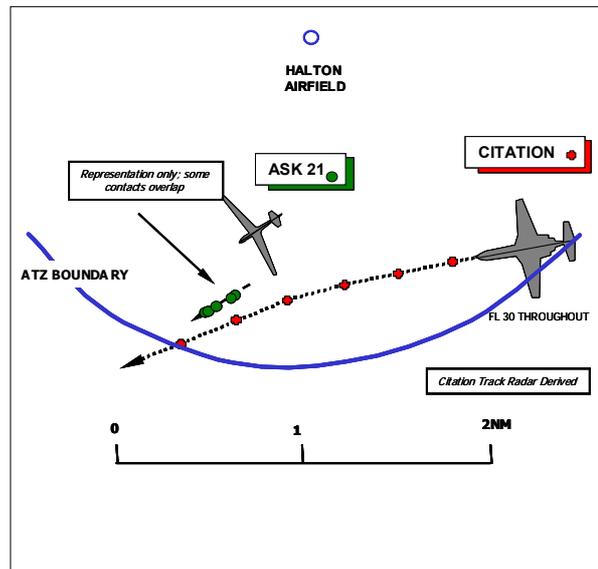
AIRPROX REPORT NO 159/04

THE ASK 21 PILOT reports flying a white glider on an instructional sortie from Halton, listening out on Halton Radio. While heading 200° at 50kt and at 2500ft agl, a low-wing twin jet ac passed him from his 6 o'clock displaced to his left by about 150m at the same altitude. As the commercial ac track was from behind his glider, he was unable to take any evasive manoeuvres. He expresses the view that the pilot of the jet apparently took no avoiding action as required by the rules of the air. He appreciates that the incident occurred in Class G airspace and that collision avoidance is achieved by the 'see and avoid' principle. He expressed great concern however, that a commercial operator chose to fly so close to a busy airfield which is clearly marked on CAA charts, which hosts intense operations by gliders, motor gliders, microlights, powered ac and tug ac.

Cause: The C560 pilot flew close enough to the ASK 21 to cause its pilot concern.

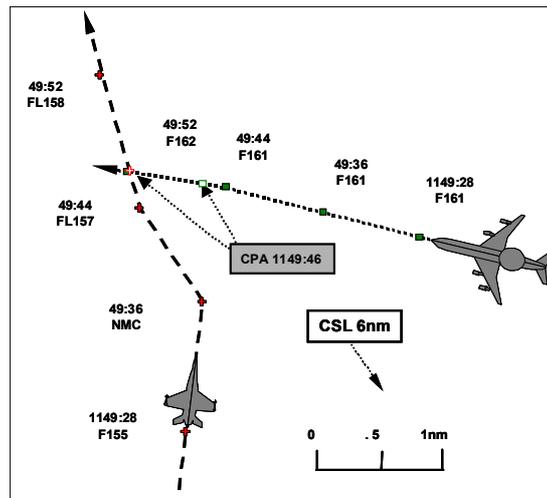
AIRPROX REPORT NO 160/04

THE E3D SENTRY PILOT reports recovering his ac from an overseas deployment IFR and OAT in receipt of a RIS from London Mil. While heading 290° at 360kt during the descent into Coningsby, ATC reported a large number of manoeuvring ac to NW of their position. TCAS initially indicated 4-6 contacts between 10-12 o'clock at 4-6000ft below. While the crew tried to locate the contacts visually, TCAS gave TA. At that point crew visually acquired the TA traffic about 5nm away, low in their 10 o'clock and manoeuvring. Their descent was stopped at FL160 whilst the conflicting traffic's flight path was assessed but the traffic continued to manoeuvre into their path and caused TCAS RA and the pilot reacted to RA climb instruction. The crew maintained visual contact with traffic throughout. An Airprox was reported to London Mil and he assessed the risk as being moderate.

Cause: Conflict in the FIR.

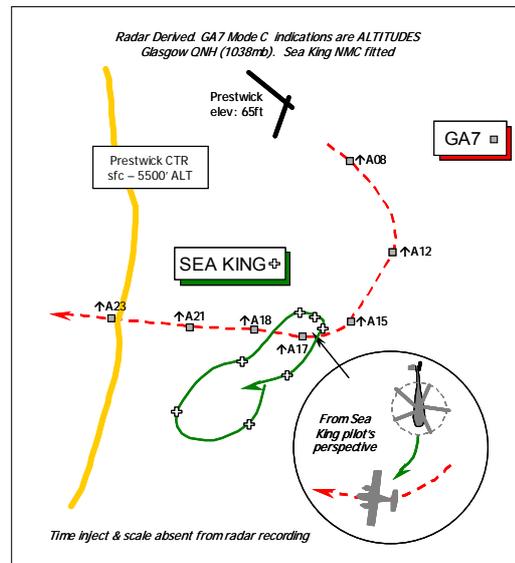
AIRPROX REPORT NO 161/04

THE WESTLAND SEA KING MK5 PILOT reports his SAR helicopter has an ocean grey and red colour scheme and the HISL, landing lamp and forward facing floodlights were all on whilst flying in the RH circuit to RW03 at Prestwick Airport conducting practise autorotations under VFR. There was no cloud and a visibility of 20km+, but he was looking into the sun. An SSR Mode A squawk of A4514 was selected but Mode C is not fitted. Neither TCAS nor any other form of CWS is fitted. He was in receipt of an Aerodrome Control Service from Prestwick TOWER on 118.15MHz. The ac crew complement included a co-pilot, observer and aircrewman.

Cause: Effectively a non-sighting by both pilots, despite traffic information being passed to both flights.

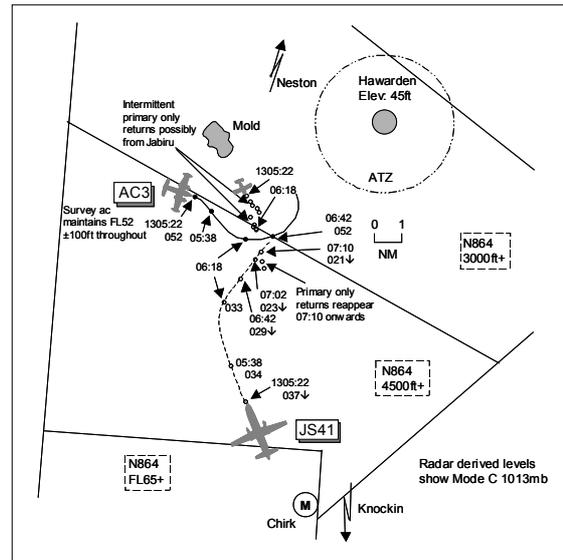
THE JS41 PILOT reports being coordinated by Manchester ACC (MACC) initially, and vectored around a surveillance ac before being turned back towards Hawarden and handed-over to APP. The weather was CAVOK and he reported visual with the airfield and intercepted the ILS LLZ. Descending through approximately 3000ft QNH 1034mb on the G/P heading 042° at 130kt, the APP told him that a survey ac was a target to his L either at FL50 or possibly 5000ft, he was not sure, and above. He looked L and spotted what he thought was a C172 coloured white in his 1030-11 o'clock position range 400m on a converging, almost head on, track about 200ft above his level of 2700ft. He called out "registration XXXXX", realised that it would pass over their ac, which it did, and as they were descending took no avoiding action. He assessed the risk as high. He later learnt that the ac sighted was a microlight similar in design to a C172 but half the size which would have meant that it had passed within 100ft vertically of their ac. During a conversation with Hawarden ATC after landing he learnt that the survey ac had been a C310 type.

Cause: Late sightings by both crews, the conflict being resolved by the Jabiru pilot.

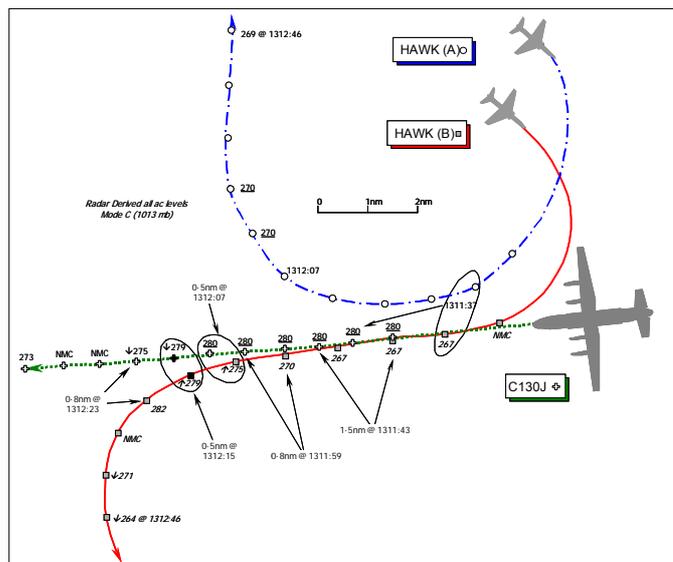
THE C130J PILOT reports his ac has a grey camouflage scheme but the HISLs were on whilst flying IFR in level cruise in VMC, outbound from Lyneham to Gander. He was in receipt of a RCS from LONDON CONTROL at LACC on 132.95MHz, the applicable squawk was selected with Mode C and TCAS is fitted.

Cause: The pilot of Hawk (B) climbed above his cleared level toward the C130, thereby inducing the TCAS RA.

[Post meeting note: In the course of the Chairman's researches, he was advised by Head of Air Traffic Standards Department (Hd ATSD), Safety Regulation Group, CAA, that a review of the policies and procedures associated with intercepts of aircraft operating as GAT and/or under the control of a civil ATSU is underway. It was therefore judged that a Safety Recommendation is not warranted. Hd ATSD undertook to advise Director UKAB on the outcome of the review. Action will be recorded.]

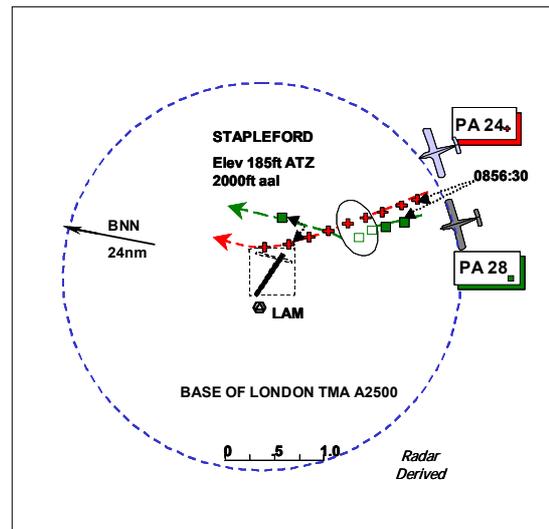
AIRPROX REPORT NO 164/04

THE PA28 PILOT reports flying a local pleasure flight from Denham with one front seat passenger in a white ac with blue stripes with anti-collision and landing lights selected on. He was flying straight and level at 2200ft, heading 280° outbound from LAM at 95kt, just to the W of Stapleford [see UKAB Note 2] and listening out on their Air/Ground frequency. He had seen many other ac in the well known busy airspace, when his previously briefed passenger alerted him to an ac on their right wing. He first saw the other ac at a distance of 50m at the same level and immediately initiated a level left turn to avoid it, since he thought the ac were on a collision course. The other ac did not appear to change its heading or altitude, as if the pilot had not seen them. He did not report the incident over the radio at the time due to his shock and reassuring his passenger; he did however call Stapleford on his return to Denham, but they had had no report from the other pilot. He assessed the risk as being very high.

Cause: In an overtaking situation the PA24 pilot flew into conflict with the PA28.

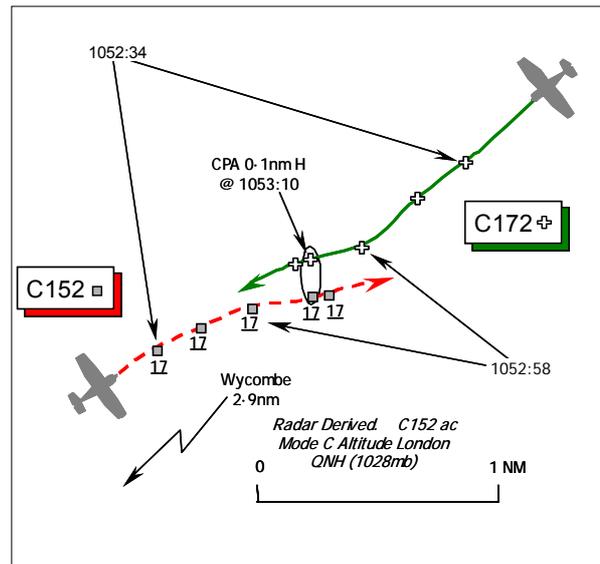
AIRPROX REPORT NO 165/04

THE CESSNA C172 PILOT, a flying instructor, reports he was instructing a student on a navigational exercise from Denham and was listening out with Denham A/G Station on 130.72MHz. The ac has a predominantly white colour-scheme and the HISL, landing and taxi lamps were all on. The conspicuity squawk of A7000 was selected, but Mode C was selected "off".

Cause: Conflict in the FIR resolved by the C172 pilot

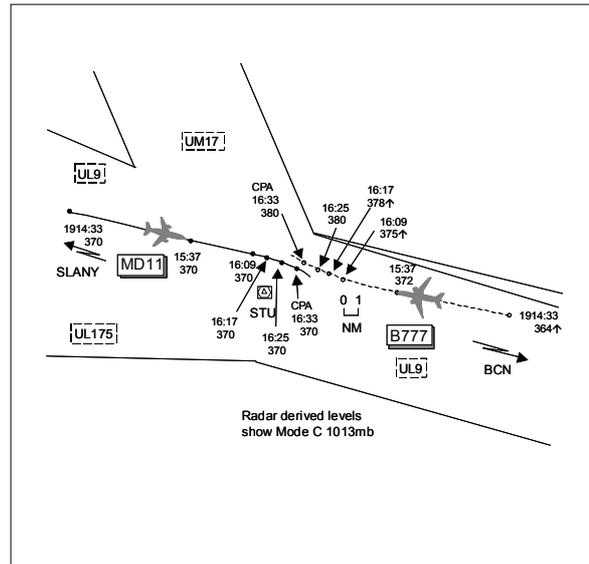
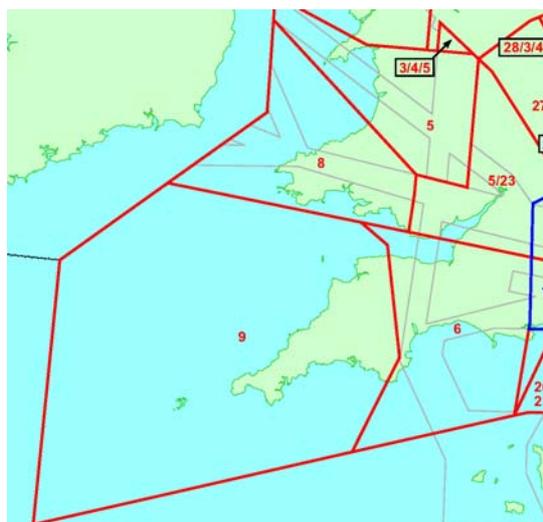
AIRPROX REPORT No 166/04

THE B777 PILOT reports en route to the USA and in receipt of an ATS from London on 129.37Mhz. Climbing through FL372, the ac tried to regain speed so reduced ROC to 300fpm. A conflicting ac was seen on the TCAS display flying in the opposite direction at FL370 about 12-15nm ahead. On receipt of a TA alert, the crew tried to increase the ROC by reducing speed which was followed by ATC giving them an immediate R turn onto 340°. Soon thereafter, when separation had reduced to about 6nm and -600ft, an RA warning was received; the A/P was disconnected and the RA guidance was followed. He ass

Cause: The S6/8&9T (A) routed the MD11 into conflict with the B777 which the S6/8&9T (B) did not detect.

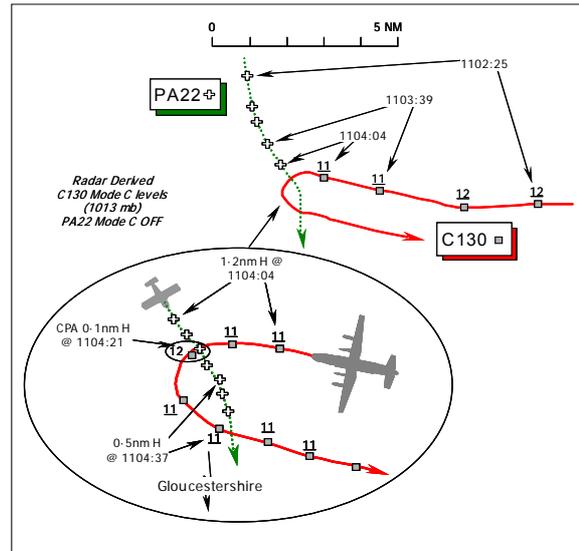
AIRPROX REPORT NO 168/04

THE PIPER PA22 COLT PILOT reports that his ac has a Beige/blue colour-scheme and he was flying in CAVOK conditions with an in-flight visibility of 25nm+. He was in transit from Wolverhampton to Kemble VFR at 100kt and was just in the process of calling GLOSTER APPROACH for a FIS. A squawk of A7000 was selected but the Mode C was selected “off”. TCAS is not fitted.

Cause: Effectively a non-sighting by the C130 pilots and a late sighting by the PA22 pilot.

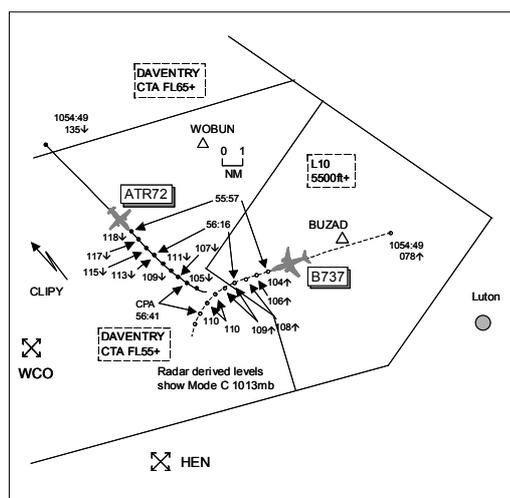
AIRPROX REPORT NO 169/04

THE B737 PILOT reports outbound from Stansted IFR and in receipt of a RCS from London on 119.77MHz squawking 2237 with Mode C. Having been cleared to FL120 heading 260° at 280kt, ATC requested, forcefully, for them to level at FL110, they were passing FL103 at the time, and to turn L heading 180°. FL110 was selected, as a TCAS RA annunciated, and the Capt, PF, took over manually and followed the avoiding action (momentary bank angle 35°). As the weather was excellent VMC (no cloud and 100nm visibility), the PNF visually acquired the other traffic, a high wing twin engine type, nose-on, in their 2 o'clock 800m away as they passed at the same level. Minimum lateral separation remained at 800m, crossing ahead of the other traffic, and as it passed to their R 200ft below, also turning away following ATC instructions. He assessed the risk as high. The Capt went on to say that the TCAS warning, directly to an RA, was received when taking the ATC avoiding action and thankfully they were in unison as it would have been very difficult to reverse the max rate turn.

neither gave a true picture of the complexity of the situation. The NW DEPS SC had a busy and complex traffic situation and, for whatever reason, he had not taken the ATR72 into account when he climbed the B737 into conflict which had caused the Airprox. The ATR's SSR label had been overlapping that of another ac at the time that the climb clearance was issued, although the confliction should have been apparent from the fpss. Having resolved the confliction between the B737 at FL80 and 2 transiting ac at FL90, he had, in the belief there was no traffic to conflict, climbed the B737 to FL120.

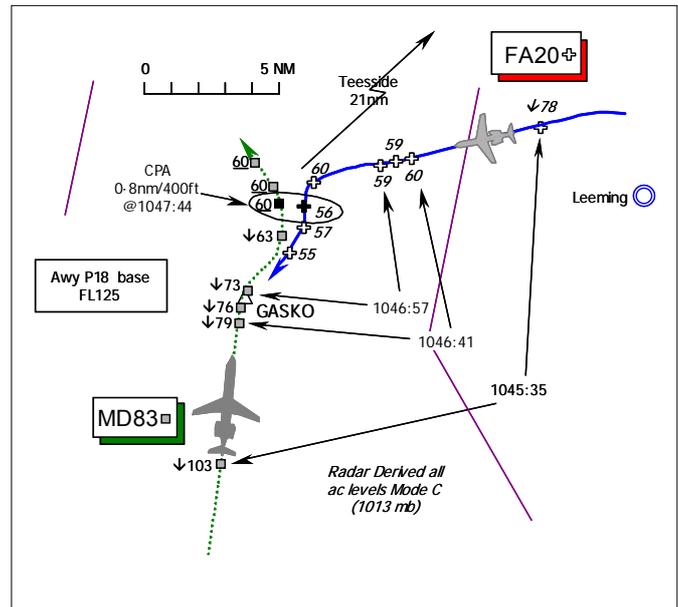
AIRPROX REPORT NO 170/04

THE TEESSIDE APPROACH RADAR CONTROLLER (APR) reports that MD83 was inbound to the airport and was squawking A5376 with Manchester and then allocated A7056 with Teesside RADAR. At about 1040 he informed Leeming about the inbound MD83, which was at that time approx 10nm W of the LBA, whereupon he was advised that Leeming had “nothing to affect”. When the MD83 crew called him on frequency he issued a descent to 4500ft Teesside QNH (1033mb) (in anticipation of a departure from Leeming which would be climbing to 3500ft). As the ac approached GASKO, Leeming ZONE called with traffic 20nm NW of Teesside maintaining FL55 and one track 5nm W of Leeming leaving FL60 descending to FL50, squawking A0402. He subsequently co-ordinated descent for the MD83 “to maintain FL60 until clear” so he immediately instructed the MD83 crew to “stop descent FL60”, under the RAS which he reports he was providing. This was not read back so he repeated the instruction whereupon it was then acknowledged by the MD83 pilot. As the MD83 was passing approx FL70 he observed the Mode C on Leeming’s A0402 squawk at FL55. He instructed the MD83 to “continue on your present heading” then stopped his descent at FL65. The A0402 then started a climb back to FL60 so he immediately turned the MD83 to the L onto a heading of 330° but the contact turned with him so he reversed the turn onto E. He called the traffic to the MD83 crew again but the contact again appeared to turn with him and the two ac passed within 1nm with a vertical separation of 300ft, he thought, on Mode C. The MD83 pilot advised he had the other ac on TCAS and was also visual with it but he did not seem unduly concerned as to its closeness. Standard separation was eroded down to 300ft vertically and 1/4nm horizontally. The MD83 was then positioned onto the ILS for RW05.

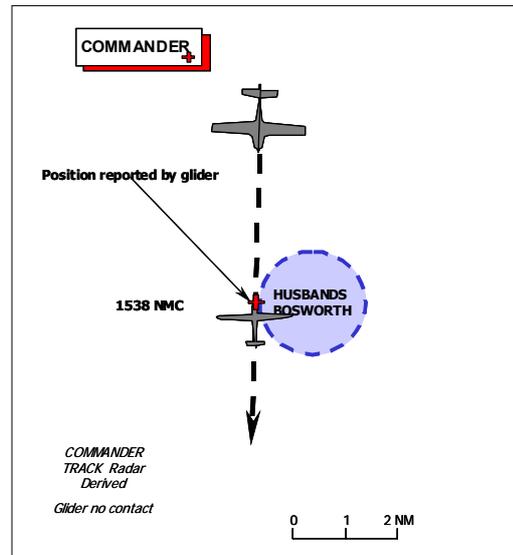
AIRPROX REPORT NO 171/04

THE ASK 21 GLIDER PILOT reports flying a GH instructional flight with a student in the front cockpit, from Husbands Bosworth (HB) in a white glider with no lighting, but in communication with HB radio. The flight had involved turn practice and co-ordination using the control column only and satisfactory progress had been made and so the instructor considered that they should attempt use of the rudder. Although they had briefed on the importance of a good look out his forward view from the rear cockpit was restricted. Whilst the student's head was lowered in the front cockpit adjusting the rudders, the instructor observed a low wing monoplane approaching fast and head on. The ac's predicted path was very slightly lower and to the left of him so immediate avoiding action was necessary to avoid a collision. The instructor executed a tight right turn and whilst in this turn he felt the glider shudder in the wake of the other ac as it passed. He continued the turn for a full 180° and saw the ac continuing on its original heading and level. Even if the pilot had not seen him head on they must have seen the glider in plan form as he banked tightly. He estimated the closest proximity to be less than his wingspan of 15m. The incident occurred less than 2nm from the airfield which is marked on maps as an area of intense gliding.

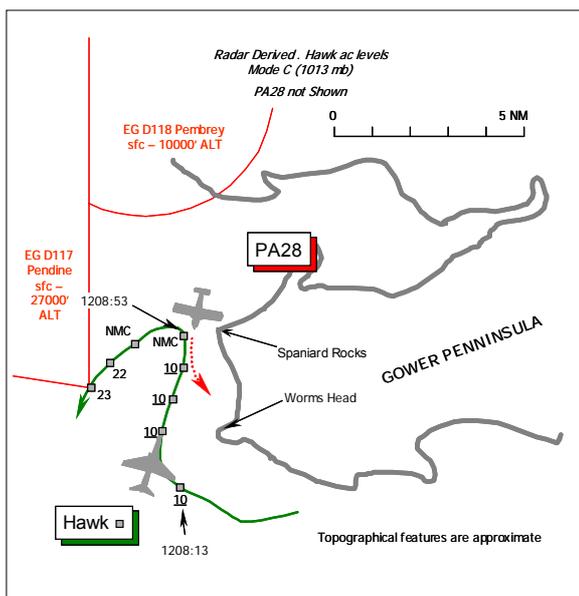
THE HAWK T1 PILOT, a QWI, reports his ac has a black colour-scheme and the HISLs were on whilst flying an instructional range sortie with a student at Pembrey Air Weapons Range (AWR). Flying in VMC, some 1000ft clear below cloud, in between layers where the visibility was "good", he was in contact with Pembrey on UHF 'Range Primary' and operating under a FIS, whilst squawking A7002 [the Danger Areas' general conspicuity squawk] with Mode C. Neither TCAS nor any other form of CWS is fitted.
