UK AIRPROX BOARD

Analysis of Airprox in UK Airspace

**Report Number 13
July 2004 - December 2004**

Thirteenth Report by the UK Airprox Board:

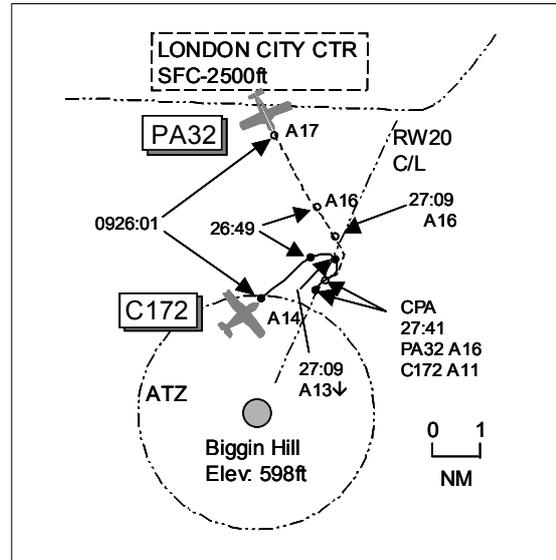
AIRPROX REPORT NO 173/04

THE PA32 PILOT reports flying VFR to Biggin Hill from Wellesbourne Mountford routing inbound from the N planning to arrive via a direct approach onto RW21. The visibility was >10km in VMC and the ac was coloured white/red/blue with wing-tip strobe and pulse lights switched on. He was working Thames RADAR on 132.7MHz for a zone crossing clearance of London City airspace whilst a second pilot onboard (P2) contacted Biggin APPROACH on VHF COM Box 2 to establish joining and landing instructions having previously obtained the latest information on the Biggin ATIS. Thames Radar had told him that a C172, not the subject reported ac, was on an ILS approach for RW21 at Biggin Hill at 7 DME. When P2 rejoined him on the Thames frequency, it was agreed that they would commence a RH orbit on the BIG 010° RAD and change frequency to Biggin Hill on 129.4MHz to request further instructions. Biggin ATC told them that they were working 4 ac, the first to land being the previously mentioned C172 from its ILS approach to be followed by a PA38 in the cct. ATC asked whether they had completed the orbit and if they had the PA38 in sight. After confirming they were visual with the PA38 and that they were halfway around the orbit (turning through heading 310°), they were told to complete the orbit and proceed via a R base leg to final approach. ATC also informed them that a fourth ac, a Cessna (the subject ac) would be positioning No 4 in traffic behind them and its pilot had been instructed to orbit LH on the downwind leg (RW21 is a RH cct) and to join final approach behind their ac. As they closed onto RW21 final approach at 120kt the controller asked them to verify that they were on final approach but this request had to be made 3 times as another ac's pilot was responding to the RT calls. During his descending R turn at 4.2DME BIG at 1200ft QFE 999mb, the onboard Skywatch system gave a TA alert on traffic 300m away and showing 300ft below. The descent was stopped with 200ft vertical separation and nil horizontal separation indicated. After he opened the radius of the R turn and commenced a climb, he saw the other ac, a white coloured high winged type, in a 15° R banked descending turn onto final approach. Biggin ATC told him that the other ac should have been orbiting on the downwind leg. He reported that he would be filing an Airprox and assessed the risk as medium, owing to the Skywatch warning, otherwise he believed it would have been high.

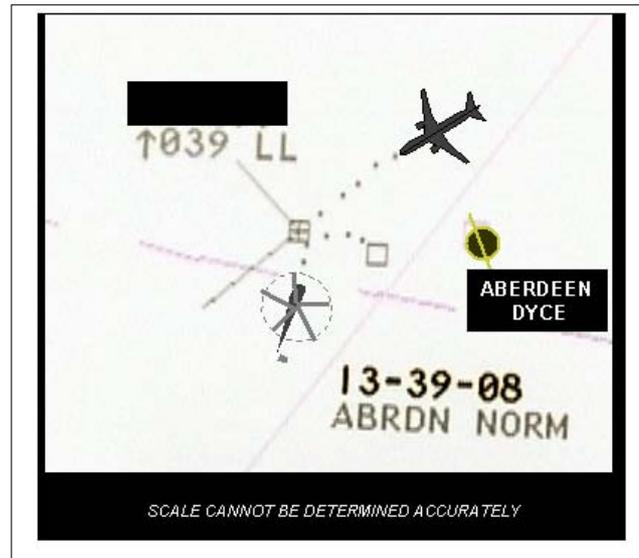
AIRPROX REPORT NO 174/04

THE AS332 PILOT reports flying a local training sortie from Aberdeen with all his lights selected on but with his SSR to standby. They were orbiting at 100kt in a wide downwind position in the circuit, awaiting clearance to conduct an autorotation, when he saw an ac take off from RW34 and turn left into conflict with them. Being night and raining its range was hard to determine. Having seen the other ac he manoeuvred to clear it: had they had not done so they would have come very close to it. Neither he nor the crew of the departing ac had been warned of each other's presence. He assessed the risk of collision as being medium.

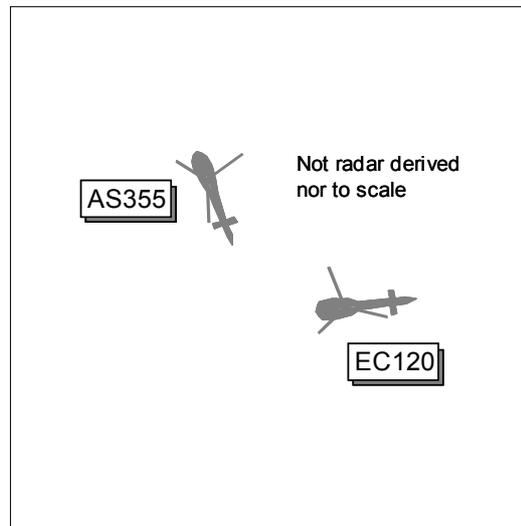
AIRPROX REPORT NO 175/04

THE AS355 PILOT reports heading 340° at 5kt in a hover at Radyr near Cardiff City at 500ft agl and in receipt of a FIS from Cardiff APPROACH on 126.62MHz squawking a discrete code with Mode C. The visibility was 10km in VMC and the helicopter was coloured dark blue/yellow with nav, strobe and night-sun spotlight all switched on. ATC gave him TI on unknown traffic not working the ATSU but displayed on the Cardiff radar heading in his direction. This traffic was displayed on his TCAS equipment about 5nm away but it was not sighted at the time. TCAS gave a warning alert and nothing was seen immediately until he looked over his R shoulder through the rear R window and saw a red coloured EC120 helicopter passing 100m behind at the same level in a descent to a private landing site. He assessed the risk as high.

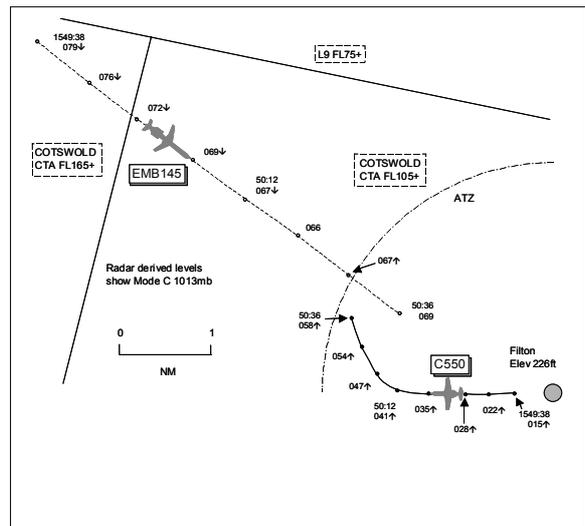
Date/Time: 22 Sep 1550
Position: 5132N 00238W (2nm WNW Filton -
Airspace: LFIR (Class: G)
Reporter: Bristol APR

<u>First Ac</u>	<u>Second Ac</u>
<u>Type:</u> EMB145	C550 Citation
<u>Operator:</u> CAT	Civ Exec
<u>Alt/FL:</u> FL66↓	↑FL70
<u>Weather</u> VMC CLAC	IMC CLAC
<u>Visibility:</u>	
<u>Reported Separation:</u>	
NR	1200ft V 0.25-0.5nm H
<u>Recorded Separation:</u>	
1100ft V 0.5nm H

Cause: The Filton APR broke the agreed coordination and climbed the C550 into conflict with the EMB145.

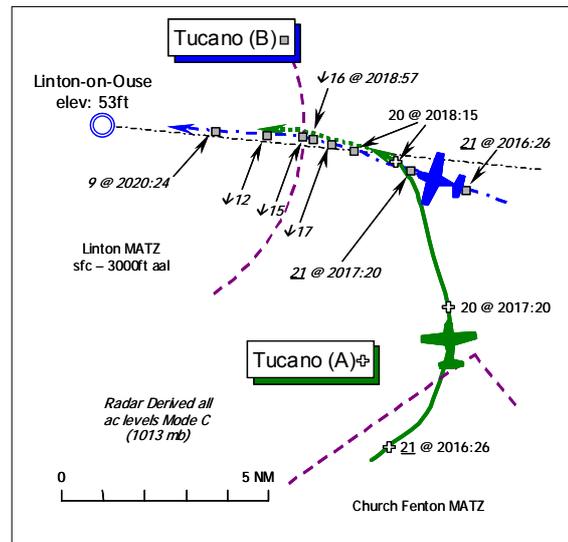
AIRPROX REPORT NO 177/04

Date/Time: 22 Sep 2019 NIGHT
Position: 5402N 00103W (5nm finals RW28 at Linton-on-Ouse - elev: 53ft)
Airspace: MATZ (Class: G)
Reporting Ac Reported Ac
Type: Tucano Tucano
Operator: HQ PTC HQ PTC
Alt/FL: 1800ft 1500ft
(QFE 1009mb) (QFE 1009mb)
Weather VMC CLBC VMC CLBC
Visibility: >10km >10km
Reported Separation:
33ftV/50m H 50ft V/50ft H
Recorded Separation:
Not recorded

Cause: Having lost visual contact, the crew of Tucano (A) flew into conflict with Tucano (B).

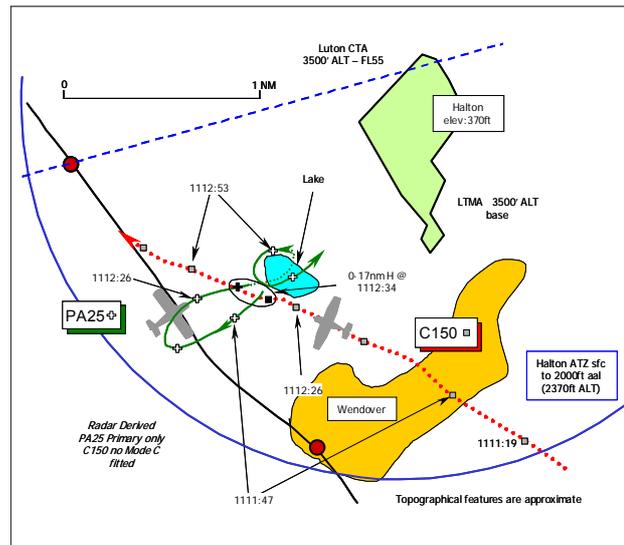
Cause: Conflict in the vicinity of the Halton ATZ resolved by both pilots.

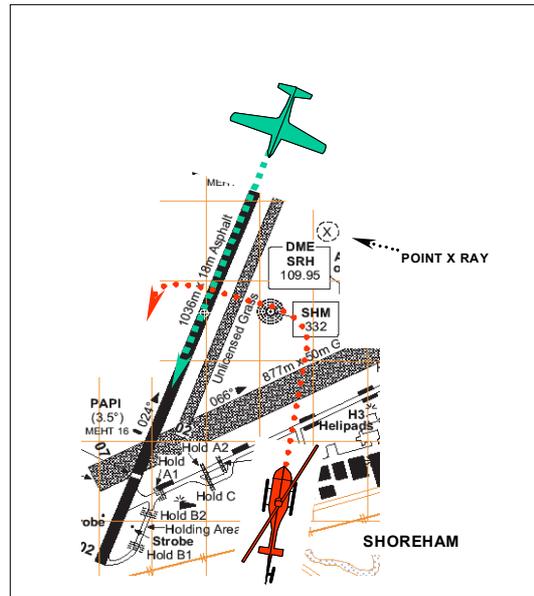
AIRPROX REPORT NO 181/04

Date/Time: 1 Oct 1116
Position: 5050N 00017W (RW20 Shoreham
 Airport - elev 7ft)
Airspace: Shoreham ATZ (Class: G)
Reporting Ac Reported Ac
Type: Chipmunk Bell 206 Jet
 Ranger
Operator: Civ Trg Civ Pte
Alt/FL: 20ft agl 100ft
 (QFE 1017 mb) (QFE)
Weather VMC CLBC VMC CAVOK
Visibility: >10km Good
Reported Separation:
 100ft V/O H 50m
Recorded Separation:
 Not recorded

Cause: The B206 pilot did not adhere to his ATC clearance and flew into conflict with the Chipmunk.

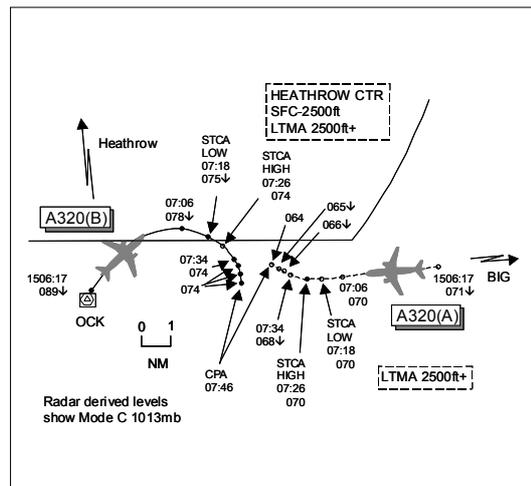
AIRPROX REPORT NO 183/04

Date/Time: 29 Sep 1508
Position: 5119N 00018W (6nm E OCK)
Airspace: LTMA (Class: A)
Reporting Ac Reported Ac
Type: A320 (A) A320 (B)
Operator: CAT CAT
Alt/FL: FL70 ↓FL70
Weather IMC IICL IMC CLBL
Visibility: 2-3nm NK
Reported Separation:
400ft V 3nm H NR
Recorded Separation:
1000ft V 1.2nm H

Cause: The LL INT DIR S vectored A320(B) into conflict with A320(A).

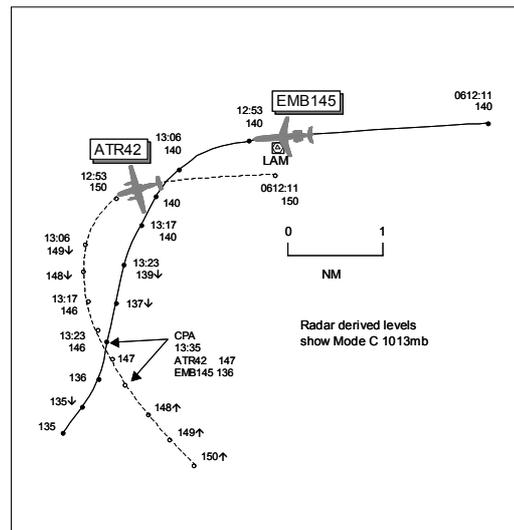
Date/Time: 15 Sep 0614
Position: 5137N 00005E (3nm SW LAM)
Airspace: LTMA (Class: A)
Reporting Ac Reporting Ac
Type: ATR42 EMB145
Operator: CAT CAT
Alt/FL: ↓FL120 FL140

Cause: The TC LAM SC descended the ATR42 into conflict with the EMB145.

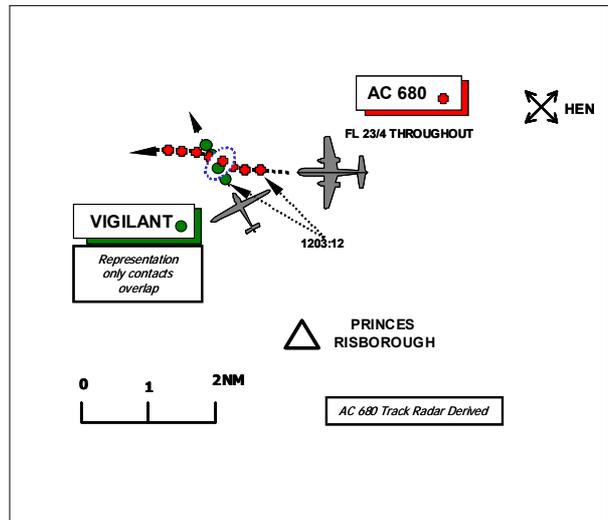
AIRPROX REPORT NO 185/04

Date/Time: 2 Oct 1202 (Saturday)
Position: 5144N 00052W (6nm SW Halton)
Airspace: London FIR (Class: G)
Reporting Ac Reported Ac
Type: Vigilant Mk 1 AC680
Operator: HQ PTC Civ Pte
Alt/FL: 2000ft NR
 (QFE 1005)
Weather VMC CLBC VMC
Visibility: 25km 10km
Reported Separation:
 100ft V/NR H 0m V/100m H
Recorded Separation:
 Not recorded V/~200m H

Cause: A very late sighting by the AC680 pilot.

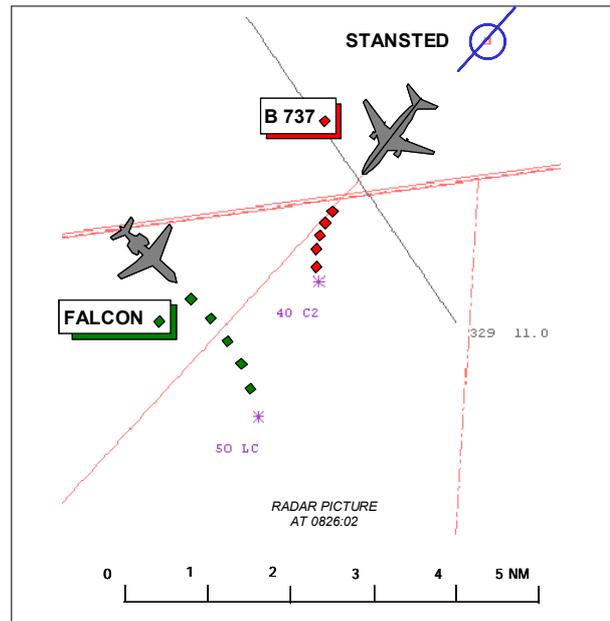
Recorded Separation:
 As 1000ft vertical separation lost,
 1.95nm H (ac diverging)
 CPA 800ft V/1.7nm (ac diverging)

Cause: The B737 pilot climbed above his SID altitude into conflict with the Falcon 900.

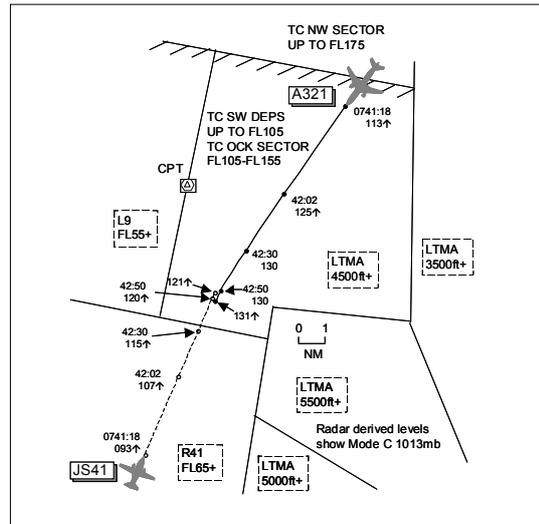
Date/Time: 6 Oct 0743
Position: 5125N 00111W (5nm S CPT)
Airspace: LTMA (Class: A)
Reporting Ac Reported Ac
Type: JS41 A321
Operator: CAT CAT
Alt/FL: FL121↑ ↑FL150

Cause: The TC BNN/NW Deps did not take the A321 into account when he climbed the JS41.

The conditions relating to Standing Agreements to ensure that ac cannot be released to another controller with the potential to be climbed or descended into direct conflict with each other.

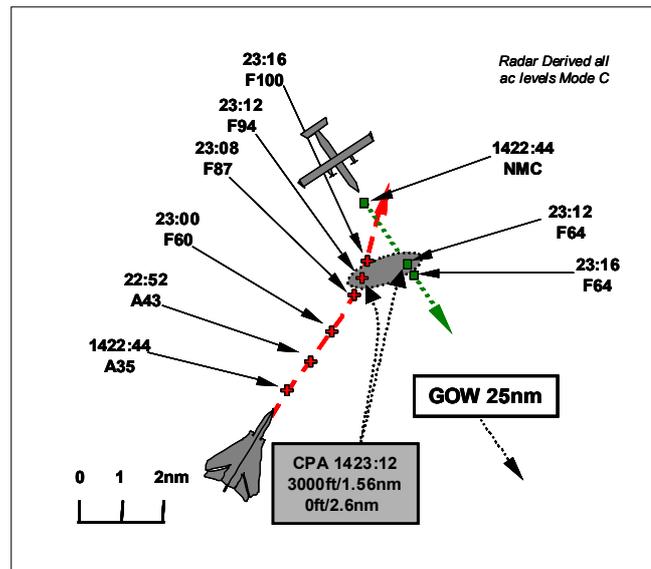
<u>First Ac</u>	<u>Second Ac</u>
<u>Type:</u>	BN2P	Tornado GR4
<u>Operator:</u>	Civ Com	HQ STC
<u>Alt/FL:</u>	6400ft (QNH)	3000ft (RPS 1015 mb)
<u>Weather</u>	IMC	VMC CLBC
<u>Visibility:</u>	In cloud	30km
<u>Reported Separation:</u>	Not seen.	Not seen
<u>Recorded Separation:</u>	3000ft V/ 1.56nm H (0V /2.6nm H)

Cause: Conflict in IMC in Class G Airspace.

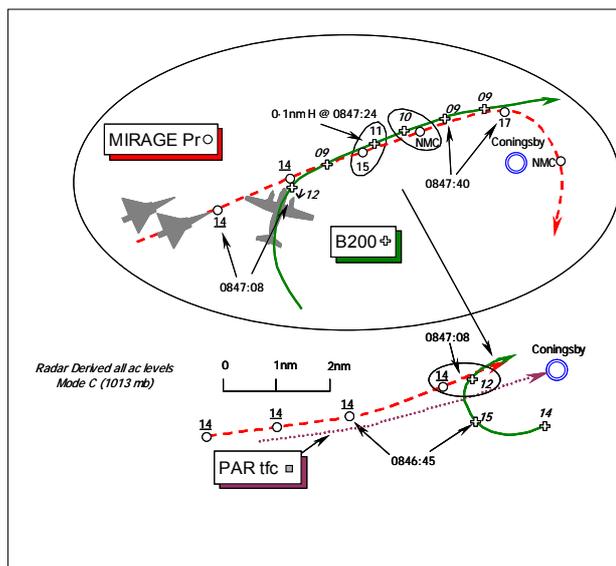
Cause: The Mirage formation leader joined the Coningsby circuit at the same height as the orbiting Kingair.

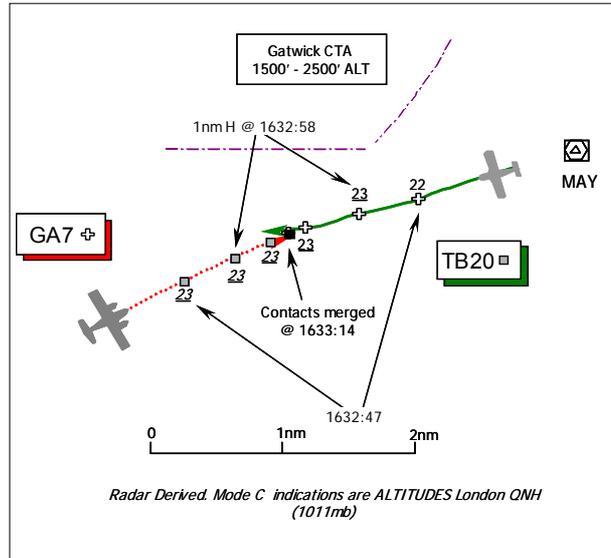
AIRPROX REPORT NO 195/04

Date/Time: 26 Oct 1633
Position: 5100N 00004E (2¼nm WSW MAY VOR)
Airspace: London FIR (Class: G)
Reporting Ac Reported Ac
Type: TB20 GA7 Cougar
Operator: Civ Pte Civ Pte
Alt/FL: 2300ft 2300ft
(QNH 1012mb) (QNH)
Weather VMC CAVOK VMC NR
Visibility: 10km >10km
Reported Separation:
10 metres Not Seen
Recorded Separation:
Contacts merged with nil V

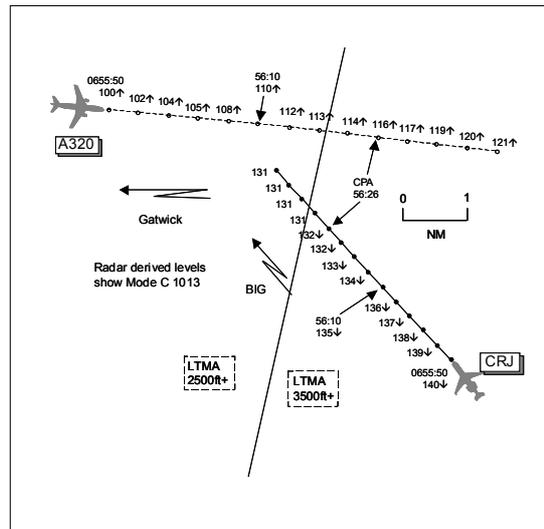
Date/Time: 22 Oct 0656
Position: 5108N 00019E (15nm SE BIG)
Airspace: LTMA (Class: A)
Reporting Ac Reported Ac
Type: A320 CRJ
Operator: CAT CAT
Alt/FL: ↑FL130 ↓FL140

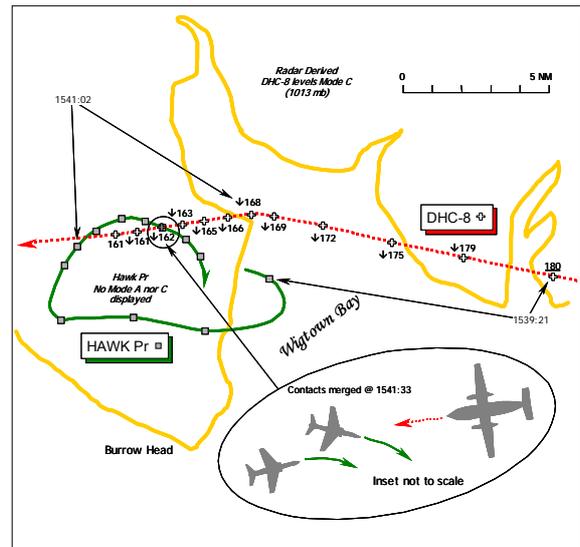
AIRPROX REPORT NO 198/04

Date/Time: 27 Oct 1541
Position: 5449N 00425W (8nm N of Burrow Head)
Airspace: London FIR (Class: G)
Reporting Ac Reported Ac
Type: Hawk x2 DHC8
Operator: HQ PTC CAT
Alt/FL: 15000ft ↓FL160
 RPS (979mb)
Weather VMC CLBL IMC IICL
Visibility: >10km 10km when CLOC
Reported Separation:
 2-300ft V/nil H Not seen
Recorded Separation:
 Contacts merged in azimuth

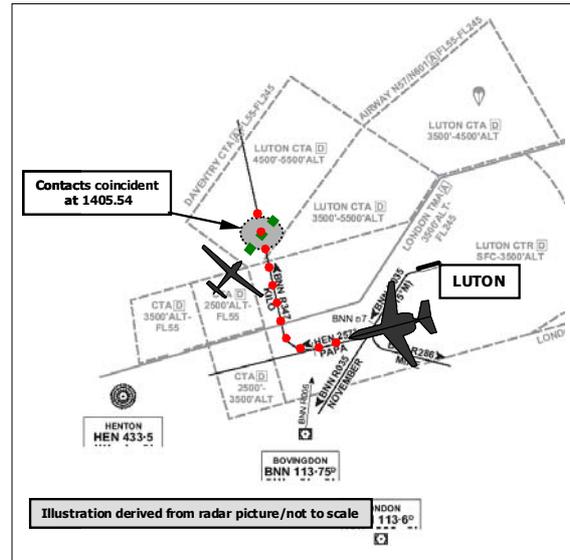
AIRPROX REPORT NO 200/04

Date/Time: 3 Nov 1406
Position: 5153N 00035W (10nm W Luton Airport)
Airspace: London FIR (Class: G)
Reporting Ac Reported Ac
Type: ASK21 Hawker 800
Operator: Civ Trg Civ Pte
Alt/FL: 2900ft 3000ft
 (QNH) (QNH)
Weather VMC CAVOK VMC CAVOK
Visibility: NR NR
Reported Separation:
 100ft V/O H 5-600ft on the diagonal
Recorded Separation:
 Contacts merge

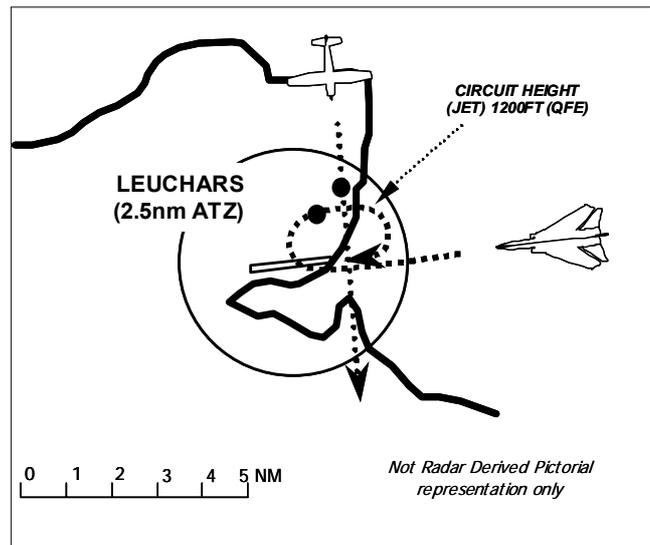
AIRPROX REPORT NO 201/04

Date/Time: 4 Nov 1525
Position: 5622N 00252W (Downwind Leg 27
 Circuit Leuchars - elev 38 ft)
Airspace: Leuchars ATZ (Class: G)
Reporting Ac Reported Ac
Type: Tornado F3 C172
Operator: HQ STC Civ Pte
Alt/FL: 1200ft 2000ft
 (QFE 1010 mb) (not known)
Weather VMC CAVOK VMC HAZE
Visibility: 50km 15km
Reported Separation:
 0 V/50ft H 0 V/<0.5nm H
Recorded Separation:
 Not Recorded

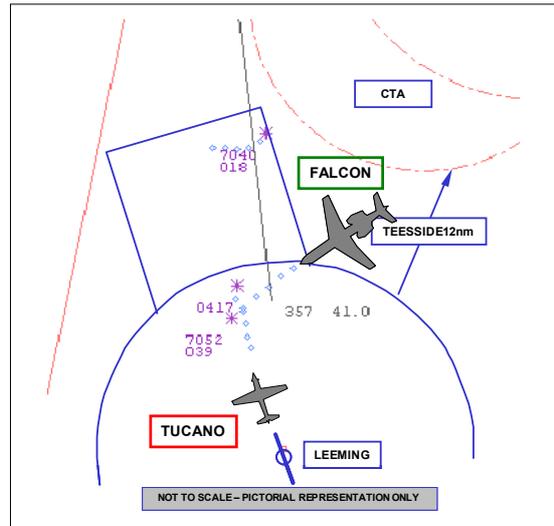
AIRPROX REPORT NO 203/04

Date/Time: 8 Nov 1005
Position: 5421N 00103W(3nm NE Leeming)
Airspace: London FIR (Class: G)
Reporting Ac Reported Ac
Type: FA20 Tucano
Operator: Civ Comm HQ PTC
Alt/FL: 3500ft 2500ft-3000ft
 (QNH 1019 mb) (QFE 1014mb)
Weather IMC in layers IMC in layers
Visibility: 2-5km Good
Reported Separation:
 200ft V/300yd H 2-300ft V/>1nm H
Recorded Separation:
 600ft V/ 0.5 nm H

Cause: Aware of each other's ac, a lack of positive control by Teesside APR and Leeming APP allowed the ac to fly into conflict.

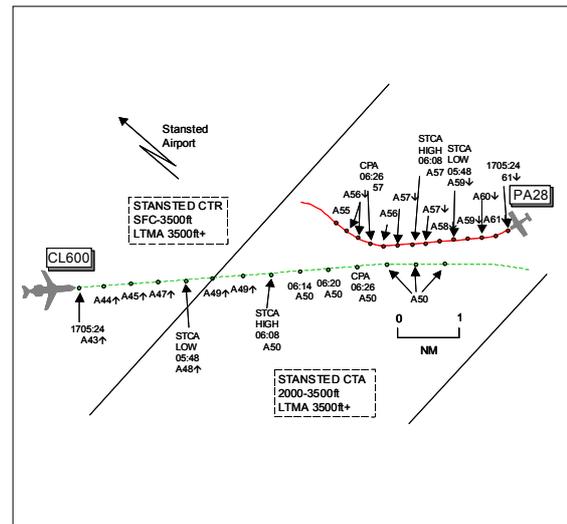
AIRPROX REPORT NO 204/04

Date/Time: 14 Oct 1706
Position: 5149N 00022E (7nm SE Stansted)
Airspace: LTMA (Class: A)
Reporting Ac Reported Ac
Type: CL600 PA28
Operator: Civ Comm Civ Pte
Alt/FL: 5000ft 6000ft
 (QNH 995mb) (QNH 995mb)
Weather VMC CLAC VMC CLAC
Visibility: UNL >10km
Reported Separation:
 600ft V/0.5nm H not seen
Recorded Separation:
 700ft V/0.4nm H

Cause: The PA28 pilot descended into conflict with the CL600 owing to a probable altimeter subscale mis-setting.

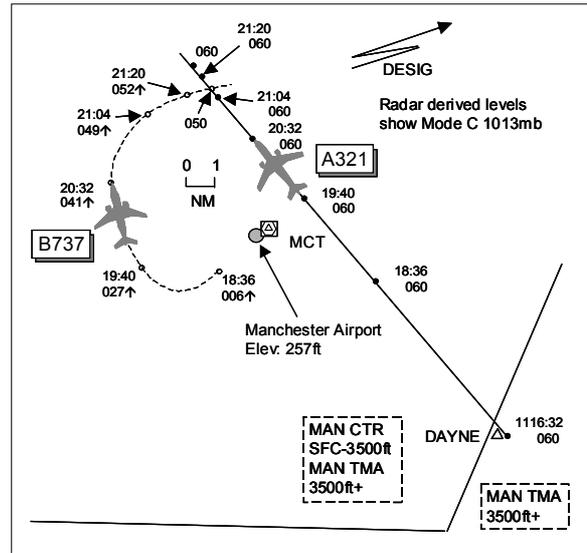
AIRPROX REPORT NO 205/04

Date/Time: 5 Nov 1121
Position: 5326N 00219W (5.5nm NW Manchester Airport - elev 257ft)
Airspace: Manchester TMA (Class: A)
Reporting Ac Reported Ac
Type: B737-300 A321
Operator: CAT CAT
Alt/FL: 5000ft↑ FL60
 (QNH)
Weather IMC IICL VMC CLBL
Visibility: 10km
Reported Separation:
 700ft V 0.5nm H 700ft V 1-2nm H
Recorded Separation:
 800ft V 0.7nm H

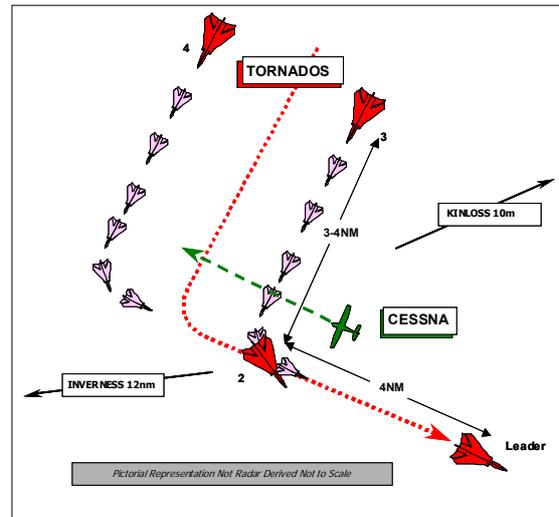
AIRPROX REPORT NO 206/04

Date/Time: 10 Nov 1532
Position: 5735N 00346W (5nm WSW of Forres)
Airspace: Scottish FIR (Class: G)
Reporting Ac Reported Ac
Type: C152 Tornado GR4
Operator: Civ Trg HQ STC
Alt/FL: 1000ft 600ft AGL
(QFE 1020mb) (Rad Alt)
Weather VMC CLBC VMC CLBC
Visibility: >10km 30km
Reported Separation:
Nil V/500m H Nil V/6000ft H
Recorded Separation:
Not Recorded

Cause: Conflict in the Lossiemouth AIAA.

It is recommended that the RAF Kinloss based Flying Club consider adopting the same procedure as recommended to fast jets, when operating within 15nm of Inverness airfield, in that they contact Inverness TWR on 122.6 for a FIS. From the Cessna pilot's report it would also be beneficial for RAF Lossiemouth ATC to brief the flying club on what information pilots can expect when flying under a FIS.

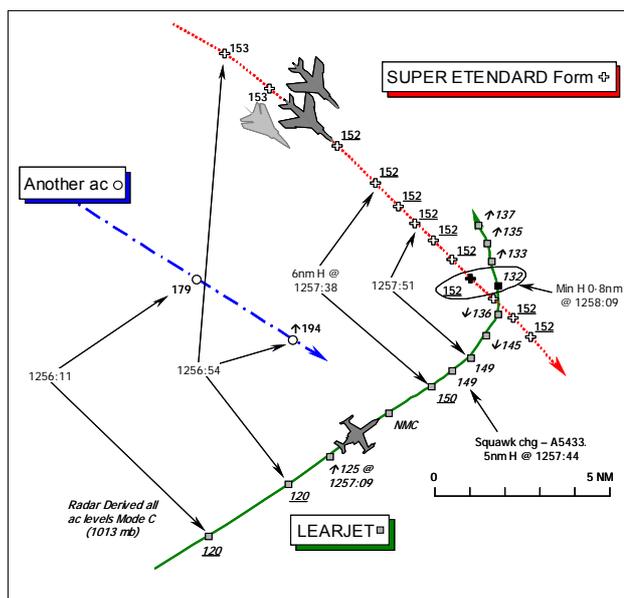
AIRPROX REPORT NO 207/04

Date/Time: 4 Nov 1258
Position: 5257N 00150E (26nm NE Norwich)
Airspace: London FIR (Class: G)
Reporting Ac Reported Ac
Type: Learjet 45 Sup. Etendard formation
Operator: Civ Pte Foreign Mil
Alt/FL: FL132↑ FL150
Weather VMC HAZE VMC NR
Visibility: NR 10km+
Reported Separation:
>100ft V 500ft V/2nm H
Recorded Separation:
300ft V @ 5nm H
0.8nm H @ 2000ft V

Cause: The Norwich APR vectored the Learjet into conflict with the mixed Super Etandard formation.

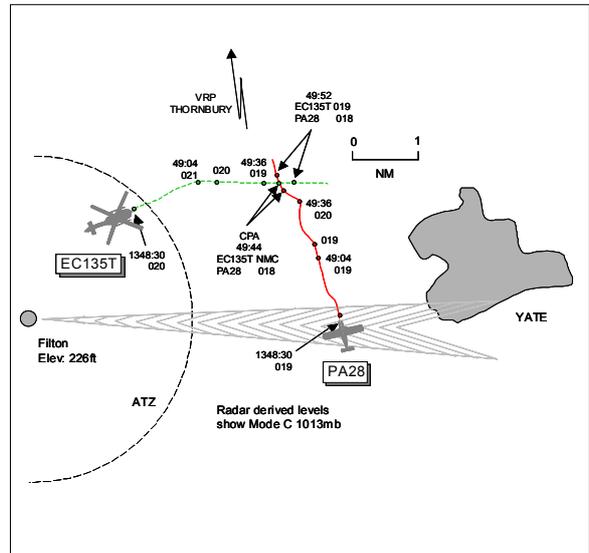
AIRPROX REPORT NO 208/04

Date/Time: 4 Nov 1350
Position: 5133N 00229W (4.25nm NE Filton - elev 226ft)
Airspace: LFIR (Class: G)
Reporting Ac Reported Ac
Type: EC135T PA28
Operator: Civ Trg Civ Pte
Alt/FL: 2000ft 2000ft
(QFE 1015mb) (RPS)
Weather VMC CLBC VMC
Visibility: 15km 20km
Reported Separation:
200ft V/100m H 200-300ft V/2nm H
Recorded Separation:
100ft/0.15nm H

Cause: Late sighting by the PA28 pilot and an effective non-sighting by the EC135T pilot.

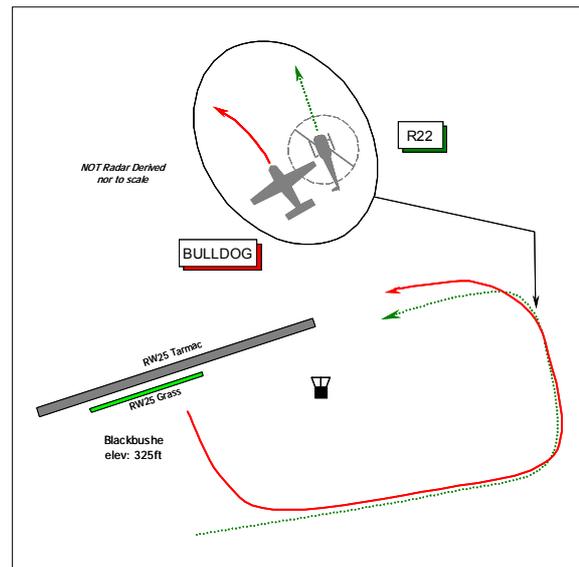
AIRPROX REPORT NO 210/04

Date/Time: 13 Nov 1123 (Saturday)
Position: 5119N 00050W (Blackbushe a/d Cct- elev 325ft)
Airspace: Blackbushe ATZ (Class: G)
Reporting Ac Reported Ac
Type: R22 Bulldog
Operator: Civ Trg Civ Pvt
Alt/FL: 500ft 600ft
(QFE 1022mb) (QFE 1022mb)
Weather VMC nil cloud VMC CAVOK
Visibility: 10km+ >10km
Reported Separation:
50ft V/50ft H Not seen
Recorded Separation:
Not recorded

Cause: The Bulldog pilot flew into conflict with the R22 which he did not see.

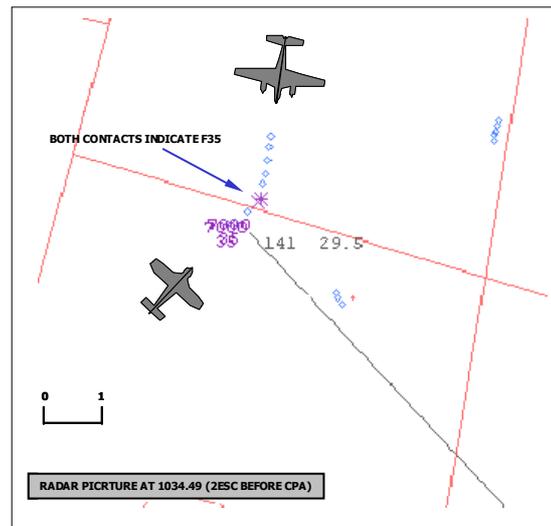
AIRPROX REPORT NO 211/04

Date/Time: 14 Nov 1035 (Sunday)
Position: 5114N 00117W (18nm N SAM)
Airspace: London FIR (Class: G)
Reporting Ac Reported Ac
Type: DR400 BE58
Operator: Civ Pte Civ Pte
Alt/FL: 3600-3800ft 3750ft
(RPS 1037 mb) (QNH mb)
Weather VMC CAVOK VMC CAVOK
Visibility: >30km >10km
Reported Separation:
>50m H 100ft V/0 H
Recorded Separation:
0 V/·1nm H

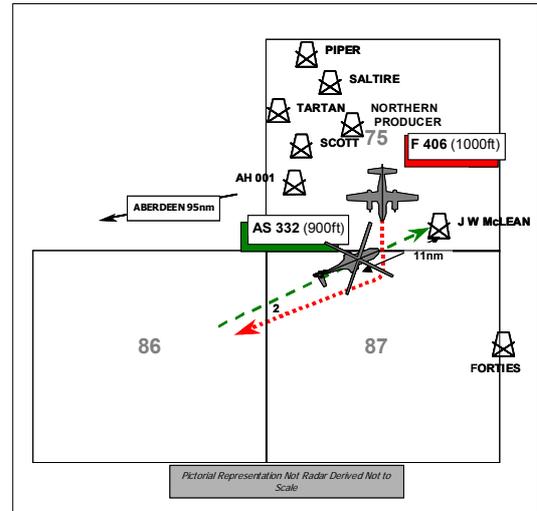
AIRPROX REPORT NO 215/04

Date/Time: 17 Nov 1155
Position: 5755N 00050E (071° ADN 96nm)
Airspace: Scottish FIR (Class: G)
Reporting Ac Reported Ac
Type: AS332L F406
Operator: CAT Civ Comm
Alt/FL: 900ft 1000ft
 (QNH 1004mb) (QNH 1004mb)
Weather VMC CLBC VMC CLBC
Visibility: 5nm 8nm
Reported Separation:
 1- 300ft V¹/₄ -¹/₂nm H Not seen
Recorded Separation:
 Not recorded

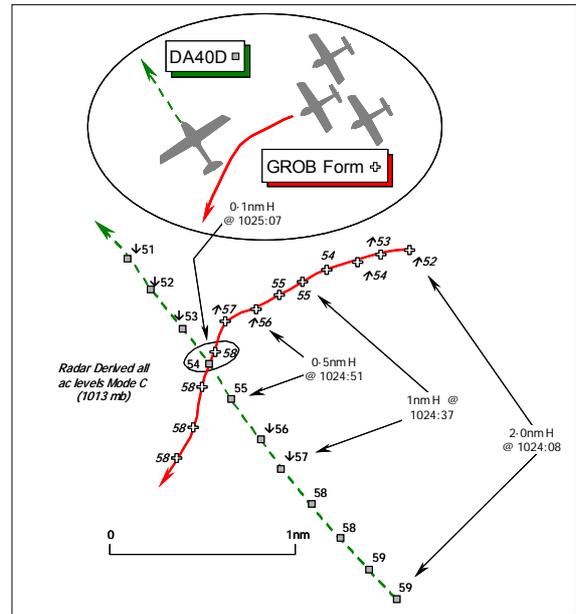
AIRPROX REPORT NO 216/04

Date/Time: 19 Nov 1025
Position: 5305N 00042W (8½nm SW of Waddington)
Airspace: Lincolnshire AIAA (Class: G)
Reporting Ac Reported Ac
Type: DA40D Grob Tutor
Operator: Civ Pte HQ PTC
Alt/FL: 4700ft FL50
 (RPS 1020mb)
Weather VMC Sky clear VMC nil cloud
Visibility: >30km Unlimited
Reported Separation:
 Nil V/300m H 200ft V/¾nm H
Recorded Separation:
 100ft V @ 0.5nm
 0.1nm H @ 400ft V

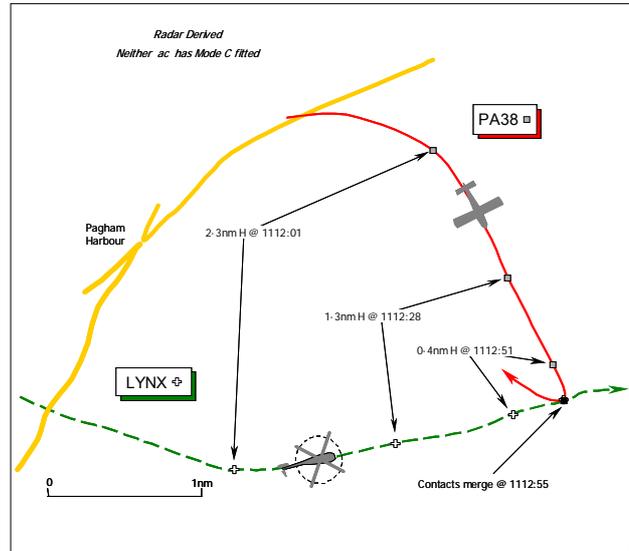
AIRPROX REPORT NO 217/04

Date/Time: 22 Nov 1112
Position: 5044N 00043W (2½nm NE of Selsey Bill)
Airspace: London FIR (Class: G)
Reporting Ac Reported Ac
Type: Lynx HAS 3 PA38
Operator: CinC Fleet Civ Trg
Alt/FL: 3000ft NR
 (1019mb) NR
Weather VMC Fog VMC NR
Visibility: 10km "fairly poor"
Reported Separation:
 Nil V/100m H 200-300m H
Recorded Separation:
 Contacts merged

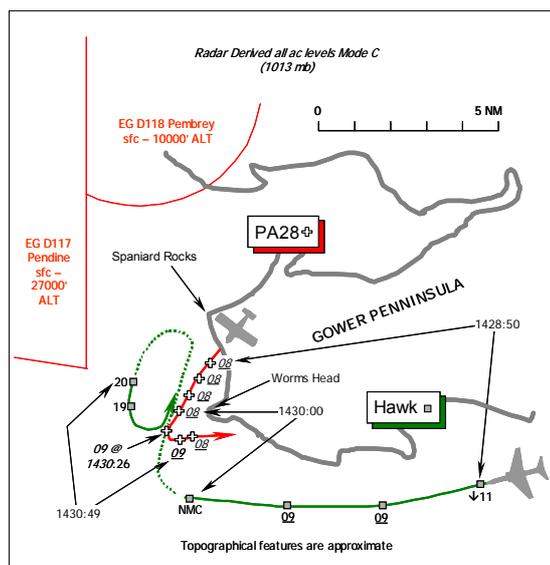
AIRPROX REPORT NO 221/04

Date/Time: 25 Nov 1430
Position: 5133N 00420W (1½nm SW of Worms Head - Gower Peninsula)
Airspace: UKDLFS/FIR (Class: G)
Reporting Ac Reported Ac
Type: Hawk T Mk1W PA28
Operator: HQ PTC Civ Trng
Alt/FL: 1000ft 1300ft
(QFE 1020mb) (QNH)
Weather VMC CLBC VMC Haze
Visibility: 8km 5-7km
Reported Separation:
150ft V/100yd H 300ft V/300m H
Recorded Separation:
Not recorded

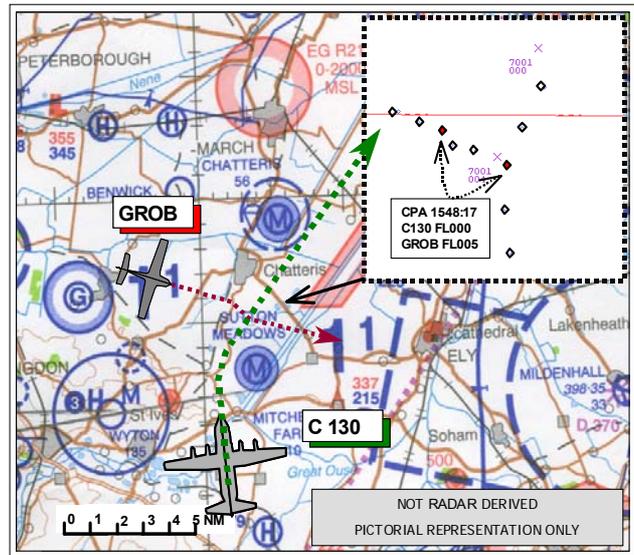
AIRPROX REPORT NO 222/04

Date/Time: 25 Nov 1548
Position: 5225N 00005E (S of Chatteris)
Airspace: UKDLFS (Class: G)
Reporting Ac Reported Ac
Type: C130J Grob Tutor
Operator: HQ STC HQ PTC
Alt/FL: 250ft agl 500ft agl
(Rad Alt)
Weather VMC HAZE VMC below
HAZE
Visibility: NR 6-7km
Reported Separation:
300ft V/1/2nm H 300ft V/>1/2 nm H
Recorded Separation:
500ft V/0.6nm H

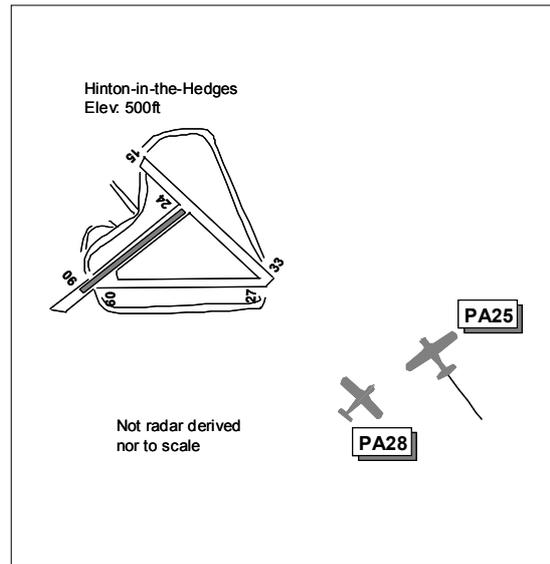
AIRPROX REPORT NO 223/04

THE PA28 PILOT reports joining the LH cct at Hinton-in-the-Hedges to land on RW24 and making RT calls to Hinton 'Traffic' on the promulgated frequency of 119.45MHz squawking 7000 with Mode C. The visibility was 40km below cloud in VMC and the ac was coloured blue with strobe lights switched on. He had joined on the downwind leg heading 060° at 100kt and 1500ft QNH 1021mb (1000ft agl) and was No2 behind a Rockwell 114 ahead. He was also aware that a 'paradrop' was imminent (2min). When abeam the RW24 threshold, he looked up to see a white coloured PA25 Pawnee with a cable attached, registration X-XX, in his 1 o'clock position, in the top of the windscreen about 100-200ft above crossing from R to L descending, the distance was such that he could not see if anything was attached to the tow cable. He dived to avoid any contact with the cable; the PA25 was by now in his 10'clock when he passed under the cable end, estimating he missed the cable by 50-100ft. He saw the PA25 continue its descent and landing on RW27 grass, its pilot's first RT call was just prior to landing and he assessed the risk as high.

Cause: Non-sighting by the PA25 pilot and a very late sighting by the PA28 pilot in the Hinton cct area.

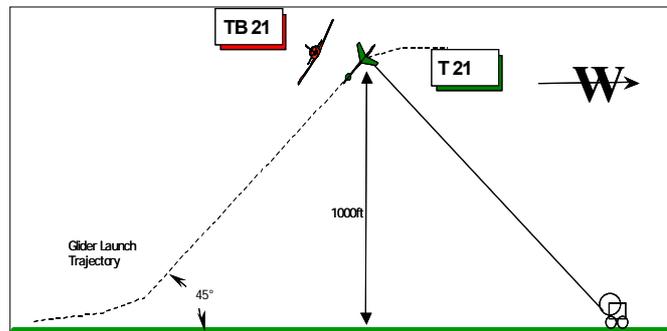
THE T21 SLINGSBY GLIDER PILOT reports flying a red and white glider, solo on a training sortie from Snitterfield, with no radio or SSR fitted. He was passing 900/1000ft on a winch launch at an attitude of about 45° nose-up, heading 270° at 45kt, when a single-engined low-wing ac with red trim appeared at his height on his left, and in a hard, level turn away from him. The other ac had initially been obscured due to the glider attitude before it appeared a few hundred metres away. He did not take any avoiding action as the other ac was already turning away and was avoiding him. Although he only saw it only for a second, he assessed that it had passed within 500ft of him; he did not assess the risk. The Duty Instructor had also observed the incident from the ground.

Cause: The TB21 pilot flew close enough to a glider on a winch launch to cause its pilot concern.

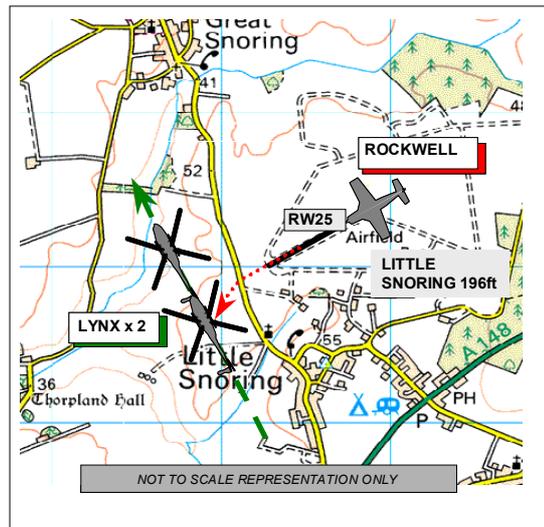
AIRPROX REPORT NO 226/04

THE LYNX PILOT reported that he was LHS captain, but not HP, of the lead ac of a 2-ship, low-level tactical training sortie in the UKDLFS from Wattisham. The ac were camouflaged green in colour with HISLs and anti-colls switched on and were approaching a tactical holding area 1500m to the W of Little Snoring Light Ac Landing Site, at 80kt and 100ft agl. They were preparing to descend into the holding area on a heading of 334° and he had warned the pilot in the RH seat [HP] that there was an airfield to the right and a village and indicated the position of the landing area. The pilot looked right for any traffic from Little Snoring, called descending and transmitted 'Descend Descend Descend' to the formation. Both ac descended and his pilot and the crew of the second Lynx reported an ac passing within 100m H and 200ft V above the formation. His pilot had seen the ac at a distance of 600m getting airborne from the SW RW at Little Snoring and had elected to remain on course and descend as the best form of avoiding action, a decision with which he concurred. The formation was low-level, outside CAS and was monitoring Wattisham APP on 125.8 MHz and squawking 4537. The risk of collision between any of the ac involved was low. All ac were unaffected but they were unsure if the other pilot had seen their formation. Having completed the low-level section of their mission, they climbed to 500ft and reported the Airprox to Wattisham APP. He then elected to land at Little Snoring and talked to some people on the ground to confirm what ac it was and that they were safe. He was informed that the ac was a Rockwell 114 based at Old Buckenham.

Cause: A conflict in the FIR/UKDLFS resolved by both pilots.

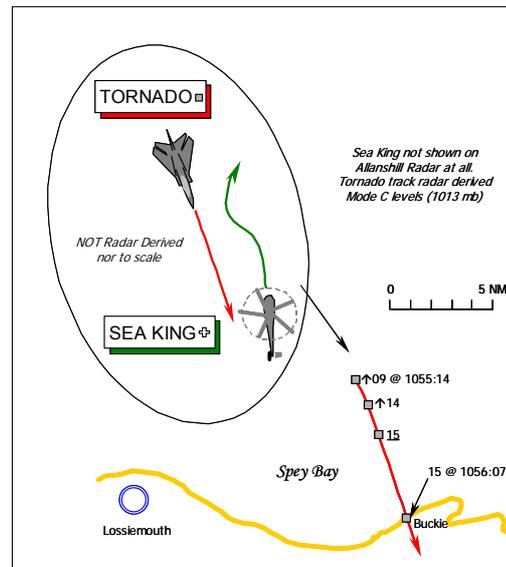
THE SEA KING MK3 PILOT reports that his helicopter has a bright yellow colour-scheme and the HISLs were on whilst carrying out a training sortie in Spey Bay about 8nm ENE of Lossiemouth. The PF was handling the ac under an IF visor from the R seat (RHS), whilst the L seat (LHS) pilot was operating as safety pilot with the crewman assisting with lookout from between the pilots seats: the radar operator was also manning his radar. They were operating VFR in VMC with nil cloud or weather at their altitude and a flight visibility of >20km, whilst in receipt of a FIS from Lossiemouth APPROACH (APP) on 118.9MHz VHF and squawking A3732 with Mode C selected on. Neither TCAS nor any other form of CWS is fitted.

Cause: A non-sighting by the Tornado GR4 crew and a very late sighting by the Sea King crew.

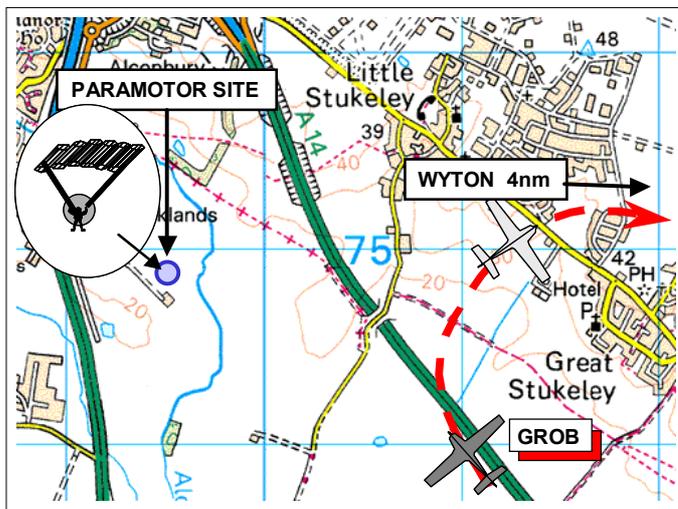
THE PARAMOTOR INSTRUCTOR reports that he was instructing a student by radio from the ground at Brooklands Farm microlight site on his third paramotor flight when the student called that there was an ac heading straight at him from the S at the same height, which he reported as 700ft on the Wyton QNH [equivalent to 565ft agl] which the instructor had set 30min prior to the incident. The paramotor was coloured red and black and at the time of the incident was heading S at 10kt. As he was calling, the Grob pilot saw him [he thought] and turned right to avoid him. The incident was witnessed by other pilots on the ground who thought that the ac were around 300ft apart when the Grob turned right on to an E'ly track.

Cause: Sighting report.

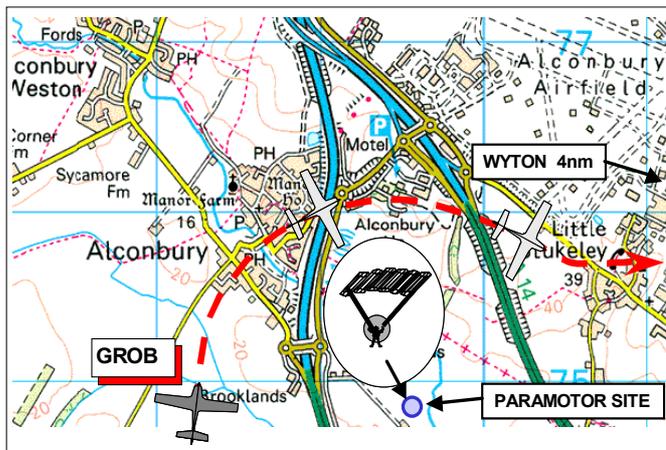
AIRPROX REPORT NO 229/04

THE PARAMOTOR INSTRUCTOR reports that he was instructing a student by radio from the ground at Brooklands Farm microlight site on his third paramotor flight when the student called that there was an ac heading towards him from the W just above his height, which he reported as 700ft on the Wyton QNH [equivalent to 565ft agl] which the instructor had set 30min prior to the incident. The paramotor was coloured red and black and at the time of the incident was heading W at 10kt. The Grob pilot saw him [he thought] and turned right onto SE to avoid him and then continued towards Wyton. The paramotor Instructor saw the Grob 10sec before the ac passed with about 100ft separation.

Cause: Sighting report.

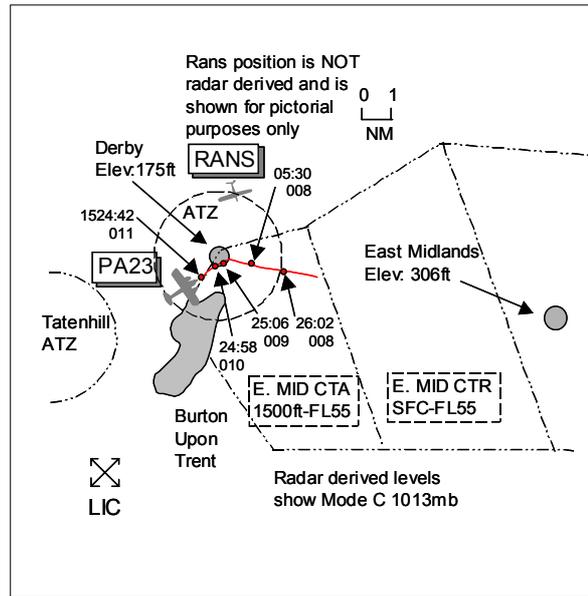
AIRPROX REPORT NO 231/04

THE DERBY A/G OPERATOR reports that at 1525Z a twin engine a/c was observed at approximately 1000ft agl flying from W to E directly O/H Derby tower – no RT call had been received by him. He immediately warned traffic that was inbound on R base about the twin and another ac, the subject Rans S6, took evasive action to separate from the twin, which was by now at about 800ft agl. He contacted East Midlands ATC who confirmed the identity of the ac as a PA23 inbound to land.

Cause: The PA23 pilot entered the Derby ATZ without complying with the requirements of Rule 39 of the Rules of the Air and flew into conflict with the RANS S6.

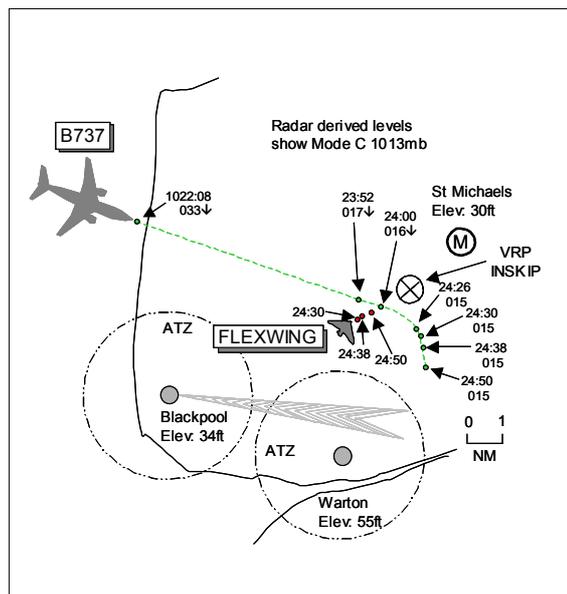
THE B737 PILOT reports heading 100° at 220kt being vectored RH downwind for RW28 at Blackpool and in receipt of a RAS from Blackpool APR. Level at 1700ft QNH, he thought, they saw a M/light in their 1 o'clock range 500ft in a descending R turn which passed in the opposite direction 300ft down their RH side about 200ft below their level. The M/light was a single engine pusher type with a red leading edge to the high-wing; no lighting was observed. The Blackpool airfield visibility was reported as 2500m in mist and the radar had shown neither primary nor secondary returns from the M/light and no target had been displayed on TCAS. Owing to the M/light's descending flight path on first contact, he assessed there to be no risk of collision and he took no avoiding. This had been a late sighting, their view over the ac's nose had been poor owing to the pitch attitude at 220kt.

Cause: Conflict in Class G airspace.

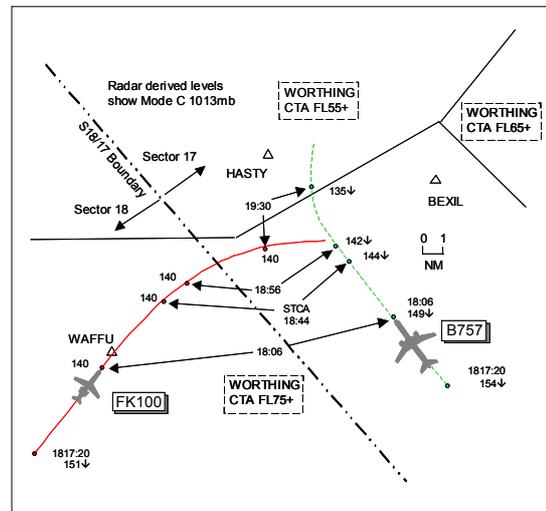
AIRPROX REPORT NO 233/04

THE OFFGOING TC BIG/TIMBA SC reports that during the handover of the Sector, one of his last transmissions was to issue a descent clearance to the B757 crew to FL90. He was unaware of the FK100 which was inbound to Manston.

Cause: The LACC S17 controllers transferred the B757 to the TC BIG/TIMBA SC without co-ordinating the FK100.
