UK AIRPROX BOARD

Analysis of Airprox in UK Airspace

**Report Number 19
July 2007 - December 2007**

Nineteenth Report by the UK Airprox Board:

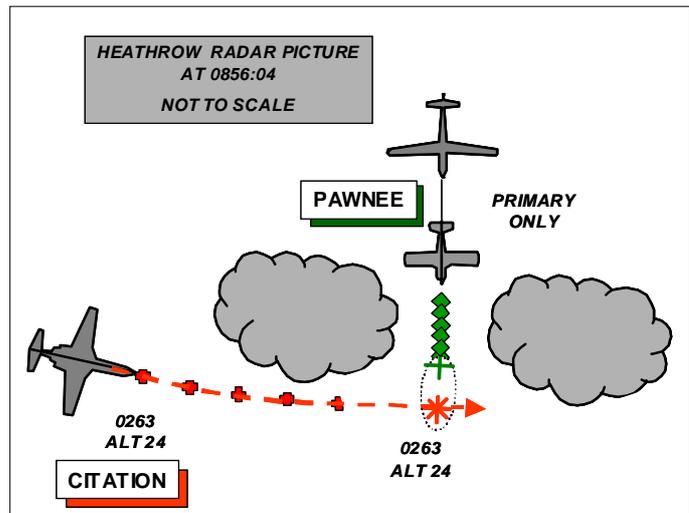
~30ft V/ 400m H (see UKAB Note (2))

Members noted that the radar recording showed the Citation to be flying at 2400ft and about 240kt through the Class G airspace just S of Halton, the base of CAS being 3500ft reducing to 2500ft ahead on the Citation's track. Two pilot Members considered 240kt to be unwise in a congested area and in such cloud/weather conditions; one stated that his company imposed a limit of 190kt to allow more time to 'see and avoid'. He also observed that, in his experience and although there was nothing to suggest that this was the case in this instance, a small number of pilots thought that by flying IFR in Class G airspace this somehow absolved them of their 'see and avoid' obligation.

Cause: A non-sighting by the Citation crew and an effective non-sighting by the Pawnee pilot.

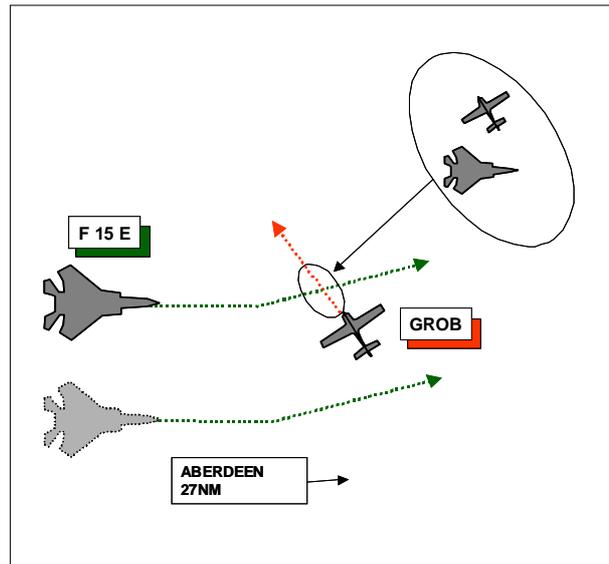
100ft v/~1nm in 12 o'clock (reducing)
(See Note (1))

Members were not able to resolve the apparent anomaly between the descriptions of the Grob's routeing given by the pilots and the radar recording. The Board accepted, however, that it was the manoeuvre by the Grob that highlighted it to the F15 leader. The investigation revealed that the Grob had not been manoeuvring to avoid the F15 but to regain his planned track after a small weather deviation. Nonetheless, the separation was never close enough to cause either pilot serious concern, the F15E pilot noting that had the Grob not manoeuvred then it would have passed very close indeed to their ac, or compromise the safety of their ac.

Cause: Conflict in the UKDLFS/FIR.

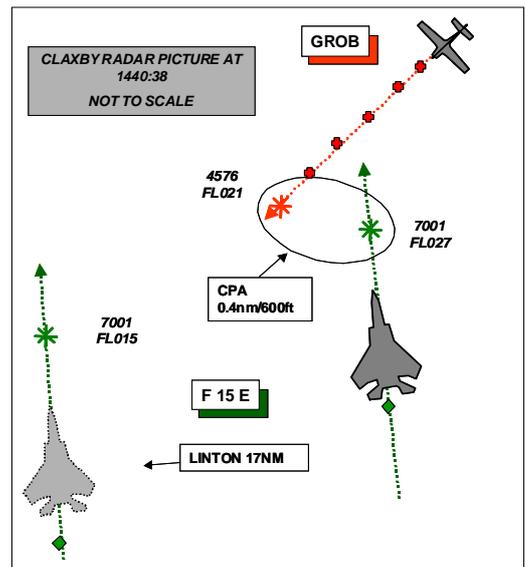
AIRPROX REPORT NO 089/07

Date/Time: 5 Jul 1441
Position: 5404N 00046W (17nm E Linton on Ouse)
Airspace: UKDLFS (Class: G)
Reporting Ac Reported Ac
Type: F15E Grob Tutor
Operator: Foreign Mil HQ Air Trg
Alt/FL: 1500ft agl 2500ft
(QFE) (RPS)
Weather VMC NR VMC CLBC
Visibility: 10nm 30km
Reported Separation:
0ft V/300m H 100ft V/900m H
Recorded Separation:
600ft V/ 0.4nm H

Cause: Conflict in the UKDLFS/FIR resolved by the F15 pilot.

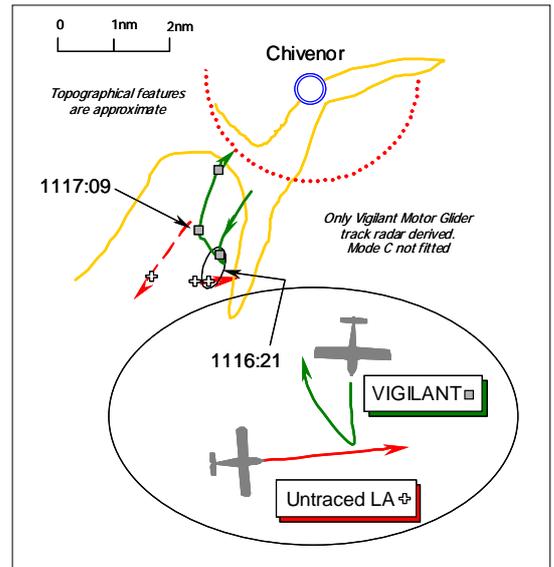
AIRPROX REPORT NO 091/07

Date/Time: 7 Jul 1116 (Saturday)
Position: 5102N 00412W (4nm SSW Chivenor - elev 27ft)
Airspace: London FIR (Class: G)
Reporting Ac Reported Ac
Type: Grob 109B Unknown LA
Operator: Air Cmd (Trg) N/K
Alt/FL: 1900ft NR
 (QFE 1020mb)
Weather VMC CLOC NK NR
Visibility: 30km NR
Reported Separation:
 10ft V/200m H NR
Recorded Separation:
 Not recorded

It was unfortunate that it had not been possible to trace the LA involved here and clearly in the absence of a report from its pilot the Board had only one half of the story. Therefore, it was difficult to come to any meaningful conclusions as to Cause and Risk. Nonetheless, as this Airprox occurred in the see and avoid environment of the 'Open FIR' this seemed to be fundamentally a lookout issue. The Vigilant Instructor's frank and honest account had revealed that he had been closely monitoring his student through the rejoin checklist prior to the turn back towards Chivenor and it was his student that had spotted the LA in the first instance. It seemed that the joining checks had been the focus of the instructor's attention at the critical moment, perhaps diverting his scan inside the cockpit. Fortunately, the student's 'heads-up' came just in time for his instructor to take decisive and robust action to avoid the LA to their R as, with the motor-glider under power, the Vigilant Instructor was indeed responsible under the 'Rules of the Air' for 'giving way' to the LA in the situation that the reporting pilot had described. Whilst it was indeed feasible that the LA pilot had not spotted the Vigilant at all, there was insufficient data on which the Board could comment so without a corroborating report any speculation on that score would be meaningless. Thus on the information conscientiously provided by the Vigilant instructor the Board could only conclude that this Airprox had resulted from a late sighting by the Vigilant pilot.

Cause: A late sighting by the Vigilant pilot.

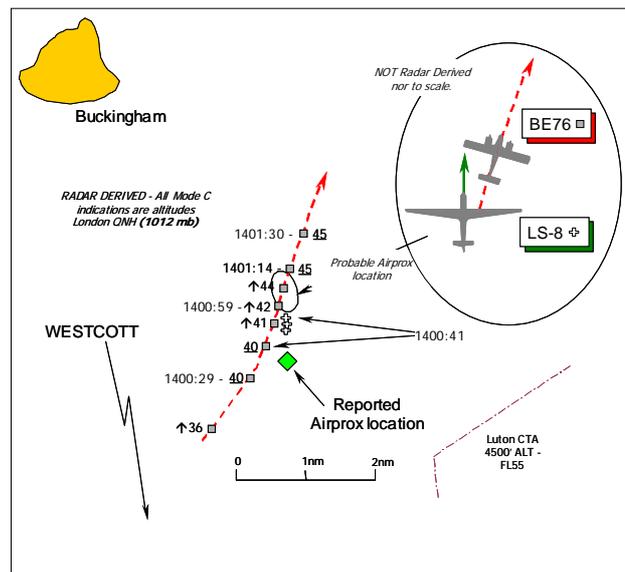
The Gliding Member was also familiar with the BE76, which he recalled, has reasonable visibility but, like all twins some blind spots however, these are generally downwards rather than upwards. He also noted that with IF screens in place for instrument training, as here, this can hamper visibility to some extent. Nevertheless, well

Cause: A probable non-sighting of the LS8 glider by the BE76 instructor pilot.

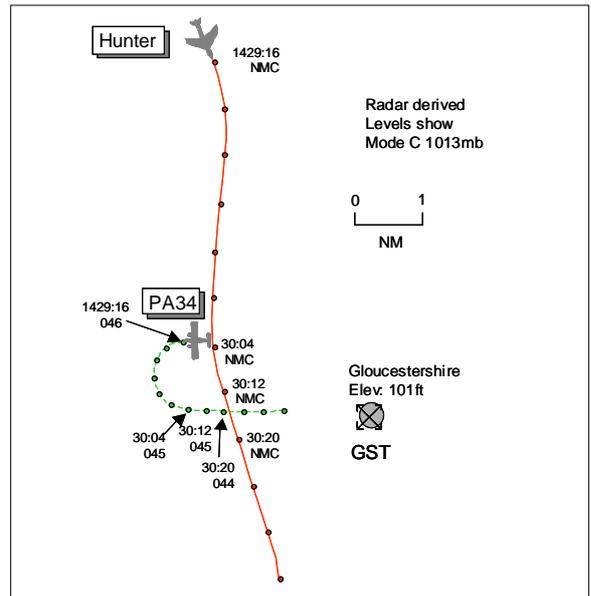
AIRPROX REPORT NO 096/07

Date/Time: 16 Jul 1430
Position: 5154N 00213W (2nm W Gloucestershire)
Airspace: LFIR (Class: G)
Reporting Ac Reported Ac
Type: PA34 Hunter
Operator: Civ Trg Civ Pte
Alt/FL: FL45 FL40↓
Weather IMC IICL VMC CLOC
Visibility: >10km 50km
Reported Separation:
 Nil V/50-100m H Not seen
Recorded Separation:
 0.25nm H

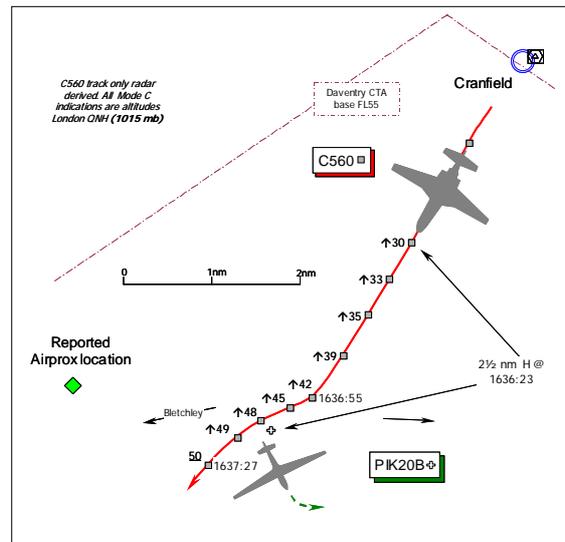
AIRPROX REPORT NO 097/07

Date/Time: 8 Jul 1637 (Sunday)
Position: 5201N 00040W (4nm SW Cranfield)
Airspace: London FIR (Class: G)
Reporting Ac Reported Ac
Type: PIK 20B Glider Cessna 560
Operator: Civ Club Civ Comm
Alt/FL: 4100ft↑ ↑FL50
QFE (1009mb)
Weather VMC CLBC VMC NR
Visibility: >10nm 20+km
Reported Separation:
100ft V/3m H ~500ft V/NK H
Recorded Separation:
Not recorded

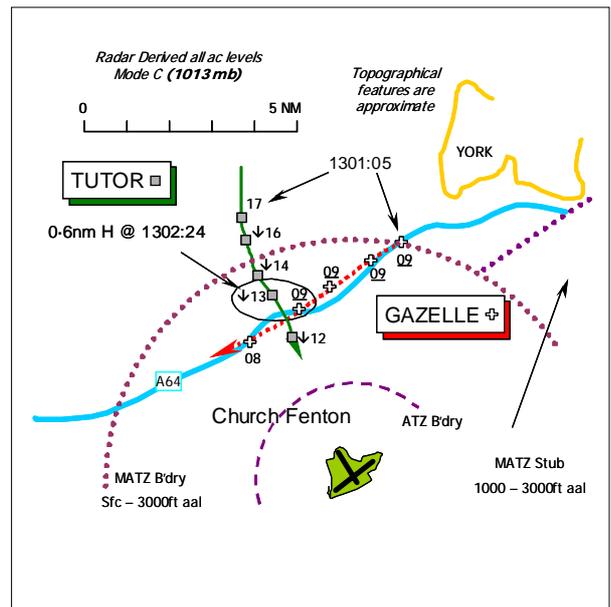
AIRPROX REPORT NO 099/07

Date/Time: 13 Jul 1302
Position: 5354N 00114W (3½nm FINALS RW16 Church Fenton - elev 29ft)
Airspace: MATZ (Class: G)
Reporter: Church Fenton TALKDOWN
First Ac Second Ac
Type: Grob Tutor Gazelle
Operator: HQ AIR (Trg) Civ Pte
Alt/FL: 1100ft↓ NR
 QFE (1009mb)
Weather IMC In cloud NR NR
Visibility: NR NR
Reported Separation:
 350ft V/¼nm H NR
Recorded Separation:
 400ft V/0.3nm Min H

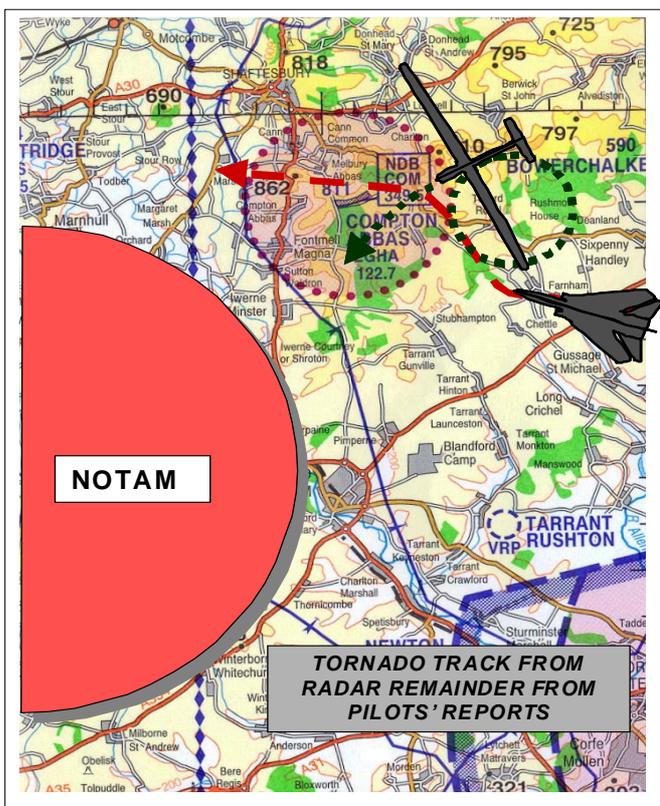
AIRPROX REPORT NO 100/07

Date/Time: 19 Jul 1205
Position: 5058N 00209W (Compton Abbas - elev 811ft)
Airspace: Lon FIR (Class: G)
Reporting Ac Reported Ac
Type: Duo Discus Tornado F3
Operator: Civ Pte Air Ops
Alt/FL: 3800ft 3940ft
(QNH 1015mb) (RPS 1015mb)
Weather VMC CLBC VMC CLBC
Visibility: 20km >10km
Reported Separation:
100ft V/0m H 200ft V/0m H
Recorded Separation:
NR

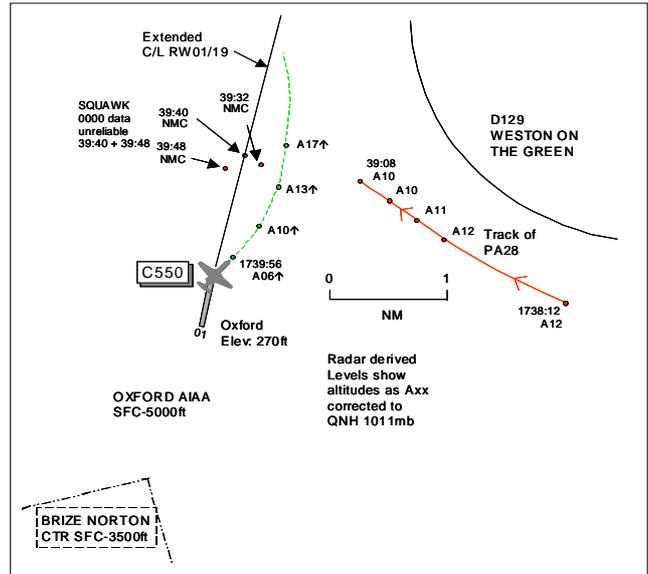
AIRPROX REPORT NO 102/07

Date/Time: 21 Jul 1740 (Saturday)
Position: 5151N 00119W (1nm N Oxford/
 Kidlington - elev 270ft)
Airspace: Oxford AIAA (Class: G)
Reporting Ac Reported Ac
Type: C550 PA28
Operator: Civ Comm Civ Pte
Alt/FL: GL↑ 1100ft
 (QNH 1012mb) (QFE)
Weather VMC CLBC VMC CLBC
Visibility: >10km 8km
Reported Separation:
 Nil V/500-600m H NR
Recorded Separation:
 NR

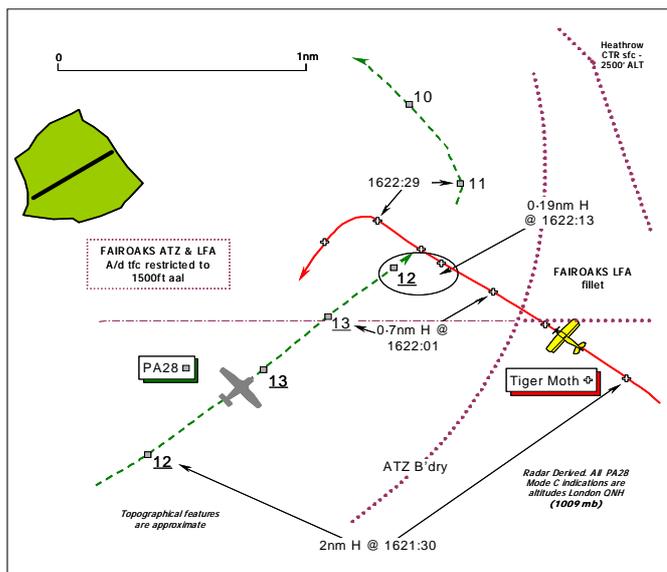
Date/Time: 22 Jul 1622 (Sunday)
Position: 5120N 00031W (1.4nm ESE of Fairoaks Aerodrome RW24 Cct - elev 80ft)
Airspace: Fairoaks ATZ (Class: A)
Reporting Ac Reported Ac
Type: PA28 Tiger Moth
Operator: Civ Trg Civ Pte
Alt/FL: 1100ft 1500ft
QNH (1012mb) QNH
Weather VMC COCISOS VMC NR
Visibility: 10km+ 10km+
Reported Separation:
100ft V/Nil H 60ft V/Nil H
Recorded Separation:
Not recorded

Cause: The Tiger Moth pilot entered the Fairoaks ATZ in contravention of Rule 45 of the Rules of the Air Regulations 2007 and flew into conflict with the PA28.

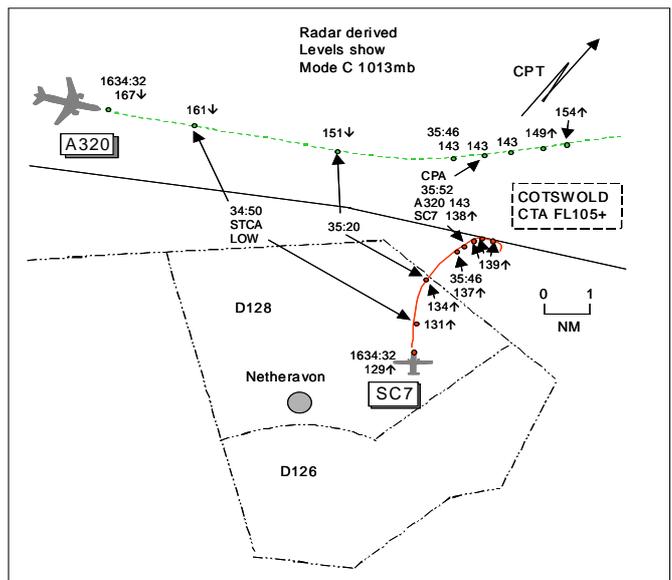
Date/Time: 21 Jul 1636 (Saturday)
Position: 5120N 00139W (19nm SW CPT)
Airspace: Cotswold CTA/FIR(Class: A/G)
Reporting Ac Reported Ac
Type: A320 SC7 Skyvan
Operator: CAT Civ Club
Alt/FL: FL150↓ NR
 (N/K)
Weather IMC CLAC VMC CLOC
Visibility: 6km 'unlimited'
Reported Separation:
 500ft V/2nm H Not seen
Recorded Separation:
 500ft V/2.2nm H

Cause: Perceived conflict at the boundary of CAS.

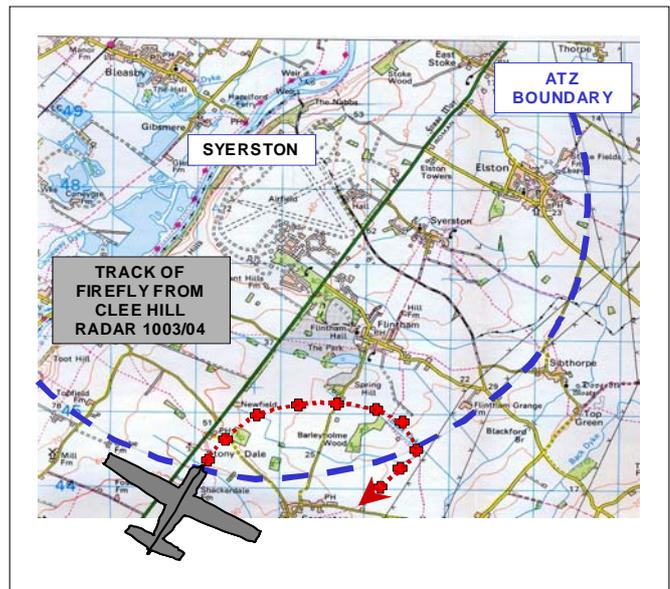
Date/Time: 27 Jul 1003
Position: 5300N 00054 W (1nm SE Syerston)
Airspace: Syerston ATZ (Class: G)
Reporting Ac Reported Ac
Type: DR400 Firefly 260
Operator: HQ AIR (Trg) HQ AIR (Trg)
Alt/FL: 800ft 2500ft↓
 (QFE NR mb) (RPS NR mb)
Weather VMC CLBC VMC Good Visibility
Visibility: >10km >10km
Reported Separation:
 300ft V/300m H 300ft V/1/2nm H
Recorded Separation:
 NR

Cause: A sighting report of traffic on the boundary of the Syerston ATZ.

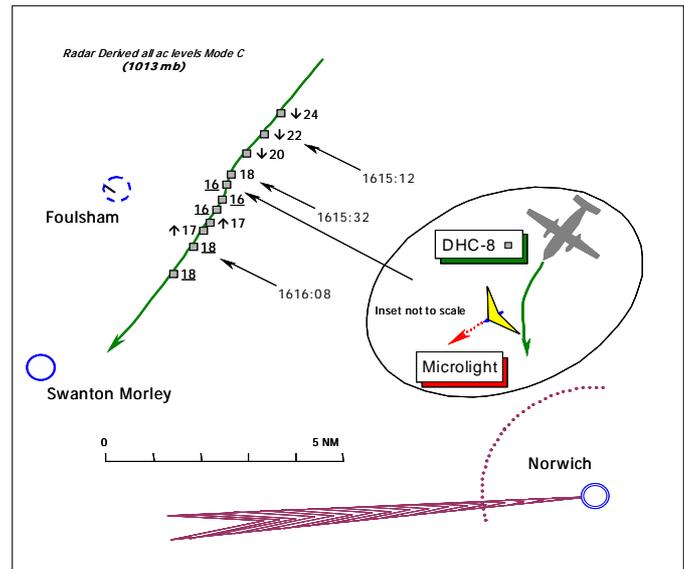
Date/Time: 31 Jul 1615
Position: 5248 N 00104 E (11nm NW of Norwich - elev 117ft)
Airspace: London FIR (Class: G
Reporting Ac Reported Ac
Type: DHC-8 Pegasus 912
Operator: CAT Civ Pte
Alt/FL: 2000ft 2500ft
 QNH (1019mb) QNH (1016mb)
Weather VMC CLBC VMC CAVOK
Visibility: 10km 10km+
Reported Separation:
 100ft V NR
Recorded Separation:
 Not recorded

Cause: A conflict in the FIR resolved by the DHC-8 pilot.

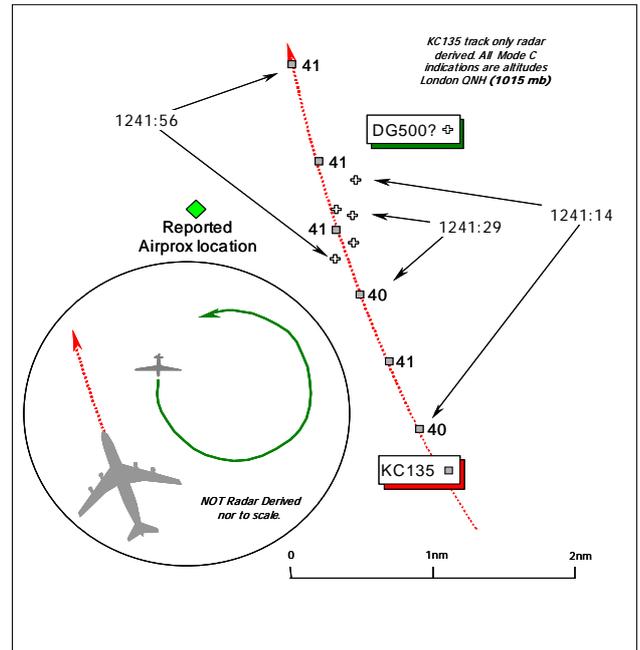
Date/Time: 28 Jul 1241 (Saturday)
Position: 5214N 00011W (2nm E St Neots)
Airspace: London FIR (Class: G)
Reporting Ac Reported Ac
Type: DG500 Glider KC-135
Operator: Civ Pte Foreign Mil
Alt/FL: 3200ft 4000ft
 QFE (1005mb) QNH
Weather VMC CLBC VMC
Visibility: 15nm+ NR
Reported Separation:
 500ft V/400m H NK
Recorded Separation:
 Not recorded

Cause: Sighting Report.

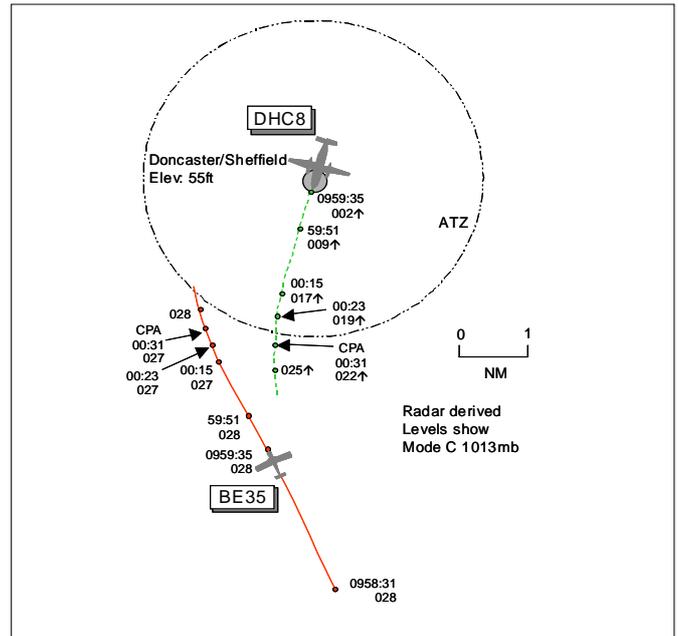
Date/Time: 7 Aug 1000
Position: 5326N 00102W (2.5nm S Doncaster/Sheffield - elev 55ft)
Airspace: ATZ/FIR (Class: G)
Reporting Ac Reported Ac
Type: DHC8 BE35
Operator: CAT Civ Pte
Alt/FL: 2100ft↑ 2500ft
(QNH 1016mb) (QNH)
Weather VMC CLBC VMC CLBC
Visibility: 20km 50km
Reported Separation:
400ft V/1nm H 'Below'/500m H
Recorded Separation:
500ft V/1nm H

Cause: The DHC8 crew was released to depart without TI on the conflicting BE35.

Following this Airprox and 149/07, ATSI was tasked by the Chairman to contact DSA to follow up progress of proposed changes to the departure release procedure, as Members were minded to issue a safety recommendation that a review was needed owing to the length of time between Tower ATCO requesting a departure release and the ac presenting itself to radar.

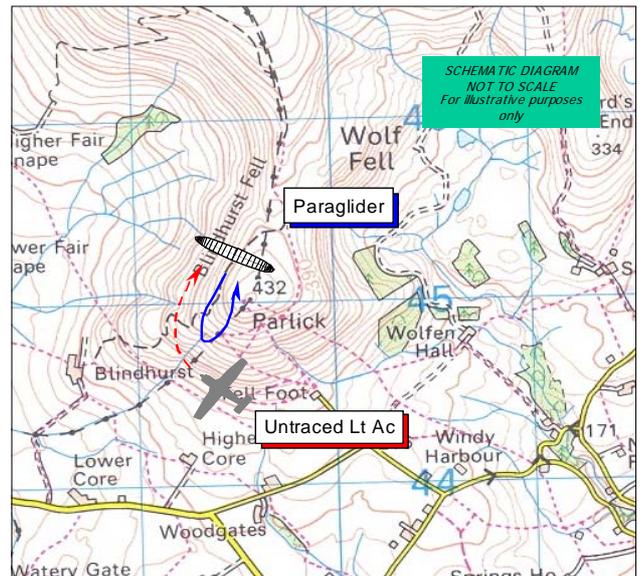
Date/Time: 1 Aug 0900
Position: 5354N 00237W (Parlick)
Airspace: London FIR (Class: G)
Reporting Ac Reported Ac
Type: Paraglider Light Ac
 Untraced
Operator: Civ Pte N/K
Alt/FL: 1400ft NR
 amsl
Weather VMC CLBC NK
Visibility: 100km NR
Reported Separation:
 Nil V/20yd H NR
Recorded Separation:
 Not recorded

Cause: Conflict resolved by the Paraglider pilot.

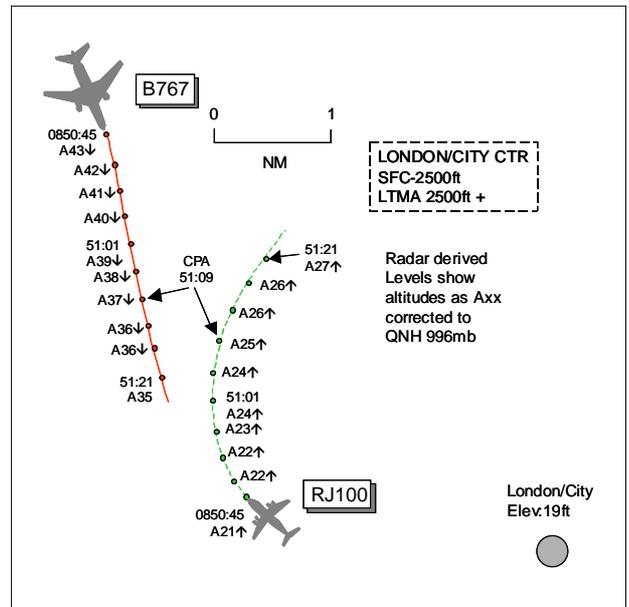
Date/Time: 15 Aug 0851
Position: 5132N 00002W (4nm NW London/City - elev 19ft)
Airspace: City CTR/LTMA (Class: D/A)
Reporting Ac Reported Ac
Type: RJ100 B767-300
Operator: CAT CAT
Alt/FL: 2000ft↑ ↓4000ft
(QNH 996mb) SAS
Weather IMC KLWD NK
Visibility: 10km NR
Reported Separation:
500ft V/1nm H NR
Recorded Separation:
1200ft V/0.7nm H

Cause: The B767 crew did not set the QNH and descended below their cleared altitude.

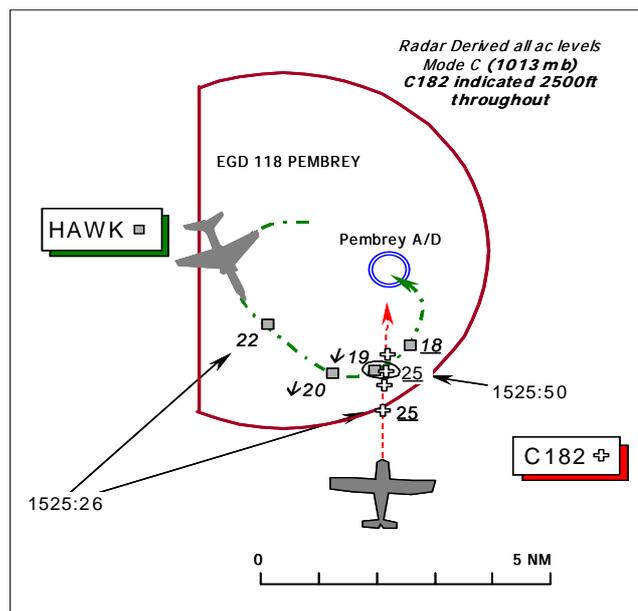
Recorded Separation:

600ftV @ 0.2nm H

Cause: The C182 pilot unknowingly entered a promulgated Danger Area active with live firing and flew into conflict with the Hawk.

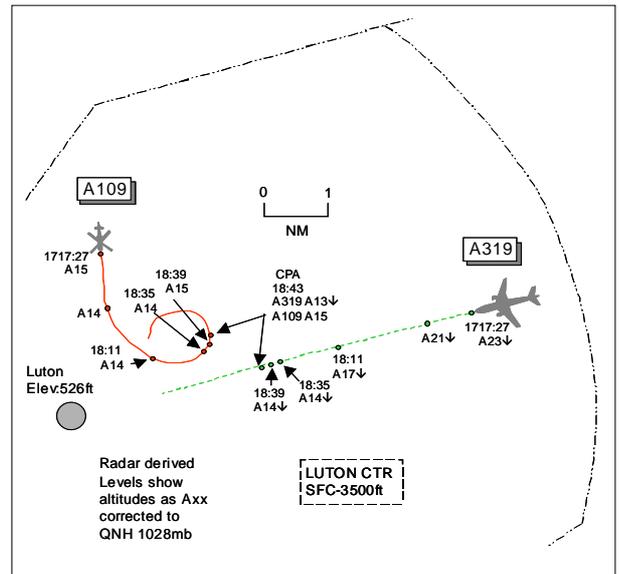
AIRPROX REPORT NO 124/07

Date/Time: 26 Aug 1719 (Sunday)
Position: 5153N 00018W (2.5nm FIN APP RW26
 Luton - elev 526 ft)
Airspace: CTR/ATZ (Class: D)
Reporting Ac Reported Ac
Type: A319 A109
Operator: CAT Civ Pte
Alt/FL: 1250ft↓ 500ft
 (QNH 1028mb) (agl)
Weather VMC NR VMC
Visibility: 1.5nm
Reported Separation:
 Nil V/1nm H NR
Recorded Separation:
 200ft V/0.9nm H

LTCC ATSI made a recommendation which SRG ATSI endorses: - *'It is recommended that LTCC Ops consider a more comprehensive MATS Pt 2 entry on the handling of VFR overflights and in consultation with Luton Tower include advice on coordination and transfer of communications in appropriate circumstances.'*

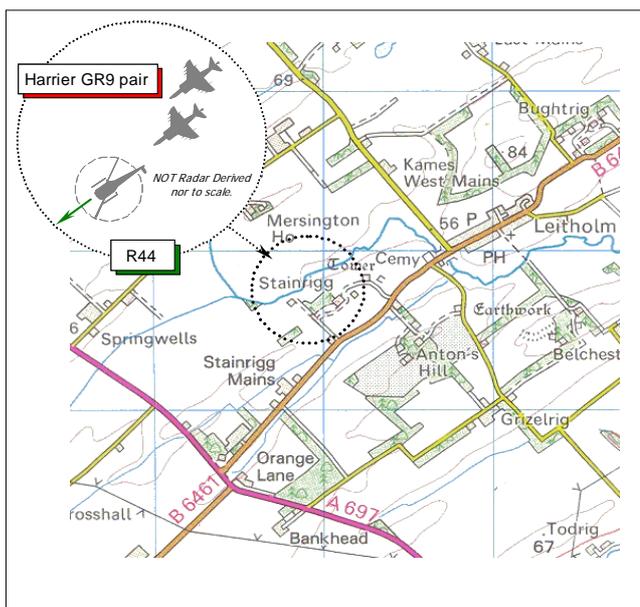
AIRPROX REPORT NO 126/07

Date/Time: 30 Aug ~ 1200
Position: 5541N 00221W (6nm NE of Kelso)
Airspace: Scottish FIR/LFA16 (Class: G
Reporting Ac Reported Ac
Type: Robinson R44 Harrier GR9
Operator: Civ Pte HQ AIR (Ops)
Alt/FL: 50-80ft↑ 250ft
agl msd
Weather VMC CLOC VMC NR
Visibility: 10km+ 50+km
Reported Separation:
100-150ft V/nil H Not seen
Recorded Separation:
Not recorded

Cause: A conflict in the FIR/LFS.

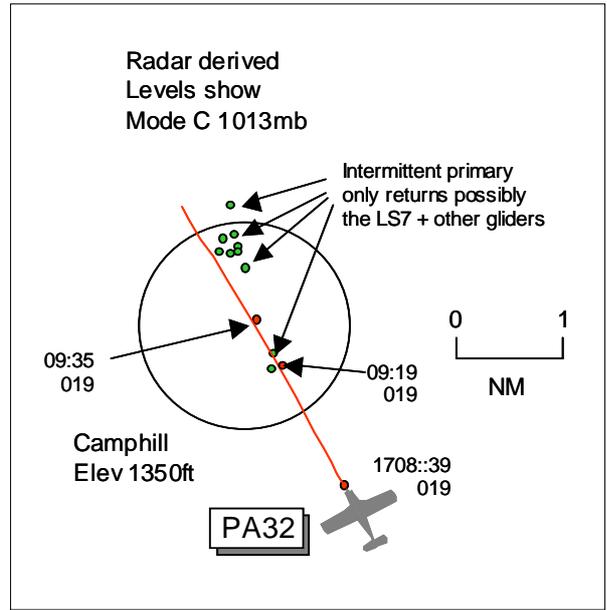
AIRPROX REPORT NO 127/07

Date/Time: 26 Aug 1710 (Sunday)
Position: 5318N 00144W (0.5nm NW Camphill
 G/S - elev 1350ft)
Airspace: FIR (Class: G)
Reporting Ac Reported Ac
Type: LS7 Glider PA32
Operator: Civ Pte N/K
Alt/FL: 1000ft↓
 (QFE) (N/K)
Weather VMC CLBC NK
Visibility: >5nm
Reported Separation:
 50-100ft V/60m H
Recorded Separation:
 NR

Cause: The PA32 pilot flew overhead a notified and active glider site into conflict with the LS7.

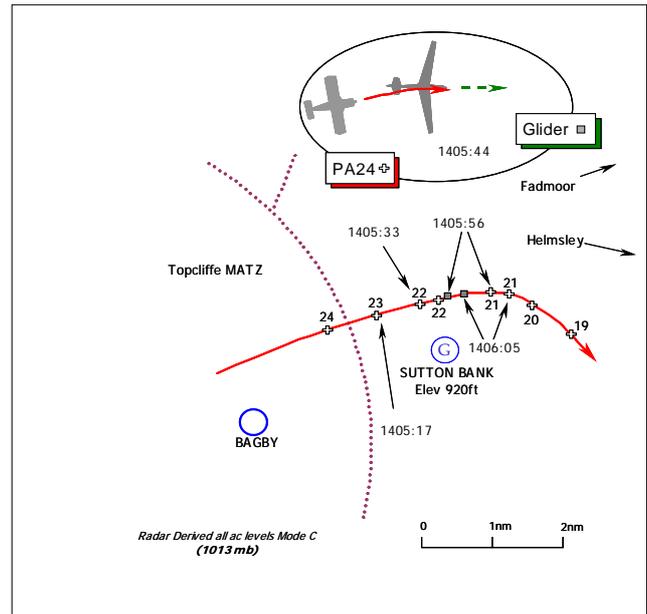
Date/Time: 29 Aug 1405
Position: 5414N 00112W (1nm N of Sutton Bank
 - elev 920ft)
Airspace: London FIR (Class: G
Reporting Ac Reported Ac
Type: Glider PA24
Operator: Civ Club Civ Pte
Alt/FL: 1750ft NR
 QFE amsl
Weather VMC CLOC VMC CLOC

Visibility: 10km+ "Reasonable"
Reported Separation:
 50-100ft V/nil H NR
Recorded Separation:
 Not recorded

Cause: The PA24 pilot flew sufficiently close to cause the glider pilots concern.

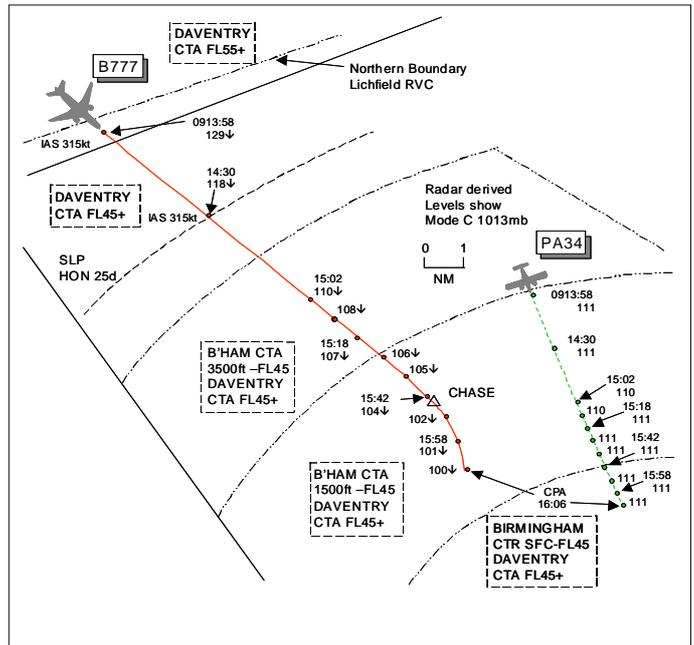
Recorded Separation:

700ft V/4.8nm H
OR 1100ft V/4.1nm H

Cause: The MACC SE Tactical did not ensure that standard separation would be maintained before transferring the B777 to Birmingham ATC.

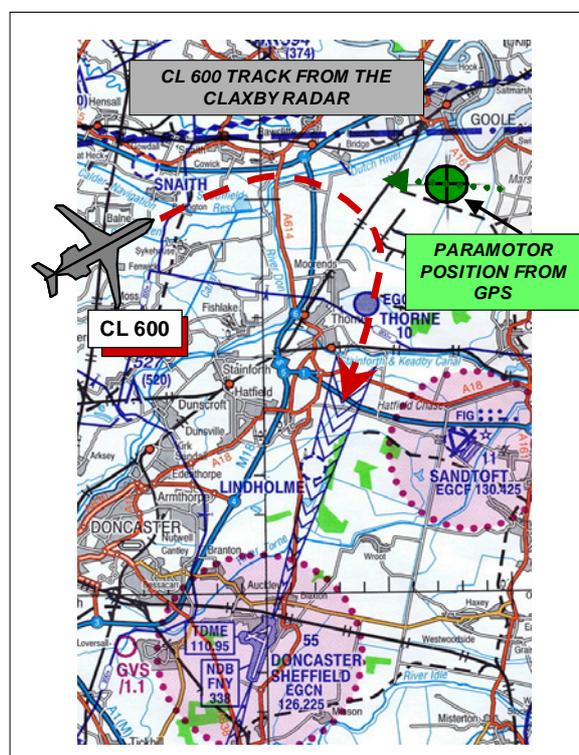
Recorded Separation:

NR

Cause: Sighting report.

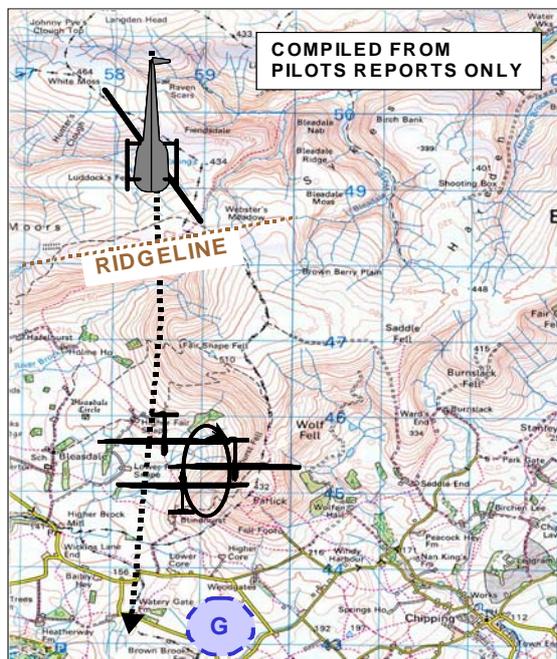
Reported Separation:
100ft V0 H NR

Recorded Separation:
NR

Cause: The R44 pilot flew sufficiently close to the gliders to cause the SZD pilot concern.

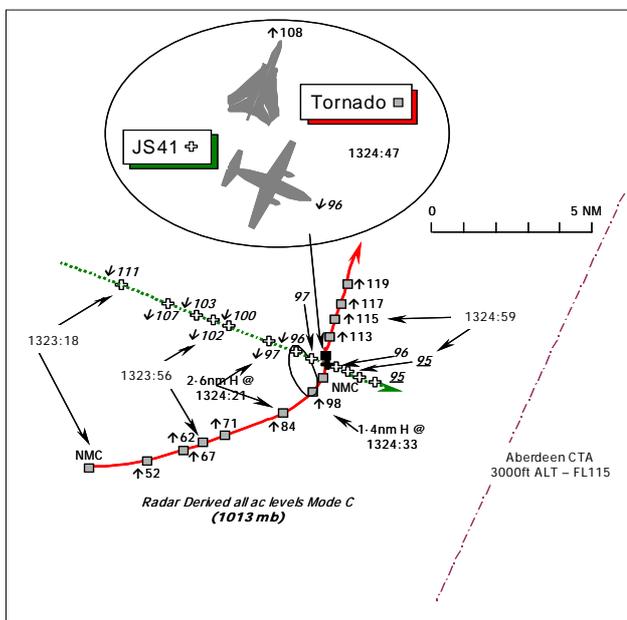
200ft V/1.4nm H @ 1324:33

1200ft V/0.2nm H of @ 1324:47

Cause: A conflict in Class G airspace.

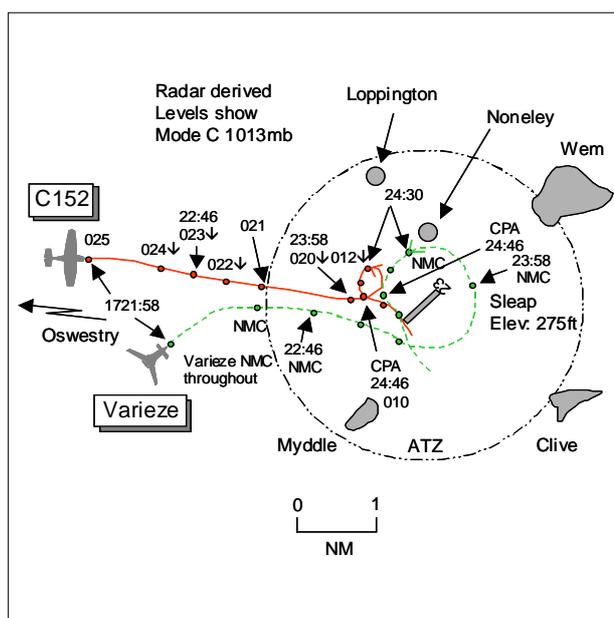
Reported Separation: 150ft V+H 150ft V/100m H

Recorded Separation: <0.25nm H

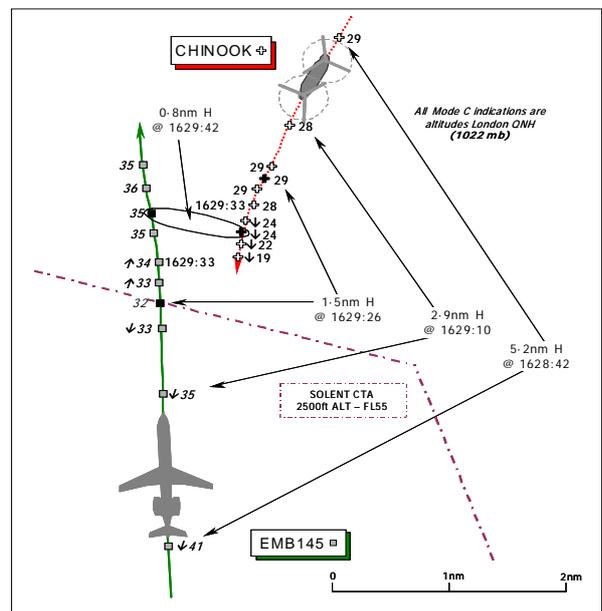
<u>Reported Separation:</u>	
300ft V/nil H	500ft V/1½nm H

<u>Recorded Separation:</u>	
300ft Min V @ 1.5nm	
0.8nm Min H @ 1100ft V

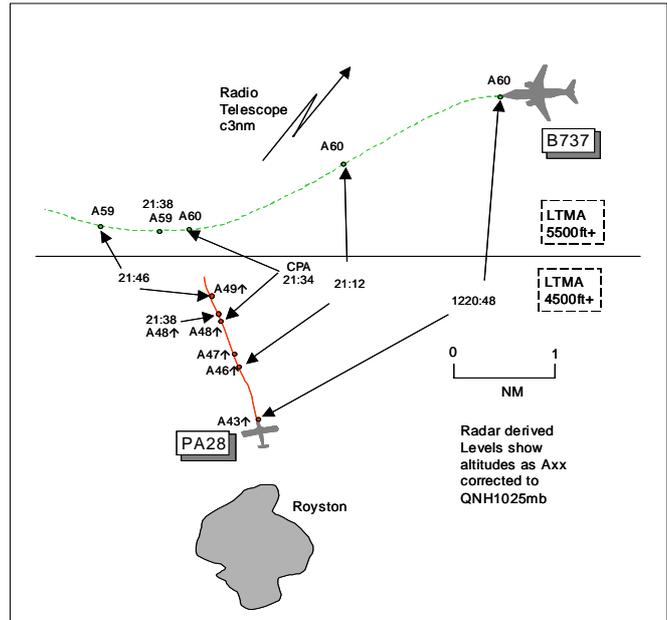
Reported Separation:
 INT DIR - 1000ft V/1nm H
 800ft V/NR H 1000ft V/2-3nm H

Recorded Separation:
 1200ft V/1nm H

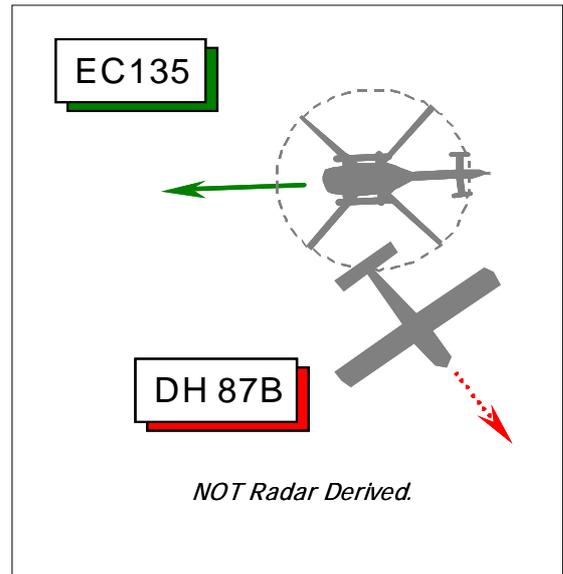
AIRPROX REPORT NO 140/07

Date/Time: 18 Sep 1217
Position: 5131N 00229W (4nm E of Filton - elev 226 ft)
Airspace: London FIR (Class: G
Reporting Ac Reported Ac
Type: EC135 DH87B
Operator: Civ Trg Civ Pte
Alt/FL: 1520ft↓ 1500ft
 QNH (1026mb) amsl
Weather VMC CLBC VMC
Visibility: >10km Unlimited
Reported Separation:
 50ft V/nil H NR
Recorded Separation:
 Not recorded

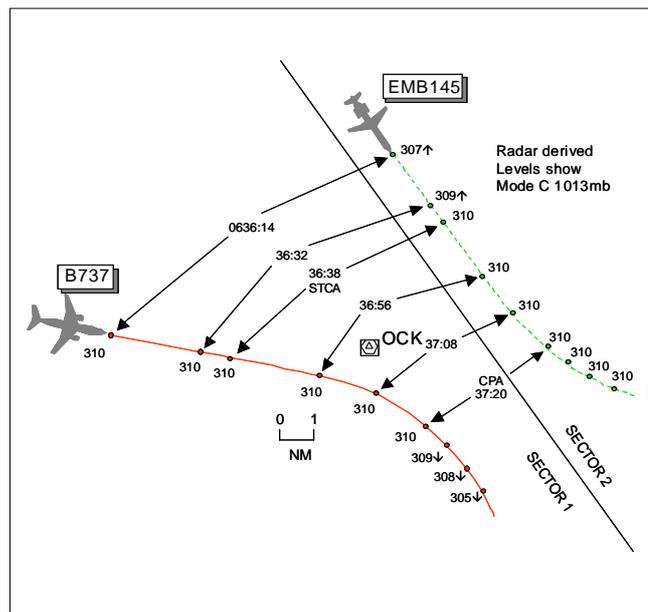
Recorded Separation:

Nil V/4.1nm H

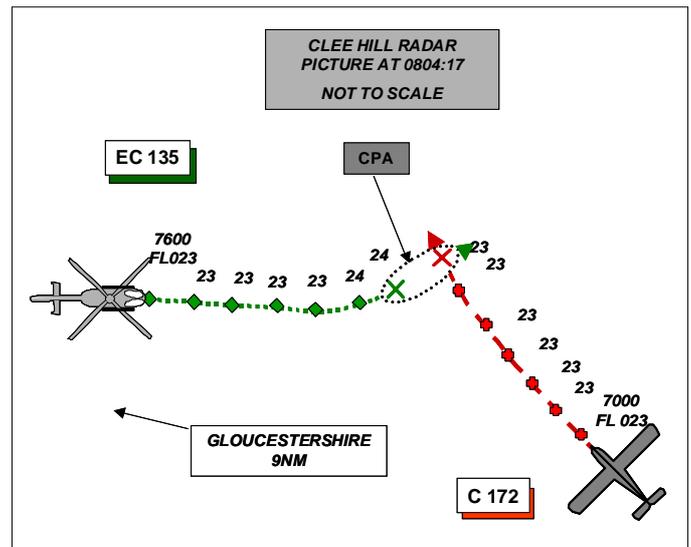
AIRPROX REPORT NO 142/07

Date/Time: 21 Sep 0804
Position: 5153N 00155W (9nm E Gloucestershire Airport)
Airspace: Lon FIR (Class: G)
Reporting Ac Reported Ac
Type: EC135 C172
Operator: Civ Trg Civ Pte
Alt/FL: 2300ft 2300ft
 (QNH 1014mb) (QNH NR)
Weather IMC KLWD IMC KLWD
Visibility: 0-1000m IMC
Reported Separation:
 0 V/500m H Not Seen
Recorded Separation:
 100ft/ 0.3nm

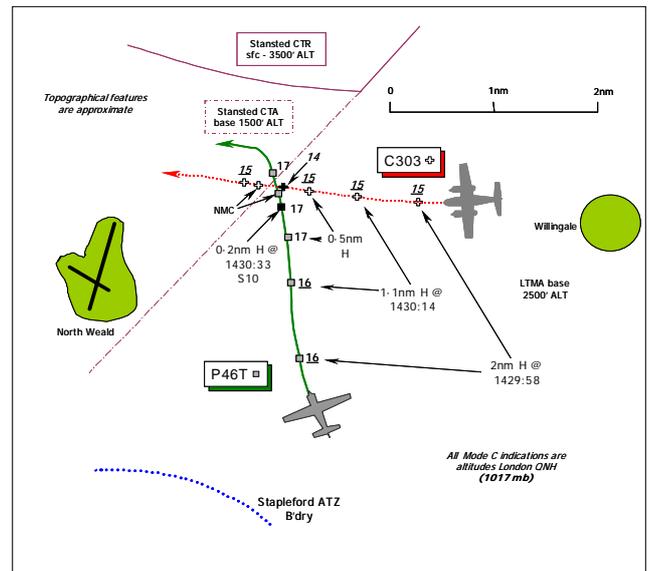
AIRPROX REPORT NO 143/07

Date/Time: 23 Sep 1430 (Sunday)
Position: 5144N 00012E (2nm ENE of North Weald A/D - elev 321ft)
Airspace: CTA/London FIR (Class: D/G)
Reporting Ac **Reported Ac**
Type: PA46T C303
Operator: Civ Pte Civ Pte
Alt/FL: 1400ft 1400ft
 QNH (1020mb) QNH
Weather VMC CLOC VMC NR
Visibility: 10+km 10+km
Reported Separation:
 100ft V/0.2nm H NR
Recorded Separation:
 300ft V @ 0.2nm H

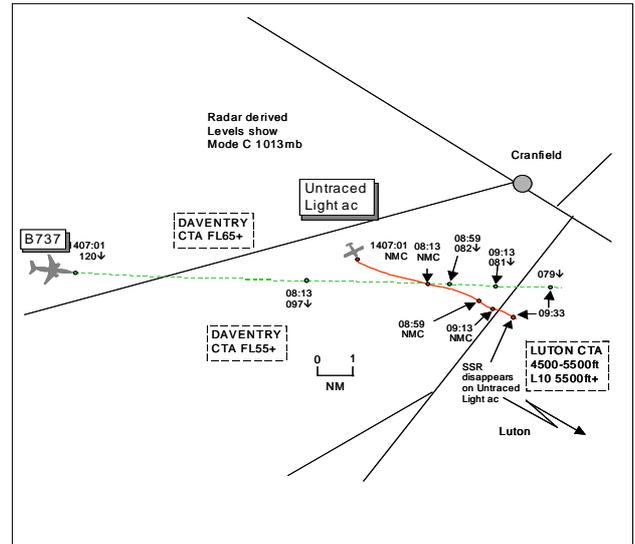
AIRPROX REPORT NO 144/07

Date/Time: 22 Sep 1409 (Saturday)
Position: 5201N 00039W (13nm NW Luton)
Airspace: Daventry CTA (Class: A)
Reporting Ac Reported Ac
Type: B737-700 Untraced
 Light ac
Operator: CAT N/K
Alt/FL: ↓FL80 NK
Weather IMC IICL NK
Visibility:
Reported Separation:
 Nil V/1nm H NK
Recorded Separation:
 0-6nm H

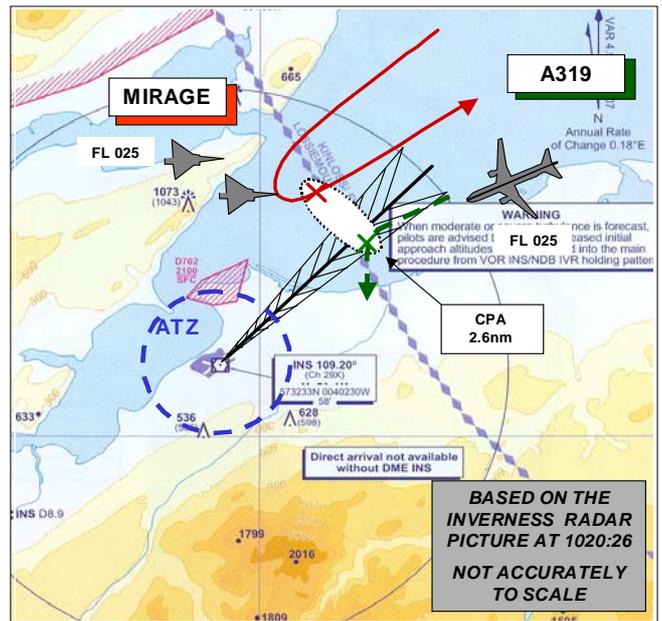
AIRPROX REPORT NO 145/07

Date/Time: 20 Sep 1021
Position: 5739N 00350W (7.8nm RW23
 Inverness - elev 31 ft)
Airspace: Scottish FIR (Class: G)
Reporting Ac **Reported Ac**
Type: A319 Mirage 2000 x 2
Operator: CAT Foreign Mil
Alt/FL: 2100ft NR
 (QNH) (N/K)
Weather VMC NR VMC NR
Visibility: 10km 10km
Reported Separation:
 3-4nm H(TCAS) Not Seen
Recorded Separation:
 100ft V/2.6nm H

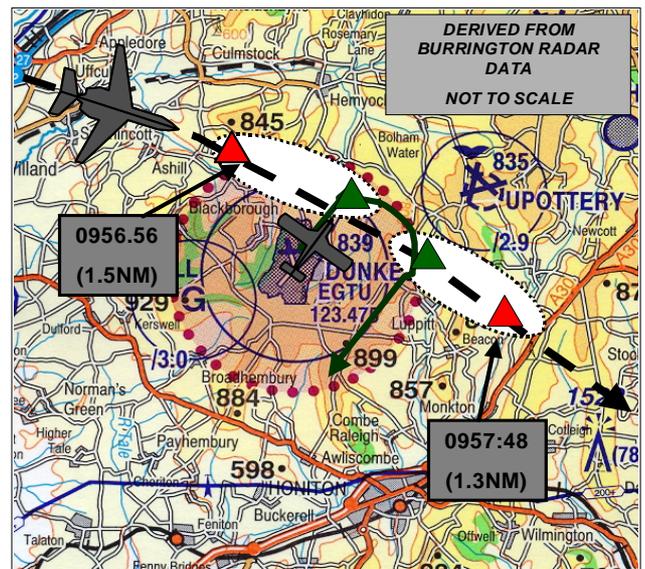
AIRPROX REPORT NO 146/07

Date/Time: 27 Sep 0957
Position: 5052N 00312W (¾nm NE Dunkeswell - elev 839ft)
Airspace: Dunkeswell ATZ (Class: G)
Reporting Ac Reported Ac
Type: PA28 Dominie
Operator: Civ Trg HQ AIR (Trg)
Alt/FL: 800ft 300ft
(QFE 993mb) (N/K)
Weather VMC CLBC VMC NR
Visibility: >20km 20km
Reported Separation:
500ft V/½nm H 300ft V/1nm H
Recorded Separation:
400ft V/0.5nm H (as ac abeam one another)

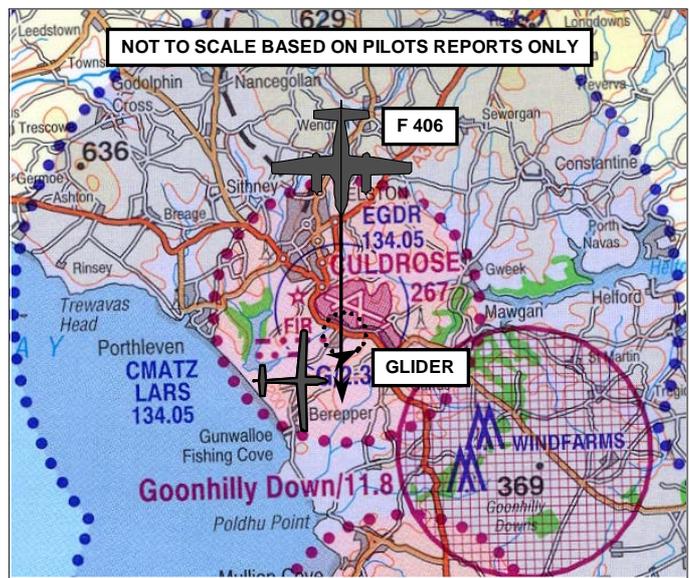
AIRPROX REPORT NO 147/07

Date/Time: 29 Sep 1225 (Saturday)
Position: 5005N 00515W (Culdrose Airfield - elev 267ft)
Airspace: ATZ (Class: G)
Reporting Ac Reported Ac
Type: Capstan Glider F406
Operator: Civ Club Civ Comm
Alt/FL: 1000ft 1750-2050ft
(QFE NR) (RPS NR)
Weather VMC CLBC VMC NR
Visibility: 5nm >20km
Reported Separation:
100ft V/300ft H Not Seen
Recorded Separation:
NR

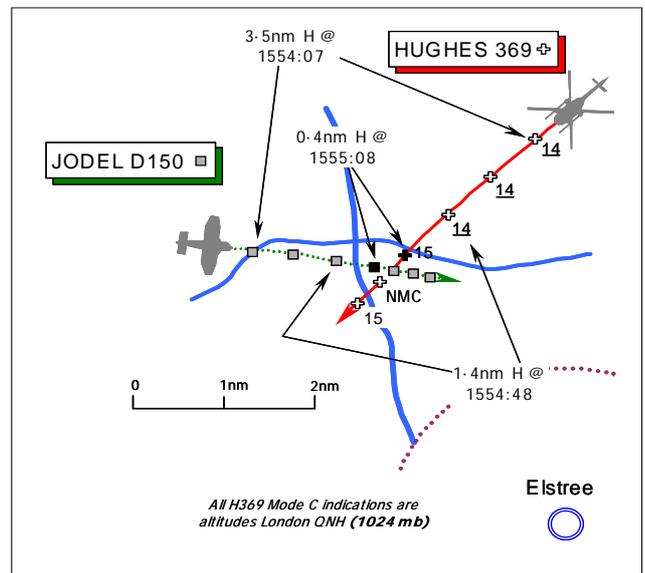
AIRPROX REPORT NO 148/07

Date/Time: 5 Oct 1555
Position: 5142N 00022W (3½nm NW by N from Elstree)
Airspace: London FIR (Class: G)
Reporting Ac Reported Ac
Type: Jodel D150 Hughes 369
Operator: Civ Club Civ Pte
Alt/FL: 1400ft 1500ft
 QNH (1026mb) QNH
Weather VMC CLOC VMC CAVOK
Visibility: 10km+ 10nm
Reported Separation:
 30-50ft V/nil H 15-20ft V/nil H
Recorded Separation:
 Contacts merged

scheme of very small cross sectional area, closing on a steady relative bearing with no crossing motion to draw attention to its presence, despite a disciplined lookout and the two HISLs fitted to the Hughes H369. Providentially, the Jodel pilot did manage to spot it, just in time at minimal range in his 10 o'clock - about 100m away he reported – which enabled him to push forward and take avoiding action. This was clearly less than ideal and the Members agreed that a very late sighting by the Jodel D150 pilot was part of the cause.

Cause: An effective non-sighting by the Hughes H369 pilot and a very late sighting by the Jodel D150 pilot.

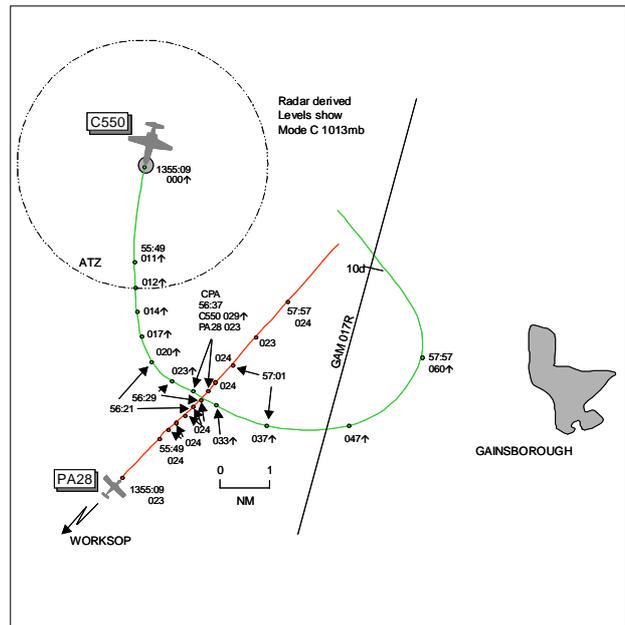
600ft V/0.3nm H

Members noted similarities within this Airprox to Airprox 112/07, which was assessed earlier in the same meeting. The DSA APR had released the C550 but then about 4min had elapsed before this flight was actually airborne. The PA28 pilot had already established a FIS with the APR over 15min before the Airprox and had passed his flight's cross-country turning points, the pilot reporting turning at Worksop when the C550 release was given. Although the subject PA28 was not identified at the time - SSR had been lost 8min earlier - the ac was known traffic to the APR, turning onto a known track, which would pass close to the C550's departure route. Also the PA28 would have been showing as a primary radar contact on his display. However the 4min delay was significant here and resulted in the PA28 being much closer to DSA as the C550 became airborne. Although there was no requirement to separate the subject ac (IFR v VFR traffic with both in receipt of an Approach Control service in Class G airspace), the minimum requirement was for DSA ATC to pass timely TI to both flights. The ideal time to pass this to the C550 crew would have been as the PA28 pilot reported turning at Worksop, via the ADC, before the flight became airborne. Members believed that being forewarned with this TI, the C550 crew would have been better placed to decide a course of action – perhaps select a better ROC, a tighter turn or even reject the departure clearance until the conflicting ac was clear. The APR was cognisant of the potential for a confliction, as he had asked another flight departing Netherthorpe to route to the W of DSA owing to the C550's impending departure. That said, the APR only gave TI and avoiding action immediately after the C550 flight's initial call on his frequency which was too late. Members agreed therefore, that the cause of this Airprox was the Doncaster/Sheffield APR Mentor did not ensure that the C550 pilot was given TI on the conflicting PA28 prior to departure.

Cause: The Doncaster/Sheffield APR Mentor did not ensure that the C550 crew was given TI on the conflicting PA28 prior to departure.

Following the Board's assessment of this Airprox and 112/07, the ATSI Advisor was tasked by the Chairman to contact DSA in order to follow up progress of proposed changes to the departure release procedure. Members were minded to issue a Safety Recommendation requesting that a review was needed owing to the length of time between Tower ATCO requesting a departure release and the ac presenting itself to radar.

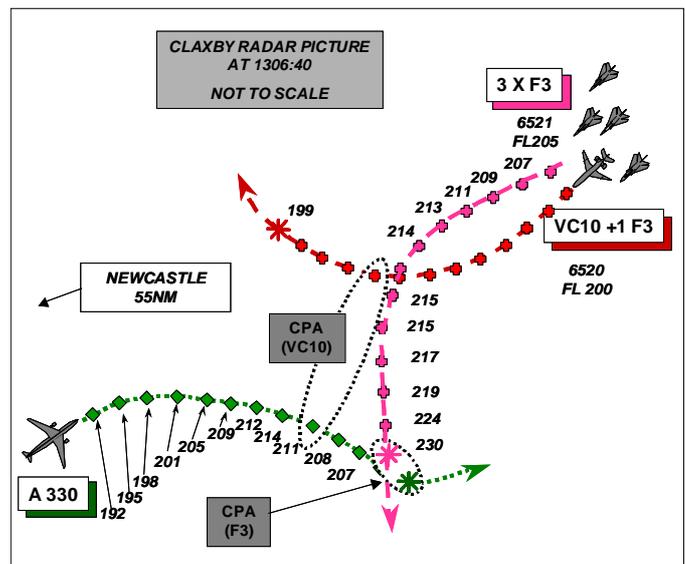
Weather VMC NR VMC NR
Visibility: Unlimited Unlimited
Reported Separation:
 300ft V/3nm H NK
Recorded Separation:
 1100ft/5.1nm H (2300ft V on the F3s at min H (1.3nm))

The Tyne Controller was under the false impression that all the military activity would be confined to the level band FL180-FL210. Although the tanker and remaining F3 stayed in this block, the departing the departing F3s did not and came closer to the A330 shortly after the first CPA with the VC10 and most likely caused the RA.

Experienced controller Members noted that the significant breach in co-ordination that had allowed the A330 to continue climbing into conflict with the Tanker formation had been that the Tyne Sector Controller elected to climb the A330 through the level of ('jump') the formation, in an attempt to maintain a continuous climb, rather than to stop the climb at FL170 temporarily until it was 10nm clear of it horizontally, the 'agreement' that the Tyne Sector Controller had negotiated with Scampton. One Controller Member opined that in such circumstances when not adhering to a previously agreed co-ordination, even when for good reason, good practise is to call the other unit and inform them of the change of plan.

Cause: Contrary to the co-ordination agreed between the Tyne Sector Controller and CRC Scampton, the Tyne Sector Controller elected to climb the A330 into conflict with the Tanker formation.

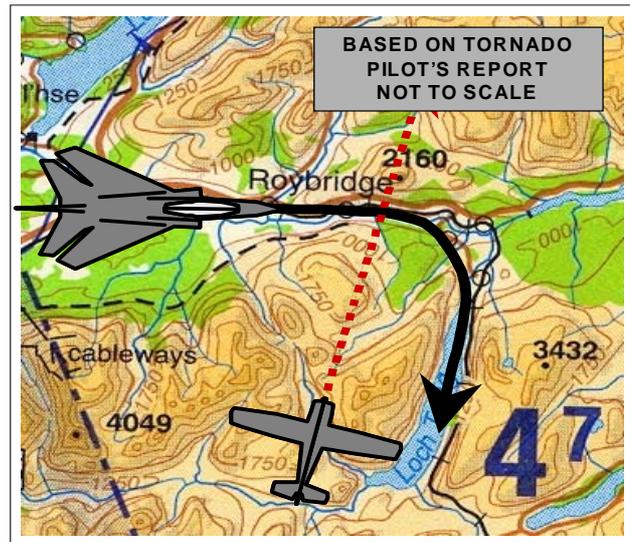
AIRPROX REPORT NO 152/07

Date/Time: 27 Sep 1100
Position: 5653 N 00442 W (Roybridge)
Airspace: LFA 14 (Class: G)
Reporting Ac Reported Ac
Type: Tornado F3 Cessna
Operator: HQ AIR (Ops) NK
Alt/FL: 400ft NR
(RPS 1020mb)
Weather VMC NR NR
Visibility: >10nm NR
Reported Separation:
200ft V/200m H NR
Recorded Separation:
NR

Cause: Assumed non-sighting by light ac pilot and late sighting by Tornado crew.

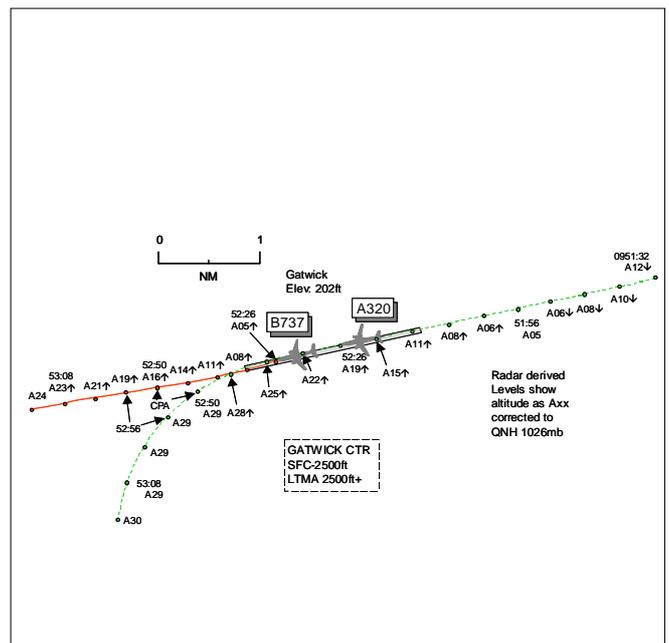
Recorded Separation:
1300ft V/0.4nm H OR
600ft V/0.9nm H

Cause: Following an unstable high-energy approach the A320 crew went around into conflict with the B737.
