UK AIRPROX BOARD

Analysis of Airprox in UK Airspace

**Report Number 19
July 2007 - December 2007**

Nineteenth Report by the UK Airprox Board:

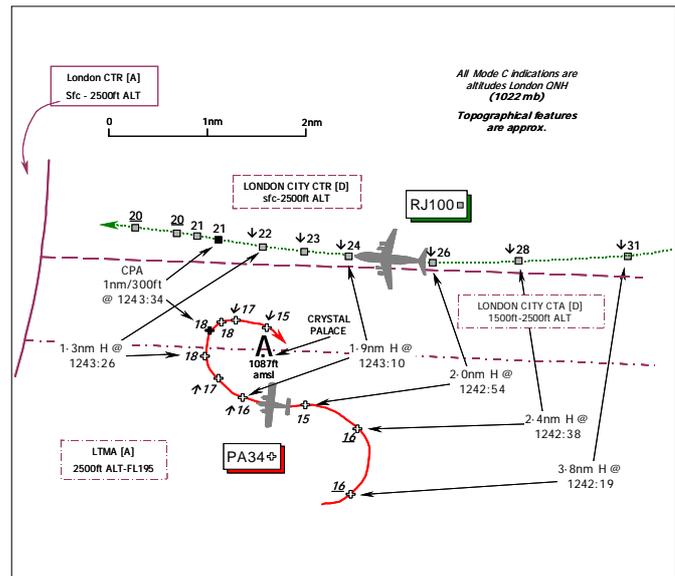
Recorded Separation:
300ft V/1nm H

As the RJ100 was flying "late downwind" for RW10, the PA34 was observed to be orbiting at 1800ft London QNH inside the London City CTA, at a range of 1½nm from the RJ100 that was descending to 2000ft. Avoiding action was not given to the RJ100 crew as the latter was turning away from the PA34. The PA34 pilot was instructed to move S immediately, given traffic information and reported visual with the RJ100. Later, the PA34 pilot was cleared into the Zone, to operate W of London Bridge and E of Vauxhall Bridge.

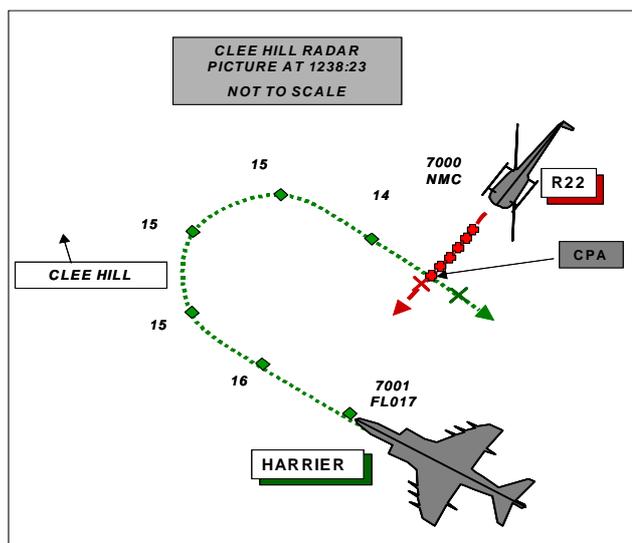
NR V/ 100m H

The Board noted that both ac had been operating legitimately in Class G airspace, the Harrier in the UKLFS and the R44 in the open FIR; that being the case the pilots had an equal and shared responsibility to see and avoid their respective ac. Members were briefed that the Harriers had been operating slightly higher than is usual for tactical low level sorties since they were on a high workload, initial conversion, 4-ship, tactical evasion mission. The student pilot in the front seat would have been concentrating on maintaining visual with and forming on his leader following the turnabout through 180 degrees. Following the turn however, the Harrier instructor in the rear seat saw the R22 appear slightly below them (below the horizon) in their 12 o'clock but not in time to take any avoiding action; the R22 pilot did not see the Harrier(s) at any time. Specialist Members thought that the helicopter had probably been slightly lower than its pilot reported and it would have been very difficult to see in the winter light, especially as it was effectively on a 90-degree collision course with the Harrier.

Cause: Non-sighting by the R22 pilots and an effective non-sighting by the Harrier pilots.

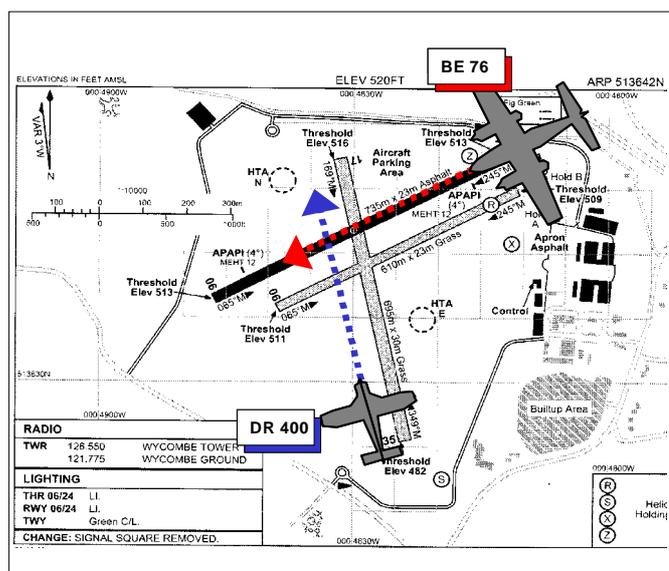
Recorded Separation:
NR

Members agreed unanimously that the DR400 pilot had incorrectly adopted gliding procedures when, in fact, he was not flying on any gliding associated duties. From the moment he adopted the callsign 'Tug XX' confusion had been caused not only to the ATCO as to his intentions but also to anyone else listening on the frequency. Further, since apparently the pilot did not call Gliding Control (located in another tug ac on the ground at the time) on 129.975, assuming they did not see the DR400, they too would have been unaware of its presence or intentions. The information that Control passed to the ATCO when requested if he could clear the BE76 for take-off, was therefore to the best of their knowledge correct. The Board was not able to determine why the DR400 pilot had not heard the BE76 making the Taxi, Clearance, Line Up or Takeoff calls (a total of 27 transmissions from the BE76 pilot or Tower, 5 of which referred to RW24 and one the hard RW). Even after the DR400 had crossed RW35 grass to the gliding side the Gliding Member was surprised that the pilot had not informed Gliding Control of his presence and intentions as this too could have broken the chain of events by allowing them in turn to tell the ATCO that an ac was about to get airborne from the gliding area and he would have held the BE76 for a short time.

Cause: The DR400 pilot took off from the wrong part of the aerodrome, without ATC clearance, and flew into conflict with the BE76.

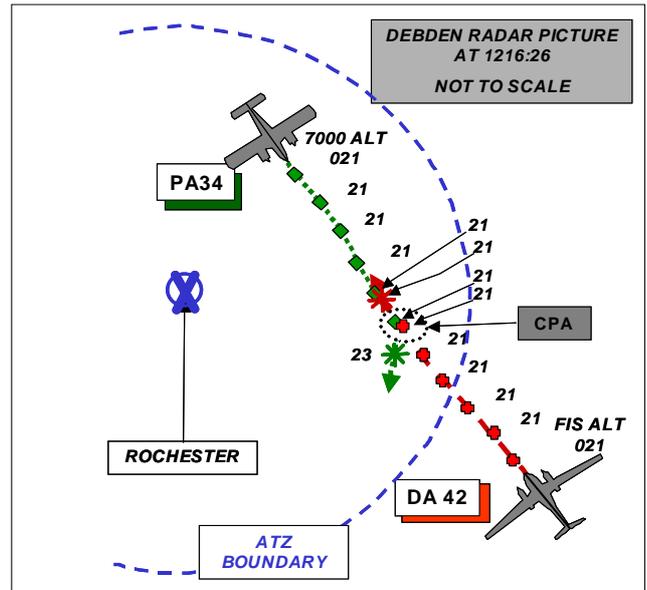
AIRPROX REPORT NO 158/07

Date/Time: 4 Nov 1216 (Sunday)
Position: 5121N 00034E (Rochester - elev 426ft)
Airspace: Rochester ATZ (Class: G)
Reporting Ac Reported Ac
Type: PA34 DA42
Operator: Civ Pte Civ Pte
Alt/FL: 2000ft 2300ft
 (QNH 1029mb) (QNH NR)
Weather VMC CAVOK VMC CAVOK
Visibility: >10km 10km
Reported Separation:
 Nil V/<50m H 100ft V/150m H
Recorded Separation:
 0 V/<100m H

Members noted that the PA34 pilot had correctly called Rochester when transiting their ATZ and was given the information necessary to fly safely through the area. The DA42 pilot, on the other hand, was not aware of his position (as witnessed by the radar recording) or that he had entered the ATZ. Notwithstanding this Members unanimously agreed that even when planning to fly close to an ATZ it is wise to call them and advise one's intentions so that information can be passed to other pilots in the area. This is particularly important near aerodromes that are manned by a FISO, since his information source is limited to pilots' radio reports. In this case the FISO was not aware of the presence of the DA42 so he was unable to inform the PA34 pilot about it so that he could see it earlier and thus avoid it.

The radar recording verified that the incident took place within the Rochester ATZ which is Class G airspace where 'see and avoid' pertains. One Member noted that sometimes pilots assume that when within an ATZ they are in a known and notified traffic situation and allow their lookout to be less vigilant however, as this incident amply demonstrates one should always be cognisant of unexpected traffic. Although both pilots saw the opposing traffic, both had done so very late indeed (about 100m). At a closing speed of about 300kt (150m/sec) this gave both pilots under a second to effect meaningful avoidance. Members were unable to resolve the apparent anomaly of the PA34 pilot and the FISO noting that the ac descended while the radar recording apparently showed a climb. This was however not considered to be important as it was agreed that, since both pilots saw the opposing ac in their 11 o'clock and turned right, they were not going to collide even if the avoidance was only partially effective or even ineffective. The lateness of the sightings however meant that safety had not been assured.

Cause: late sightings by both pilots.

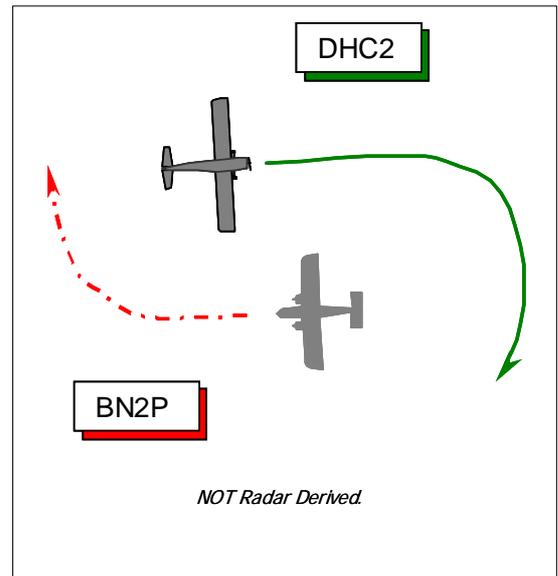
AIRPROX REPORT NO 159/07

Date/Time: 9 Nov 1124
Position: 5109N 00132W (Middle Wallop A/D - RW27RH cct - elev 288ft)
Airspace: Middle Wallop ATZ (Class: G)
Reporting Ac Reported Ac
Type: dHC Beaver AL1 Islander BN2P
Operator: SAAvn Civ Comm
Alt/FL: 1000ft 1200ft
 QFE (1017mb) RPS (1024mb)
Weather VMC Sky clear VMC CAVOK
Visibility: 20km+ 10+ km
Reported Separation:
 Nil V/400m H 200ft V/3-400m H
Recorded Separation:
 Not recorded

The unit investigation found that the second controller in the approach room – 'another Radar controller'- having answered the call from Boscombe ZONE and approved the two aircraft to transit, did not pass this information onto either the APR or the ADC. The unit's MATS Part 2 clearly states that Boscombe Down is the controlling authority for the Combined MATZ (CMATZ) but that they have no authority to allow ac to enter the Middle Wallop ATZ. However, as the Boscombe controller made it clear that the BN2P wished to route on a direct track from SW of Chilbolton direct to Netheravon, which necessitated crossing the ATZ, by the Wallop controller saying '*nothing to affect*' this could, not unreasonably, be taken as implicit clearance to cross the ATZ. The fact that the BN2P approached Middle Wallop from the E rather than transit on a direct track simply made the problem worse rather than causing it.

Cause: The Middle Wallop radar controller did not coordinate with the ADC the BN2P's transit of the MATZ/ATZ, leading to a conflict in the cct.

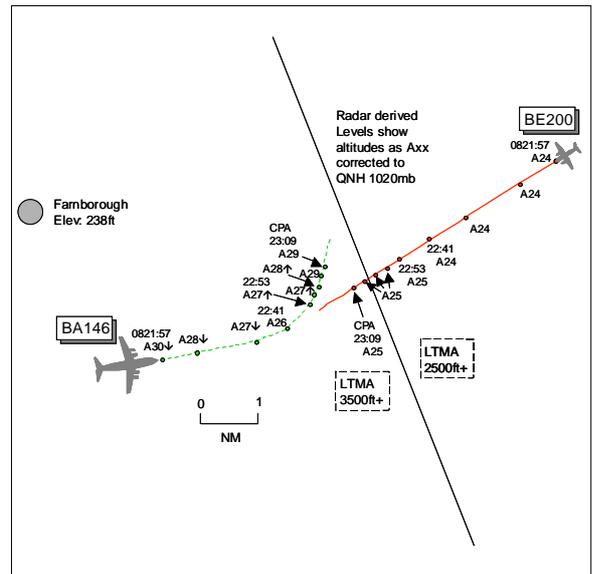
AIRPROX REPORT NO 160/07

Date/Time: 8 Nov 0823
Position: 5116N 00038W (5.5nm ESE Farnborough - elev 238ft)
Airspace: LFIR (Class: G)
Reporting Ac Reported Ac
Type: BA146 BE200
Operator: Civ Comm Civ Comm
Alt/FL: ↓1900ft 2300ft
(QNH 1020mb) (QNH 1020mb)
Weather VMC CLBC VMC NR
Visibility: >10km NR
Reported Separation:
300ft V/100m H 1000ft V/2-3nm H
Recorded Separation:
400ft V/0-6nm H

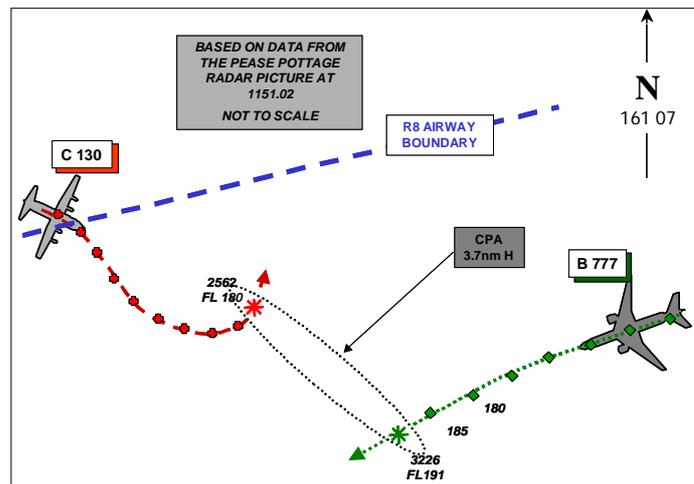
AIRPROX REPORT NO 161/07

Date/Time: 18 Oct 1151
Position: 5054N 00127W (5nm SW SAM)
Airspace: R8 (Class: A)
Reporting Ac Reported Ac
Type: B777 C130
Operator: CAT HQ AIR (Ops)
Alt/FL: ↑FL180 FL180
Weather NR VMC CAVOK
Visibility: NR Unrestricted
Reported Separation:
0ft V/5.6km H 4nm H
Recorded Separation:
1100ft V/3.8nm H

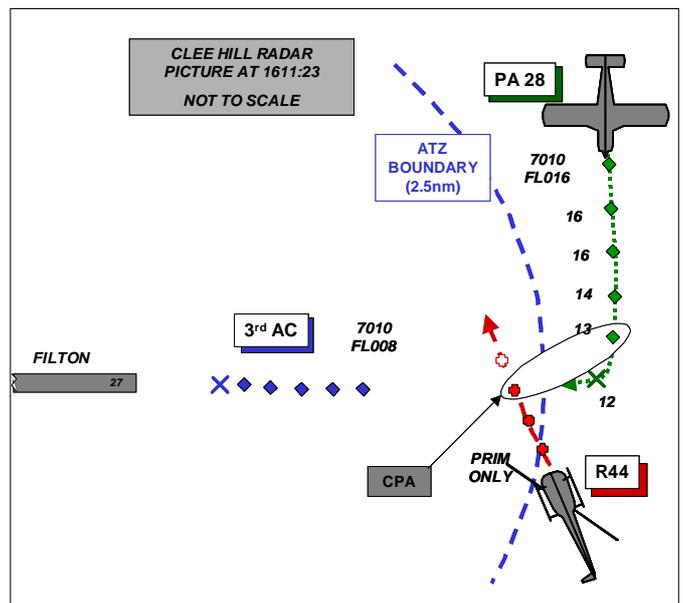
AIRPROX REPORT NO 162/07

Date/Time: 11 Nov 1611 (Sunday)
Position: 5131N 00231W (2.4nm E of Filton - elev 226ft ft)
Airspace: Filton ATZ (Class: G)
Reporter: Filton ATC
1st Ac 2nd Ac
Type: PA28 R44
Operator: Civ Pte Civ Trg
Alt/FL: 1000ft 1200ft
(QFE 1013mb) NR
Weather VMC CLOC VMC NR
Visibility: 20nm NR
Reported Separation:
100ft V/350m H NR
Recorded Separation:
NR V/0.5nm (900m) H

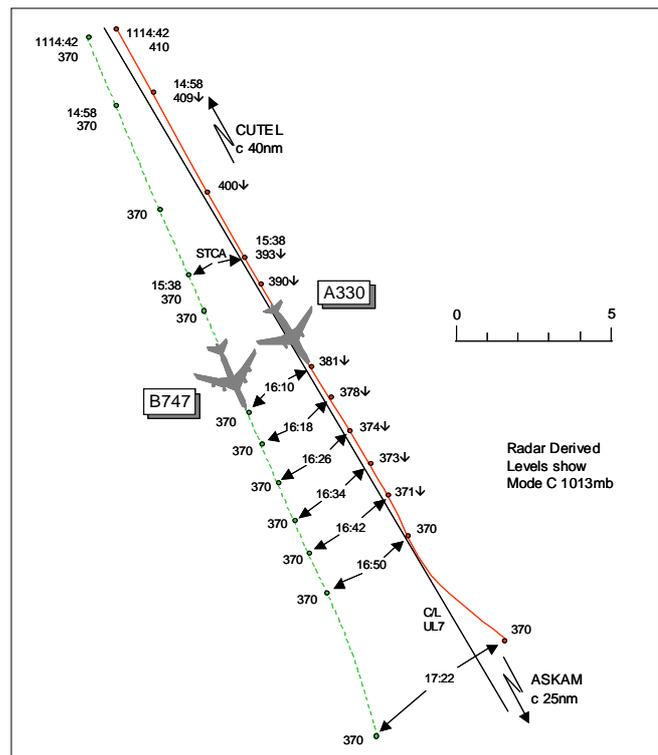
Separation:
800ft V/2.7nm H OR
Nil V/3.2nm H

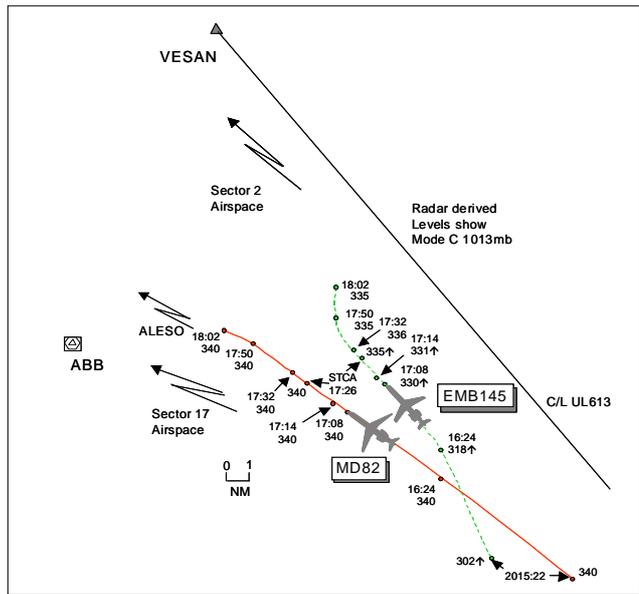
Weather VMC CLOC NR
Visibility: 10km
Reported Separation:
300ft V/2nm H 3nm H
Recorded Separation:
400ft V/2.8nm H OR
900ft V/2.2nm H

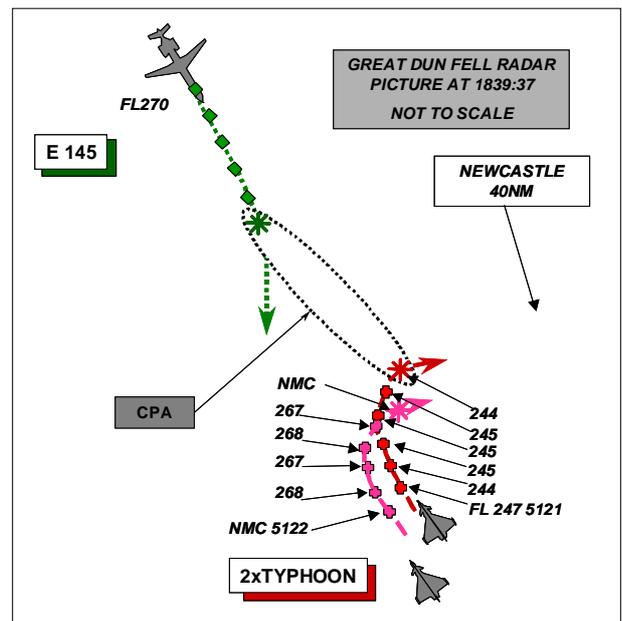
AIRPROX REPORT NO 168/07

Date/Time: 29 Nov 1840 (Night)
Position: 5540N 00215W (40nm NNW Newcastle)
Airspace: UN610 (Class: C)
Reporting Ac Reported Ac
Type: EMB145 Typhoon
Operator: CAT HQ AIR (Ops)
Alt/FL: FL270 ↓26000ft
 (RPS 993mb)
 (see Mil ACC report)
Weather NK NR VMC CAVOK
Visibility: NR NR
Reported Separation:
 200ft V/ NR H >5nm H
Recorded Separation:
 Min H 1000ft /7.7nm
 (Min V 200ft/11nm)

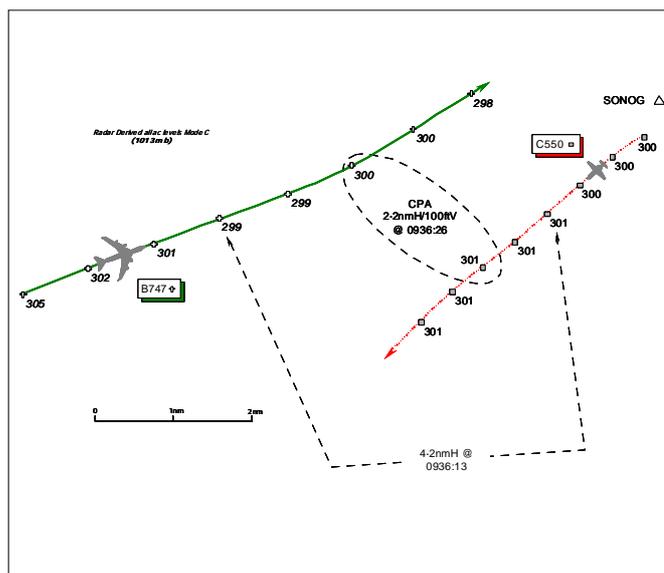
100ft V/2.2nm H

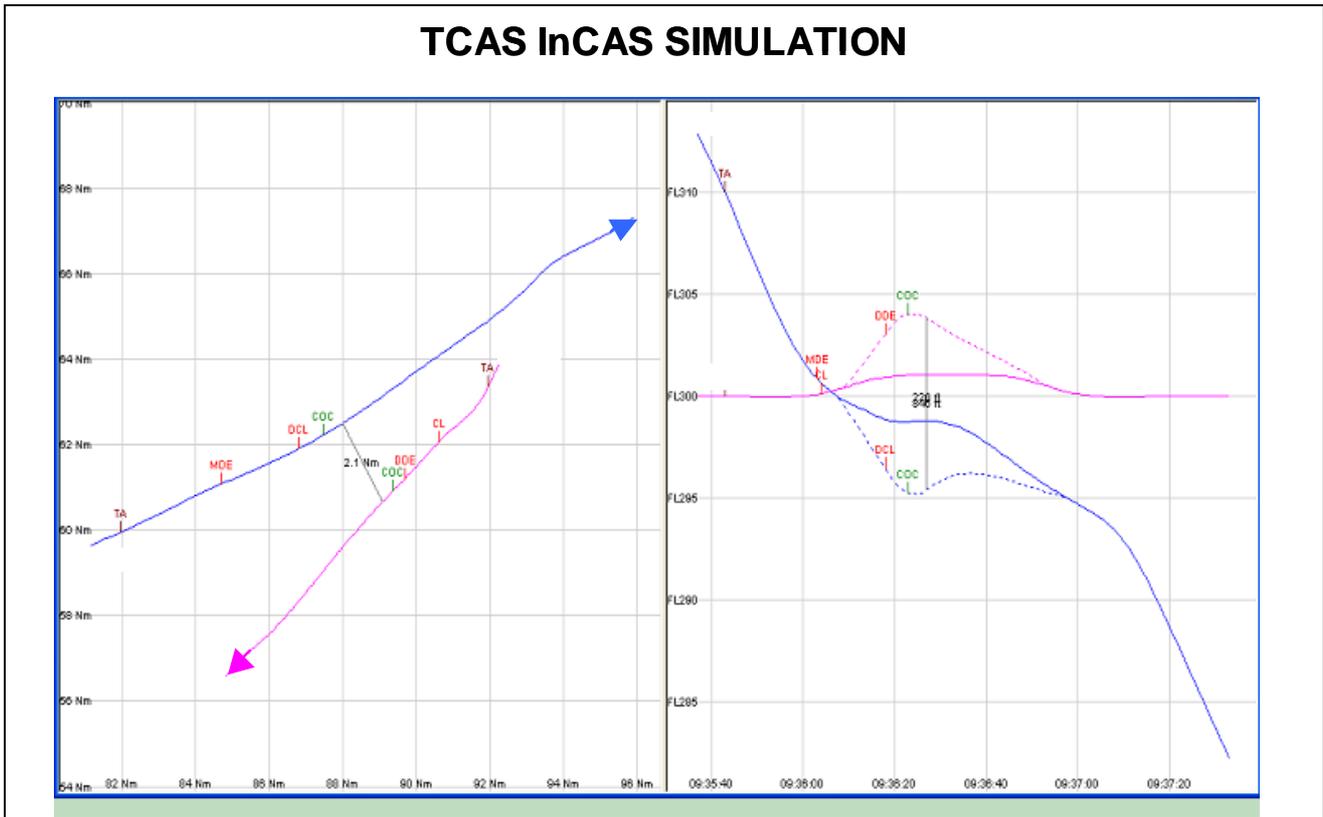
TCAS InCAS SIMULATION

UKAB Note (3): The Debden radar recording shows the B747 descending through FL302 at 0936:02 and steady ENE, the C550 having just crossed through the B747's 12 o'clock at a range of 7nm maintaining FL300. The B747 levels momentarily at FL299 and climbs 100ft (which is not shown on the InCAS) at the CPA of 2.2nm to FL300. The C550 also climbs 100ft at this point to FL301, before the B747 then resumes a steady descent.

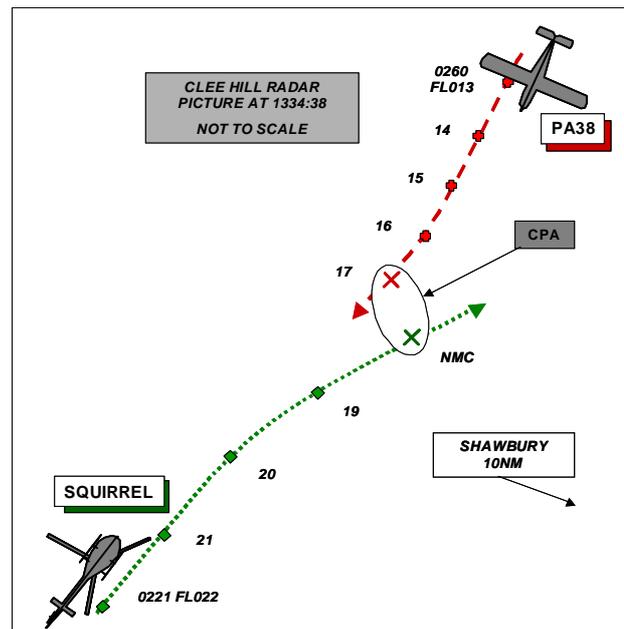
100ft V/0.1nm H

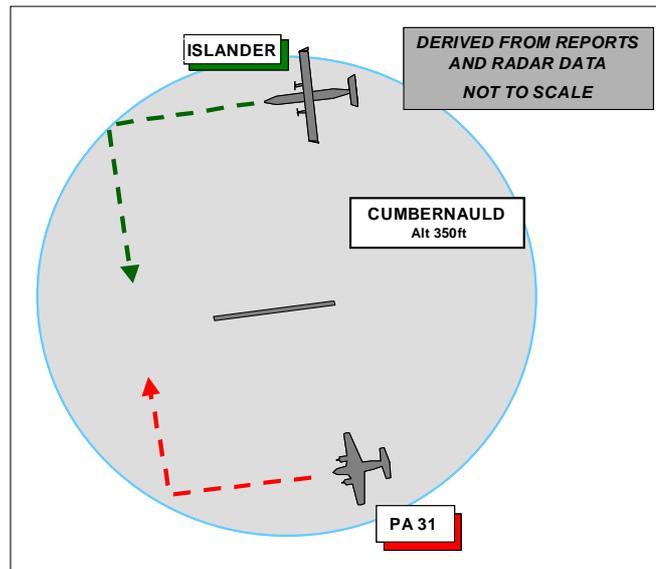
THE BN2B (ISLANDER) PILOT reports flying a commercial flight inbound VFR from Colonsay and re-familiarising another pilot on the approach to Cumbernauld. He was squawking 7000 with Mode C, was in contact with Cumbernauld A/G and the cloudbase was about 1700ft aal. The circuit was active for RW08 LH and he joined at beginning of downwind leg at 80kt and made all the standard calls. He only spotted the conflicting traffic, a low wing, white, twin ac about 250yd away in his 10'clock and slightly above, as they were heading 170° on base leg and about to turn final. He assumed that the other ac was apparently joining on the right base and it broke off the approach when he saw their landing lights. Since the other opposite direction ac was apparently avoiding them he did not take any further avoiding action and continued his approach but reported the Airprox to the Tower after landing; he assessed the risk as being high.

Members unanimously agreed that the PA31 pilot had not joined the Cumbernauld circuit in the approved manner and thus had flown into conflict with the Islander, as it was about to turn finals. Since however, the PA31 had correctly broken off the approach with the Islander in sight, albeit at a very late stage and that the Islander pilot had seen the PA31 and continued without having to take any avoidance, Members were persuaded that there had not been any risk.

Cause: The PA31 pilot did not conform to the published and active traffic pattern and flew into conflict with the BN2B.

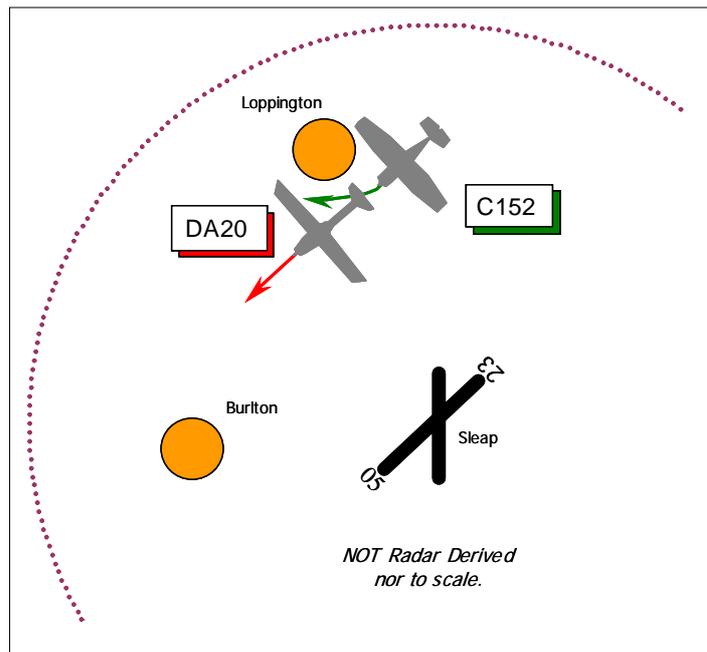
THE C152 PILOT reports that his ac has a red/white colour scheme and the HISLs were on whilst flying in the LH circuit for RW05 at Sleaf. Flying in VMC some 1000ft clear below cloud with an in flight visibility of 6-7km in haze, he was in communication with Sleaf RADIO A/G Station on 122.45MHz. Whilst on the LH DOWNWIND leg heading 230° (M) level at the circuit height of 1000ft QFE (1028mb) at 90kt, another pilot was heard on RT reporting DOWNWIND. A DA20 was then seen passing some 20ft above his C152 about 100ft away on the same heading. He altered course to give clearance on the DA20 and radioed its pilot to warn of the proximity of his own aeroplane. The DA20 pilot replied that his C152 had not been seen beforehand. He assessed the risk as "high".

Cause: The DA20 instructor did not integrate into the circuit correctly and descended into conflict with the C152 which was not seen.

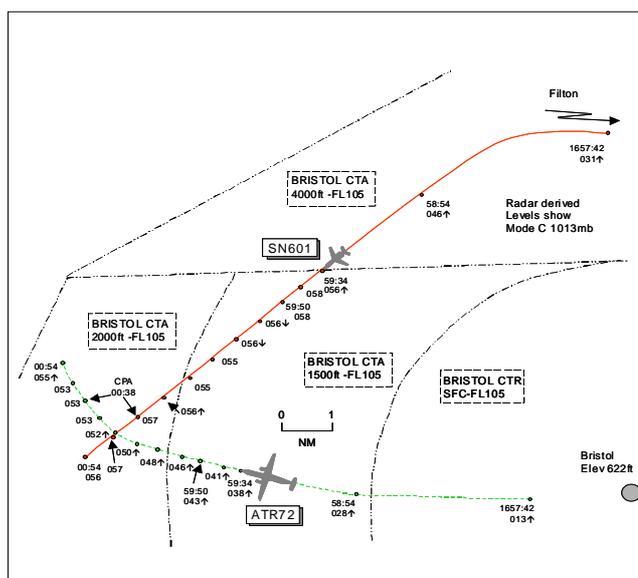
AIRPROX REPORT NO 174/07

Date/Time:	20 Dec 1701	NIGHT
Position:	5125N 00259W (10nm W Bristol - elev 622ft)	
Airspace:	Bristol CTA	(Class: D)
	Reporting Ac	Reported Ac
Type:	ATR72	SN601 Corvette
Operator:	CAT	Civ Pte
Alt/FL:	↑6000ft (QNH 1030mb)	6000ft (QNH 1031mb)
Weather	VMC CLAC	VMC CLOC
Visibility:	>40km	4000m
Reported Separation:	200ft V/NK H	400ft V/1-2nm H
Recorded Separation:	400ft V/1nm H

330° and were about to level-off at 6000ft when a TCAS TA alert was heard against traffic coming from behind them crossing R to L. TCAS quickly changed into an RA requiring a descent at 1000fpm or more, which was promptly followed by an instruction to level-off. During the RA the controller asked that they level-off but the RA was followed. The other ac was seen on TCAS to pass from their R and behind and about 200ft vertically above. They were then asked to change to Cardiff and the RA was reported to them. He assessed the risk as high.

Cause: The Bristol APR vectored the SN601 into conflict with the ATR72 without ensuring vertical separation.
