UK AIRPROX BOARD

Analysis of Airprox in UK Airspace

Report Number 24 January 2010 – June 2010

Twenty-Fourth Report by the UK Airprox Board:

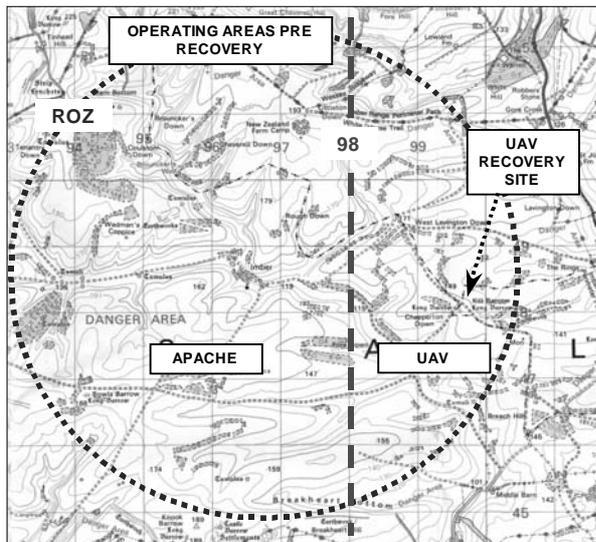
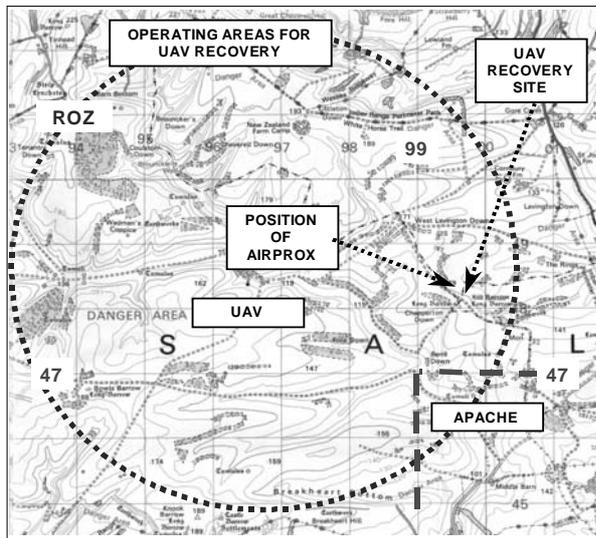
AIRPROX REPORT NO 2010004

THE DH3 UAV PILOT reports that he was operating a small, non-SSR or TCAS equipped UAV in an exercise ROZ [Restricted Operating Zone], 2nm in radius from 0-1500ft amsl centred on 5114N 00203W (see diagram). Meanwhile an Apache was cleared to operate in the ROZ and was being deconflicted geographically by the Tactical Air Control Party (TACP). He understood that the Apache was cleared to operate W of the 98E 'line' and his UAV was to operate to the E.

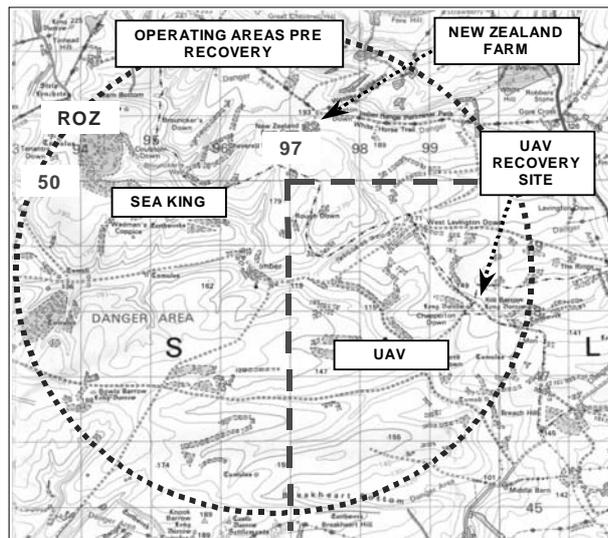
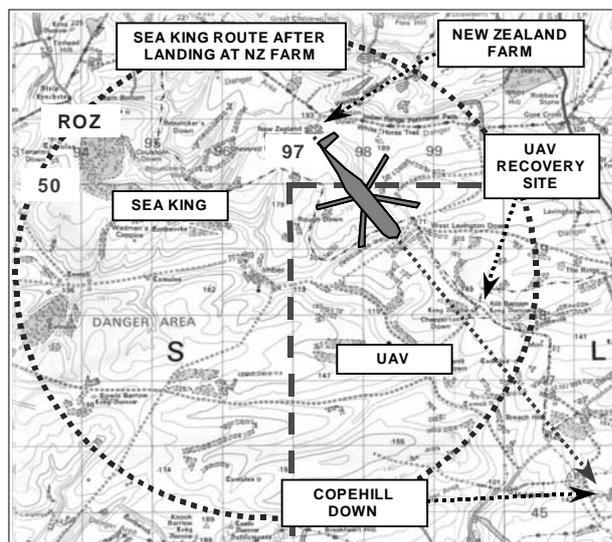
AIRPROX REPORT NO 2010005

THE DH3 MUAV PILOT reports that he was operating a small, non-SSR or TCAS equipped UAV in an exercise ROZ, 2nm in radius from 0-1500ft amsl centred on 5114N 00203W (see Diagram). Meanwhile a Sea King was cleared to operate in the ROZ and was being deconflicted geographically from the UAV by the Tactical Air Control Party (TACP).

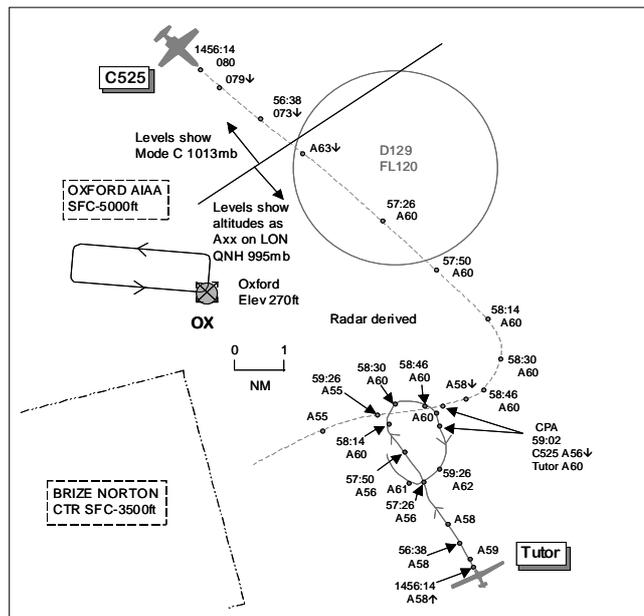
AIRPROX REPORT NO 2010006

THE C525 PILOT reports flying solo inbound to Oxford IFR routeing from PEPUL [33nm NW OX] on a very late handover to Oxford ATC from London when only 5nm from the OX NDB, descending to FL65. After an introductory call to Oxford he was already at the OX and he requested further instructions. ATC told him to either orbit or join the hold at FL65 and he elected to join the hold. He turned R and entered the hold and almost immediately TCAS commanded a 'dive'. He saw the traffic, a single-engine ac, flying amongst the cloud tops and heading straight towards him. He initiated a rapid dive and immediately entered cloud becoming fully IMC, estimating the CPA as 0.5nm at the same level. He informed ATC of their actions and was cautioned on other traffic in the hold at FL35. He stopped descent at FL55, he thought [actually FL60], and the other traffic in the hold was identified on the TCAS screen. Meanwhile a new target entered the hold area from the NE heading directly towards them, which led to a second TCAS RA 'descend'; he turned sharp L to avoid the traffic. He descended to FL35 and by now his ac was S of the hold. He informed ATC who told him the Wx was clearer to the NW and recommended further descent in this area. After turning onto a NW'ly heading he found a 'wall' of ac targets, so many that despite a TCAS range of 5nm he was unable to read many of their heights owing to 1 target covering the altitude numbers of others. He turned W to try and find a gap in the traffic and a way through. Eventually he headed N in clear air and descended to 2000ft QNH. He then realised that after flying at FL35 he had entered the Brize CTR by descent whilst looking for a way N. He later rang Brize Supervisor to apologise and he also spoke to Oxford ATC who was unaware of the conflicting traffic. At no time was his IFR status officially cancelled. He considered that his ac was at great risk on several occasions and the situation of a protected environment whilst IFR and IMC should be considered.

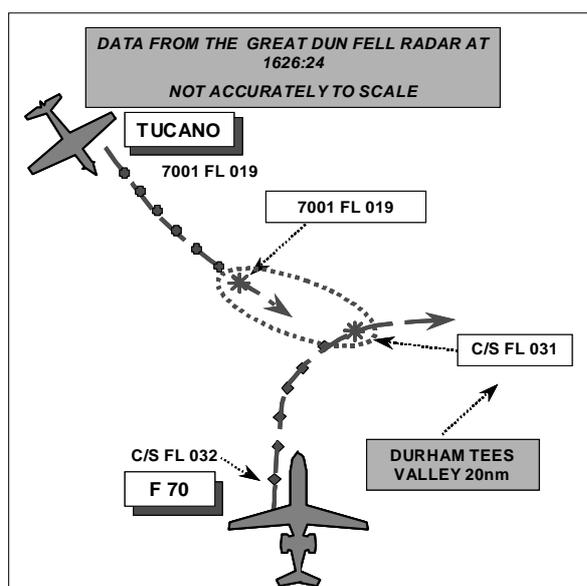
THE DURHAM TEES VALLEY RADAR CONTROLLER reports that at about 1523, he descended an FK70, heading 350° inbound for an ILS approach to RW05, to 3500ft on the QNH of 1028mb. The Supervisor previously noted on radar a 7001 squawk, S of Warcop and NW of GASKO, tracking SE indicating 2500ft so he (the controller) turned the FK70 on to 005° to tighten it up towards the FAT and still achieve separation. Shortly after, the SSR of the ac previously squawking 7001 disappeared but he continued tracking the primary contact until it 'partially faded' from radar about 20nm W of the airfield. The blip then re-appeared 3nm NE of GASKO shortly followed by an SSR return. At that time it was 6nm NE of the FK70, indicating 2500ft, the latter descending through 4500ft for 3500ft. Although the FK70 had already reported visual with the airfield, he called the traffic adding "if not sighted turn right heading 090 degrees". Soon after as the FK70 was passing 4100ft, he requested the pilot to level at the first opportunity and he responded, "level at 3500ft". The turn was made but it was immediately clear to him that separation was being eroded, so he issued an avoiding action turn onto 120° believing the 7001 to be manoeuvring and instructed the FK70 to climb to 4500ft to achieve some extra vertical separation albeit not the full 3000ft. When he saw the 7001 contact pass about 1nm behind the FK70 and 1000ft below, he turned it on to 360° and descended it to 3000ft.

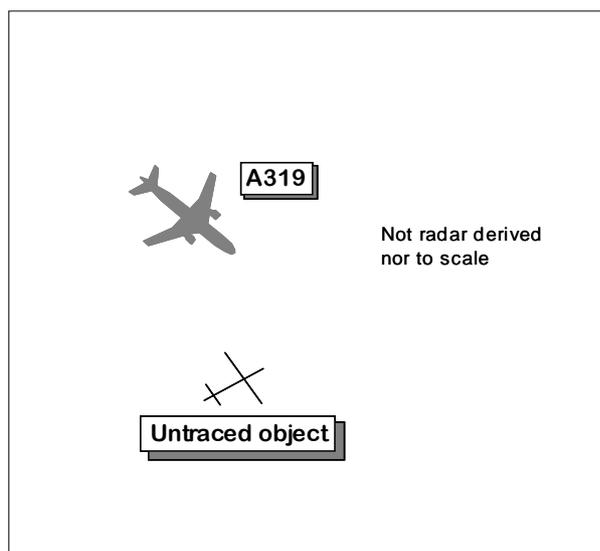
AIRPROX REPORT NO 2010012

THE A319 PILOT reports inbound to Bristol IFR and receipt of a RCS from Bristol, squawking an assigned code with Modes S and C. Whilst descending to 6000ft on radar heading 140° at 220kt, the FO pointed out an object in their 12 o'clock position at roughly the same level. He, the Capt PF, looked out and saw the object fly under the ac's nose; its level was difficult to judge but he thought it was between 50-100ft below. The FO described the object as ac shaped coloured white with a red stripe, in an apparent bank to its R and he, the Capt, having only seen it for 3-4sec confirmed the colour and shape. The radar controller was asked for any TI or possible contacts but nothing was seen on radar.

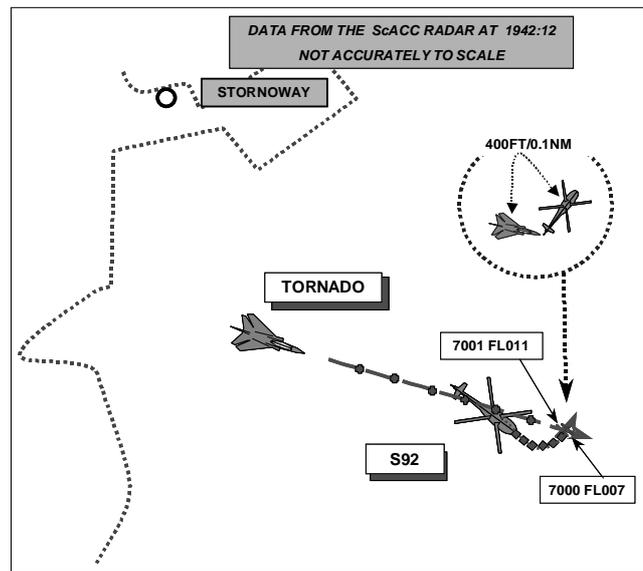
AIRPROX REPORT NO 2010014

THE S92A PILOT reports that they departed Stornoway Airport at 1933Z on a SAR training exercise, under IFR, in a TCAS(1) equipped ac, squawking 7000 with Modes C and S; nav lights and upper and lower red and white strobes were switched on. The sortie was planned to work with a surface vessel 23nm to the SE of Stornoway. They climbed to 1500ft on the Stornoway QNH of 1034mb and tracked 140° at 80kt towards the vessel. When they were about 10nm out from Stornoway they cleared from Stornoway APP since it was due to close and advised them that they would continue with Scottish Info on 127.275 as they would be clear of the Stornoway area (If they had been operating in the Stornoway area, they would have remained on Stornoway and transmitted blind calls even when ATC is closed). Prior to calling Scottish, they heard a Tornado on the APP frequency and heard ATC passing the Tornado crew details of their approximate height and position and suggesting that they (the Tornado) call Scottish for further information.

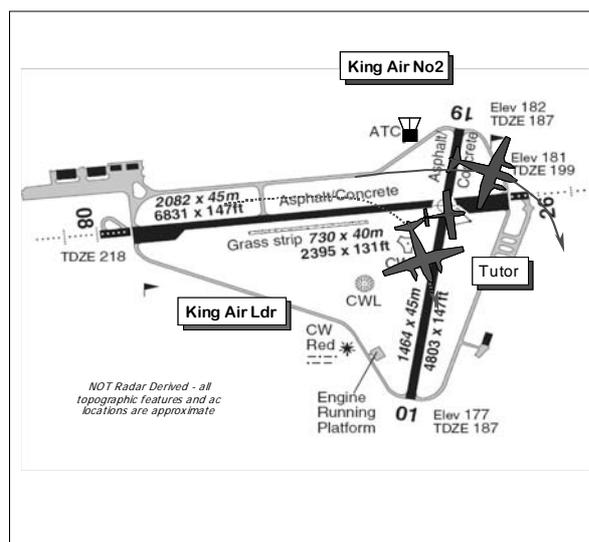
THE GROB 115E TUTOR T Mk 1 PILOT, a QFI, reports he was conducting a VFR instructor-training sortie in the cct at Cranwell whilst in communication with TOWER on 125.05MHz. They were flying in the RH cct (RHC) and using the RW08 grass strip. As P-I-C he was seated in the R seat with his student instructor in the L seat. His ac has a white colour-scheme and the HISLs and landing lamp were both on. Mode S is fitted, but SSR was selected to 'standby' in accordance with unit cct procedures.

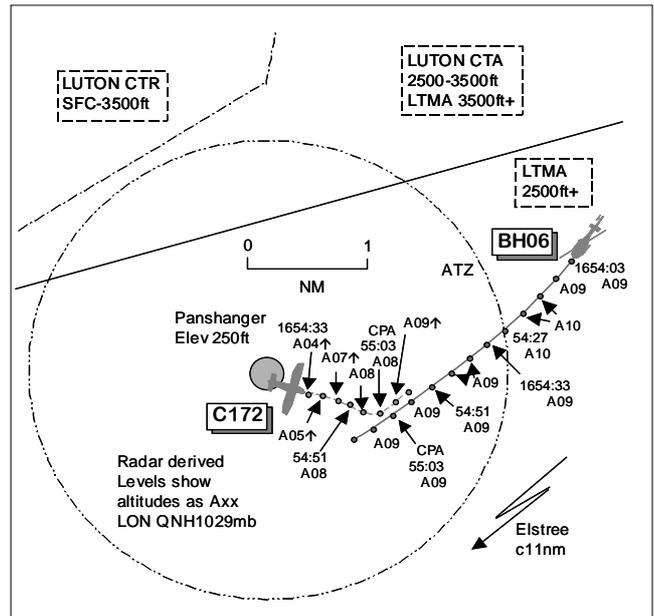
AIRPROX REPORT NO 2010016

THE C172 PILOT reports flying a cct familiarisation training sortie at Panshanger on RW11 LH cct and in communication with Panshanger Radio, squawking 7000 with Mode C. The visibility was >10km below an overcast sky; the cloud base was significantly above cct height, and the ac was coloured white/orange with the anti-collision light switched on. On climbout RW11 heading 110° at 70kt the student lowered the ac's nose to perform a look-out check whereupon the student noticed, and brought to his attention, a helicopter at approximately his 11 o'clock range 0.75nm, slightly higher than themselves entering the ATZ on a crossing SW'ly track from L to R. He made a radio call to ascertain whether the helicopter was on frequency but received no response. As the helicopter showed no signs of changing its flightpath, he urged his student to turn crosswind early to avoid a potential collision; the helicopter was maintaining a constant bearing. As they turned L climbing through 800ft QFE the helicopter passed down their RHS at the same level, allowing him a good view of it from his RH seat and close enough to read its registration. It appeared the helicopter, a blue/white JetRanger with strobe lights on, did not deviate from its course throughout. Having established that the helicopter had flown through the ATZ with no radio contact, he called Farnborough N LARS to enquire whether the JetRanger pilot was working them. The reply was negative but the helicopter was showing on radar squawking 7000 so he asked for them to track it to establish where it landed. Shortly after this Panshanger Radio told him that Farnborough had called by telephone stating the helicopter had landed at Elstree. He asked the A/G operator, another instructor, to telephone Elstree and verify the registration and type, which was confirmed. He assessed the risk as low.

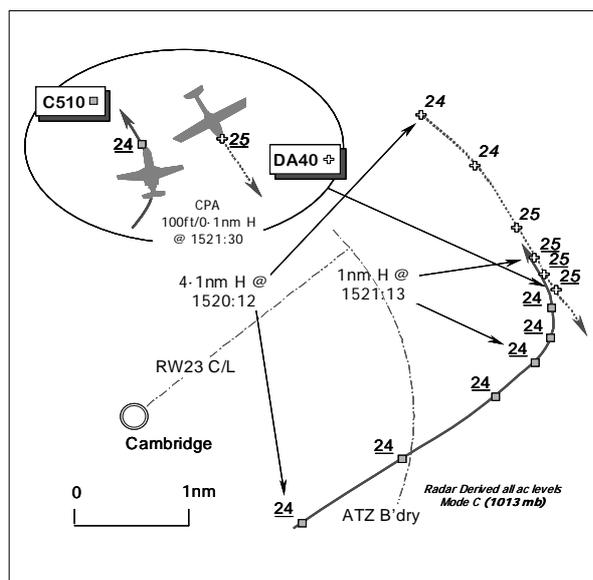
AIRPROX REPORT NO 2010017

THE CESSNA CITATION 510 PILOT reports he was conducting a local VFR training flight from Cambridge and in receipt of an Aerodrome Control Service from Cambridge TOWER on 122.2MHz. The local Cambridge conspicuity squawk was selected with Mode C; a Traffic Information System (TIS) – a form of TCAS I - is fitted which provides TAs only. His ac is coloured white and the HISLs and landing lights were on.

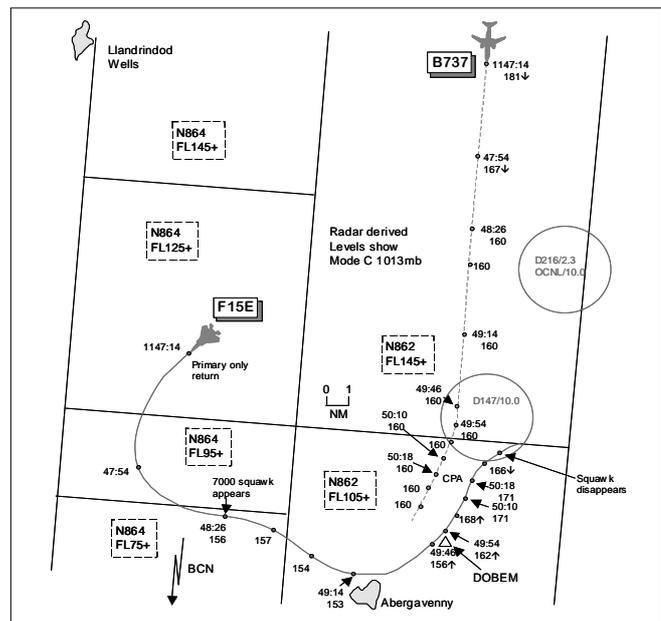
THE CARDIFF RADAR CONTROLLER reports that he was instructing a low time trainee and, just before the incident, had taken over the RT from the trainee to resolve an unrelated situation developing near BCN. The B737 was inbound to Bristol from the N and was placed on a radar heading against outbound traffic from Bristol that was joining airway L9 W'bound. As the B737 passed RILES an unknown intermittent contact appeared on radar about 8nm SW of the B737 tracking E'bound at >300kt and it briefly indicated FL150. At this point he thought the ac might have been infringing CAS but that it posed no hazard to the B737 owing to its E'ly track. He left the B737 on its present heading as he thought it was the best course of action at this stage. The unknown contact was then observed to turn NE'bound still at FL150 (intermittent Mode A and C) so he turned the B737 R onto heading 210° to take it away from the unknown contact's predicted track. When about 6nm S of the B737 the unknown traffic then turned towards the B737 and began to climb, the B737 pilot reporting that he had 'TCAS' traffic range 5nm and then an unintelligible phrase relating to 'avoiding'. He believed this reference to 'avoiding' and 'TCAS' meant that the B737 was following his own response to a TCAS RA so he told the pilot that it was unknown traffic, possibly military, and to continue as required to avoid. The pilot elected to continue on the assigned heading and remained at FL160 before reporting visual with the other ac, commenting that it was a military type. There were intermittent Mode C readouts as the unknown traffic passed 2nm E and 1000ft above the B737, before it then descended about 3nm behind the B737, indicating FL166. After this the Mode A and C readout from the unknown traffic were no longer visible and the primary contact also disappeared shortly thereafter.

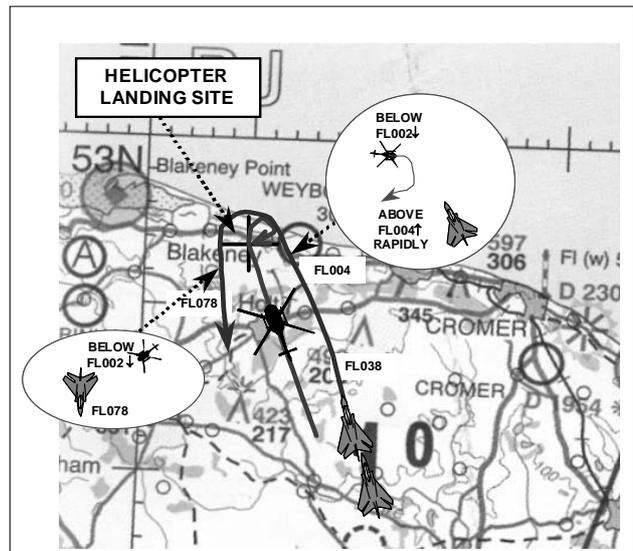
AIRPROX REPORT NO 2010019

THE BK117-C1 pilot reports that he was flying a yellow ac on a Helimed flight answering an emergency call to Salthouse from Norwich in a TCAS (1) equipped ac and they were squawking 0020. While heading 350° at 135kt, as they were about to carry out the landing site identification 1min before landing, he received a call from Norwich Radar, who were providing him with a BS, passing TI regarding 2 military jets descending behind them and heading N. He checked the TCAS and simultaneously received a TA indicating an ac at 2nm in his 6 o'clock at about 500ft. After acknowledging the call, he checked the TCAS again and noted that the TA was now indicating 1nm and 300ft above so he elected to take avoiding action by descending straight ahead and he called Norwich Radar informing them of his descent. At about 100ft in the descent he made a right turn to try to acquire the ac but he did not see it so he continued the right turn and landed into wind (240/05) just to the N of the A149 at Salthouse. Since he only saw the other ac on TCAS he did not assess the risk.

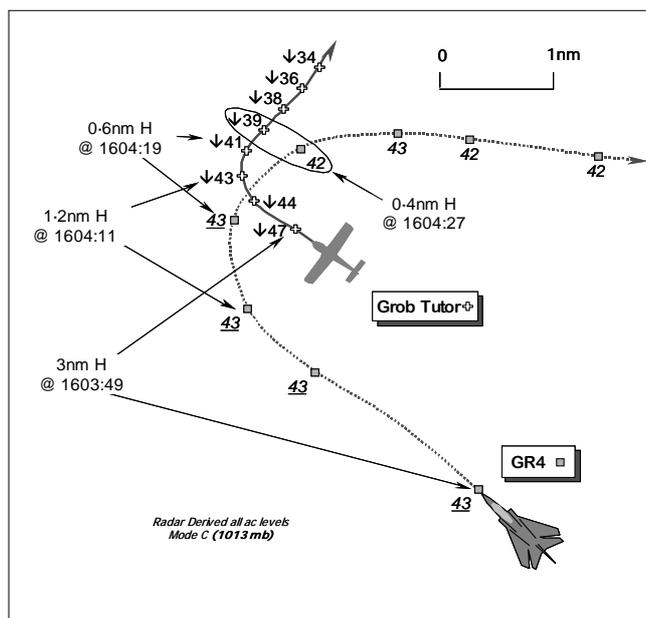
AIRPROX REPORT NO 2010020

THE GROB 115E TUTOR T Mk1 PILOT, a QFI, reports he was flying VFR in CAVOK conducting an instrument training sortie under simulated IFR for his student who was flying the Tutor for a radar recovery to Barkston Heath for an SRA. They were in receipt of a TS from Cranwell APPROACH (APP) on UHF and the assigned squawk of A2620 was selected with Mode C on; elementary Mode S is fitted.

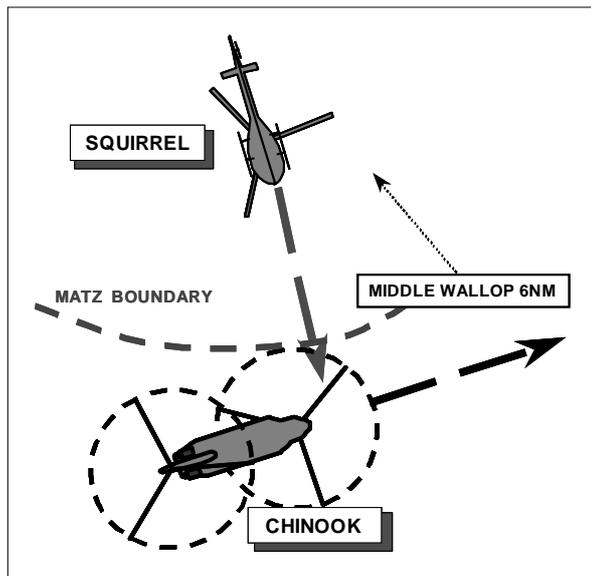
AIRPROX REPORT NO 2010021

THE SQUIRREL PILOT reports that they were flying a standard night departure from Middle Wallop, in receipt of a BS from TWR and squawking with Mode C. When they were approaching the southern MATZ boundary, heading 170° at 90kt, having cleared with TWR, they commenced a descent to 200ft agl and while in the descent a Chinook passed through their 12 o'clock flying from right to left, about 100ft lower than them and about 300m ahead. He assessed the risk as being high.

Cause: Non-sighting by the Chinook crew and late sighting by the Squirrel crew.

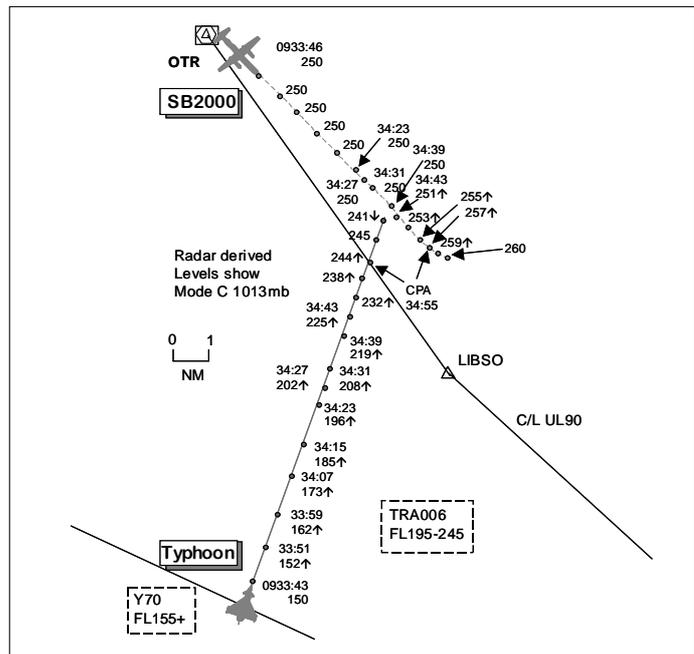
AIRPROX REPORT NO 2010022

THE SCACC E SECTOR RADAR CONTROLLER reports that the SB2000 was inbound to Norwich in the area of OTR at FL250. A military squawk [the subject Typhoon] was seen crossing under airway Y70 NE'bound at FL150 and then it commenced a climb at a high rate so he asked the Planner to call London Mil Console 15 to coordinate. The Console 15 controller said that he would stop-off the Typhoon at a lower level but as the Typhoon was passing FL200 the SB2000 crew received a TCAS RA and climbed to FL260. As the crew were already responding to the RA and the Typhoon's track was taking it behind the SB2000 it was deemed unnecessary to give avoiding action. Instead he gave TI to assist the crew in locating the traffic. The Typhoon continued with its high ROC and was observed at FL246 with 1.6nm lateral separation against the SB2000. He commented that this had been the 3rd time a civil ac under his control had had to respond to a TCAS RA against fast climbing military traffic.

Cause: The Typhoon crew climbed above their assigned level.

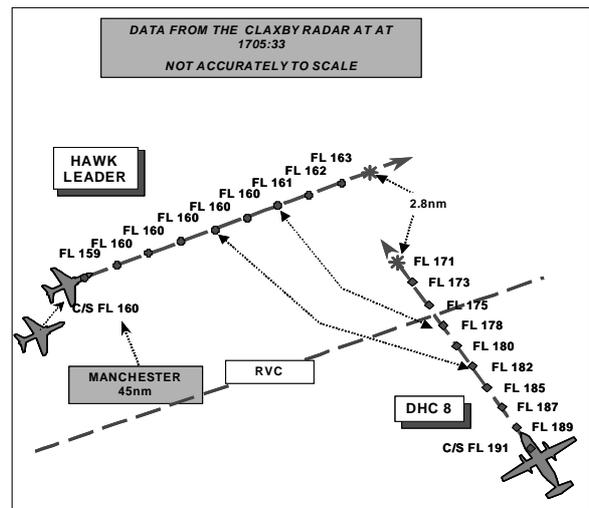
AIRPROX REPORT NO 2010024

THE DHC-8 PILOT reports flying a scheduled passenger flight under IFR, squawking as directed. Shortly after levelling at FL170, heading 325° at 240kt under RC from ScACC, about 50nm SE of MAN, the crew noted on TCAS an ac crossing about 5nm ahead and 1000ft below. Shortly afterwards the TCAS displayed a TA with "Traffic, Traffic" and it was noted that the ac had commenced a climb; by then the lateral separation was less than 5nm. Shortly thereafter ATC issued an instruction "avoiding action turn left 280 degrees" so the Captain disengaged the autopilot and made a level left turn and satisfactory separation was quickly attained. The minimum separation was estimated to have been 1nm and 600ft. ATC commented that the traffic was in the Lichfield RVC and did not have permission to climb above FL160. He believed that the traffic was a formation of 2 Hawk ac but only one was seen on TCAS.

Cause: The Hawk pair climbed above their cleared level.

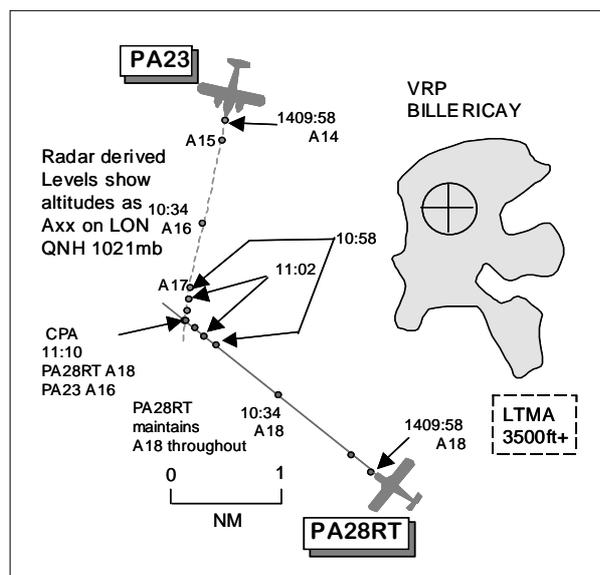
AIRPROX REPORT NO 2010025

THE PA23 PILOT reports enroute to Redhill, VFR and in receipt of a BS from Farnborough on 132.8MHz, squawking 5031 with Modes S and C; PCAS was fitted. The visibility was 20nm in CAVOK VMC and the ac was coloured white/blue/red. Heading 200° at 1900ft QNH 1021mb and 130kt, the pilot seated in RH seat saw, identified and pointed out to him fast-moving traffic, a bronze coloured single-engine low-wing T-tailed ac in his 9 o'clock at the same height. He immediately initiated a dive estimating the other ac passed 50ft above and 100m clear ahead, appearing to continue W'y uninterrupted. No TA alert was received during the encounter and he assessed the risk as high.

Cause: Non-sighting by the PA28RT pilot and a late sighting by the PA23 pilot.

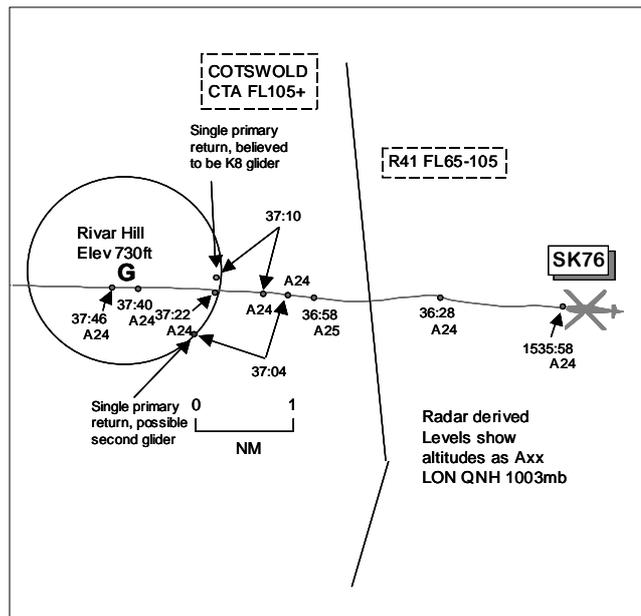
AIRPROX REPORT NO 2010026

THE K8 GLIDER PILOT reports flying a local solo sortie from Rivar Hill non-radio. The visibility was 10km flying 400ft below cloud in VMC and the ac was coloured green/white. Soaring in weak lift about 0.25nm E of Rivar Hill heading 180° at 35kt and 1600ft QFE 978mb he heard a helicopter and spotted it about 0.25nm on his port side heading 270° and closing rapidly. He dived his glider to accelerate out of the helicopter's flightpath and provide vertical separation. The helicopter, an Agusta type, he thought, passed about 20ft above and 100yd behind, maintaining course and speed and showing no sign of having seen his glider. He assessed the risk as high. The helicopter then passed O/H Rivar Hill, a winch launch site with permission to launch to 3000ft agl, thus infringing the cable hazard. The incident was seen by the Duty Instructor, who was airborne in another glider about 0.5nm to the S at 1300ft QFE, and personnel on the ground.

Cause: A non-sighting by the SK76 pilot and a late sighting by the K8 pilot in the vicinity of a notified and active gliding site.

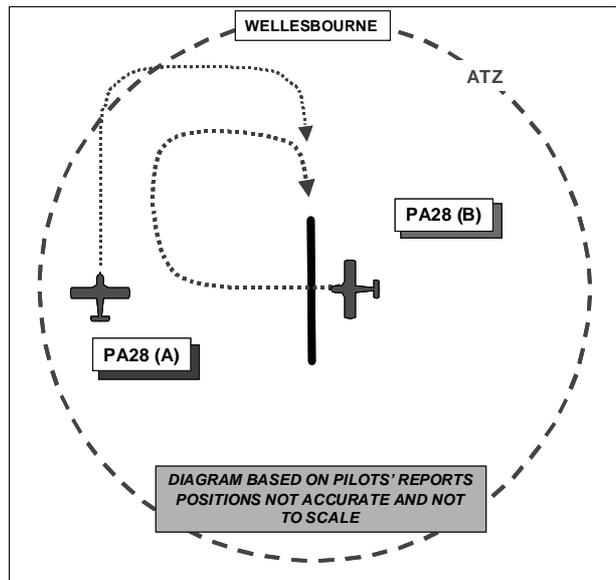
AIRPROX REPORT NO 2010027

THE PA28 PILOT (A) reports flying a local training flight with a student as the handling pilot in a white and green ac with HISLs switched on, squawking 7000 with Modes C and S and in contact with Wellesbourne Info. They were downwind in the RH cct for RW18 when a dark blue and white PA28, joining from the deadside onto the downwind leg, turned inside them in a tight and unconventional cct. The AFISO alerted them to look for the ac, but they already had him in sight. The other pilot was alerted to them when he made his downwind call and he also stated that he had their ac in sight. The ac passed a few hundred feet behind them and then positioned to their 7 o'clock but they were unable to see it due to the blindspot behind the cabin. They continued to final approach at normal speeds (initially 70kt) being aware of several other ac ahead and made the appropriate RT call in the correct position. They checked their 5 o'clock and 7 o'clock positions looking for the other ac but since nothing was seen and the pilot had stated he had them in sight they assumed it was positioning behind them on final; further no RT calls was heard from the ac indicating that it was in any other position.

Cause: The pilot of PA28 (B) did not integrate into the circuit pattern established by PA28 (A) ahead.

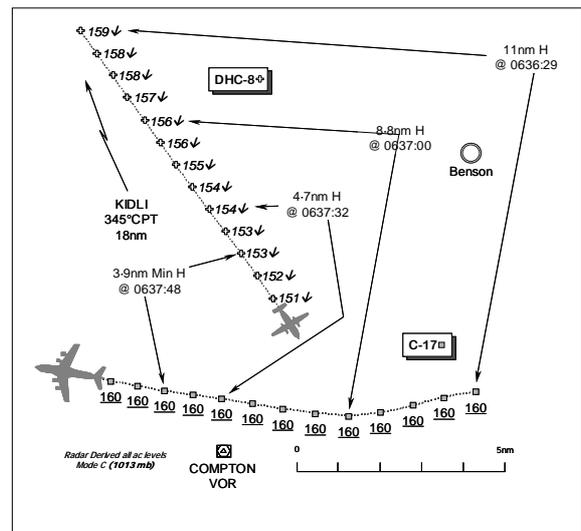
AIRPROX REPORT NO 2010028

THE de HAVILLAND DHC-8 Q400 PILOT (DHC-8) reports he was en-route from Leeds Bradford Airport to Gatwick IFR and in receipt of a RCS from LTCC on 133.175 MHz [TC MIDLANDS]. The assigned squawk was selected with Mode C; Mode S is fitted. Southbound at 250kt, they were cleared by London to descend to FL150. Descending clear above cloud, in between layers with an in-flight visibility of 25km, as they approached their assigned level a large dark-coloured ac with a T-tail was seen 3-4nm away on the nose crossing from L to R. TCAS displayed the other ac around 600ft above and about 3nm away. A TA caution was enunciated 'traffic traffic' and they positively identified the cause as the other ac they had spotted ahead - the C-17 - in level flight. An RA was not indicated and no avoiding action was taken. He assessed the risk as 'low' as they were flying in VMC, but added that in IMC it would be, potentially, more risky.

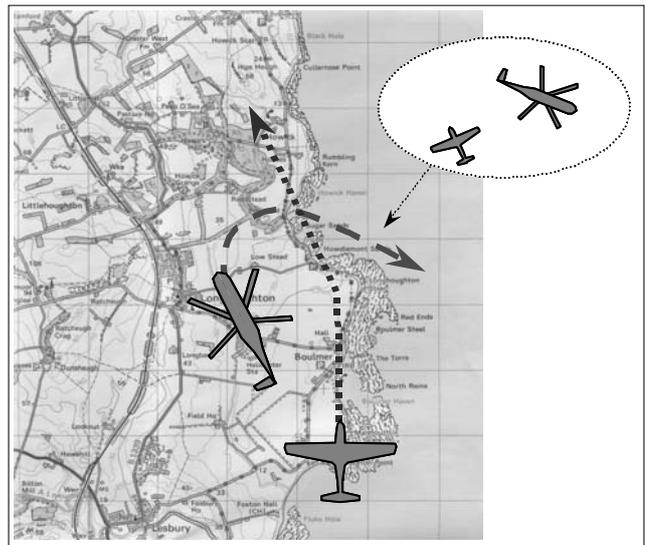
AIRPROX REPORT NO 2010031

THE SEA KING PILOT reports flying a yellow helicopter on a local S&R training flight squawking 7000 with Mode C in contact with Boulmer Radio. Whilst completing the finals turn of a drum winching circuit, in a period of high workload, in a 30° aob right turn onto 120° at 50kt and descending from 150ft AMSL towards 100ft, the winchman, who was primarily concentrating his attention on remaining visual with the simulated survivor through the right-hand bubble window, called “ac 2 o'clock high”. The reported ac was a red and white Chipmunk, initially 300m away, which passed 125m to the right and 50ft above. The winchman continued to observe the ac and call its position as it descended northwards along the coast passing behind them. He did not take any further avoiding action as he was already in a descending turn to 50ft asl. The ac was last seen behind them on the coast where it was then obscured by the terrain. At a time interval of 90sec after the CPA, the winchman judged that the ac appeared to be flying at 100ft agl, based on the height of the Sea King and the backdrop with the horizon.

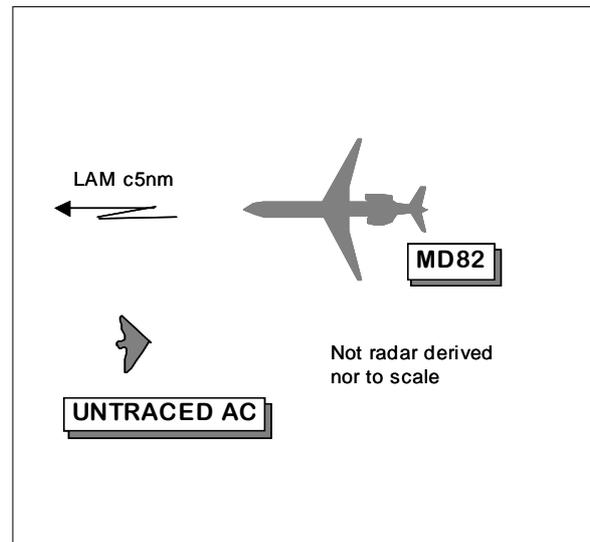
AIRPROX REPORT NO 2010034

THE MD82 PILOT reports descending towards LAM to enter the hold while looking for the preceding ac. Suddenly, in front and a little to the L, there appeared a dark object coming in their direction. As it got closer it appeared to resemble a green/white coloured parachute/hang-glider, which was much bigger than a Wx balloon. It passed about 50-100m to their L. No action was required but ATC was informed.

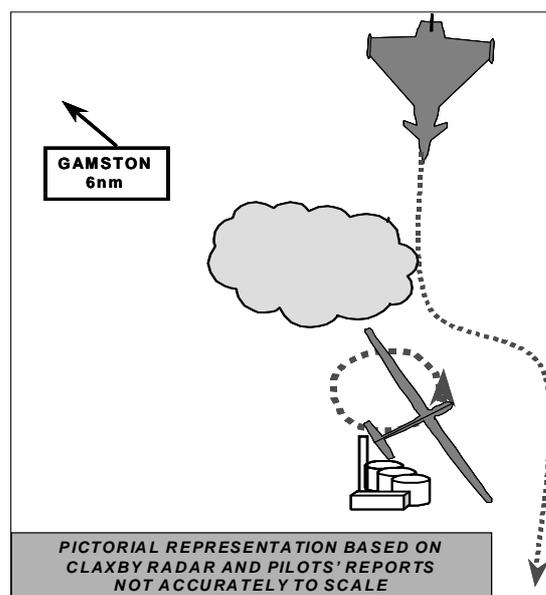
AIRPROX REPORT NO 2010035

THE TYPHOON PILOT reports flying a grey ac with HISLs and nav lights switched on, on a dual training flight from Coningsby, squawking 7001 with Mode C but not in receipt of an ATS; TCAS was not fitted. While heading 180° at 360kt and at 2300ft on the RPS, a mid wing, unpowered glider was seen about 2nm ahead in a left turn, at the same alt, but to the right of the nose. Initially he did not consider it necessary to take avoiding action, as the glider appeared to be moving away to the right, so his unaltered flight path would take him safely behind the glider without alarming its pilot. As they closed however, he observed that the glider's high turn rate and low turn radius was such that it had performed a level left hand turn through about 120° and was then converging from right to left and significantly reducing the separation distance. He therefore broke left to give the greatest spacing possible and generated a lateral miss-distance of about 500ft thus ensuring that there was no risk of collision.

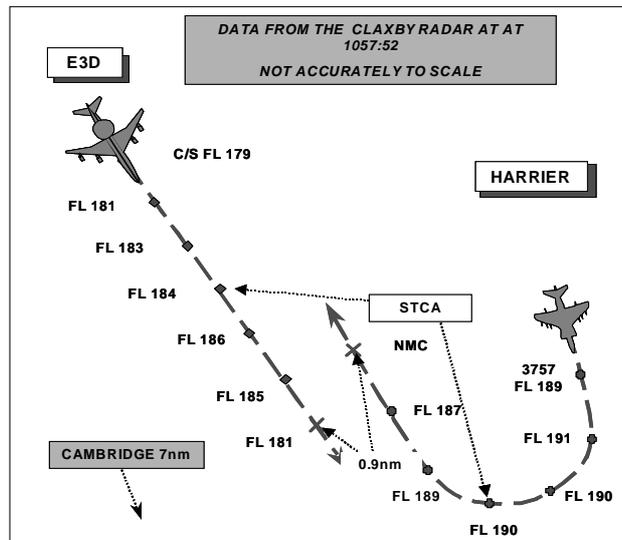
Date/Time: 29 Apr 2010 1058Z
Position: 5220N 00010E (7NM N CAM)
Airspace: Lon FIR (Class: G)
Reporting Ac Reported Ac
Type: E3D Sentry Harrier
Operator: HQ AIR (OPS) HQ AIR (OPS)
Alt/FL: FL180↑ FL90

NR V / 1.0nm H at 1057:52 (100ft V /1.0 H on previous sweep at 1057:49)

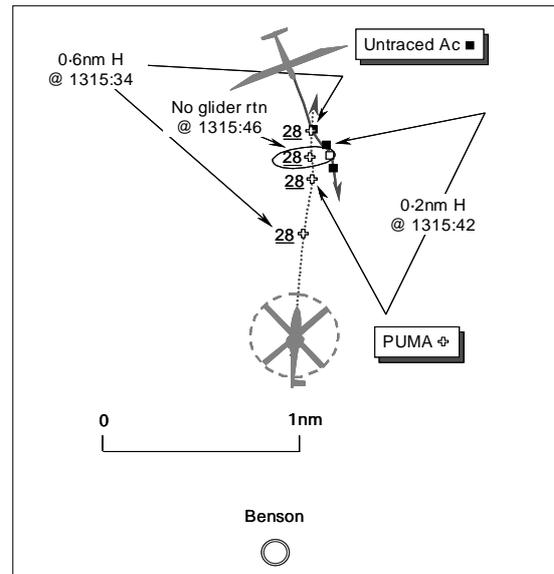
Reported Separation:
150ft V/nil H

THE PUMA HC1 HELICOPTER PILOT reports that the Airprox occurred during an IFR training sortie whilst flying the Benson COPTER TACAN [BSO] procedure for RW19 and in receipt of a TS from Benson APPROACH (APP) on 376.65MHz. The assigned squawk of A3617 was selected with Mode C; Mode S is not fitted. The helicopter is coloured olive green, but the white HISL and landing lamp were on.

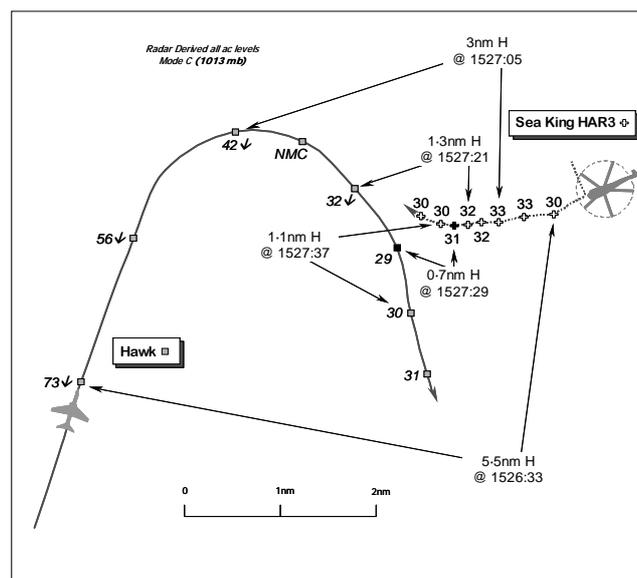
AIRPROX REPORT NO 2010038

THE WESTLAND SEA KING HAR3 PILOT reports that he had departed from Boulmer VFR to conduct an air test with a crew of 2 pilots and was in receipt of a TS from Newcastle RADAR (RAD) on VHF - 124.375MHz. A squawk of A3760 was selected with Mode C; neither Mode S nor any form of TCAS is fitted. The helicopter has a yellow high-conspicuity colour-scheme and the upper and lower HISLs were on.

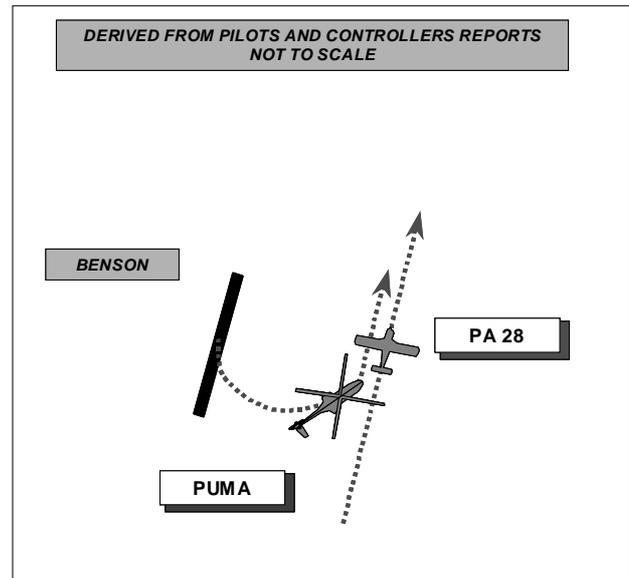
THE PUMA PILOT reports flying a training sortie in the Benson Circuit for RW19LH, in communication with Benson TWR. While levelling downwind at 1000ft QFE, passing through heading 060° at 100kt, another ac called to join the Benson circuit downwind and a blue and white low-wing light ac was seen simultaneously, 50-75m ahead and at the same height virtually in the circuit. He decelerated to increase the separation and assessed the risk as being medium.

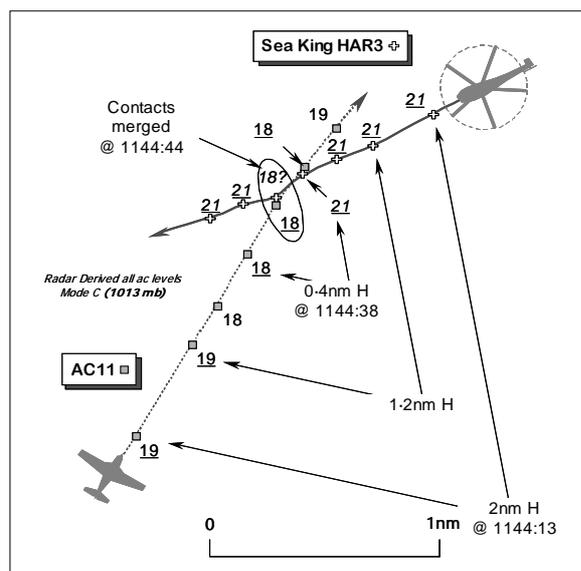
AIRPROX REPORT NO 2010040

THE WESTLAND SEA KING HAR 3 CAPTAIN reports he was conducting a local VFR training flight from Wattisham and in receipt of a TS from Wattisham APPROACH (APP) on UHF 277.725MHz. His ac has a yellow colour-scheme and the HISLs were on. A squawk of A4523 was selected with Mode C.

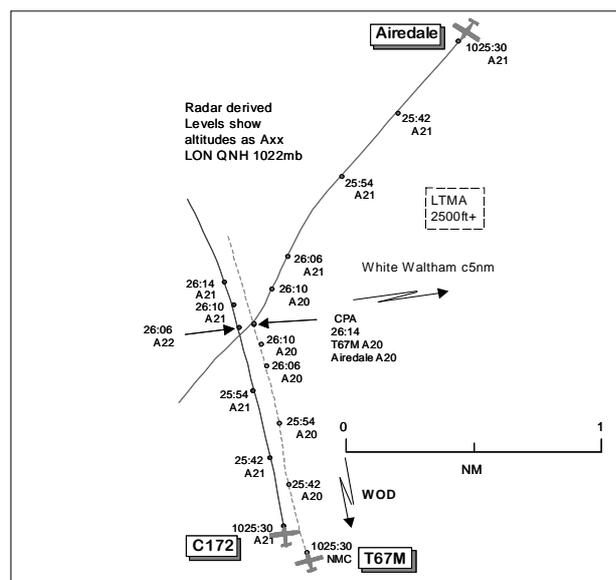
AIRPROX REPORT NO 2010041

THE C172 PILOT reports en route to Wellesbourne VFR and in loose formation with a T67M whilst under a BS from Farnborough W on 125.25MHz, squawking an assigned code with Modes S and C. The visibility was >30km flying 1000ft below cloud in VMC and the ac was coloured white/blue with strobe lights switched on. The route flown was via Guildford, WOD NDB and then on towards WCO whilst the T67M was flying slightly behind and to starboard. In the vicinity of WOD heading 355° at 100kt and 2200ft he saw another ac, a high-wing single-engine type coloured white/blue, about 200m away to his R and 50-100ft below on a near collision course. The other ac was very close to his R windscreen pillar, so he thought it had been concealed behind it previously, which would have contributed to his late sighting. He quickly determined that the other ac, although close, would pass behind him with no risk of collision which it did about 2sec later about 50-100ft below and 100m laterally. His attention turned immediately to the T67M which was going to get much closer to it. He considered whether he could alert the T67M pilot to the other ac by making an RT call but there was too little time to say anything that could have helped without making things worse. It was difficult to see exactly how the other ac would appear to the T67M pilot – below/above or relative position. The T67M did have 2 pilots onboard so he hoped 1 of them would see the conflicting ac; however, they did not until they were very close. With the visibility being excellent and having a pax who was new to light ac flying, he had not wanted too much radio work so did not consider a higher level of service. However, he later realised that he had omitted to tell Farnborough that he had another ac in formation. The T67M pilot then reported the Airprox to Farnborough a few minutes later. He assessed the risk of collision as low.

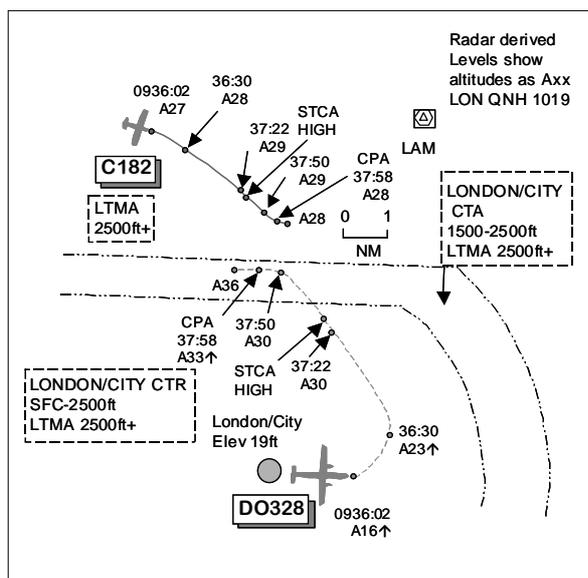
AIRPROX REPORT NO 2010064

THE DO328 PILOT reports outbound from London/City IFR following a BPK4U SID and in receipt of a RCS from London on 118.825Mhz, squawking 5412 with Modes S and C. Heading 330° level at 3000ft QNH 1019mb at 250kt, TCAS generated a TA on traffic range 5nm at the same altitude (Mode C unverified) closing on a S'ly track. ATC gave an avoiding action L turn onto heading 275° and a TCAS RA 'climb' was received and both were actioned. The other ac was not seen visually but TCAS indicated it passed <3nm away at the same level. He assessed the risk as medium.

THE C182 PILOT reports en-route from a private strip to France VFR with another pilot and listening out with London Information, squawking 7000 with Modes S and C. Heading 100° at 130kt at 2800ft they both sighted a high-wing twin-engine ac about 1nm or more away at the same altitude which was climbing and heading generally W. No hazard was perceived and no avoiding action was required. They had had difficulty contacting London Information; they were extremely busy, and suffered an altimeter setting error. He assessed the risk as none. He explained that he initially attempted to contact London Info at BOV VOR to activate his FPL and make a mid-channel call but was not successful until over the channel. He remembered listening to the QNHs being passed from London Info on the frequency and setting the altimeter sub-scale but he could not recall whether these were local or regional settings. After discussing the difference between these settings post-flight with his ex-instructor he realised that it could amount to quite a bit. He admitted he might have made an error setting the altimeter sub-scale. His ex-instructor also explained that regional QNH is an extreme for the whole altimeter setting region and that it will always push ac higher which is good for terrain clearance but bad for airspace avoidance.

Although the radar replay indicates that CAIT activated at 0935:28 – 2min before STCA, the Watch Manager's report states that neither the NE Deps controller, the NW Deps controller, nor the N Coordinator observed the CAIT alert. The controllers expressed some doubt about whether the CAIT activation actually showed on the TMA N radar positions – although it was evident on the Slave radar replay during the watch investigation. The radar replay was subsequently reviewed using the slave picture (controller's screen) for the TC NE & TC NW positions as well as the Debden, H23 and MRT radars. The CAIT activation was observed on all radar pictures and sources viewed.

Although CAIT was visible to the TC NE Deps controller, it was not observed. The failure to consciously see an object, even though it is in plain sight, is termed *inattentional blindness*. This occurs when our attention mistakenly filters away important information.

within the Class A airspace of the LTMA for which an ATC entry clearance is required. This had not been requested and the ac's flightpath placed it in conflict with the DO328. These two factors had caused the Airprox.

Cause: The C182 pilot entered the LTMA without clearance and flew into conflict with the DO328.

Recommendation: It is recommended that the CAIT vertical parameters be changed so that an alert is not triggered until Mode C indicates a 200ft deviation from the base of CAS (currently 100ft); airspace designated CTA/CTR to remain unchanged.

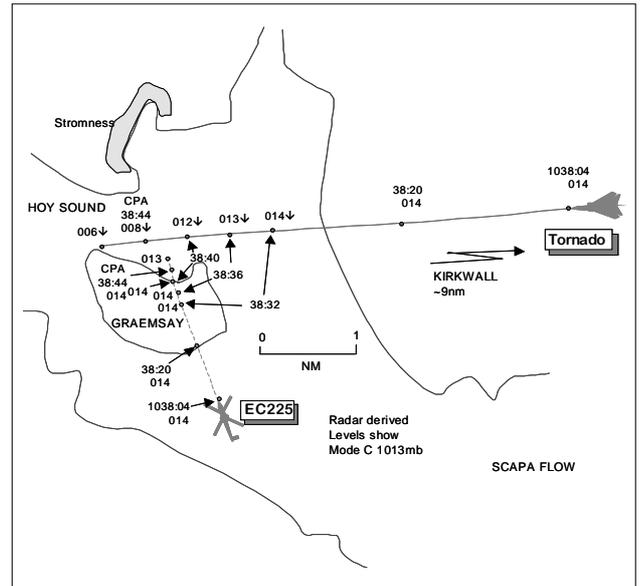
AIRPROX REPORT NO 2010065

THE EC225 PILOT reports flying en-route to an oil rig (about 90nm NW of Kirkwall) on a direct track from Aberdeen, VFR and in receipt of a BS from Kirkwall Approach on 118.3MHz, squawking with Modes S and C. The visibility was 35km flying 500ft below cloud in VMC and the ac was coloured red/grey with anti-collision, nav, flood and strobe lights all switched on. Approaching Stromness [12nm W of Kirkwall] heading 350° at 148kt and 1500ft QNH 1017mb, they became aware of a pop-up ACAS contact appearing 5-10nm to the E. They very quickly became visual with an ac and within a few seconds an ACAS aural TA sounded and the contact turned amber. They believed the other ac to be on a constant bearing and growing rapidly in the windscreen. The apparent speed and direction placed the other ac in their 2 o'clock on a converging course, slightly below. The PF started a deliberate action to reduce speed and allow the ac to climb. The other ac was identified as a military fast-jet, possibly a Tornado. The Tornado rolled to the L and appeared to descend passing an estimated 0.5nm ahead and approximately 400ft below. The PNF made a report to Kirkwall stating there was conflicting military traffic, however the controller had no reports of such ac in the area. The military jet pilot then called stating he was on frequency and had seen their helicopter at 1nm. They later informed Kirkwall that they would be filing an Airprox. They assessed the risk as medium.

Cause: The Tornado crew flew close enough to cause the EC225 crew concern.

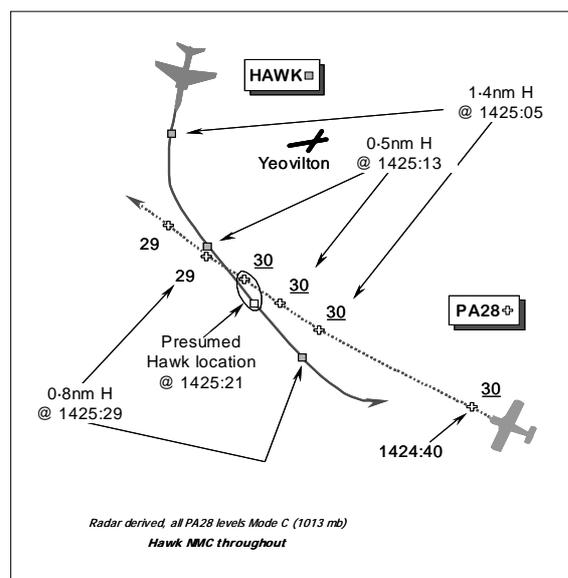
AIRPROX REPORT NO 2010066

THE HAWK T Mk1 CAPTAIN, the PNF in the rear seat, reports he was conducting a local training sortie from Yeovilton and was operating in the visual cct to RW27 whilst in communication with TOWER on 375.575MHz. SSR was selected to off.

It appears there are Human Factors at work here. I suspect that there was an element of under arousal and of over familiarity, in that HIGH KEY is normally given to Local without any comment or restriction. This Airprox and the subsequent Safety Survey were the subject of lengthy discussions during a recent Safety Management Executive meeting. The main recommendation from the survey, that controllers be reminded of the relevance and importance of High Key requests, has been adopted; the other recommendations remain under review. In addition, the ATC Fixed Wing Liaison Officer will be discussing the procedure in detail with Naval Flying Standards Flight (NFSF) to ensure all parties are fully aware of what each other is intending to do and what they should be expecting from each other at all stages of the procedure; it is possible, though less likely, that this incident could have occurred whilst the Hawk was climbing to High Key.

Accepting that ATC should have played their part more fully in averting this Airprox, pilot Members emphasised the importance of lookout, both in the visual aerodrome cct and also whilst transiting Class G airspace. Ultimately, it was a pilots responsibility to 'see and avoid' other ac in this situation, with or without the assistance of ATC. A pilot Member noted that pilots in receipt of a BS should not expect TI as a matter of routine. Their lookout scan should be robust enough to see traffic in time to avoid it and even though the PA28 pilot had requested a MATZ penetration - but here was actually flying just above the MATZ - both ac were operating in Class G airspace where not all ac will be known to ATC. Notwithstanding the reasonable presumption that ATC was providing a service to both pilots and should have told them about each other, each had a duty to lookout and sight the other in time to effect appropriate separation. In this instance the Hawk PNF had not seen the PA28 until it passed 100ft directly beneath his Hawk; no avoiding action was taken because of the late sighting thus, in the Board's view, he was unable to affect the outcome and this was, effectively, a non-sighting. Similarly, the PA28 pilot took no avoiding action as the jet passed 100ft port abeam after first sighting it 500ft away he reports. The radar recording reflects that the PA28 descended marginally after the CPA and that the jet was turning head-on; since the Hawk was also descending on its PFL, it was not flying straight and level as the PA28 pilot thought. Taking all these factors into account, the Board concluded that this Airprox had been caused because TI was not passed to either ac leading to effective non-sightings by the pilots in both ac.

Cause: TI was not passed to either ac leading to effective non-sightings by the pilots in both ac.

The Safety Survey has now been submitted and whilst it was felt that overall the procedures in place are fit for purpose, it does make several recommendations that will enhance them. Firstly Yeovilton ATCOs will be reminded of the relevance and importance of High Key requests. Secondly when a Hawk is in the visual cct, traffic information will be passed to ADC for any traffic crossing through or over the MATZ at or below 5000ft. Finally all requests for High Key will be passed through the Radar Supervisor who will maintain an overview of both the APP and LARS positions. At RN Air Stations the Radar Supervisor's place of duty is in the ACR where they remain closed up for the whole period of their watch, therefore, this change of procedure will not necessarily read across to other military aerodromes where this isn't the case. Two other minor recommendations were made in the survey but these have not been adopted at this time. NFSF (FW) was consulted as part of the Survey process, as were CFS, RAF Valley and Boscombe Down.

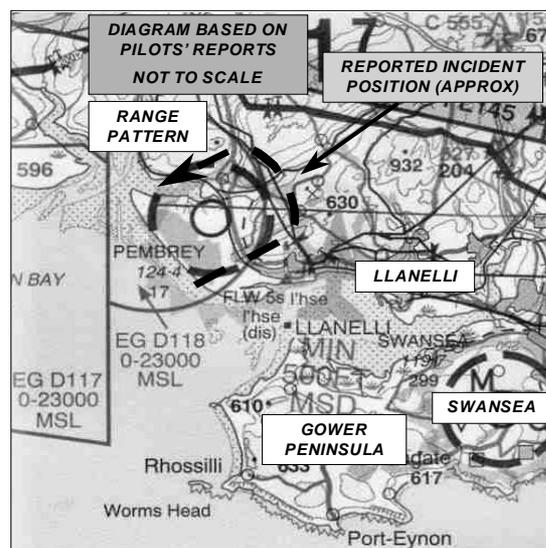
AIRPROX REPORT NO 2010067

THE TORNADO PILOT reports that he was operating as No2 in a pair of Tornado GR4 ac with all lights switched on and squawking 7002 with Mode C. They were operating in Pembrey Range conducting dive attacks on an LOA of 240° to Target 4. While in the left hand base turn for a 5° dive attack, climbing slowly through 1100ft and passing through a heading of 010° at 420kt they nearly collided with a light ac, thought to be a PA28. They first saw the light ac at a distance estimated as 300m; it had a white top surface with a blue underside, was in straight and level flight and was tracking 020° at 1400ft amsl. He took avoiding action by overbanking to 135°, pulling to 4G and they passed about 200ft below and slightly left of the ac. Both crewmembers had been looking into the turn and the PA28 had been obscured by the canopy arch.

Range weaponry training is a high workload exercise requiring aircrew to concentrate on acquiring and aiming at the target and conducting challenge and response checks. In this case the pilot reported that both crewmembers had been looking into the turn towards the target and had not seen the PA28 until after it emerged from behind the canopy arch. While accepting this, Members observed that the crew still had a responsibility to see and avoid other airspace users.

In this incident the PA28 pilot did not see the Tornado and the Tornado crew did not see the PA28 in time to take early avoidance; Members considered this to be the cause of the incident and further, a combination of this and the relative proximity of the two ac had led to a reduction of normally accepted safety standards.

Cause: Non-sighting by the PA28 pilot and a late sighting by the Tornado crew.
