UK AIRPROX BOARD

Analysis of Airprox in UK Airspace

Report Number 24 January 2010 – June 2010

Twenty-Fourth Report by the UK Airprox Board:

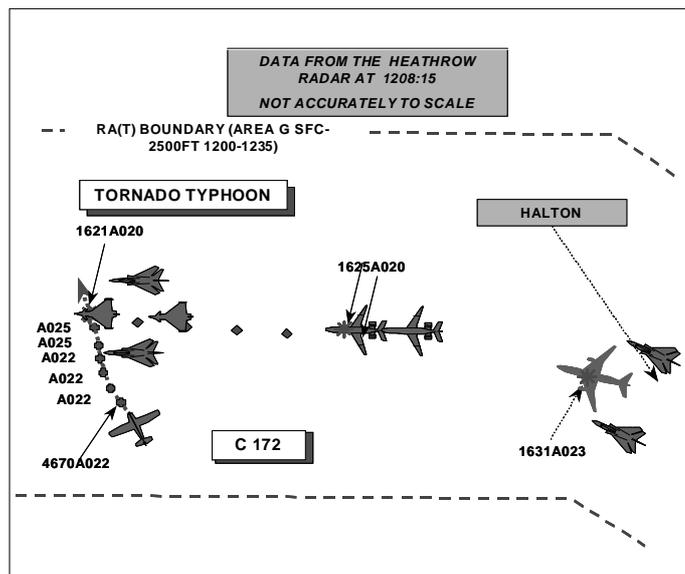
THE TORNADO F3 PILOT reports that he was in close formation with the leader of the lead section (2 Typhoons and 2 Tornado F3s) of a 30 ac extended formation participating in the Queen's Birthday Flypast in receipt of a TS from Luton Radar and squawking with Mode C. They had passed over London a few minutes previously but were still in a high workload situation, flying at 270kt and preparing to split the formation, when Luton Radar warned them of an unknown track at an unverified Mode C level [at an alt of 2200ft] directly ahead of them. At 1207 a formation pilot called the conflicting traffic estimated to be 2nm away just to the left of their track and in a turn. The intruder was a white high-wing light ac, which rolled out on a northerly heading on a direct collision course with his element so he called the formation to descend immediately.

The Board noted that the C172 pilot had checked the NOTAMs but Members were unable to come to any conclusion as to why he had assimilated the RA (T) activation times as being local rather than UTC, which is always used in NOTAMs.

Cause: The C172 pilot infringed the RA (T) and flew into conflict with the military formation.

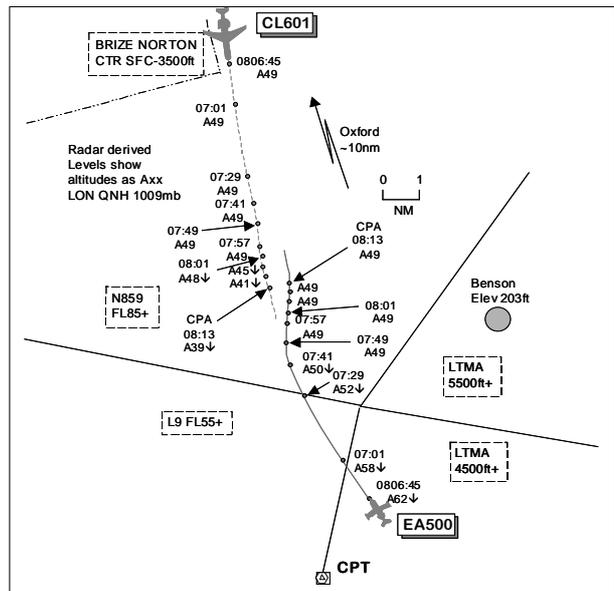
THE CL601 PILOT reports outbound from Oxford on a positioning flight to Farnborough IFR. Clearance was obtained from Oxford Tower before take-off for a standard RW01 CPT departure, which involves a climb to FL50 via the Oxford O/H and then a transfer to Brize for a radar service. Wx conditions at the time were OVC 900ft with N'y wind of 10kt. They departed RW01, made a L turn as usual to route back through the O/H and then direct CPT. Very quickly they entered cloud and became completely IMC with no visibility whatsoever. They contacted Brize and requested and received a TS squawking 3710. As usual they were displaying TCAS at a range of 25nm and they noted a few ac, which were also pointed out by Brize, none of which were deemed to be a threat and the climb was uneventful. About 15nm N of CPT level at FL50 a TCAS contact suddenly appeared ahead of their track at about 10nm; this contact did not drift into the TCAS display from the edge as expected but suddenly appeared as if a transponder had just been switched on. It was his habit to scan the TCAS display very frequently when in such conditions so he saw the exact moment when this contact appeared. He commented to his co-pilot "look at that" and immediately zoomed in the TCAS range to 10nm. He was the PF so already had his finger hovering over the Touch Control Steering (TCS) button ready for a possible RA. At the same time he saw the contact, Brize also gave them a traffic alert about the same new contact, Brize stating it was 5nm ahead and descending through their level. Both he and the co-pilot noted the contact was indicating 100ft above them and showing a down arrow so they believed it would keep descending below their level. He couldn't tell if the contact was coming towards them or flying slowly in the opposite direction but for sure they were getting closer. The other ac levelled at FL50, the same level as them, and was now getting closer, perhaps 2nm or less. He was just about to take avoiding action when they received a TCAS RA commanding a descent, which he duly did. As he initiated a rapid descent he thought he heard Brize try and give them avoiding action but he wasn't sure. They descended to FL35 and observed the other traffic on their display passing O/H before they then climbed to FL50 and continued onto Farnborough without further incident. He was satisfied that they had reacted in a timely and correct manner as per their SOPs. He had a lot of experience flying in uncontrolled airspace (especially around Oxford) and understood the risks involved. With hindsight he thought given their direction of flight they should have been at FL55 (odds +500ft) but FL50 seems to be the standard level used when transiting towards CPT. He assessed that this had been a 'close one' with a serious risk of collision which, thanks to TCAS and training, was avoided.

The poor read back of clearance by Oxford APP combined with the use of non-standard phraseology during the telephone conversations between the two units contributed to a misunderstanding by Oxford APP. MATS Pt1, Appendix E, Page 2, paragraph 1.1, states: 'Radiotelephony provides the means by which pilots and ground personnel communicate with each other. Used properly, the information and instructions transmitted are of vital importance in assisting in the safe and expeditious operation of aircraft. However, the use of non-standard procedures and phraseology can cause misunderstanding. Incidents and accidents have occurred in which a contributing factor has been the misunderstanding caused by the use of non-standard phraseology. **The importance of using correct and precise standard phraseology cannot be over-emphasised.**'

Members noted the CL601 Capt's observations when he saw the EA500 suddenly appear in conflict on his TCAS display. However, the recorded radar clearly shows a continuous radar return on the EA500 squawking an ORCAM assigned code tracking NW'ly and descending within CAS towards CPT. While the Board could not explain the late appearance of the EA500 on the CL601's TCAS, the CL601 crew had seen the approaching EA500 about the same time that LARS had passed TI, had monitored the deteriorating situation and had taken robust avoiding action following the TCAS RA. Although SOPs had led to frequency/ATSU split seen in this incident, Members agreed that both Brize LARS and Oxford APP had, in isolation, discharged their responsibilities but that this been an entirely avoidable Airprox, where coordination would have nipped the incident in the bud. Removing the ATC aspects from the equation and with both flights flying under IFR in IMC, the Board agreed that this incident had been a conflict within Class G airspace and the robust actions taken by the CL601 crew had quickly removed the risk of collision.

Cause: A conflict between IFR traffic in IMC in Class G airspace.

Members endorsed the ATSI recommendations that Oxford Airport review tactical and coordination procedures for inbound and outbound IFR ac and that controllers are reminded of the importance of using correct and precise standard phraseology.

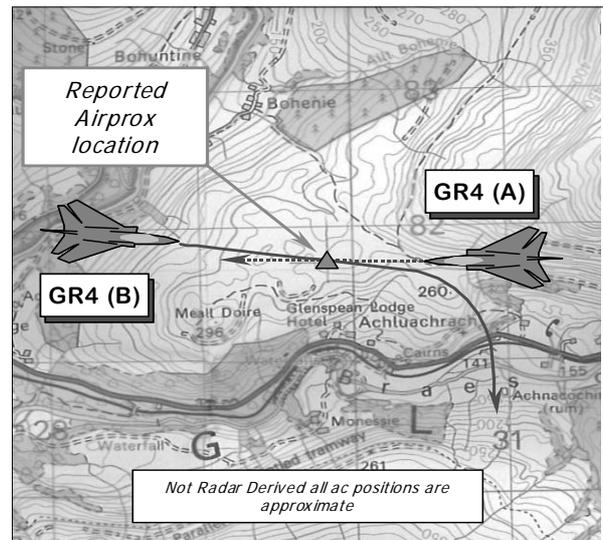
AIRPROX REPORT NO 2010070

Having determined the Cause to be, effectively, non-sightings by the crews of both ac, Members considered the inherent Risk. As the pilot of GR4 (B) only saw GR4 (A) in his mirrors afterwards, Members leaned towards the pilot of GR4 (A)'s view of the geometry and separation as being potentially more reliable. Without the benefit of a radar recording the geometry could not be independently verified but there was no reason to doubt the veracity of the separation quoted by the pilot of GR4 (A) – that he flew 50ft vertically above GR4 (B). With neither crew involved able to affect the outcome of this very close quarters encounter beforehand, any separation that did exist was purely fortuitous. Therefore, on the basis of the pilots' frank accounts, Members agreed unanimously that there had been a Risk of collision.

Cause: Effectively, non-sightings by the crews of both ac.

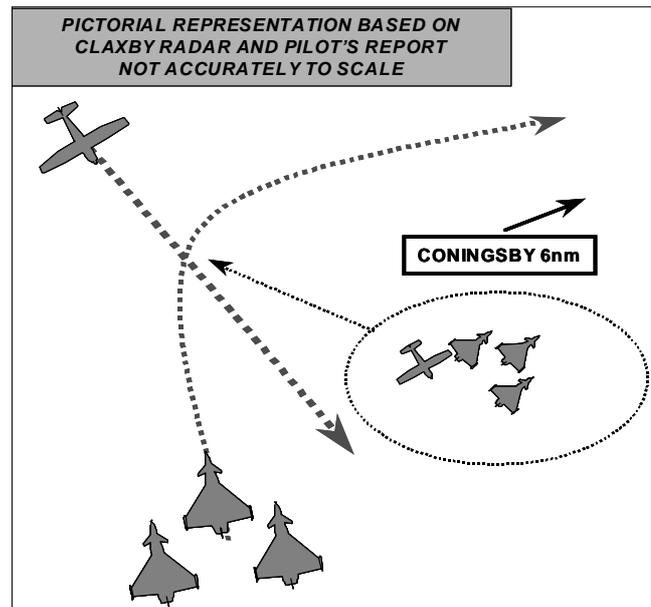
AIRPROX REPORT NO 2010071

In addressing the lookout issues Members noted that 2 of the 3 Typhoon handling pilots would have been concentrating largely on closing to and maintaining close formation. Also the leader would have been busy lining up smoothly with the RW centreline and achieving his timed arrival; Members considered, however, that he also had a significant lookout responsibility. The C150 was level at 2000ft and the formation, although initially above and descending, was levelling at 2000ft just before commencing the right turn onto the centreline and, since the C150 should have been visible to them, the leader's non-sighting was part of the Cause. Members debated whether or not the C150 pilot's sighting of and reaction to the formation had been early enough for him to change the ac flightpath. Although there were differing opinions, a majority agreed that it had not and therefore his was an 'effective non' rather than a 'late' sighting.

Cause: In the absence of TI to the Typhoon formation or a warning to the C150 pilot, a non-sighting by the Typhoon Leader and effectively a non-sighting by the C150 pilot.

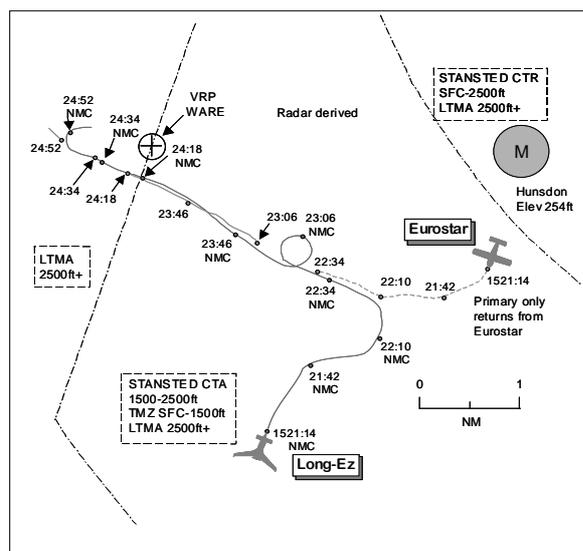
AIRPROX REPORT NO 2010072

THE EV97 EUROSTAR PILOT reports flying en-route from Hunsdon airfield [8nm SW Stansted] to Bourn VFR with another PPL-holder and listening out on the Microlight common frequency 129.825MHz; no transponder was fitted. The visibility was 50km flying 4000ft below cloud in VMC and the ac was coloured silver; no lighting was mentioned. He departed the cct to the S and on reaching the A414 he turned R onto heading 290° at 80mph. He was cruising at 850ft QNH 1018mb to comply with the TMZ entry/exit rules for non-transponder fitted ac into and out of Hunsdon. After turning onto heading 290° he handed over control to the other pilot for the rest of the flight. Some 3min later he suggested that they could track to the N of Ware, 10° R turn needed, or continue on their present track routing to the S. The PF elected to continue on track negating the need to turn. Some 15sec later they were overtaken by a very fast white coloured Rutan Long-Ez on their starboard side, about 10ft above and 50ft distant; its speed well over 110mph. The Long-Ez then made a climbing R turn and disappeared behind them. A few minutes later the same ac returned and flew alongside about 100ft away at the same height before it rolled L then R and then did a climbing R turn away, departing to the NE. He thought he might see the ac's registration letters but although he could see the whole underside of the Long-Ez no markings were visible. He was concerned that had they turned when he suggested they would certainly have been hit by this ac. He assessed the risk as high.

THE RUTAN LONG-EZ PILOT reports flying a local sortie from North Weald VFR and monitoring the Farnborough frequency 132.8MHz and Essex Radar on 120.625MHz squawking 7010 [aerodrome traffic pattern conspicuity code] with NMC. The visibility was 10km in CAVOK VMC and the ac was coloured white; no lighting was mentioned. To the W of Stansted CTR whilst under the CTA stub and within the TMZ flying at 1250ft and 125kt he saw an Evektor Eurostar tracking NNW'ly about 3-4km ahead. He believed he recognised this ac as one owned by pilots/CFIs, with whom he had flown, from a local airstrip. He overtook the silver coloured Eurostar to the R and above it, separated by 500ft, and was visual contact with it throughout. He orbited to their R, having slowed down on the first pass to 90kt, he passed the Eurostar again for a second time to their R, again by 500ft or more. He believed there was never a risk of collision but he may have startled the Eurostar pilot as he approached from behind and above. Even if the Eurostar pilot had commenced rapid manoeuvring, his vertical and horizontal separation was sufficient to maintain a good margin of safety between them. He contacted Essex owing to traffic density and because his track took him over Hunsdon and right up to the CTR boundary and was given an assigned squawk 0202 but was not informed of an Airprox being filed; the Eurostar flight was not heard on any of the local frequencies. He opined that given the restrictions within the TMZ flying below 1500ft and the proximity of Luton and Stansted CTRs and with multiple ac and powered paragliders known to operate, this area is very restricted. He is investigating the fitting of a small TCAS system and to upgrade to Mode S to perhaps avoid such incidents from occurring as well as making his presence known to other flights by monitoring microlight frequencies used in the Ware area.

It was noted that the Long-Ez pilot did not comply with the requirements for entry into the TMZ. Listening out was of no use; a positive call to either Farnborough or Essex/Stansted was required, as the ac was not fitted with Mode C. However, this element had not contributed to the Airprox. The EV97 pilot was complying with the exemption granted to ac operating to and from Hunsdon. Members expressed concern that the Long-Ez pilot had, on the spur of the moment, elected to carry out a close fly-past of the Eurostar, believing he knew the pilot onboard. An experienced pilot Member opined that making a snap decision in the air without any pre-planning or prior consideration of the potential hazards was poor airmanship and a recipe for unforeseen consequences to fall out of the actions taken. This manoeuvre had undoubtedly startled the Eurostar pilot as the Long-Ez had approached unseen from behind and passed close-by with a faster airspeed. The opportunity was there earlier for the Eurostar pilot to see the Long-Ez, when the ac were approaching each other on opposite direction tracks but, for whatever reason, Long-Ez's initial approach from the SW went unnoticed. Although the Eurostar pilot was concerned about the Long-Ez pilot's manoeuvres, Members agreed that the Long-Ez pilot was always in a position to manoeuvre his ac further away should it be necessary, which allowed the Board to conclude that any risk of collision had been effectively removed.

Cause: The Long-Ez pilot flew close enough to the Eurostar to cause its pilot concern.

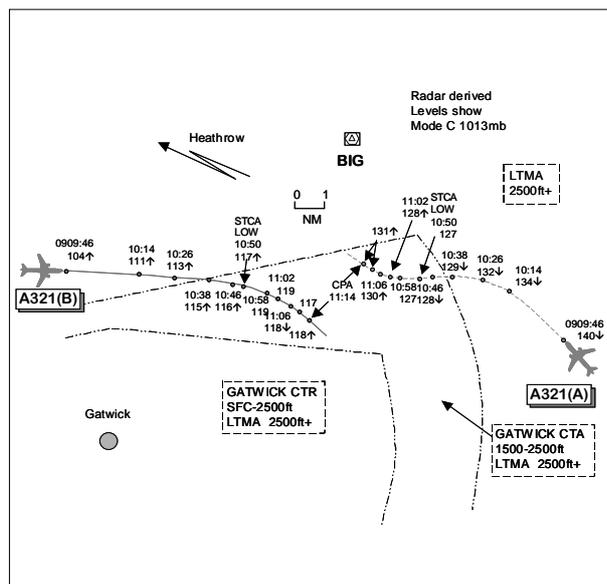
AIRPROX REPORT NO 2010073

THE A321(A) PILOT reports inbound to Heathrow IFR on radar heading 270° descending to FL100. ATC issued heading of 330° and then a 'stop decent now' before TCAS generated an RA 'climb' demanding >1000fpm. The RA guidance was followed and the other ac passed with an estimated separation of 800ft vertically and he assessed the risk as low.

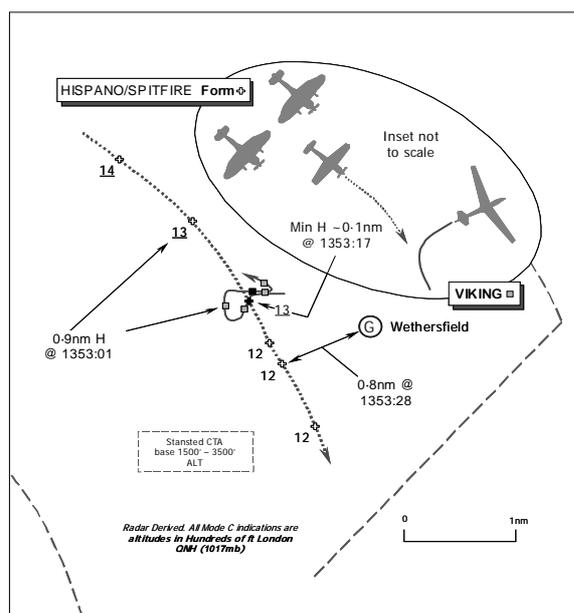
AIRPROX REPORT NO 2010074

THE VIKING T Mk1 GLIDER PILOT, a gliding instructor, reports launching from Wethersfield on a basic training sortie in VMC and at the time of the Airprox was teaching a cadet the effects of controls, rolling R into a gentle R turn. Crosswind for RW33 in a LH cct at 50kt, at a height of 1200ft aal, the ac Captain spotted what appeared to be some birds in the distance. Only seconds later, as the glider turned through 050°, it became apparent that the birds were actually a formation of ac heading towards their glider at a range of about 1nm. To avoid confusing the other pilots about their intentions, they continued their right turn with the intention of steadying on 090° to maintain sight of the approaching aircraft while flying away from their flightpath. Unfortunately the formation approached much too quickly to be able to manoeuvre the glider off any collision course and they passed the glider only 10secs after the instructor first spotted them. The formation ac lost some height and passed about 200-250ft beneath the glider with a 'very high' Risk of collision. There was no indication that the pilots of the other ac had attempted to take avoiding action. No RT call was made during the Airprox as the ac Captain's primary concerns were to fly the glider and watch the conflicting ac. However, another pilot from Wethersfield made a call on 129.975Mhz to warn of the formation ac flying through. The student felt nervous after the Airprox and the Captain was also feeling unsettled, so they returned to the airfield as soon as the conflicting formation was clear. The Airprox was reported immediately to the OC, who had also observed the incident from the control caravan.

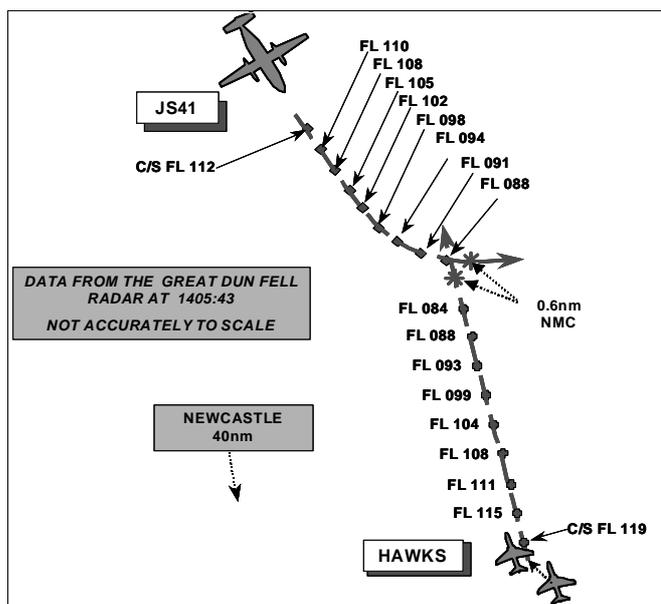
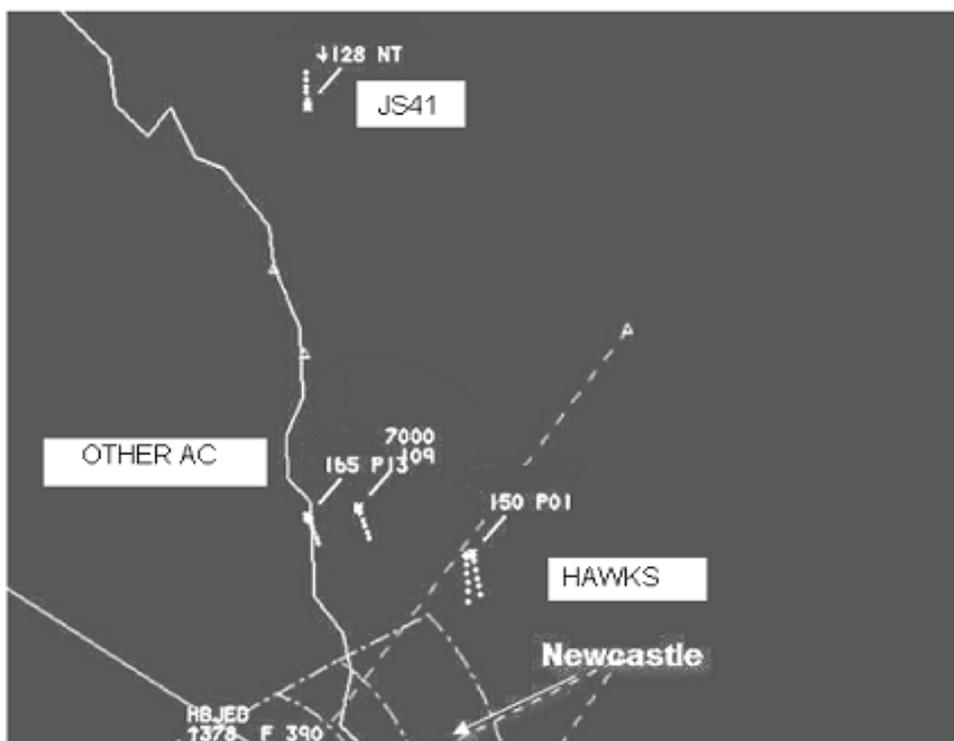
AIRPROX REPORT NO 2010075

UKAB Note (1): On the sweep of the CPA the Mode C of both ac drops out. On the sweep before the CPA (8 sec) the JS41 indicates FL088 and the Hawks FL084 and on the sweep after the JS41 087 and the Hawks FL078. Therefore, by interpolation, the vertical separation was about 600ft.

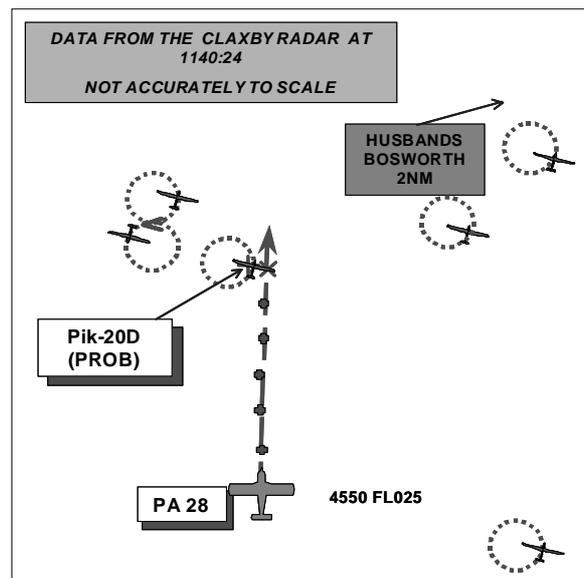
THE PIK-20D PILOT reports that he had just released from an aerotow to 2000ft QNH (1000mb) for a competition flight, behind a Chipmunk; he had turned left as is normal procedure and joined another circling glider just to the E of the release position. After one turn of 360° at 50kt and again passing through E, a PA28 (Reg given) passed immediately behind him at 2600ft QNH traveling from S to N. The PA28 was not seen by the reporting pilot, or by the other glider pilot who was 100-150ft below him, until it passed very close to them when they both saw the ac. The white and blue PA28 did not deviate from its Northerly track and he also took no avoiding action as it was too late and the PA28 was then departing to the N. His ac was not ACAS or SSR equipped.

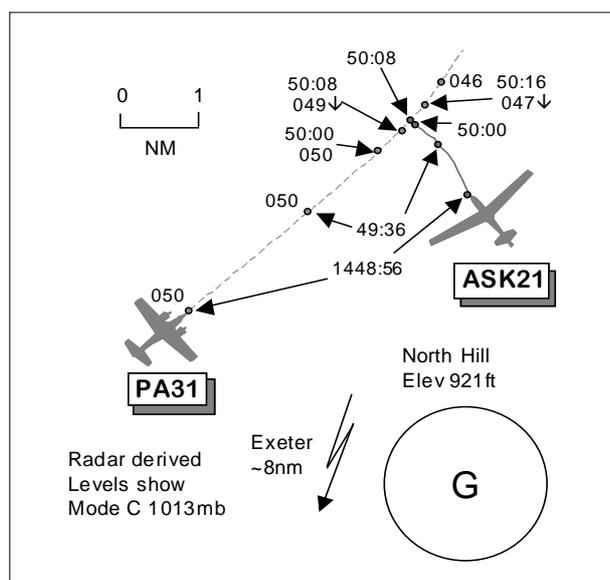
THE PA31 PILOT reports flying solo in the cruise at FL50 heading 050° at 180kt and in receipt of a TS from Exeter, squawking an assigned code with Modes S and C. The visibility was 10km flying 1000ft below cloud in VMC and the ac was coloured white/orange with nav and strobe lights switched on. There seemed to be a lot of gliding activity and he was given a series of traffic warnings, the latest being on 2 contacts “12 o’clock and 2 o’clock, height and type unknown”. He spotted the one to his R (surprisingly) at the same level and probably about 1nm away but the other was not seen until a white glider appeared in his RH windscreen about 200m away flying straight and level at or slightly above his level. He took immediate avoiding action by diving his ac, estimating he passed 300ft below it, assessing the risk as high. He thought that he saw the second glider late as it was in the blind spot caused by the rib which divides the LH and RH windscreens. Also, his attention dwelt on the glider to the R rather than immediately resuming his scan for the as yet unseen one. He was surprised by the number of gliders that day at that altitude. He thought that the radar service provided by Exeter was of a high standard and believed that the controller repeated the call on the glider that was not seen initially. He offered 2 further observations. First, gliders are hard to spot so it would be safer if they were obliged to carry Mode C transponders so that ATC can better assess the risk of conflict. During this 1hr 15min flight he thought he probably received warnings on about 20-30 ac, most of which he never saw; this ‘crying wolf’ fosters inattention in the pilots so warned. Second, in order to mitigate blind spots when looking out, he has been reminded by this incident to move his head and not just his eyes in this and similar ac.

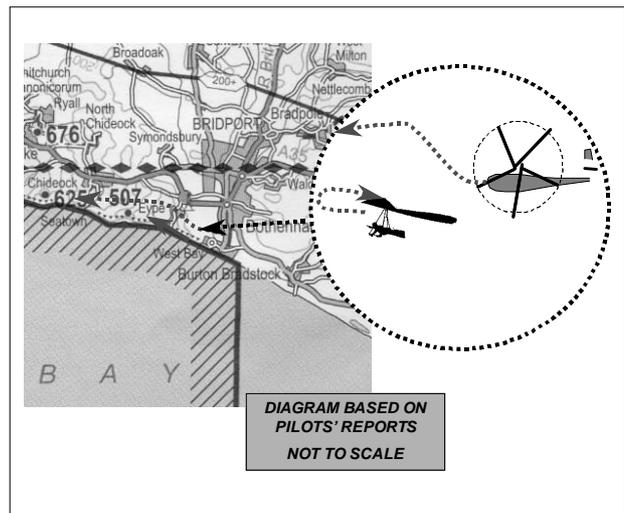
AIRPROX REPORT NO 2010079

THE PARAGLIDER PILOT reports flying a brightly coloured paraglider with no lights, radio or SSR, cliff-soaring along the S Dorset Coast near Bridport at about 400ft amsl and at 20kt. There were other paragliders in the area. A dark coloured helicopter appeared from his blind area, behind and above. The helicopter may well have judged his rotor downwash would pass well inland of these paragliders but that day the wind strength he experienced above Thornecombe Beacon some 15min earlier was weak and only just significant enough to allow him to reach a maximum height of 600ft (around 70ft above the beacon). The helicopter pilot took some avoiding action but then climbed above several other paragliders and continued in a Westerly direction immediately above the paragliders. He assessed the risk as being Medium and provided a photograph of the event.

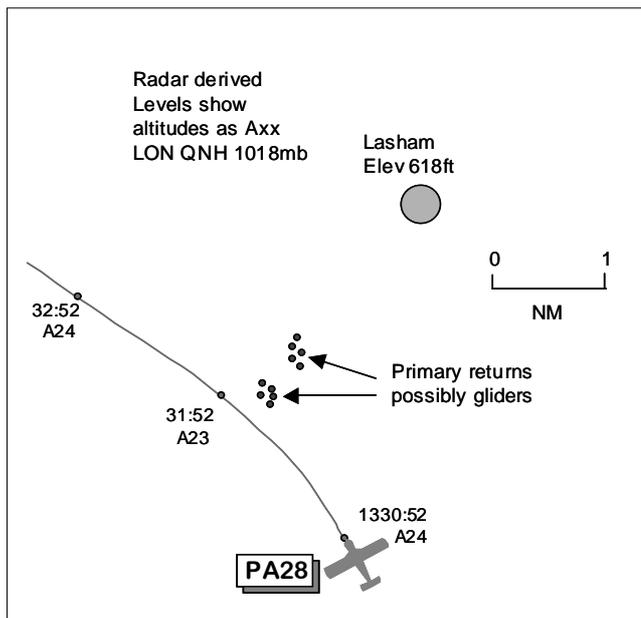
AIRPROX REPORT NO 2010080

THE DR400 PILOT reports towing a K13 glider from Lasham and in communication with Lasham Ground on 131.025MHz; no transponder was fitted. The visibility was 20km flying 1000ft below cloud in VMC and the ac was coloured black/yellow; no lighting was mentioned. About 2-3nm SW of Lasham heading 240° climbing through 2600ft QNH, he thought, at 60kt the K13 instructor pilot pointed out traffic, simultaneously with him noticing, a PA28 about 0.5nm away to his L on a converging course. He waited to see what avoiding action the PA28 flight would take but when he saw it was maintaining course he reduced power to reduce his ROC – he needed to maintain 60kt with the glider under tow – and passed 100-200ft beneath the PA28. He was aware that abrupt avoidance was to be avoided if possible whilst aero towing. He attempted to contact Farnborough to report the Airprox but was told to standby and he then had to change back to Lasham frequency during his approach back into Lasham. He assessed the risk as high.

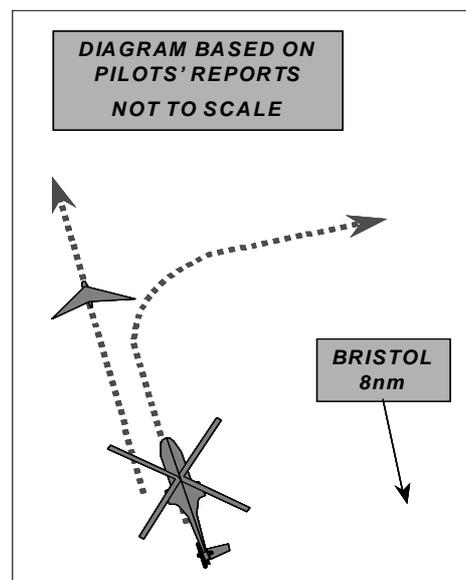
AIRPROX REPORT NO 2010106

THE MICROLIGHT PILOT reports flying a flexwing microlight with no SSR fitted, on a private flight from Bodmin to Broadmeadow Farm Microlight Flying Club (near Hereford) at 50kt, in good VMC and listening out on the microlight frequency. While heading 359° to the W of Bristol, despite wearing a headset he heard a noise and, on looking behind his ac, he saw a green Puma helicopter about 30m away at the same height. The Puma pulled up in his 4 o'clock position, stayed there for a few sec and then dropped away to his right, as he turned left away from it. He reported the incident by letter to the BMAA and thence to the UKAB.
