UK AIRPROX BOARD

Analysis of Airprox in UK Airspace

**Report Number 18
January 2007 – June 2007**

‘Analysis of Airprox in UK Airspace’

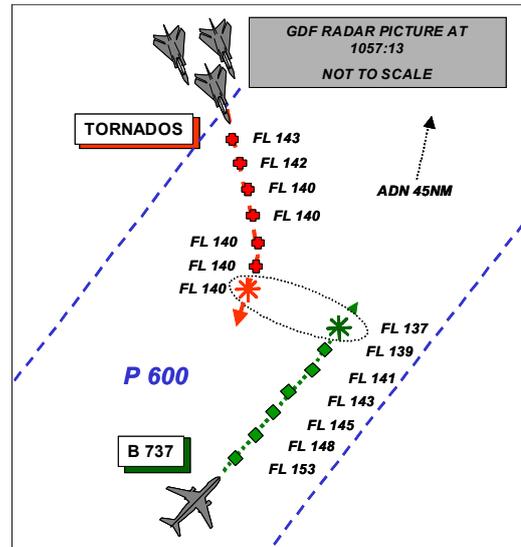
AIRPROX REPORT NO 004/07

[UKAB Note (1): The incident showed clearly on the Great Dun Fell Radar (GDF) but at the extremity of its range (135nm). The horizontal separation when measured on the (non-digital and much larger area) ScACC recording was of the order of 3.9nm; the vertical was the same as on the GDF. The horizontal separation should therefore be regarded as approximate].

delaying the implementation of planned turns. WC4's incompletely applied plan and her failure to take sufficiently positive action were major factors in this Airprox.

Cause: Boulmer WC4 did not ensure that standard separation was maintained between the Tornado formation and the B737.

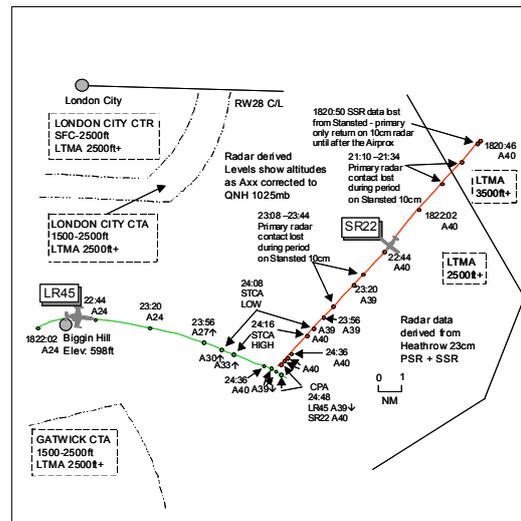
AIRPROX REPORT NO 006/07

NATS INVESTIGATIONS reports that immediately after the event the duty watch removed the Stansted 10cm radar from use by Thames Radar. The radar had been reported on several occasions in the past for poor performance and lost radar returns and with this in mind, engineering were tasked with carrying out a thorough investigation into the radar's performance. At the time, the radar was operating within specification but it was found that it had been operating with some suppression selected (RAG2 mode) since the beginning of the year. RAG2 is the highest level of suppression and, in conjunction with RAG1, is used to reduce false returns and lessen its susceptibility to weather. Looking at problems since May 2006, SSR failures were tracked down to a faulty Inductosyn circuit which was repaired. Poor PSR detection was found to be caused by a faulty T/R cell. Subsequently a number of reports about poor SSR performance over Luton and Detling were received but the majority of these were down to poor transponder performance which was demonstrated by similarly poor detection of the same ac by other radars. The number of reports over Luton may have been compounded further owing to an issue with turning data utilised by the Programmable GTC functionality. This anomaly has been resolved and the situation will be monitored pending any further reports regarding poor SSR performance in the Luton area. Other reports on poor PSR were analysed and it was found that other radars also struggled to track the same targets, this typically being due to the ac having low Radar Cross Section and outside the design parameters of the radar. Although there is a lack of ATC confidence in the Stansted Radar, there is no technical evidence to suggest the radar is performing below expectations.

Engineering also identified that the SR22 was a composite ac with a small Radar Cross Section and at the time of the incident was flying away from the radar head at an oblique angle. Investigation into the transponder showed that the aerial is shaped like a 'lollypop' and is positioned under the ac just aft of the engine firewall. The strength of the SR22's responses was significantly lower than comparable ac at similar ranges and bearings. The signal strength varied as the ac manoeuvred and this was most likely caused by shielding of the antenna by ac structures.

Turning to risk, the TC Biggin SC had reacted as quickly as possible to the rapidly deteriorating situation and given the LR45 crew an immediate avoiding action R turn and descent instruction. The LR45 crew had received a TA alert during their initial contact RT call and attempted to reverse the ac's climb into a descent to follow the ATC instruction. The TI subsequently given allowed the LR45 crew to catch a glimpse of the SR22 above them and to their L but the crew was unable to assess separation distances. The Thames Radar controller saw the STCA alert but was unable to assimilate the situation from his display (only the LR45 label was flashing red) until he changed radar heads, which then revealed the SR22's SSR response, however, by then the Airprox had occurred and it was too late to pass TI to its pilot. Fortunately, the SR22 pilot had detected the approaching LR45 on TCAS to his R, below but climbing, and had monitored its flightpath. The SR22's TCAS 1 generated a TA alert when vertical separation was shown at -200ft and it was then that he broke out of cloud and saw the LR45 to his R. Quickly assessing that collision was not imminent, he watched the LR45 cross from R to L in front of his ac and diverge to his L with lateral separation of about 0.4nm at the CPA. Although the LR45 crew had complied with ATC instructions, they had not assimilated the initial TCAS corrective 'maintain vertical speed, crossing maintain' RA which had led to the TCAS reversal. Members agreed that this had reduced the actual vertical separation distances at the CPA but the lateral separation distances were not duly affected, resulting in the LR45 crossing 0.6nm in front of the SR22 before diverging SE bound. The Board concurred with the SR22 pilot's assessment; his good situational awareness and then visual sighting had removed any actual risk of collision but the subject ac had passed in such close proximity in Class A airspace with the LR45 just commencing its descent – albeit lagging behind the TCAS guidance this left the Board in no doubt that safety had been compromised during this encounter.

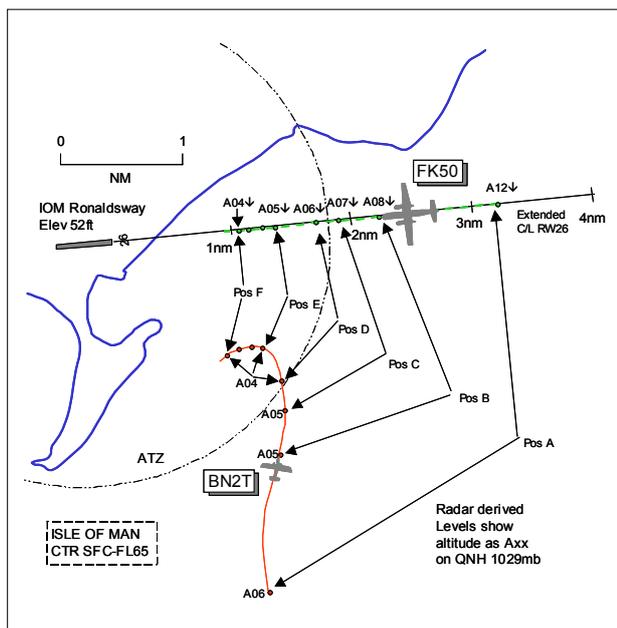
THE RONALDSWAY ADC reports that the FK50 was on the ILS at 2nm from touchdown on RW26 and cleared to land. The BN2T flight was transferred to Tower frequency 118.9MHz by Radar but no contact call was made and the ac was seen on the Tower ATM to be heading directly towards the FK50 and not positioning behind it as instructed by Radar. As no contact call was made, a 'blind' transmission was made on 118.9MHz instructing the BN2T flight to turn L immediately with TI on the FK50. The BN2T pilot then acknowledged the instruction and added that he had the other ac on TCAS. The FK50 was by now on short final at 200ft and continued its approach and landed. The BN2T was separated by approximately 1nm at the CPA as the FK50 descended through its level.

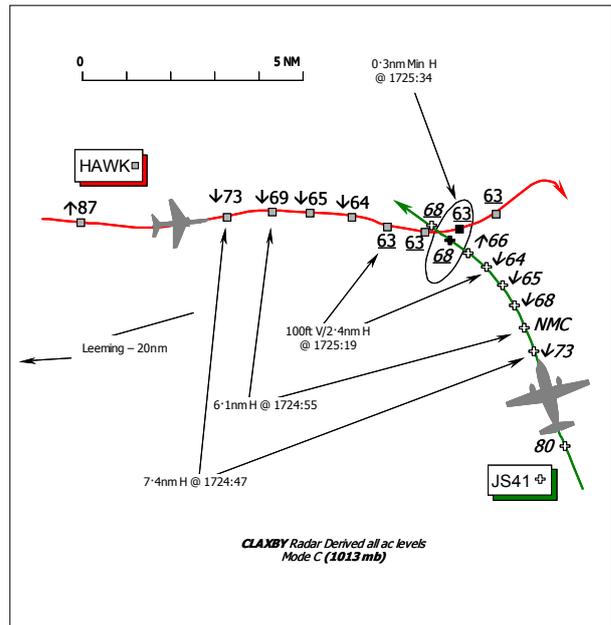
THE DURHAM TEES VALLEY (DTVA) APPROACH RADAR CONTROLLER (DURHAM RADAR) reports that the JS41 was inbound to DTVA under IFR and he was vectoring the ac under a RAS from the SE for an ILS approach to RW23. The JS41 was squawking A7062 with Mode C, flying level at FL80 and remained at this level for some time due to several A7000 squawks transiting through the vicinity NW - SE (one of which infringed the DTVA CTA some 5nm SW of the airport). In addition to these contacts, two further ac were observed departing Leeming tracking E and climbing. He notified the JS41 crew of these various contacts and that he would keep them advised. The second of the Leeming ac squawking A0404 – the subject Hawk - was on a steady easterly track and once this ac had passed FL85 and appeared well clear of the JS41 he instructed the crew to descend to 3500ft DTVA QNH (1022mb). It was during this descent that the Airprox occurred. The Hawk ac altered its track and started heading towards the JS41 so he issued traffic information and an avoiding action turn onto W. However, the Hawk then altered course again towards the JS41 so he gave another avoiding action turn onto NE and instructed the crew to stop descent. There were no other options available to him and in response to a TCAS RA the JS41 pilot executed a climb. Following the RA, the Hawk ac began a transit to the E again and the JS41 was vectored as normal into the ILS pattern.

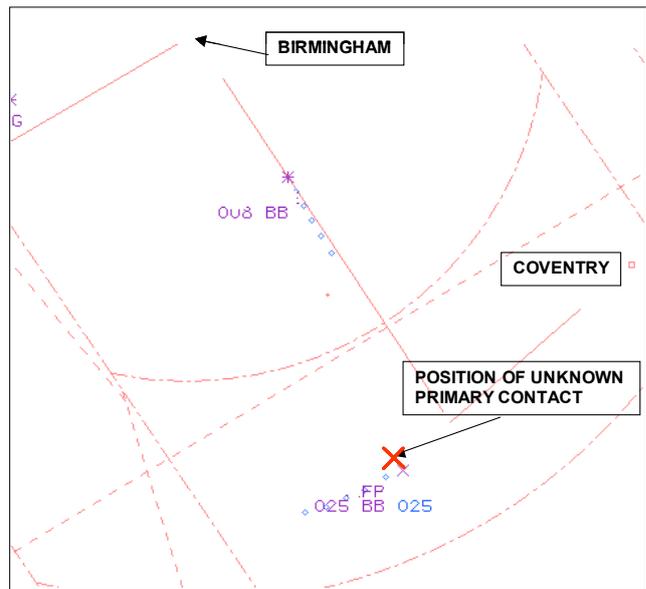
THE BIRMINGHAM APR reports that he was on duty in the Birmingham Director (DIR) position when a BAe146 was being vectored downwind left hand for an ILS approach to RW33, towards the end of a sequence of traffic. Shortly before turning it onto a base leg heading he observed a primary contact in the Warwick area, S of the airfield by about 12nm. In that position he would expect traffic to be below the base of CAS and not above 1400ft amsl. However, the strength of the primary contact gave him cause for concern as the base of CAS to the S is 3500ft and he was uneasy about vectoring the BAe146, descending to 2500ft, directly overhead the contact. He called Coventry Radar to ascertain if the traffic was known to them but it was not. He therefore continued the BAe146 on a heading to miss the primary contact and passed TI. The vectors then placed the ac E of the approach and it closed to the centreline from the right.

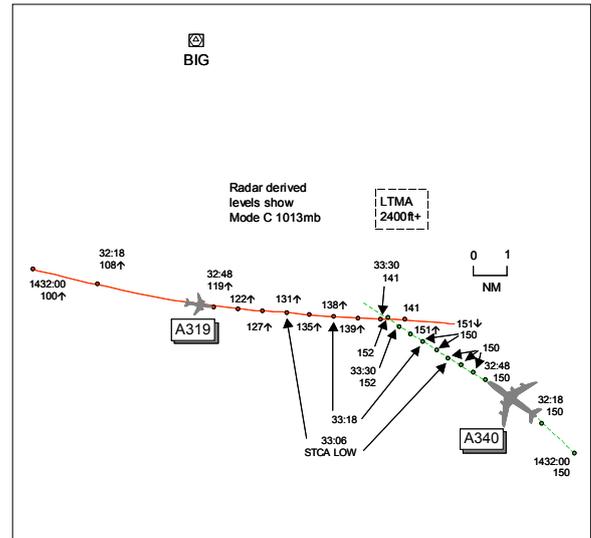
THE A340 PILOT reports heading 305° at 250kt inbound to Heathrow IFR and in communication with London Radar squawking an assigned code with Mode C. Level at FL150 about 20d inbound BIG, a TCAS RA 'climb' command was received and the PF immediately followed the guidance. 'Clear of conflict' was annunciated by FL152, 200ft above their cleared level, and the controller was informed of the occurrence. The other ac was not sighted visually but was believed to be <1000ft below and, from the TCAS display, within a 'few hundred' metres horizontally. He assessed the risk as medium.

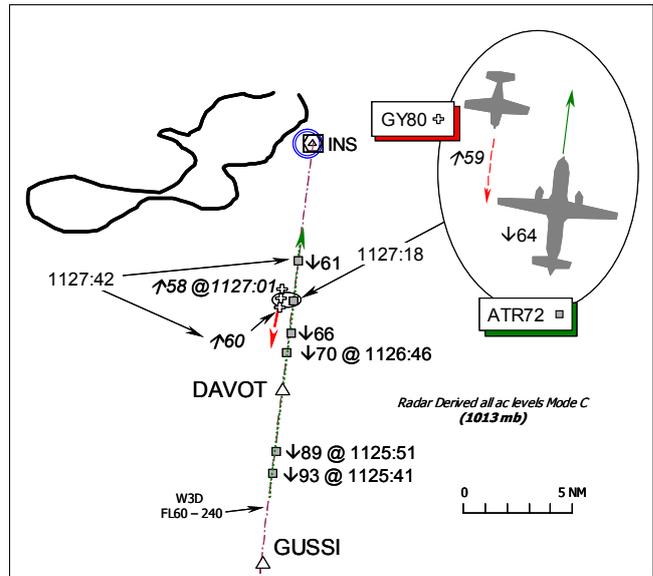
AIRPROX REPORT NO 012/07

THE ATR72-200 PILOT provided a very comprehensive account reporting that he was inbound to Inverness from Dublin under IFR but flying in VMC. A squawk of A6226 was selected with Mode C on; TCAS and Mode S (Elementary) are fitted.

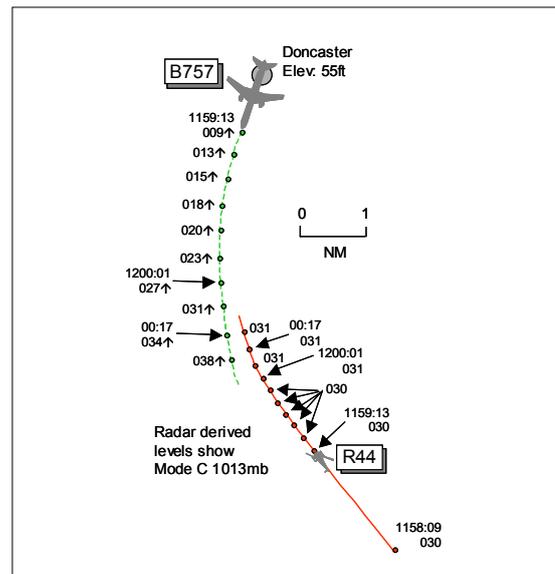
THE B757 PILOT reports outbound from Doncaster/Sheffield (DSA) IFR following a GOLES RW20 East departure route and in communication with Doncaster Tower then Radar squawking an assigned code with Mode C. Turning through heading 190° at 180kt climbing through 2500ft QNH 1005mb, a TCAS TA then RA was received on a contact 2nm S of them showing at the same level and climbing, he thought. They stopped the L turn and followed the TCAS guidance to FL45 during which a small black helicopter was visually acquired 1nm away tracking 350° towards DSA which passed 300m clear to their L with nil vertical separation. The departure was complex from DSA with increased workload (heads down) owing to ATC issuing instructions which were not simple; the L turn was into the conflicting traffic. He assessed the risk as high. The DSA SSR was NOTAM'd as being u/s.

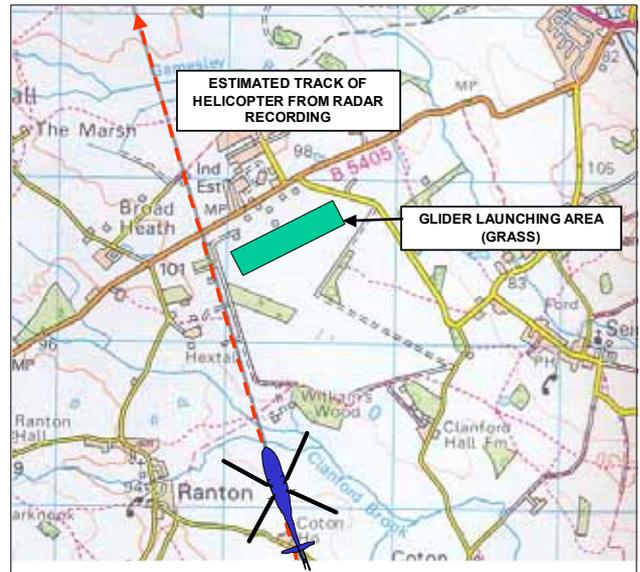
AIRPROX REPORT NO 015/07

THE GROB TWIN II GLIDER PILOT reports that he was flying solo in a white club glider and was circling at 50kt in weak lift and in a low workload situation over the S boundary of the airfield at about 1000ft agl when a blue and white retractable undercarriage helicopter flew straight over the airfield on a S to N track at the same height. He initially saw the helicopter when it was about 1nm away but its head-on aspect did not show the unexpectedly high closing speed that he later estimated as being about 150kt; consequently he needed to take rapid avoiding action by tightening the turn into a spiral dive to provide horizontal and vertical separation. Despite this, the helicopter passed between 100-200yd away and 50ft above; as a result of the height lost in taking the avoiding action, he immediately flew an abbreviated circuit and landed on the airfield. He reported the incident to the CGI on landing and assessed the risk as being high.

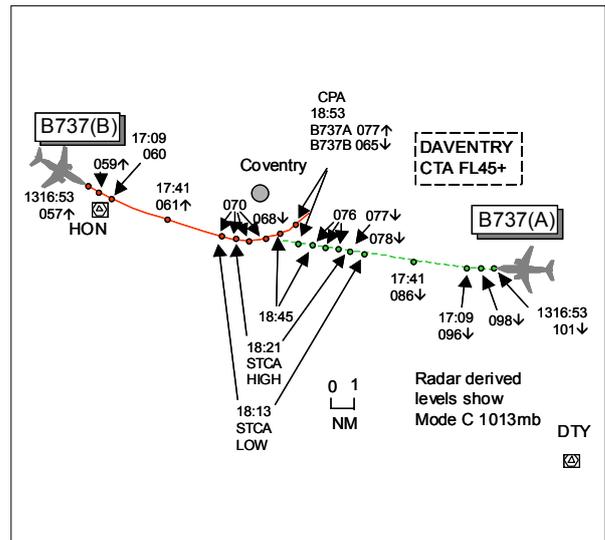
AIRPROX REPORT NO 016/07

THE B737(A) PILOT reports inbound to Coventry IFR and in receipt of a RAS from Birmingham squawking an assigned code with Mode C. Initially following a GROVE1C arrival, they were given vectors by Radar towards HON and then L around for a downwind LH pattern for the ILS RW23. A continuous descent from FL220 was made and after passing FL90 cleared to FL70 heading 350°, he thought, at 250kt, a target was seen on the EHSI 5nm ahead climbing towards them which became a TA alert. It was apparent that if both flightpaths continued they would be extremely close. He disconnected the A/P and A/T and instigated a climb from FL77 coincident with an RA 'climb' being annunciated. They informed ATC of the climb who replied that they were not cleared to FL70. Both pilots heard the clearance to FL70 with the PF, setting 7000 in the window which the FO read back to ATC. The other ac was not seen visually owing to IMC but TCAS indicated it passed within 700ft and 1.5nm and he assessed the risk as high. Post flight he contacted the Birmingham ATC Watch Manager who told him that the controller had made a mistake having indeed cleared them to FL70.

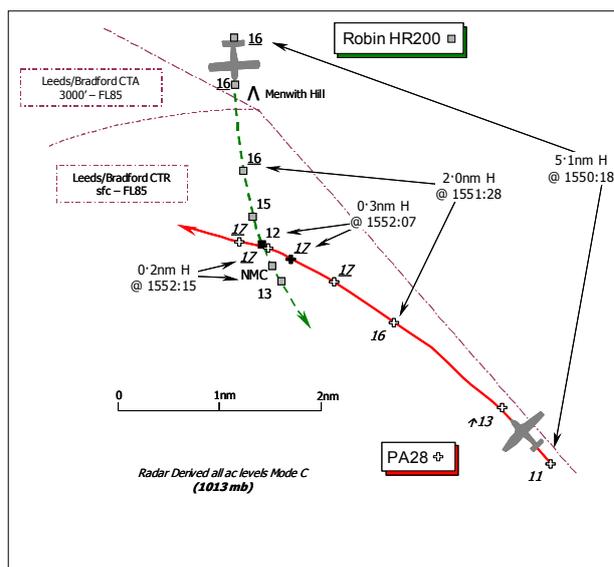
THE ROBIN HR200/120B PILOT, a flying instructor, reports that he was returning to Leeds Bradford Airport (LBA) VFR, from the vicinity of Ripon/Harrogate during a local general handling instructional sortie with a PPL student. He was in receipt of a RCS from LBA RADAR on 123.750MHz, squawking A2651 with Mode C on whilst flying in VMC, in level cruise at 1700ft QNH (1022mb).

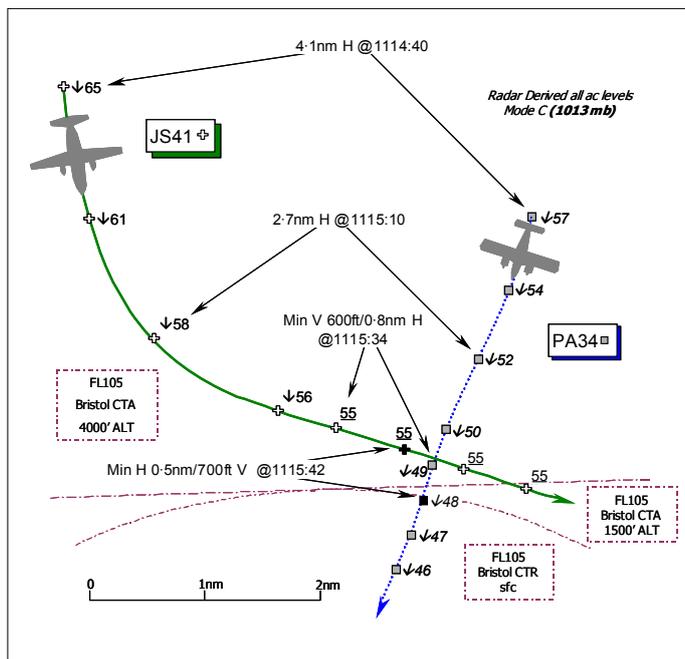
THE BRISTOL APPROACH RADAR CONTROLLER (APR) provided a laudably frank account reporting that the PA34 was flying a standard IFR training route ALVIN - BRI at FL80. The crew was instructed to leave ALVIN heading 175° and descend to 5000ft Bristol QNH (1031mb). The JS41 was inbound to Bristol under IFR and was released by Cardiff heading 175° descending to FL90. On first contact, the JS41 crew was instructed to descend to an altitude of 6000ft Bristol QNH (1031mb), the intention being to descend the flight to 1000ft above the PA34 before over-flying the latter, thereby positioning the JS41 as No 1 in the pattern for RW27. When the ac were about 9nm N of Bristol - both still in the descent - a departure was released on a BADIM 1X SID. At this stage, the PA34 was passing about FL62 and the JS41 passing FL73. In order to make the cross and turn the JS41 onto a downwind heading, the APR turned the PA34 onto a heading of 210° and then the JS41 onto a heading of 100°. Traffic information about the PA34 was given to the JS41 crew and that it was passing their assigned level descending to 1000ft below. However the relative rates of descent of the 2 ac were such that the vertical separation was not ensured. Also the very high QNH of 1031mb led the controller to perceive that the PA34 was just passing 6000ft QNH when it was indicating FL62 Mode C, the APR subsequently realising that this ac was actually still much higher than it seemed [about 6740ft QNH (1031mb)]. No avoiding action was issued. On passing clear of the PA34 the JS41 crew advised that a TCAS RA had been triggered but no other information was passed. Prescribed separation was eroded down to 600ft vertically when the ac were 1nm apart.

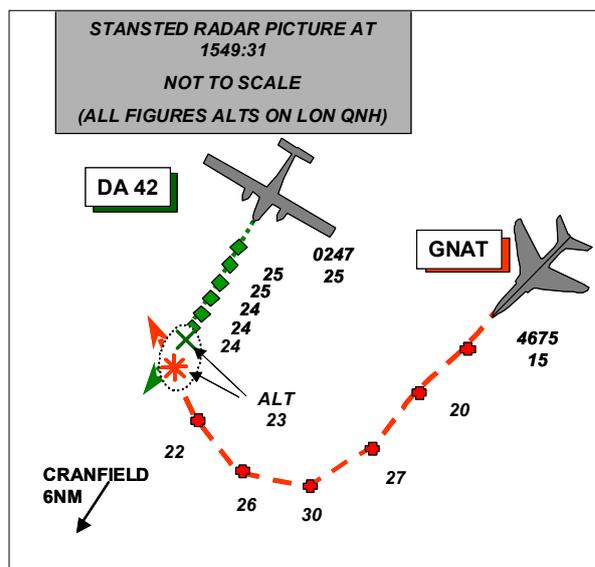
THE DA42 PILOT reports that his student was flying a simulated asymmetric ILS to Cranfield in a white ac with strobes and nav lights switched on, squawking 0247 (Cranfield IFR conspicuity) with Mode C and in receipt of an APP service from them. Although IF screens were fitted, the instructor's vision was unrestricted from the RHS. They were flying at 105kt, on the localiser, had just intercepted the glide path and commenced a descent with the gear down when the instructor spotted a Gnat ac at their level, 5 to 10° left of their nose crossing left to right but almost on a reciprocal heading (their heading was about 216° to hold the localiser (QDM214°)). He estimated the Gnat's heading to be 025° and its range was 100 to 200m on first sighting. He took control instantly and broke up and to the right, losing sight of the Gnat but "he was waiting for the impact". He visually re-acquired the Gnat that was flying a very large orbit round him.

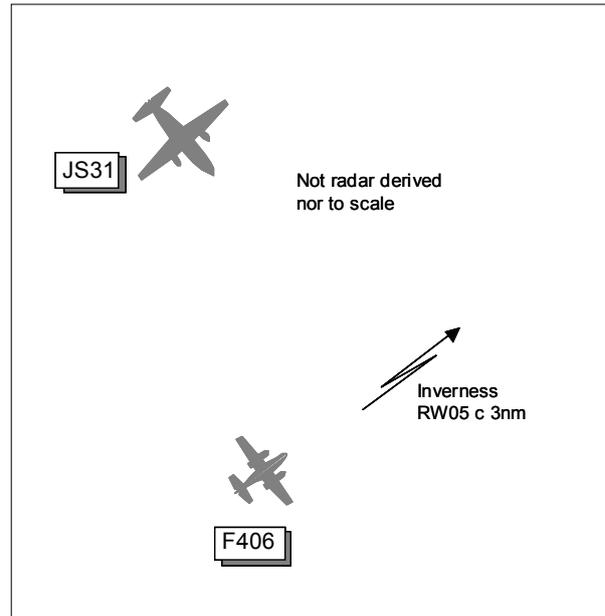
THE INVERNESS APP/ADC reports that the inbound F406 from Stornoway converted from an ILS to a visual approach onto RW05 at 10nm final. The VFR inbound JS31 flight, also from Stornoway, was told to report S coast of Black Isle to enable sequencing to final. After the JS31 flight called S of Black Isle, he asked the crew if they had the F406 in sight and they replied 'negative' so he then instructed the flight to continue downwind LH and report traffic in sight which they did immediately. He then told the JS31 crew to position No 2 to the F406 but there may have been a clipped transmission from the JS31 flight. He looked out of the VCR window to visually acquire the JS31 and, as he did so, he saw the JS31 fly <100ft underneath the F406 on short final, manoeuvre to the S of the final approach before it positioned onto R base. He believed that owing to the proximity of the ac, safety was not assured. Following telephone conversations with both Captains, he learnt that the JS31 Captain had called the F406 pilot on company frequency shortly after departing Stornoway and indicated his intention to carry out 'TCAS training' but the F406 pilot was unable to accommodate this owing to being time critical. The F406 pilot did hear a call from the JS31 flight, when it was downwind for RW05, stating their intention to carry out training. However, it appears that as soon as the JS31 pilot stopped speaking, the pilot of the F406 looked to his L to find the JS31 already in close proximity.

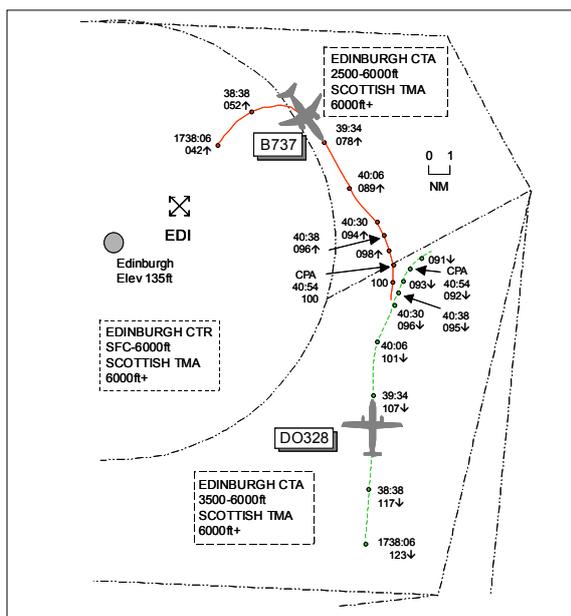
THE EDINBURGH APR reports carrying out OJTI duties with a colleague as the Radar1 controller. When the DO328, inbound to Dundee, was transferred from Scottish, it was given a R turn onto 005° in order to keep the ac to the E of S'bound departures. Tower was instructed to 'Check South' so that TLA departures would be coordinated before take-off. At this time the ADC asked for a release on the B737 which was approved, on a TLA 6D departure with no restrictions. Once airborne the B737 flight was climbed to FL100 on the SID whilst the DO328 was now descending to altitude 5000ft. He realised that further action was needed to maintain separation so after a short delay due to the trainee's workload, the DO328 was turned further R onto 025°. Further action was still needed so the B737 was turned R onto 200° at which point the crew queried traffic that they could see so the flight was turned further R onto heading 240°. Immediately after this the DO328 flight was given an avoiding action R turn onto 090°, the crew reporting visual with the B737.

Edinburgh is authorised to use 3nm minimum radar separation, under certain conditions, which were met on this occasion. The radar recordings reveal that when the subject ac were 2.7nm apart (1740:38), the B737 was passing FL96 and the DO328 FL95. Vertical separation increased while the horizontal separation reduced. As they passed (1740:54) 0.7nm apart, vertical separation was 800ft. The mentor commented that STCA did activate, initially a low, amber alert, then going to a high red alert. He added that as the ac passed close to each other he was not aware of the separation as the SSR returns overlapped. It is possible to individually change the position of SSR returns but it is time consuming. The Edinburgh radar display, unlike at other NATS ATC Units, does not show a separate box indicating the traffic involved in any STCA and their respective levels. Therefore the following recommendation is made.

Cause: The Edinburgh APR mentor allowed his trainee to vector the climbing B737 and descending DO328 into conflict.

ATSI Recommendation: It is recommended that the local ATC Management review the STCA display system at Edinburgh to establish the practicability of displaying a separate box to show the ac involved in the alert and their respective levels.

The NATS Advisor informed Members that Edinburgh ATC was actively pursuing the ATSI recommendation. This proposal had further potential benefits as four other NATS ATSU's used the same radar display equipment as Edinburgh. Also, this incident was highlighted in the May unit safety publication.

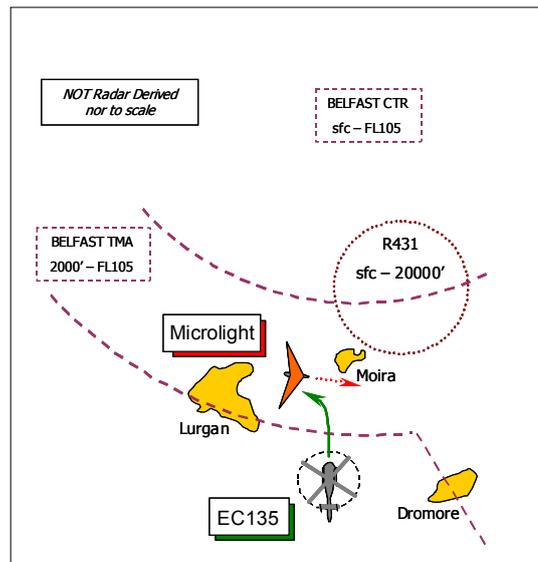
AIRPROX REPORT NO 025/07

THE EC135 HELICOPTER PILOT reports that he had departed in his blue-coloured ac from an aerodrome in the republic of Ireland inbound to a private helicopter landing site (HLS) at Ballinderry within the Belfast CTR in CAVOK weather. He was in receipt of a FIS from Aldergrove APPROACH on 128.5MHz and a squawk of A7000 was selected with Mode C.

Heading 360° with the Sun off his port quarter, he was descending through an altitude of 2000ft in the vicinity of Moira to the S of the Aldergrove CTR. With about ½nm to run to controlled airspace at 120kt, he observed a microlight ac ahead of his helicopter about 100ft away at the same altitude. To avoid the microlight – which had an orange/red wing and a white body - he executed a 60° AoB descending turn to the L, as the other ac passed some 30m away at the same altitude. At this point, he thought he had struck the microlight and proceeded to ensure the other ac was OK. After circling the microlight and ensuring it was indeed safe he reported an Airprox to Aldergrove APPROACH. The controller informed him that the other ac was just outside CAS and had not established communications with them. As the ac did not show on Aldergrove's primary radar, they had no way of knowing the ac was there. He stressed that in his view as a commercial pilot, Aldergrove ATC provide a first-rate service and afford every assistance to pilots on a daily basis in an extremely helpful and professional manner.

Cause: A non-sighting by the microlight pilot and a late sighting by the EC135 pilot.

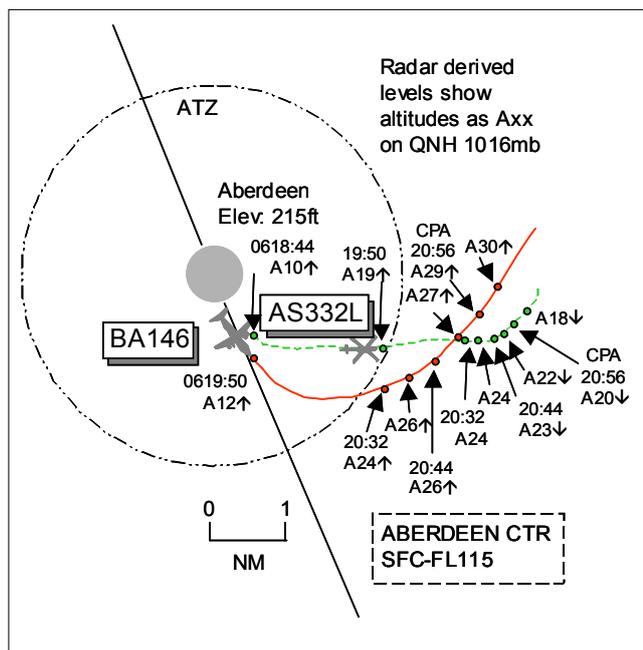
THE ABERDEEN ADC reports working the Tower position during the usual outbound morning rush. He received a radar release for both the AS332L and the BA146 – the AS332L was given a L turn and was asked to report turning L. As the BA146 was lined-up, the flight was given ‘hold position, after departure R turn heading 300°’. The heading was read back correctly but as the crew did not read back ‘hold position’, he confirmed this with the crew, being a critical part of the read back with the AS332L in the climbout. When the AS332L flight reported turning L, the BA146 flight was cleared for take-off and he monitored that ac’s track on the ATM for the correct turn. As soon as he noticed the BA146 make a slight L turn, he told the crew to turn R heading 300. Radar then telephoned to ask about the BA146 and he told radar that he had just told the flight to turn R. He heard radar give the AS332L flight avoiding action to the L and he again tried to turn the BA146 R; at no time did he see the BA146 turn R. By the time a L turn was appropriate for avoiding action, the subject ac were about to cross with some vertical separation.

Pilots Members were surprised and disappointed that the BA146 crew did not comply with their ATC instructions, turning into conflict with the AS332L which action had clearly caused the Airprox. From the outset, the flight was given a R turn after departure onto 300° but this was not assimilated by the crew who appeared to be expecting a L turn as normal. The crew's partial readback, omitting the direction of turn, was not challenged by the ADC who focussed on the omission of the 'hold position' instruction that he had given in the same transmission. An ATCO Member opined that had the readback included a direction - L as the crew would normally be expecting - then this would have been picked up by the controller but the omission of any direction had slipped through the net. This incomplete readback (omitting the turn direction) had gone unchallenged by the ADC which, Members agreed, was the first opportunity to 'break the chain' of events that ensued and had contributed to the incident. That said, there was some sympathy for the ADC who became concerned that perhaps his 'hold position' instruction would not be acted upon, this probably diverting his concentration away from ensuring a correct readback of the ATC clearance.

Cause: The BA146 crew did not comply with ATC instructions and turned into conflict with the AS332L.

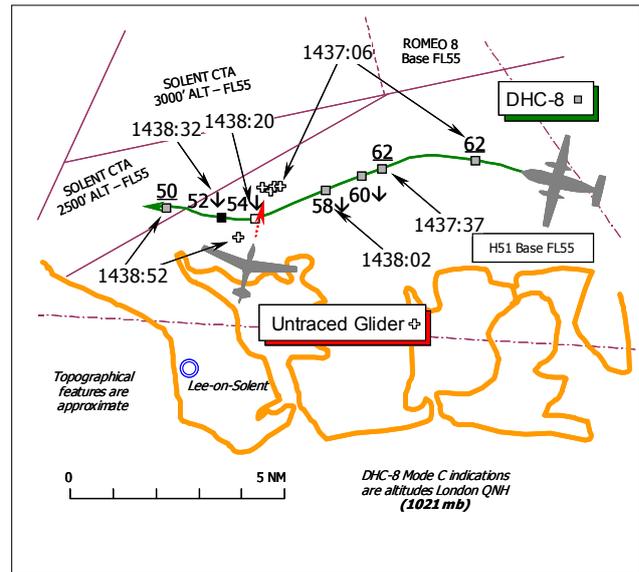
AIRPROX REPORT NO 027/07

THE DHC8 PILOT reports he was inbound to Southampton about midway between Goodwood and SAM VORs flying at 210kt. A squawk of A4445 was selected with Mode C and he was in receipt of a RCS from SOLENT RADAR who cleared them to descend from FL60 to an altitude of 4000ft Southampton QNH. Shortly afterwards the controller advised them of a possible primary radar return on a suspected glider inside CAS and possibly beneath them. RADAR advised them to level off at 5000ft QNH and for avoiding action to turn onto a heading of 290°. On that heading, the glider was spotted visually very shortly afterwards, some 400ft above his DHC8 and about ¼nm away and crossing from L to R in a shallow, descending banked turn to the R. Once it was seen, their flightpath was maintained and no further avoiding action was necessary since there was no chance of a collision as the glider was rapidly flying away from them. He assessed the risk as “moderate” and stressed that at no time was the glider on a converging course with them.

THE SOLENT APPROACH RADAR CONTROLLER (APR) reports that when the DHC8 was within the confines of airway H51, between GWC and SAM, descent was given to FL60 on a radar heading of 295°. A number of primary radar contacts were observed on the overall radar display but it was not possible to ascertain whether these were spurious or actual ac. The flight was approaching the southeastern extremity of the Solent CTA – base altitude 2500ft - where it adjoins H51 so the DHC8 was descended to an altitude of 4000ft, some 1500ft above the base of the CTA [but below the base of the airway]. He recognised that with the strong ENE'ly wind the ground speed of the ac was greater than normally expected and believed that the descent profile would keep the ac within CAS. The DHC8 crew was instructed to turn L onto 250° to parallel the southern edge of R8 where it adjoins the Solent CTA. Shortly afterwards a slow moving primary radar return was observed in the DHC8's 12 o'clock. However, there was no requirement to pass traffic information or avoiding action as, in accordance with normal procedure, there was no evidence to suggest that the primary contact was an ac inside CAS. At this stage he felt it could have been a spurious radar contact. However, as the strength of the primary return became greater – and with knowledge of primary radar coverage in this area – he was not convinced the primary contact was below CAS. Consequently, traffic information was passed on the intermittent radar contact. The DHC8 crew was instructed to stop their descent at 5500ft, he thought, but soon afterwards corrected this to level off at 5000ft followed by an instruction to turn R 290° with the intention of positioning the ac towards SAM. His plan was now to position the ac within the portion of the CTA where the base is 3000ft rather than the original plan of positioning the ac in the

Cause: The Solent APR vectored the DHC-8 out of CAS into conflict with an untraced glider.

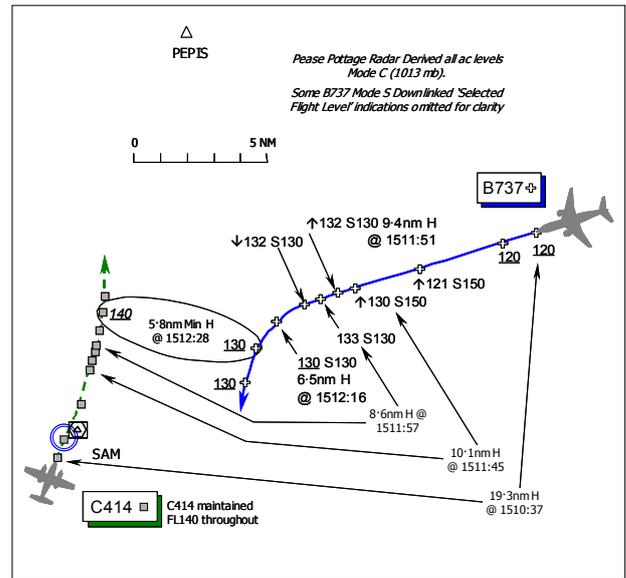
THE LACC SECTOR 19-21 TACTICAL CONTROLLER (S19 TAC) reports that the C414, level at FL140, had just been transferred to TC SW who then transferred the B737 to S19 TAC climbing to FL150 and thus into conflict with the C414. The B737 was stopped off at FL130 – but crept up to FL133 before levelling - and then turned L onto a heading of 210°. At the time, the controller was not sure if separation was subsequently lost after the stop-off and turn.

Heading 017°(M) - he thought on the 010R SAM at about 16 DME - at 180kt, the B737 was observed from the flight deck at about 2 o'clock some 5nm away to starboard and below his ac. Minimum vertical separation was about 700ft. The risk of collision was assessed as "low".

Cause: Conflict resolved by LACC S19 TAC.

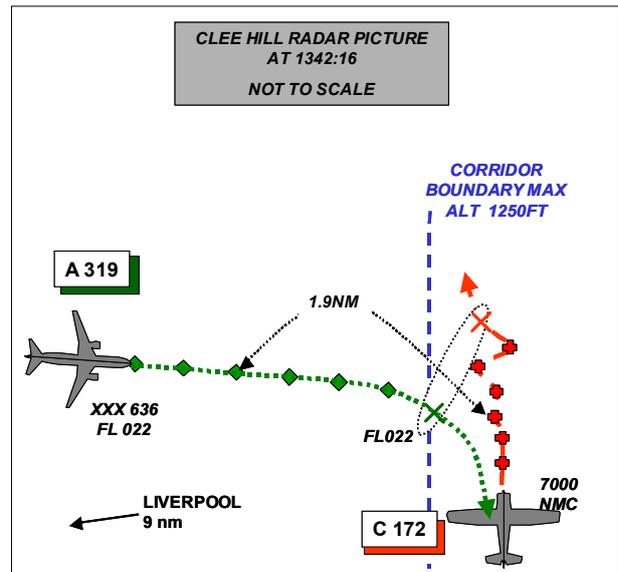
THE A319 PILOT reports flying a scheduled passenger flight to Liverpool under IFR. Liverpool DIR was vectoring him downwind in the ILS pattern for RW27, heading 090° at 195kt, and the controller said she was keeping them at 2500ft due to a light ac N'bound in the [Manchester] VFR low-level corridor. They picked up a non-mode C TCAS contact and both pilots looked for the ac below them since the maximum altitude in the corridor is 1250ft. The controller turned them S for the base leg and at the same time they saw a white, single piston, high wing light ac in their 12 o'clock at about 5nm and at the same altitude heading N. As the turn was taking them clear of the other ac, he did not call for any further avoidance but told the controller that he was visual with the other ac and that it appeared to be at the same altitude as they were. He assessed that the closest the two ac came was 3nm. He assessed the risk as being low.

In the absence of Mode C information, Members were not able to resolve the disparity in the reported altitude of the C172. The A319 pilot was not sure whether the C172 was at 2000ft or 2500ft - nevertheless he thought it to be at about the same altitude as themselves. One pilot Board Member familiar with A319 operations noted that in certain configurations and under some operating procedures, the ac can be in a slight nose-down attitude at this stage of flight. Had this been the case, it might have given the airliner’s pilots a false impression of the C172’s altitude. Although the C172 pilot was fairly certain that he did not deviate from his planned [max] altitude of 1250ft, some Members thought it possible that he might have strayed slightly above this while concentrating on looking at ground features. That the C172 pilot (in the left seat and thus closest to the A319) did not see the relatively large and brightly coloured airliner as he passed through its nose at 1.9nm was also discussed. One GA Member suggested that the airliner might have been above the Cessna’s wing thus giving some credence to the latter pilot’s reported level. The Board however could not positively resolve these disparate reports. Accepting the A319 pilot’s estimate of the risk of collision, it was clear to Members that there had been none.

Cause: Sighting report.

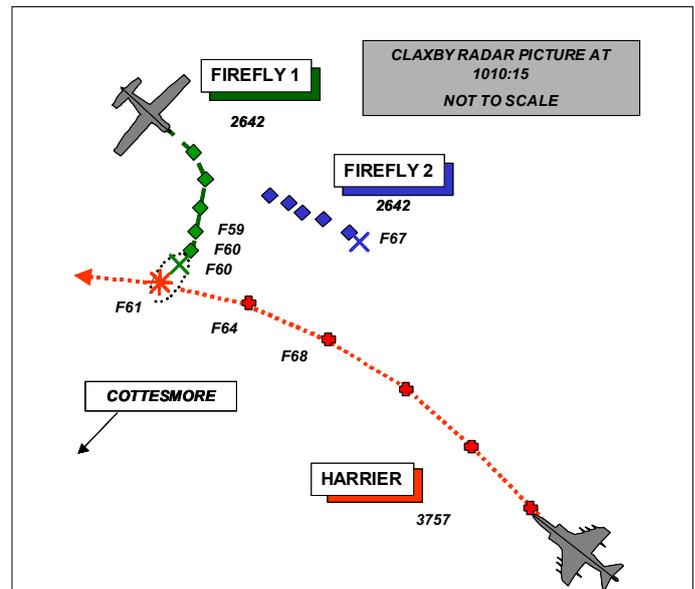
AIRPROX REPORT NO 032/07

THE FIREFLY 260 PILOT reports flying an EFTS GH instructional sortie with a student pilot in a yellow ac with nav lights and strobes switched on, squawking 2642 (Lincs AIAA Conspicuity) and listening out on Cranwell APR. He had just completed a lookout turn through 180° to the right from 360° heading, rolling out on 180°. He closed the throttle while maintaining FL60 and continued his lookout until at about 60-65kts, just before entering a full stall, he saw a Harrier ¼nm away to his left, heading about 270° at the same altitude. He assessed that it would pass just in front, which it did, at about 50m away. He could not take any avoiding action as by that time he was in the stall. The Harrier was not seen to take any avoidance: he therefore assessed the risk as being high.

Cause: Effectively a non-sighting by the Harrier crew and a late sighting by the Firefly crew.

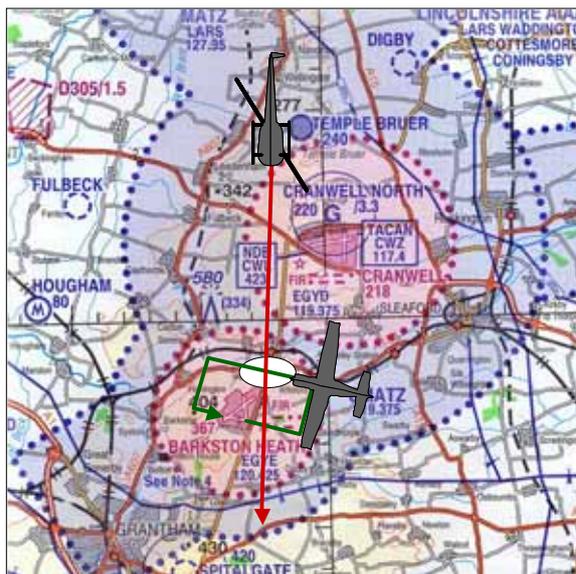
THE FIREFLY 260 PILOT reports that he was flying a 3rd circuit consolidation sortie at Barkston Heath with an ab-initio student as handling pilot who was focused on his spacing from the RW. As they rolled out downwind heading 290° at 90kt he saw a black helicopter approaching the circuit area from the N. He delayed taking control for about 5sec to see if the helicopter pilot took any avoiding action; as it did not he took control and avoided it by descending below its height. He was not at any time notified of the helo's presence. He reported the incident (although not as an Airprox) to Barkston TWR as he believes that had the student been solo, there would have been a high chance of a collision.

THE BARKSTON HEATH ADC reports that at 1109 she was pre-noted by Cranwell Radar that an R44 had requested to fly through their circuit at 1000ft. At 1113 she received a further call to inform her that the R44 was coming to her now and when clear of the MATZ it was to free call Cottesmore. She questioned the speed of the ac and was informed that it was slow moving. At 1113:58 the R44 called on VHF, just as she was completing the telephone call. She then transmitted simultaneously on VHF and UHF 281.225MHz (See UKAB Note (1)). She informed the R44 pilot that Barkston was using RW11, the QFE was 1010 and that there was one Firefly in the visual circuit. The R44 pilot responded by informing her that he was changing squawk to 7000; that he was visual

Cause: Cranwell ATC did not comply with the agreed procedures such that the R44 flew into conflict with the Firefly in the Barkston Heath cct.

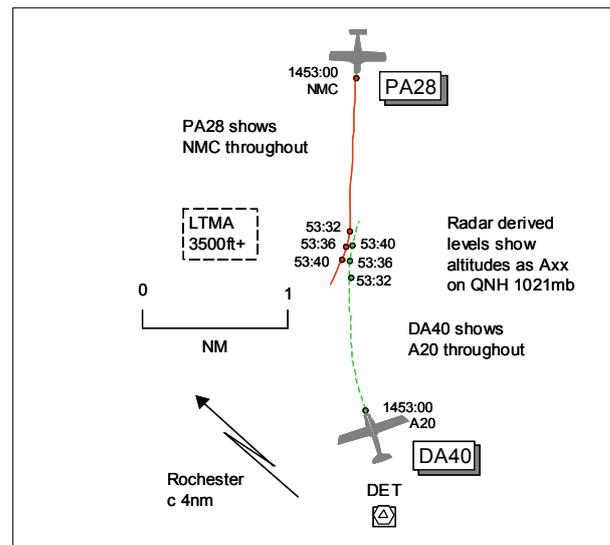
AIRPROX REPORT NO 034/07

THE DA40 PILOT reports flying a dual training sortie (exercise 18c Radio Navigation) from Rochester and in receipt of a FIS from Rochester on 122.225MHz squawking 7000 with Mode C. The visibility was 3-5km in haze and the ac was coloured white /red with strobe lights switched on. After departing Rochester they climbed to 2000ft QNH 1022mb and routed to DET on the 130°R before turning L onto the 360°R outbound. Heading 360° at 110kt and 2.8nm N of DET (1.5nm outside the ATZ) he was discussing and demonstrating a 'position fix' to the student. They were checking the DME and on looking forward they saw another single-engined ac about 1000-1500ft ahead on the reciprocal heading. Both he and the other ac's pilot simultaneously took action by banking steeply R to avoid collision, the ac passing within about 100ft (30m horizontally and 10ft vertically) of each other. He assessed the risk as medium. Apart from the variable visibility, the navigation exercise involved looking-in the cockpit for a position fix and this had resulted in a late sighting of the other ac and late avoiding action. The other pilot was not on the Rochester frequency so there was no communication regarding other ac in the locality.

Members agreed that with the weather conditions reported by the Met Office, the in-flight visibility would have been poor, as stated by the DA40 pilot - certainly marginal for flying under VFR. With the two distinct haze layers, one option for the pilots in this Airprox would have been to climb above the first layer whilst still being able to remain below the CAS base level and able to conduct their sorties where the visibility would have been better. GA pilot Members knew of the difficulties when trying to arrange the appropriate training exercise for students which are compatible with the Wx conditions that pertain at the time. Certainly, both of the subject flights being on dual training sorties (radio navigation and dual cross country) would have involved a lot of 'heads-in' but this should always be balanced with the need to maintain an adequate look out – cockpit tasks should be split into small bullets with each one interspersed with a lookout scan. However, Members were clear that the cause of the Airprox was down to a sighting issue as 'see and avoid' pertained at the time for this encounter in Class G airspace. In addition to the poor visibility was the small target aspect shown by each ac as they approached 'head-on'. This would have made visual acquisition difficult, with little or no relative movement across either pilot's field of view during their lookout scan.

Using data from both pilots' reports, there was a large difference in reported 'first sighting' distances. From the DA40 pilot's perspective, he was surprised by the appearance of the PA28 300-500yd ahead as he looked out, a very late sighting and this was a part cause of the Airprox. Meanwhile the PA28 pilot had seen the approaching DA40, he thought 1-2nm away, and turned R in good time to avoid. The radar recording reveals the PA28's turn taking effect slightly before the DA40's track shows any deviation. This led Members to opine that the sighting distance by the PA28 pilot was before the DA40 pilot's but at a distance less than he had reported and had occurred late into the proceedings - the second part-cause of the Airprox. With a separation distance shown as being <0.1nm at the CPA with both ac established turning R, the Board believed that although an actual collision had been averted, the subject ac had passed uncomfortably close whilst manoeuvring to the extent that safety had not been assured during the encounter.

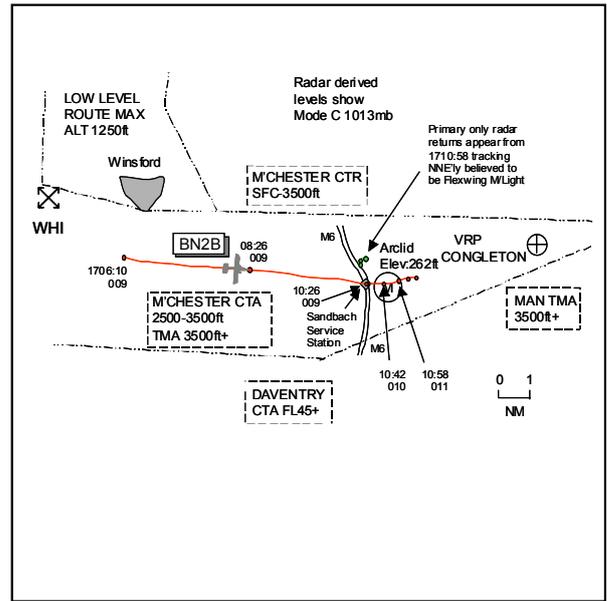
AIRPROX REPORT NO 035/07

Date/Time: 14 Apr 1710 (Saturday)
Position: 5308N 00220W (0.5nm W Arclid M/Light Site - elev 262ft)
Airspace: LFIR (Class: G)
Reporting Ac Reporting Ac
Type: Pegasus Quik BN2B
 Flexwing M/Light
Operator: Civ Trg Civ Comm
Alt/FL: 800ft 1200ft
 (QFE 1014mb) (QNH 1023mb)
Weather VMC CLOC VMC CLNC
Visibility: 15km 7km
Reported Separation:
 150ft V 50ft V
Recorded Separation:
 NR

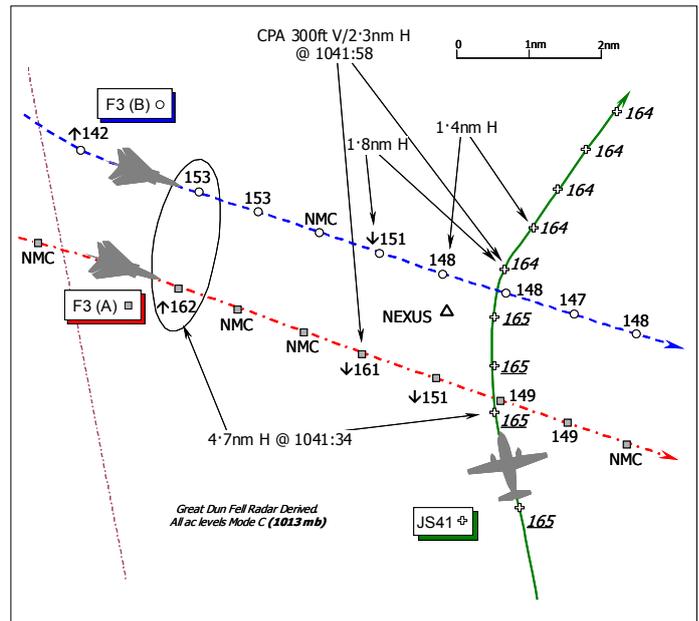
AIRPROX REPORT NO 036/07

ScATCC MIL CONTROLLER 4 (CON4) reports that he was working a JS41 routing from DTVA to Aberdeen under a RAS in a level cruise at FL165 tracking 350° approaching MADAD. A pair of ac climbing out from Leuchars had previously been noticed squawking A0201/0202 – the subject Tornado F3 pair - so he called Leuchars to co-ordinate the tracks. It was agreed with Leuchars APPROACH (APP) [co-ordinating on behalf of DEPARTURES (DEPS) 'by proxy'] that the F3 pair would not be above 15000ft TYNE RPS (1020mb) but as DEPS was in the process of handing the F3 pair to CRC Boulmer, the co-ordination would be 'passed on' to the CRC controller; he, CON4, was informed that the squawks would change to Boulmer's A5131/5132. As the F3 pair tracked closer to the JS41 he passed traffic information to the JS41 crew advising that the pair was coordinated not above FL155. Updated traffic information was passed as they closed to a range of within 19 miles; at this stage their Mode C indicated the pair was not above FL150. He then looked at his next expected ac and on returning his scan to the JS41, the Mode C of the lead F3 squawking A5131 [F3 (A)] was showing FL160 and climbing rapidly with the other element of the pair climbing through FL150. An avoiding action R turn was given to the JS41 crew and traffic information passed. The SUPERVISOR was informed who had also observed the incident and immediately called Boulmer. It was established from the fighter controller (FC) that his ac were indeed co-ordinated not above 15000ft TYNE RPS (1020mb) and that the pair had 'bust' their assigned altitude. The lead ac squawking A5131 reached FL170, before descending rapidly below FL155. The No2 - [F3 (B)] - squawking A5132 did not climb above FL153. The minimum horizontal separation was assessed to be below 2nm at the same level. Once 5nm separation was evident on radar, the JS41 was cleared to turn again for Aberdeen and he informed the crew as to what had occurred, advising them that he would be filing a report. When questioned whether the JS41 crew had received a TCAS RA, the pilot said that he had and he would be consulting with his Company.

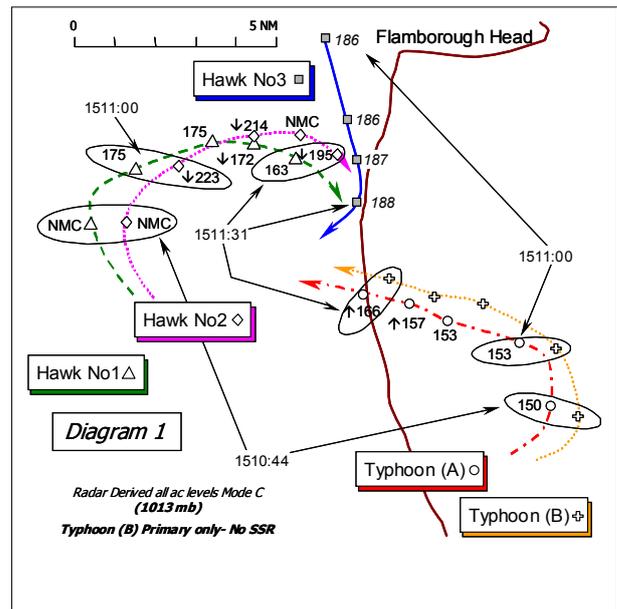
THE CRC BOULMER FIGHTER CONTROLLER (FC1) reports that he was controlling a 3-ship of Hawk ac in the Vale of York (VoY), operating within an altitude block of 7000ft – 24000ft TYNE RPS (1024mb). The weather in this airspace was good VMC and due to this the Hawk formation requested a RIS. The VoY was very busy and the traffic density caused him to have to 'knock-off' the first run. Furthermore, negotiations with various LATCC (Mil) control positions during all runs were increasing his workload further. Under guidance from his Fighter Allocator (FA), he limited the RIS but continued the sortie, pushing the intercept towards the coast where the traffic density was reduced. During the third inbound run the Hawks were aiming for a 'merge' in the vicinity of Flamborough Head. During this run, he observed an A6121 squawk [Typhoon (A)] about 10nm away heading towards their predicted 'merge' point and indicating 15000ft. When the Hawk crews were given a stranger warning under the RIS, they called "Tally, no threat well below" and continued into the 'merge'. At this point, as the A6121 track continued eastbound he felt that the ac was no longer a factor for the Hawks' merge.

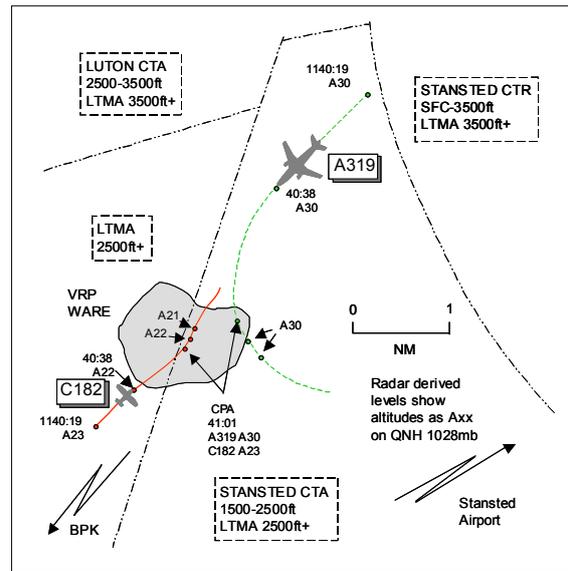
THE A319 PILOT reports that during vectoring for the ILS RW05 at Stansted heading 225° at 220kt just prior to turning base leg, they received a TCAS TA alert with traffic observed -700 and heading towards them. Almost simultaneously they received an RT call from Radar "avoiding action immediate left turn". The A/P was disconnected and bank angle was increased to slightly over 30° whilst turning onto the given radar heading. The A/P was re-engaged and the approach was continued to an uneventful landing. They were later advised by Radar that the other ac was uncontrolled GA traffic penetrating CAS. He assessed the risk as medium.

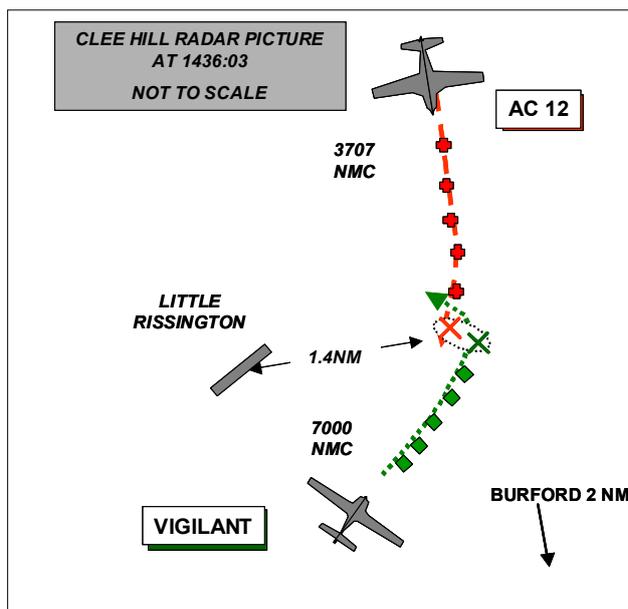
AIRPROX REPORT NO 039/07

THE VIGILANT T MK1 PILOT reports that he was flying an instructional sortie at Little Rissington with an Air Cadet Trainee who was undergoing visual circuit training, as handling pilot. They were in a white ac with day-glo wing-stripes, with all lights switched on and squawking 7000, but Mode C was not fitted. They were downwind in the circuit for RW23 LH, heading 050° at 60kt, when a light ac crossed the end of the base leg from the N to S, at considerable speed, to track along the Stow-on-the-Wold to Burford Road (A424). The conflicting ac was seen just prior to the trainee pilot initiating the turn onto base leg. He (the instructor) took control of the ac in order to prevent a head on conflict and was about to take avoiding action but before he could do so the other ac made a sudden avoiding action turn to its right, into the airfield boundary, followed by regaining the A424 through the downwind leg of the visual circuit. An RT transmission was made to Rissington Radio which prompted the Duty Instructor to telephone Brize Radar to see if they were in communication with the ac.

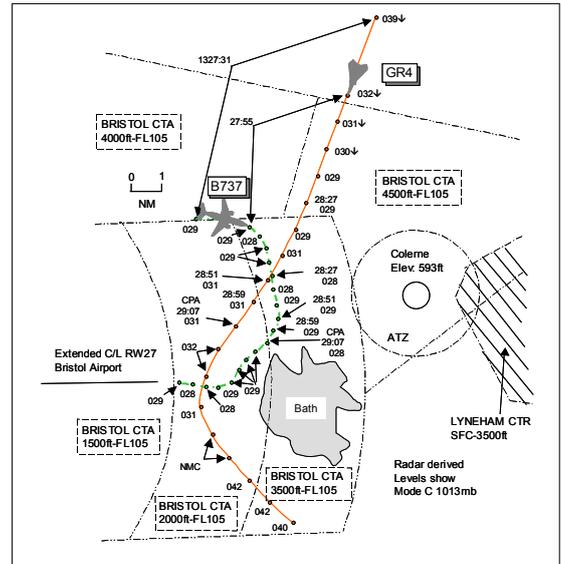
AIRPROX REPORT NO 040/07

THE B737 PILOT reports inbound to Bristol IFR and in receipt of a RCS from Bristol Approach squawking an assigned code with Mode S. Level at 3000ft QNH on base leg to RW27 they were surprised by a TCAS TA alert as they never expected proximate traffic in CAS whilst receiving vectors for the ILS. Although flying mostly in IMC, the fighter, a Tornado, became briefly visible as it crossed the LLZ ahead of them, the CPA was 200ft vertically and 0.5nm horizontally. ATC issued an avoiding action vector after the crew had advised the controller of the traffic but by then they were visual with it. They assessed the risk as high. Apparently the military ac was incommunicado whilst flying through the Bristol FAT.
