UK AIRPROX BOARD

Analysis of Airprox in UK Airspace

**Report Number 18
January 2007 – June 2007**

‘Analysis of Airprox in UK Airspace’

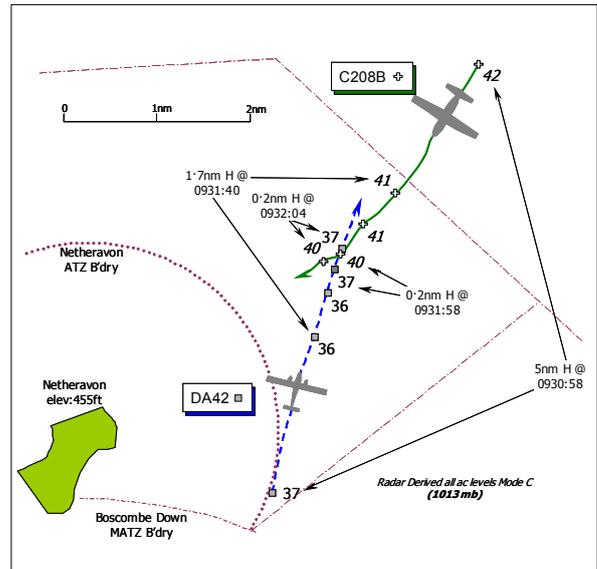
AIRPROX REPORT NO 041/07

Date/Time: 19 Apr 0932
Position: 5117N 00141W (3¼nm NE Netheravon Aerodrome - elev 455 ft)
Airspace: London FIR (Class: G)
Reporting Ac Reporting Ac
Type: Cessna 208B DA42 Twinstar
Operator: Civ Club/Trg Civ Trg
Alt/FL: FL40 3500ft
 QFE (1007mb)
Weather VMC CAVOK VMC NR
Visibility: 10+km 20km
Reported Separation:
 50-100ft V/nil H 100-200ft V/nil H
Recorded Separation:
 300ft V

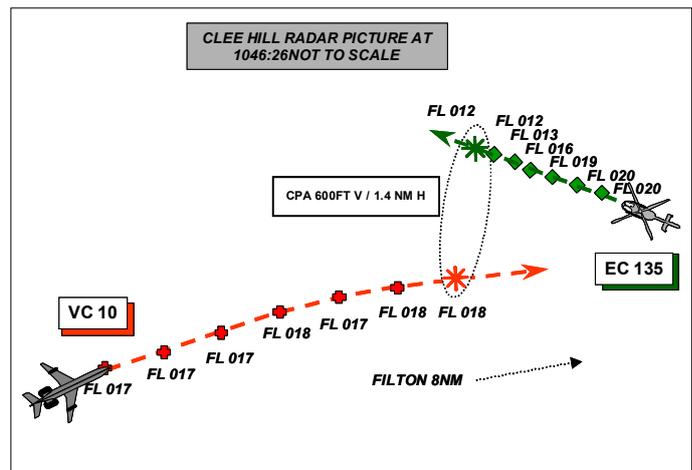
AIRPROX REPORT NO 042/07

THE EC135 PILOT reports flying a local training sortie in a red and yellow ac with HISLs switched on. He was heading 293° at 100kt on the outbound leg of a practice NDB/DME approach to RW09 at Filton, descending through altitude 2300ft at rate of descent 700ft/min, when he was warned by Filton Radar of high speed traffic approaching from the W at an altitude of 2000ft. On seeing the reported ac about 1nm away (he thought), it was apparent that it was on a steady bearing and that his level would very soon be co-incident with that of the other ac so he took control from the trainee pilot and increased the rate of descent to approximately 1500ft/min in order to ensure vertical separation from this traffic. The other ac appeared to make a shallow turn to its right as he passed through its level. He assessed the risk as being very high.

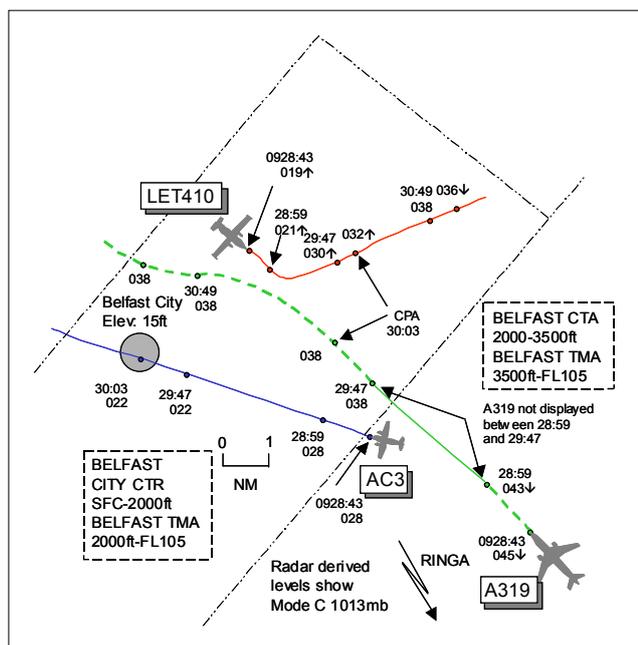
THE BELFAST/ALDERGROVE APR reports that the A319 was inbound level at 4000ft passing O/H Belfast City. Meanwhile the LET410 had been cleared to depart from City RW04 climbing 3000ft. The City APR told him that the LET410 had a problem with his navigational equipment and was therefore going to be on a heading of 165° as opposed to his clearance of direct RINGA at 3000ft: he, the Belfast/Aldergrove APR, agreed. The City APR also had a VFR overflight [AC3] at 2500ft which was going to be in conflict with the LET410. After the LET410 became airborne it was observed to be climbing towards the A319 and climbing above its cleared level so he told the A319 flight to turn away from the LET410 and maintain 4000ft whilst he tried to get the LET410 flight on his frequency. Whilst he did not use the phrase 'avoiding action', he would have had the LET410 not been turned away onto his heading that he had given the City APR.

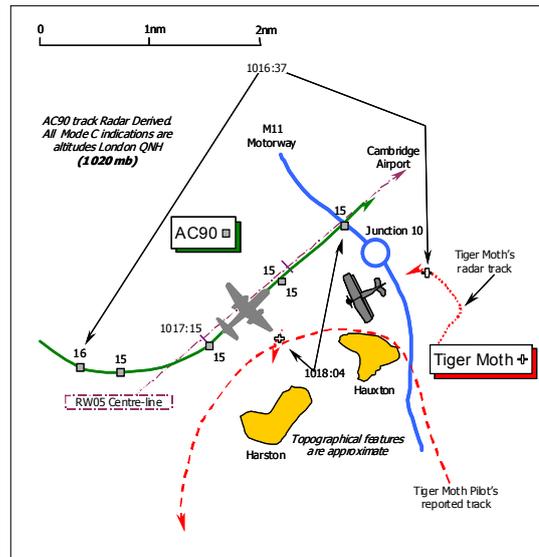
AIRPROX REPORT NO 046/07

THE AC90 PILOT reports that he was inbound to Cambridge under IFR and in receipt of a RIS, he thought, from Cambridge ATC. The assigned squawk was selected with Mode C; TCAS and Mode S are fitted. Whilst executing an NDB/DME approach procedure for RW05, heading 051°(M) at 140kt descending through 1500ft Cambridge QNH [1020mb] at about 4½nm from touchdown, shortly after gaining VMC after coming out of cloud he saw a yellow Tiger Moth at a range of 200m. The biplane passed down his starboard side, 'co-altitude', approximately 200m away and appeared to be in a 20° AOB L turn. No avoiding action was taken – it was seen too late – and although the risk was assessed as "low" he believes they were fortunate not to have been on a collision course when he came out of cloud. ATC did not know the Tiger Moth was there and he had no indication displayed on TCAS of the presence of another ac.

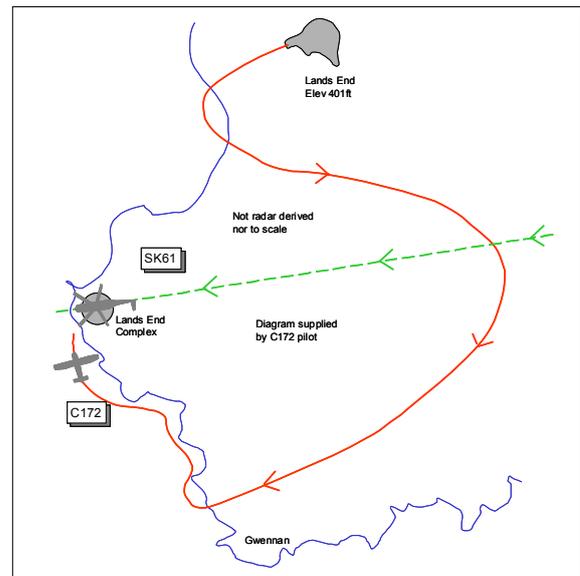
THE SK61 PILOT reports en route from Penzance Heliport to the Scilly Isles and in receipt of a FIS from Lands End Radio, he thought [actually Tower], on 120.25Mhz squawking 7046 (Culdrose Conspicuity code) with Mode C. The visibility was >10km in VMC and the helicopter was coloured red/white/blue with standard lighting plus anti-collision beacons all switched on. Lands End Radio told them of a Cessna which passed 2nm ahead R to L towards Gwennan Head (4nm S of Lands End aerodrome). The Cessna then turned back towards them, converging on what appeared to be a collision course, so he expressed concern to Lands End Radio. Approaching the coast, 2nm S of the Lands End Complex at 120kt and 1500ft St Marys QNH 1015mb, the controller called the Cessna pilot whose ac by now was 200-300m away at the same level. As they were about to take avoiding action, the Cessna banked R and passed behind. He opined that the Cessna pilot knew of his position at all times but this seemed to be a deliberate act which caused all of the flightdeck and cabin crew concern.

It was clear that both crews had seen each other throughout the encounter which occurred in Class G airspace where there was equal responsibility for collision avoidance through ‘see and avoid’. In the end and in accordance with the Rules of the Air Regulations, the C172 pilot visually avoided the SK61 - and this was stated on the RT - but the C172 pilot’s chosen flightpath had caused concern to the SK61 crew. This had caused the Airprox to be filed. Notwithstanding the requirements of the Rules of the Air Regulations, Members opined that a flight having right of way should not always assume that their ac has been seen by the other flight and should not leave any avoidance manoeuvre too late to resolve a potential confliction. In this case, the SK61 crew did confirm that the other ac’s pilot had seen their helicopter when the C172 was closing from their L. It appears that the C172 pilot was endeavouring to complete his ‘sight-seeing’ flight, affording his passengers a good view of the ‘Complex’ on their R, which may have introduced reluctance on his behalf to turn R early, behind the SK61. The GA Member opined that light ac pilots should be reminded that flying close to a helicopter, particularly large types, in any phase of flight was not a good idea, owing to vortex wake generation, and that any avoidance should be by a good margin.

Cause: The C172 pilot’s chosen flight path caused concern to the SK61 crew.

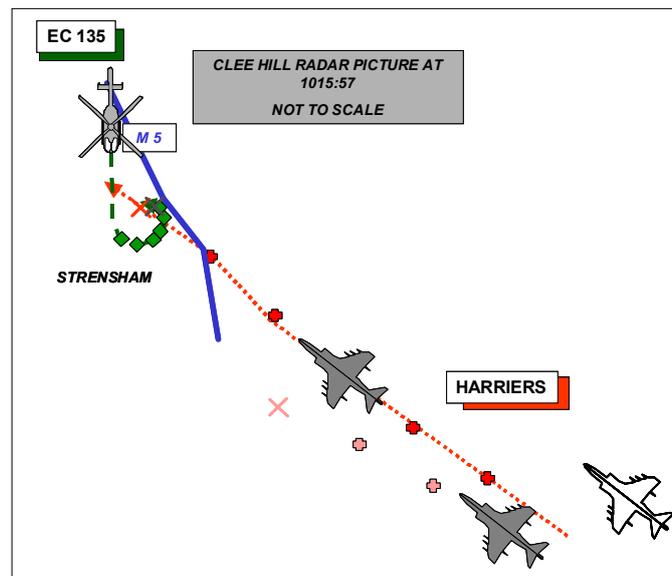
THE EC135 T2 PILOT reports that his ac is operated on behalf of the County Air Ambulance charity and that TCAS is not fitted.

HARRIER STN comments that in planning this sortie the crews of all 3 ac noted the presence of the HLS and ensured that their track did not take them directly over it. With the crews operating in 'open' airspace, under the see and avoid principle this incident reaffirms the need for all aircrew to maintain a good lookout. As the low flying chart lists the HLS as being informative and not an avoid, there is very little else they could have done to avoid the incident.

The Board noted that this incident took place near a published Helicopter Landing Site (HLS), in Class G airspace where see and avoid is the prime means of collision avoidance, the associated responsibility being shared equally between the pilots in accordance with the Rules of the Air.

Cause: Sighting report.

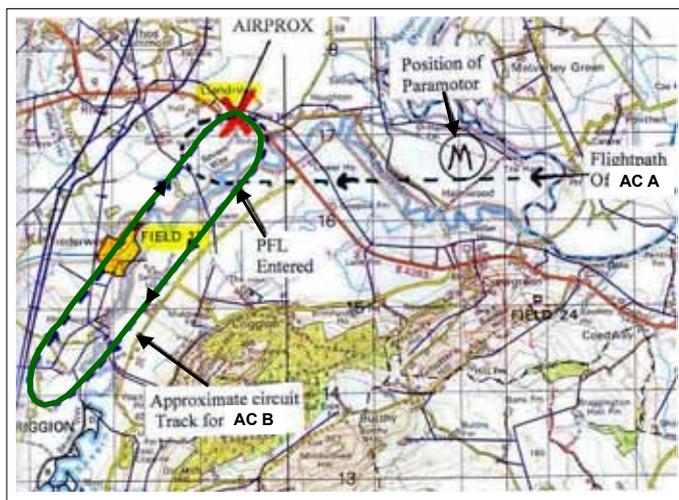
AIRPROX REPORT NO 050/07

THE GRIFFIN HT1 (A) PILOT reports flying a black and yellow ac with HISLs, landing lights and nav lights selected on, on a training flight with a student pilot. Following a formation section of the sortie, the 3 ac split to carry out individual GH. His ac (Griffin (A)) was climbed to 2000' amsl and positioned to commence a Practice Forced Landing (PFL) in receipt of a FIS from Shawbury and squawking 0221. The weather was hazy with a cloud base of about 2200ft amsl. They positioned downwind to fly a 180° PFL in a suitable area: however, a powered para-glider was seen operating at about 200-500ft agl in the selected area so they transited further downwind until they found another suitable area. The new position that they selected was about 1-2km NNE of the field where the formation had originally split as that field was still being used by the lead ac (Griffin (B)) for GH. He looked for the lead ac and saw it making an approach to the field and judged it safe to complete their PFL. The student pilot initiated the PFL, heading 070° at 70kt, and the instructor brought the throttles to idle in accordance with normal operating procedures. As they approached the site at about 500ft agl, the instructor commenced opening the number 2 throttle at the same time as the crewman called to overshoot and break left. The student pilot reacted to this call but with the throttles still not open the instructor had to block the collective and open the throttles fully before climbing away. As the instructor was seated in the LHS he did not see the other ac but the crewman informed him that an ac he thought to be Griffin (B) had passed behind and beneath them by about 100ft and rotor span displaced. The crew of the other ac apparently had not seen them at all. He assessed the risk as being high and reported the incident on landing.

Cause: A non-sighting by the crew of Griffin (B) and a very late sighting by the crew of Griffin (A).

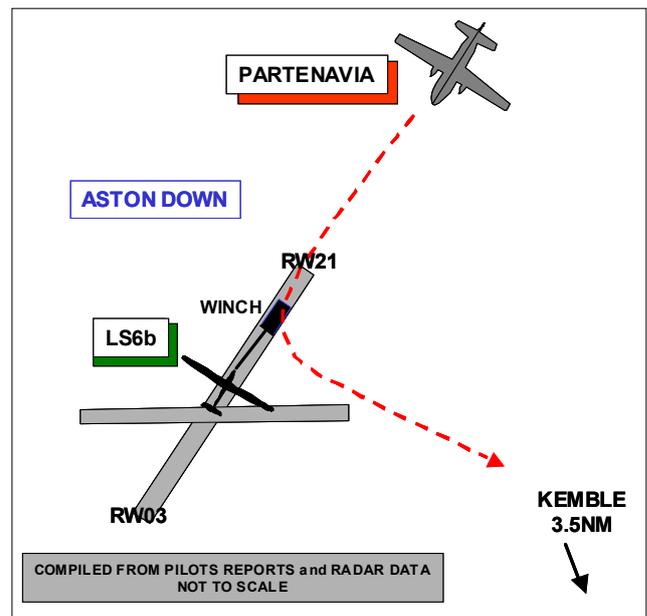
AIRPROX REPORT NO 052/07

THE LS6 GLIDER PILOT reports that he was launching by winch at 70kt to 1500ft agl in a white single seat glider from the S end of RW03 at Aston Down Airfield. The launch crew reported the sky clear above and behind and he saw nothing airborne ahead. The glider was approaching 1000ft agl in the normal winch launching attitude (nose up 45°) when observers on the ground noticed an oncoming twin-engined ac one mile away on the reciprocal course of 210° lined up on the RW, estimated (by the observers) to be at approximately 4-500ft agl. As the oncoming ac reached the threshold of RW21 it banked hard to the L above the winch and left the airfield in the direction of Kemble at the same height.

At that point he noted a glider about 300ft above and climbing. He also noted a winch wire (trailing from below the glider) and realised that he was approaching the wrong field so he executed a steep left turn to avoid going underneath the glider. He then called Kemble Radio and told them he had approached the wrong airfield and about one minute later they advised him that Aston Gliding had called them and so he asked them to apologise on his behalf.

There was no doubt that this had been a very serious incident that warranted a full investigation. The Board was informed by the specialist gliding Member - who was familiar with the incident - that there were several very experienced gliding instructors on the ground, all of whom witnessed the occurrence and corroborated the CFI's report which stated that the Partenavia had come very close to the winch cable. It was also pointed out that the winch driver at the time of the incident had been the CFI and that he had seen the Partenavia which necessarily meant that it had been forward of him - i.e. between the winch and the cable - as there is no visibility rearwards due to the structure of the winch cab. The specialist gliding Member was of the opinion that the Partenavia had actually been making an approach to RW21 at Aston Down, overshooting over/round the winch.

Cause: The Partenavia pilot entered a promulgated and active glider site and flew into conflict with the glider on a winch launch.

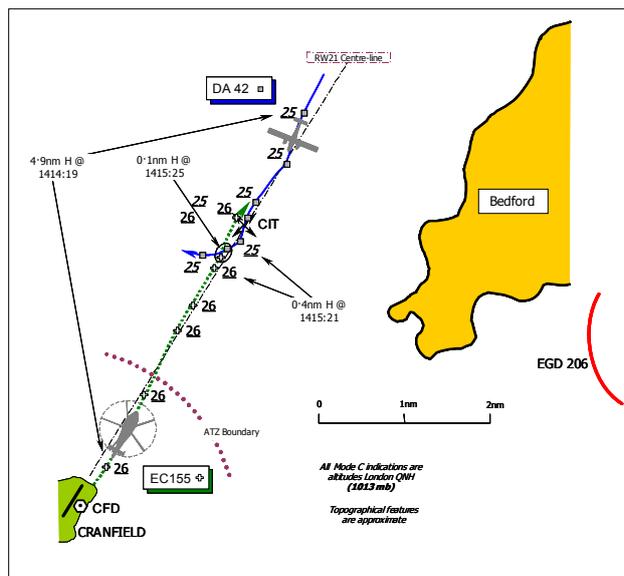
AIRPROX REPORT NO 053/07

THE EC155 B1 HELICOPTER PILOT reports he was in transit under VFR direct from COMPTON (CPT) VOR to the CRANFIELD (CFD) VOR, en-route to Norwich. Whilst in contact with Cranfield APPROACH on 122.85MHz he was receiving a FIS, flying in VMC some 400ft clear below cloud with an in-flight visibility of 10km. A squawk of A7000 was selected with Mode C. TCAS is not fitted.

It was evident to the Board from the comprehensive report helpfully provided by ATSI that this Airprox stemmed from a misunderstanding by APP of the EC155 crew's routeing. The report had made plain the controller's mistaken belief that the helicopter would fly to the Cranfield overhead, then turn R to route out S of Bedford town towards Norwich. This misunderstanding was fundamental to the cause, despite the helicopter crew reporting that they were "...en route to Norwich remaining just north of Bedford at 2600 feet...". Believing therefore that the EC155 would be remaining S of the CIT hold, no traffic information was passed either to the EC155 or the DA42 crews about each other's ac. It was clear that the combined APP/TOWER controller did not have the benefit of radar to assist him in formulating his mental model in this procedural APPROACH CONTROL environment. Nevertheless, even turning from overhead the aerodrome directly eastbound would have placed the helicopter just over 3½nm away from the CIT to which the DA42 crew were flying their procedure. Moreover, both ac were operating within 100ft of one another's altitude so it was surprising that the controller had missed the conflict. Whilst the helicopter crew's stated routeing should have been plain to APP, this Airprox illustrated well the absolute necessity to ensure that intentions are made as straightforward and as clear and unambiguous as can be: crews accustomed to operating under a radar service should be in no doubt of the difficulties that can ensue when operating in a bare procedural ATC environment. Thus no traffic information was forthcoming, which the ATSI report had shown the DA42 crew could reasonably have expected from APP as is required by national procedure. In the Board's opinion this was the crux of the issue and it was concluded that this Airprox was caused because the Cranfield combined APPROACH/TOWER controller misunderstood the EC155 crew's route and did not pass traffic information to either flight about the other.

For the helicopter pilot's part, it was clear that whilst working APP he was operating VFR in Class G airspace, unconstrained by promulgated IFR procedure levels where 'see and avoid' also prevails. Flying at an intermediate altitude of 2600ft, rather than transiting at a level equating to whole 500ft or 1000ft intervals was a wise precaution – apparently common practise amongst helicopter crews, a Member observed – but nevertheless demonstrating sound airmanship and a good lesson worth highlighting here for the benefit of others. This probably provided the only inherent vertical separation as the radar recording evinced that the DA42 was operating exactly at the promulgated altitude as the instructor pilot ensured that his student was flying the procedure accurately. Thus it was left entirely to both crews' visual scan to sight one another's ac and then afford appropriate separation. Whilst some would contend that the EC155 crew spotted the DA42 at a late stage at the reported range of 1nm, the helicopter pilot's account reveals he had time to take avoiding action by turning and climbing. Although the climb is not reflected by the radar recording the Board was briefed that a later conversation with the EC155 pilot had revealed that this was a short duration climb – only about 50ft – so given the limitations of Mode C this would not have been readily apparent on the recording. Nonetheless, he managed to climb above the twin but it was not until he passed directly above the DA42 that the latter's instructor safety pilot – also engrossed in monitoring his student's turn outbound - saw the helicopter but too late to take any action. Effectively, this was a non-sighting on the DA42 instructor's part: however, he had commented about the efficacy of the IF screens. In his view, this was a major contributory factor so Members were reassured that action was being taken to improve the design of the IF screens. Fortuitously, the radar recording showed that 100ft of vertical separation existed when the contacts merged. In the Board's view, therefore, the EC155 pilot's sighting and avoiding action was just in time to prevent an actual collision, but at these close quarters with only one crew able to take avoiding action Members agreed that the safety of the ac involved had indeed been compromised.

Cause: The Cranfield combined APPROACH/TOWER controller misunderstood the EC155 crew's route and did not pass traffic information to either flight about the other.

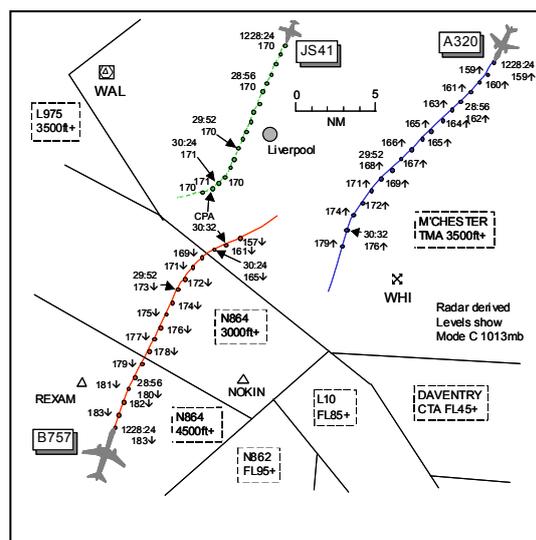
THE JS41 PILOT reports heading 215° at 288kt cruising at FL170 under a RCS from MACC on 124.05MHz squawking with Mode C. As a TCAS TA was received in their 12 o'clock range 6nm at FL162 descending, ATC told them to "turn R now". They were unable to respond to the call owing to radio congestion and looking for the traffic but the Captain, PF, disconnected the A/P and started the R turn. ATC called again, instructing them to "turn R now onto heading 270°" and during the turn they saw a low wing twin engine jet descending through their level passing 1500-2000m clear on their LHS. He assessed the risk as high.

owing to the A320, he had twice turned the B757 for a more direct routeing to Leeds and also turned the JS41 which resulted in the subject ac being on conflicting flightpaths: the controller was now basing his provision of separation on ac performance. Pilot Members noted that the B757 flight profile (low ROD) was indicative of the ac being below the VNAV profile whilst trying to manage a CDA into Leeds. That said, the ac's calculated ROD 1min before and 1min after ATC requested the flight to 'increase ROD' shows a marginal rise but not in line with what the controller was expecting. Thereafter, the B757's ROD shows a marked increase after being given avoiding action. ATCO Members agreed that the WALSY TC should have used the word 'expedite' to elicit the appropriate response from the B757 crew to ensure that his intended plan was fulfilled. The TC had then commenced handing over the Sector which had taken his attention away from the traffic situation. ATCO Members agreed that with the controller relying on ac performance, he should have monitored the traffic situation more closely to ensure that his plan was going to work, possibly before commencing the handover. These events led Members to assess that the cause of the Airprox was that the MACC WALSY TC had vectored the JS41 and B757 into conflict.

Looking at risk, the TC had seen the deteriorating situation at about the time he was warned of it both by a colleague and STCA. He had issued avoiding action turns to both flights and TI to the B757 crew who reported seeing the JS41. The JS41 crew had received a TCAS TA on the approaching B757 when the controller had given them an immediate R turn which was repeated with 'avoiding action' phraseology when no response was received to the initial call. The JS41 crew had reported seeing the B757 passing 1500m away although the radar recording shows the ac passing 3.6nm away and 1000ft below. Both flights had executed their turns promptly as well as the B757 descending more rapidly during the turn. All of these elements when combined were enough to allow the Board to conclude that any risk of collision had been quickly and effectively removed.

Cause: The MACC WALSY TC vectored the JS41 and B757 into conflict.

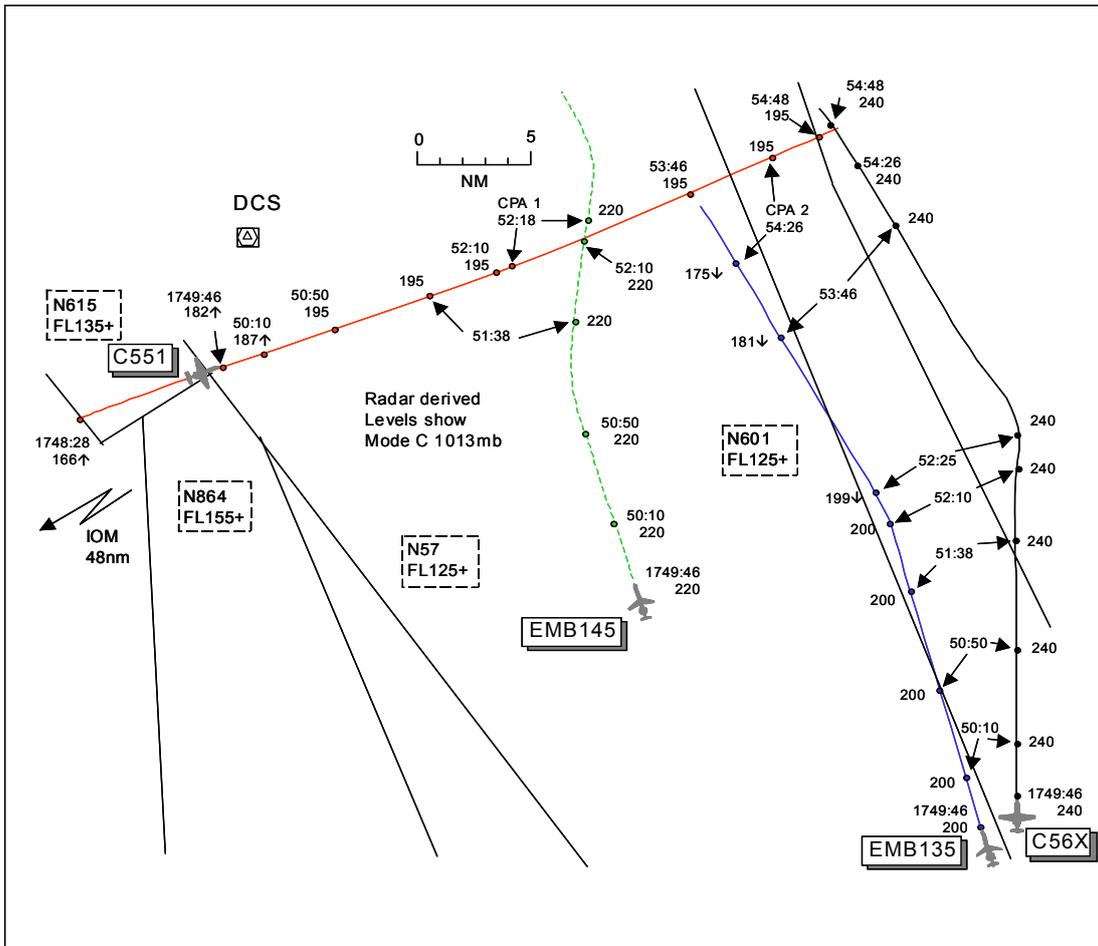
AIRPROX REPORT No 055/07

Turning to the piloting aspects, it was clear that the cause of this Airprox was the C551 pilot had entered Class A CAS without clearance. The pilot had planned his flight using an electronic VFR planning tool but had assumed that cruising at FL195 was above the CAS structure. However, the ac's radar return can be clearly seen crossing the boundary of the Class A airway N615 to the SW of DCS climbing through FL166 prior to levelling-off at FL195. Members agreed that this whole incident had been as a result of inadequate pre-flight planning by the C551 pilot, who had shown a poor appreciation of UK airspace. The C551 pilot's chosen cruising level had, in fact, placed the ac at the upper level of Class A CAS, with Class C airspace commencing above FL195. Even a cursory review of a chart would have revealed to the C551 pilot that a positive ATC clearance was needed to fly within this airspace whilst transiting towards Newcastle at that level. Moreover his IFR flight plan should have commenced at the boundary of Class A CAS to the SW of DCS.

Cause: The C551 pilot entered Class A CAS without clearance.

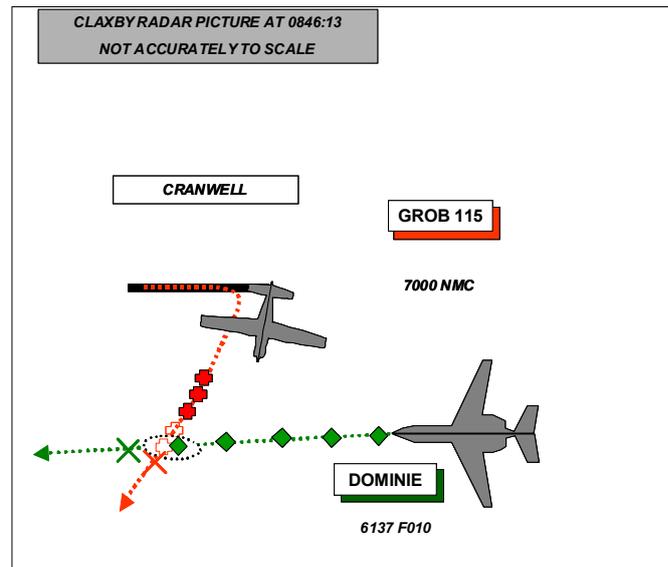
AIRPROX REPORT NO 056/07

THE DOMINIE T MK1 PILOT reports that he was conducting a pre-notified Engine Failure After Take-Off (EFATO) to join the visual circuit and then overshoot and depart on a SID. At some point after initiating the simulated engine failure, ATC informed him there was a light ac 'crosswind'. On rejoining the circuit at 1000ft QFE [having extended upwind to handle the simulated engine failure] he did not see the other ac; while continuing to look for it, he called "downwind sim asymmetric to overshoot and depart SID 2". He was part way through the pre-landing checks, heading 265° at 160kt, when the Grob suddenly appeared in his 12 o'clock, very close, so he took immediate avoiding action. He pushed hard, descending to between 700-800ft QFE. Since the other ac did not appear to take any avoiding action, he thought its pilot had not seen their ac.

HQ AIR (TRG) comments that the departure profile of the Grob did not conform to the Cranwell FOB or the ADC's expectations. The new procedures introduced by OC Ops will mitigate the risk of similar Airprox occurring in the Cranwell circuit. In VFR conditions, when safety margins have been eroded, for whatever reason, nothing can take away the value of good lookout to help avoid the mid-air.

There was much discussion regarding the coincident use of UHF and VHF frequencies and notwithstanding the Station comment, most Members considered this to be have been a significant factor. This procedure not only denied both pilots vital items of information but it significantly increased the workload on the trainee controller, possibly to the extent that he had to 'loadshed' and was making errors. Advisors explained that there were technical difficulties that prevented UHF/VHF cross coupling at RAF airfields but several experienced controller Members considered this a significant deficiency resulting not only in pilots receiving a degraded air picture but also placing a marked increase on controllers' workload. One SATCO Member said that he considered this to be such an important factor that he discourages the practise at his unit.

Military and civilian controller Members expressed surprise that the mentor (screen) controller did not step in and take control when it was apparent that the trainee was becoming overloaded, resulting in errors and omissions (possibly caused by working simultaneously on 2 frequencies). Such an intervention, controller Members thought, might have prevented the incident.

The Board spent some time in trying to analyse the cause of this incident to get to the root cause. One opinion was that the Dominie – as the overtaking ac - had flown into conflict with the Grob and another that the Grob pilot had caused the Airprox by departing in an unauthorised and un-notified manner (Members did not consider an e-mail to be an appropriate way to notify ATC of departure details as there is no assurance that it will go to the controller concerned (in this case it did not)). It was the Board's unanimous view that the Dominie pilot had a responsibility to see and avoid the Grob; he had been warned of its presence, albeit not its altitude albeit its position (passed as being *'just turning crosswind'*) was not totally accurate. For whatever reason, possibly due to the ac's turns or the poor cross-cockpit view from the Dominie, its pilot did not see the Grob until late. Ultimately he did, however, see and avoid it by a reasonable margin. The Grob pilot on the other hand, departed the airfield in a manner contrary to the procedures published in the Station FOB and therefore his actions were unexpected by both the controller(s) and the Dominie pilot. Without the benefit of TI or from hearing any RT transmissions made by or to the Dominie pilot, the Grob pilot was not warned of the latter's presence and presumably did not direct his attention and lookout towards it; he therefore did not see it as it approached and overtook from behind his left wing at the same altitude. Although there was considerable sympathy with the Grob pilot's situation, the Board concluded that his chosen departure track, and his selected altitude as he passed through the downwind position of the circuit, had been the principal cause of this incident and had caused an erosion of normally accepted safety standards.

Cause: The Grob pilot departed in a non-standard manner and flew into conflict with the Dominie.

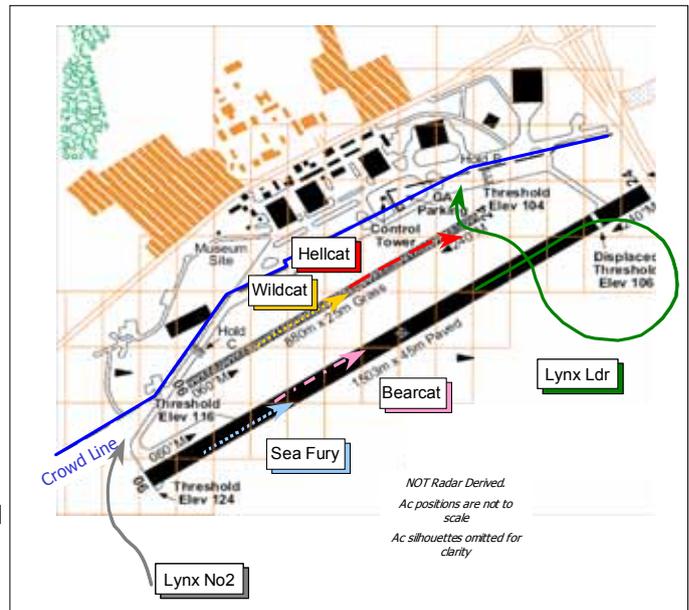
AIRPROX REPORT NO 059/07

THE WESTLAND LYNX HMA Mk8 HELICOPTER PILOT reports that he was leading a pair of grey Lynx helicopters during a flying display at Duxford and in communication with the FISO - C/S Duxford DISPLAY - on 132.9MHz. On completion of their part of the display, he as the lead pilot executed a 'wingover' manoeuvre onto a heading of 260° to clear the display line and reposition for landing to the NE of the grass RW06 at <40kt when his Observer (Navigator) in the LH front seat noticed the Grumman Hellcat rotating from the grass RW and ordered the pilot to "break right". He complied immediately and 'broke' R at 50ft aal as the Hellcat passed to the L of his helicopter at an estimated distance of 30-90m at the same height, but because of the nose-up attitude of the Lynx in the 'flare', he as the lead pilot was not visual with the Hellcat at any stage. He perceived that the Hellcat pilot took no avoiding action and in his view "extreme danger" existed with a "high" risk of a collision.

CINCFLEET comments that there are a few areas that may merit further investigation. Firstly, did the lack of positive Air Traffic 'Control' for this air display contribute to the Airprox? Allowing the Hellcat pilot to interpret when it was safe to take-off led to the incident. Secondly, in such circumstances, is the Display Director supervising the FISO? If so, is this safe? And in this instance, was there a failure of Supervision.

Following their assessment of the Cause and Risk, there was considerable debate by the Members over the level of 'Air Traffic Control' exercised during such large displays, as had been commented on by C-in-C Fleet. The Board considered whether or not a more positive Aerodrome Control Service, provided by a licensed ATCO, would be a worthwhile safeguard during an intensive air display scenario, such as this, and preferable to the unconventional FIS provided in this case. The Board was advised by ATSI that this subject had arisen in the past, when the topic of passenger carrying pleasure flights was examined. Here, standard aerodrome/cct 'information' was understandably not provided in this display scenario, but it is understood that some FISOs involved at air shows are themselves qualified ATCOs from other ATSUs. Evidently, no one in the Control Tower had stepped in on RT to warn either of the pilot's – either the FISOs or the Display Director who was monitoring the RT - when a cautionary warning could have been warranted after the Hellcat pilot reported "rolling". Clearly the Board was not being at all disparaging whatsoever about the service provided by FISOs, merely pointing out the limitations of what a FISO is empowered to do. Nevertheless, if positive ATC had been in force then the Hellcat stream take-off would have been subject to a take-off clearance, which an ATCO, with an overall view, would not have issued unless the Lynx had been clear. There were clearly arguments for and against this; many air shows operated very efficiently with the benefit of an ATCO able to take charge and issue 'instructions' to pilots in the air and thereby avert potential difficulties. A Member quoted two aerodromes that normally provide a FIS where he is the Display Director at an annual air show, but an ATCO is co-opted as an ADC and provides the additional safety net of an Aerodrome Control Service for the period of the display. Alternatively, the Board recognised that many large air shows - such as Duxford – have operated very efficiently for some years under an AFIS. Fortunately, air displays figure little in Airprox statistics and here the Board stopped short of making a Safety Recommendation on the basis of this singular risk-bearing event.

Cause: Having misinterpreted the face-to-face briefing with the Lynx Formation leader, the Hellcat pilot took-off into conflict with the lead Lynx helicopter.

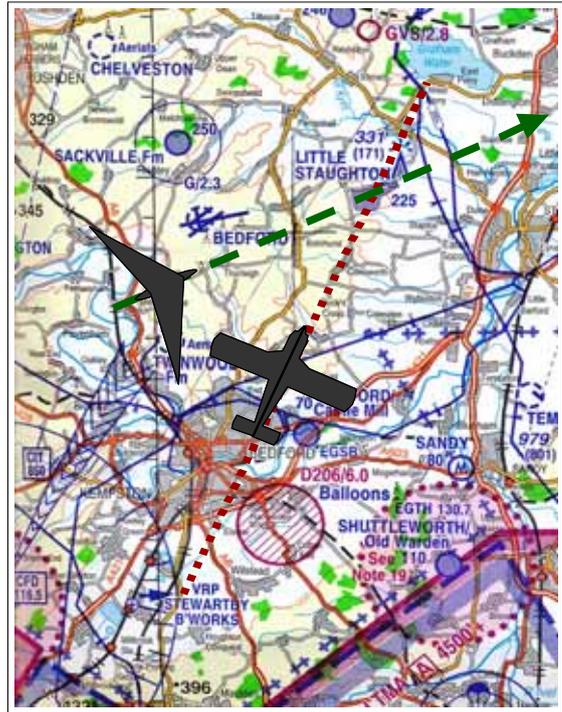
AIRPROX REPORT NO 060/07

THE PEGASUS MICROLIGHT PILOT reports that he was flying a yellow and white flexwing microlight, with no radio fitted, from Craysmarsh Farm in Wiltshire to Sutton Meadows in Cambridgeshire as personal training for future long distance microlight flights in another country. He had checked the NOTAMs and the forecast weather prior to the flight as there had been high winds and rain for several days preceding. He took off at 1548 and established a track of 060° flying at 65mph until reaching Didcot. His next track was 030° to Milton Keynes where he changed back to 060° for the remainder of the flight. (Planned route and a GPS trace were provided). The cloud base was variable between 3 and 4000ft.

The Board noted that both ac were flying VFR in Class G airspace and therefore the pilots had an equal and shared responsibility to avoid collisions, primarily by the see and avoid principle. In this incident the PA28 pilot did not see the Microlight and, although the Microlight pilot saw the PA28, his sighting was too late for him to be able to take any meaningful avoiding action. Although the Microlight pilot was busy and preoccupied with his navigation in the period leading up to the CPA, the PA28 instructor reported that he was not busy but might have been looking across the cockpit instructing his student. The microlight was being overtaken and the ac were virtually on a line of constant bearing: also, by happenstance, they were at roughly the same altitude of about 2800ft agl so sighting would have been difficult. Fortunately however the ground tracks of the ac were such that they were separated by about 50m; although uncomfortably close, there had not been any collision risk but normal safety standards had been compromised.

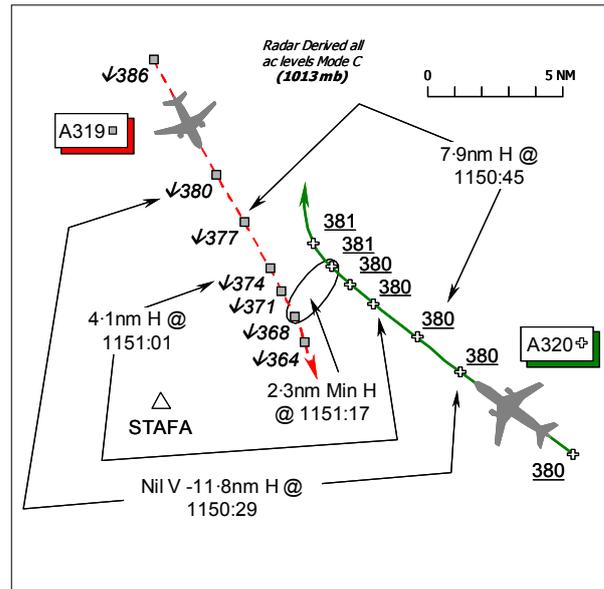
AIRPROX REPORT NO 062/07

THE A320 PILOT provided a brief account reporting that he was in transit for Dublin in a level cruise at FL380 in VMC at 425kt, in receipt of a RCS from London CONTROL on 132.86MHz. Heading 300°, he thought about 20nm SE of PENIL, a low wing ac – first sighted some 10nm away – passed about 3nm down the portside after it had crossed diagonally ahead from R – L some 400ft below his ac. LONDON CONTROL issued avoiding action of a R turn onto a heading of 360°. He assessed the risk as “medium”: both ac were at the same level and the other ac was under control on a different frequency.

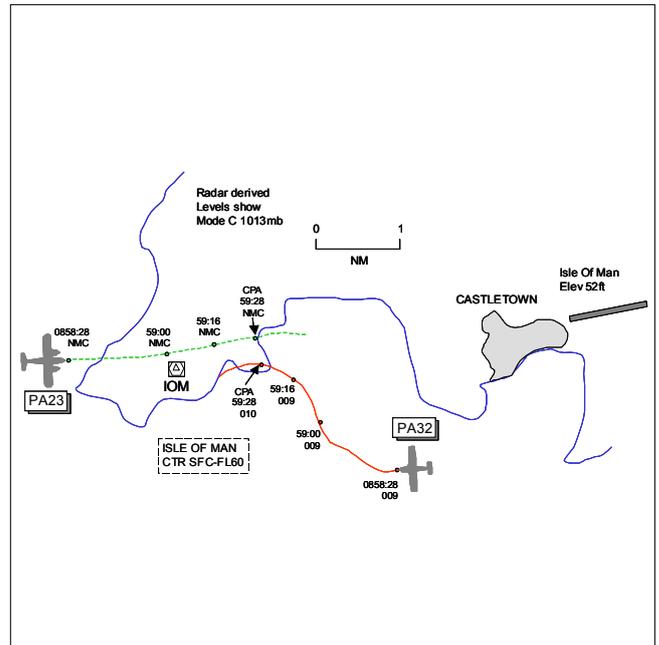
THE IOM APR reports that the inbound IFR PA23 was established on the ILS and had been transferred to Tower. The inbound VFR PA32 was heading 245° for sequencing and maintaining VMC. He told the PA32 flight *“you are No 2 to a PA23 just coasting in O/H the I-O-M, do you have the traffic in sight”*. The pilot replied *“Affirm”* to which he replied *“Roger, you are No 2 to that ac, follow it in”*. Another flight called on frequency before he noticed that the PA32 was turning towards base in front of the PA23. When the frequency was clear he transmitted *“PA32 c/s avoiding action turn L heading 180° immediately”* believing that this was the best direction of turn owing to the ac’s track and other traffic in the vicinity. The PA23 was approx 1000ft QNH as he was 3nm final RW08 on the ILS (but NMC) whilst the PA32 was indicating 1200ft QNH. He estimated the subject ac came within 0.5nm and 200ft of each other.

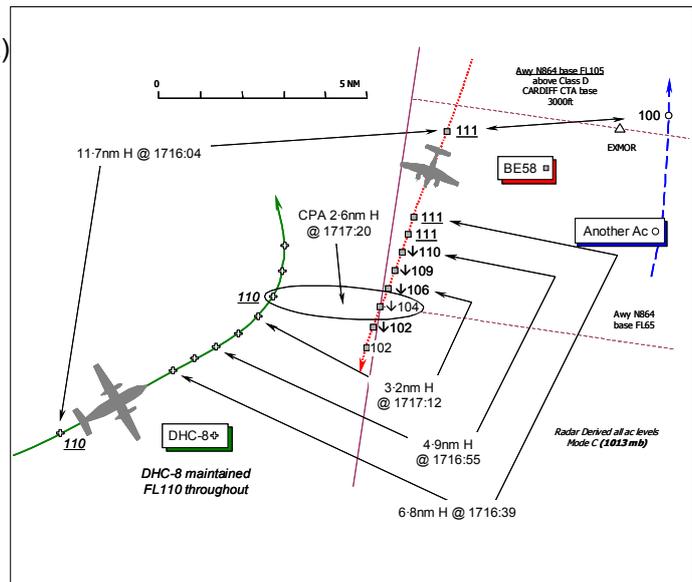
THE CARDIFF APPROACH RADAR CONTROLLER (APR) reports that at the time of the incident the RADAR 1 & 2 positions were 'bandboxed' together as RADAR. He assessed the workload as medium but he stressed an ATSA was present.

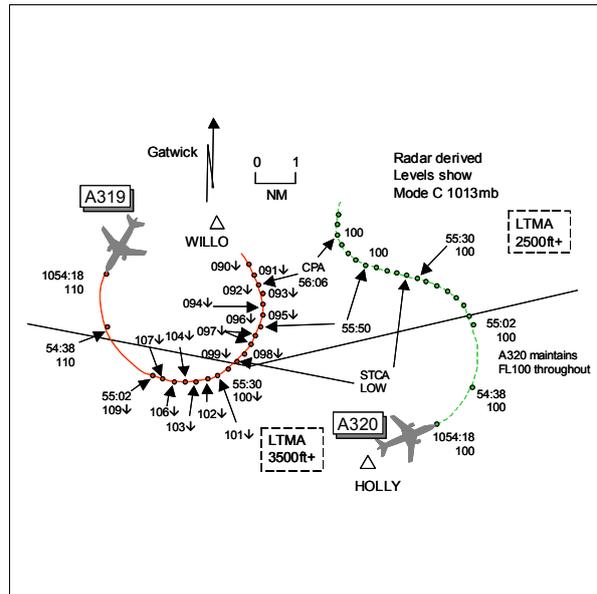
AIRPROX REPORT NO 065/07

THE A320 PILOT reports heading 290° at 210kt inbound to Gatwick IFR and in receipt of a RCS from Gatwick Approach/Director on 126.825MHz squawking with Mode S. Whilst established in the WILLO Hold at FL100 and having just completed the inbound turn back to WILLO, they received a TCAS TA on traffic showing in their 10 o'clock range 3nm which was perceived to be also established in the hold at the same level but descending. However it quickly became apparent that the traffic was on a NE'ly course towards them. Almost immediately ATC issued an instruction "A320 c/s avoiding action turn R heading 360°" but this instruction was not acknowledged immediately as they were carrying out the avoiding action manoeuvre using 40° AOB. ATC repeated this instruction and following completion of this manoeuvre, the other ac was seen on TCAS to pass close behind (within 1-2nm and 700ft vertically below). Once clear of traffic normal ATC instructions were resumed. The other ac was not seen visually as they were only 100ft above a cloud layer but with >20km visibility.

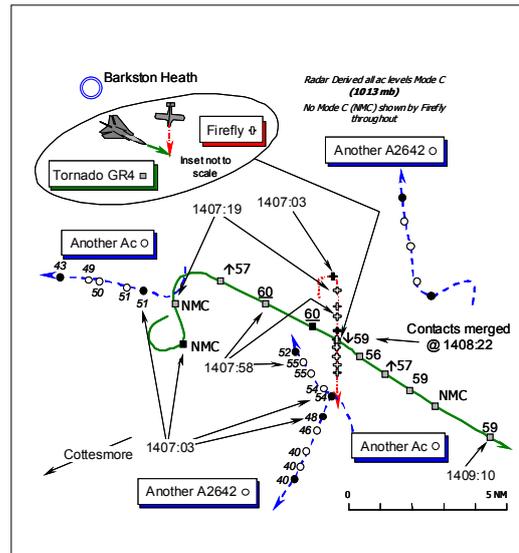
THE TORNADO GR4 PILOT reports that he was inbound to Marham VFR and in receipt of a RIS from LATCC (Mil) squawking the assigned code of A6113 with Mode C. Neither TCAS, Mode S nor any other form of CWS is fitted.

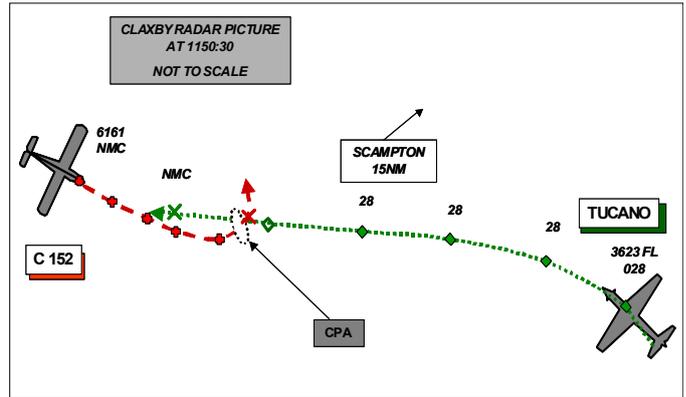
AIRPROX REPORT NO 067/07

THE TUCANO T MK1 PILOT reports that he was conducting a pilot training sortie practising an IFR approach to RAF Scampton, in receipt of a RIS from Waddington APR and squawking as directed with Mode C. At the time of the incident they were in the Scampton Tacan Hold at 3000ft on the QNH of 1020mb, heading 285° at 180kt when APR passed TI on a contact passing from left to right with no height information. Both pilots then looked into the area but no ac was seen. TCAS then gave a TA with no height, so both pilots again looked into that direction but still nothing was sighted. An ac, identified as a white Cessna 150, then appeared in the 10 o'clock high position and passed approximately 200ft above. A brief message was passed to ATC. No avoiding action was taken and he assessed the risk as being medium.

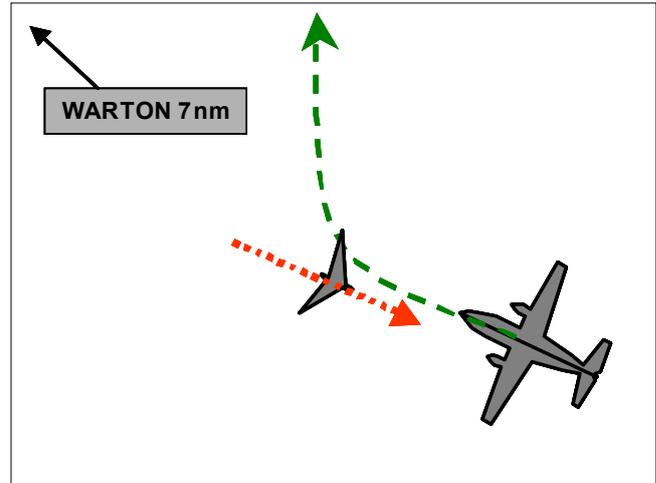
THE JETSTREAM (JS) 31 PILOT reports flying a non scheduled passenger flight from Marham to Warton with all lights switched on. They were in good VMC, squawking as directed and were in receipt of a RAS from Warton Radar. Shortly after they had been cleared direct to Warton for visual approach they descended from 3500ft heading NW at 230kt towards R base when the FO pointed out traffic on the nose less than 1nm away. The traffic was difficult to see due to the position of the Sun. A hard 40° AOB avoidance turn to the right and a 1½ G pull-up were performed, arresting the descent. A white-winged microlight was seen to pass down the left side slightly below. During the turn APR informed them that the TWR could see traffic visually in their area. Warton APR then informed them that nothing was seen on the radar. The separation from the Microlight was such that they could see the pilot and wing support wires clearly.

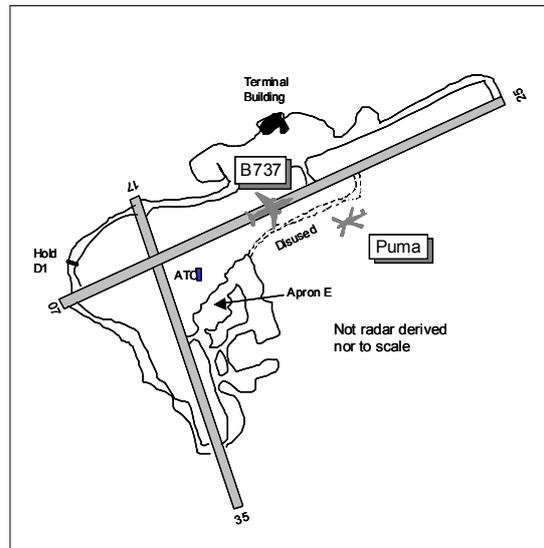
THE B737 PILOT reports outbound from Belfast RW07 and in communication with Tower on 118.3MHz squawking 7701 with Mode S. They were cleared for take-off with a helicopter in sight whose crew had been told to remain S of the Control Tower. They accepted the clearance with the helicopter in the cct, it being about 1nm from their position. During the take-off roll the Puma turned to complete his cct back to the apron S of the Control Tower and whilst it was downwind its crew were again told to remain S of the Control Tower. As the B737 reached rotation speed of 135kt the Puma was in their 2 o'clock position at 400-500ft but not S of the Tower having overshot his turn towards the Apron. It was only at this late stage did they realise that an Airprox would occur, the Puma passing 200m laterally to their R and 400ft above. The helicopter was behind them by the time they climbed through its level. They assessed the risk as medium.

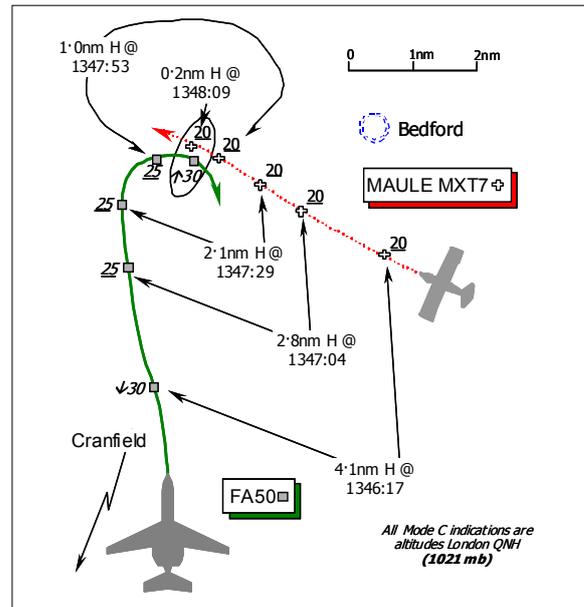
AIRPROX REPORT NO 071/07

THE FALCON DA50 (FA50) PILOT reports he was inbound to Cranfield from Palma de Mallorca, operating under IFR. Cranfield APPROACH (APP) was providing an ATS on 122.85MHz during the approach and the assigned squawk was selected with Mode C. Mode S & TCAS are fitted. Whilst flying the Cranfield NDB to ILS procedure for RW21 at 160kt, turning R though 120° onto the LLZ [at a position 010° CIT 7nm] level at 2500ft Cranfield QNH and IMC in cloud, a TCAS CLIMB RA was enunciated. Another ac was displayed on TCAS at 2100ft from a range of about 1nm; the RA was complied with and he executed a go-around into a further successful approach. The other ac was not seen at all and minimum vertical separation displayed on TCAS was 400ft. He assessed the risk as “high” and added that no information about any other traffic had been provided by APP.

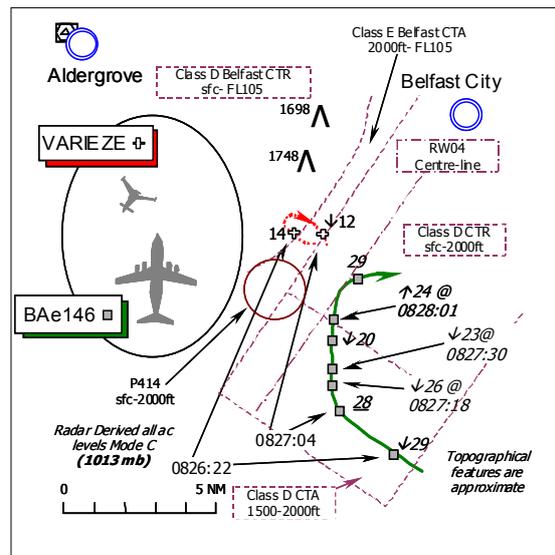
THE BAE 146-200 PILOT reports he was inbound to Belfast City from Birmingham and was approaching the Airport from the S for the LLZ/DME procedure to RW04. He was in receipt of a RCS from Belfast City APPROACH on 130.85MHz whilst flying IFR, in cloud, with no in-flight visibility at all. A squawk of A3277 was selected with Mode C. Navigation lights HISLS and landing lights were all selected on.

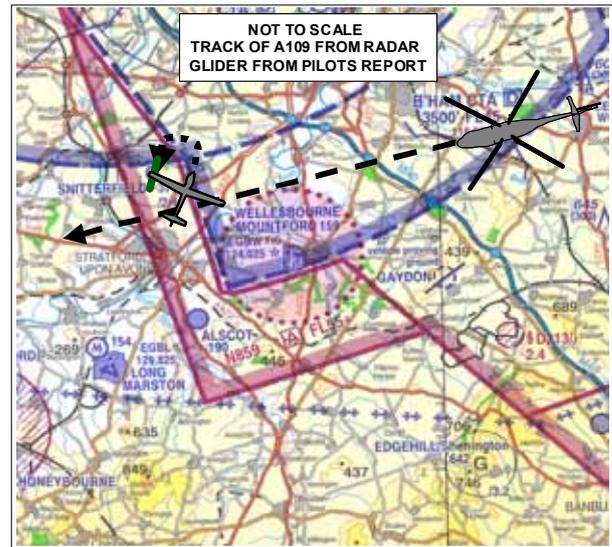
AIRPROX REPORT NO 073/07

Date/Time: 7 Jun 1507
Position: 5214N 00141W (3nm NW Wellesbourne
 - elev 158ft)
Airspace: Lon FIR (Class: G)
Reporting Ac **Reported Ac**
Type: A109E Ask 21
Operator: Civ Comm Civ Club
Alt/FL: 1300ft 1000ft↓
 (QNH 1020mb) (QFE NR)
Weather VMC CLBC VMC In Haze
Visibility: 6-8km 2km
Reported Separation:
 20ft V/30m H 20ft V/30m H
Recorded Separation:
 Not Recorded

Cause: An effective non-sighting by the A109E pilot and a late sighting by the ASK21 pilot.

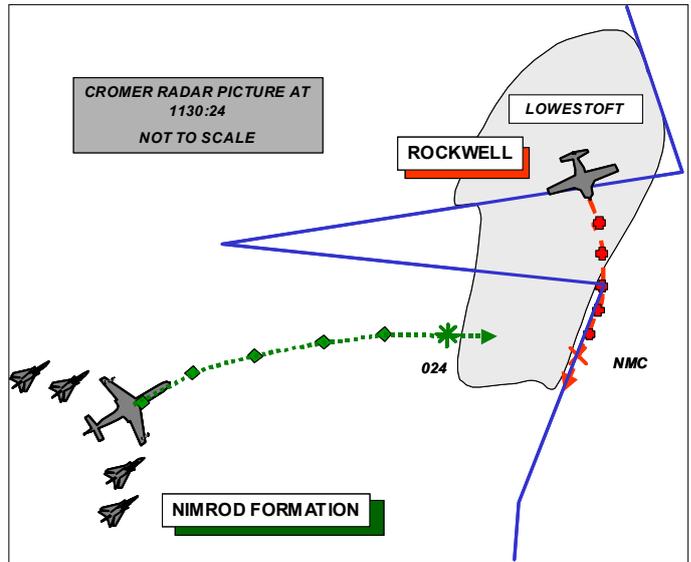
AIRPROX REPORT NO 074/07

Date/Time: 13 Jun 1131
Position: 5226 N 00145 E (off Gt Yarmouth)
Airspace: London FIR/RC(T) (Class: G)
Reporting Ac **Reported Ac**
Type: Nimrod MR2 Rockwell
 Commander 114
Operator: HQ AIR (Ops) Civ Pte
Alt/FL: 2000ft 2500ft
 (QNH 998mb) (N/K)
Weather VMC CAVOK VMC CLBC
Visibility: >30km 8km
Reported Separation:
 0ft V/400m H ~100ft V/1.5kmH
Recorded Separation:
 0 V/0.3nm (550m) H

Cause: Due to inadequate flight planning, the Rockwell pilot flew into an RA(T) and into conflict with the formation led by the Nimrod pilot.

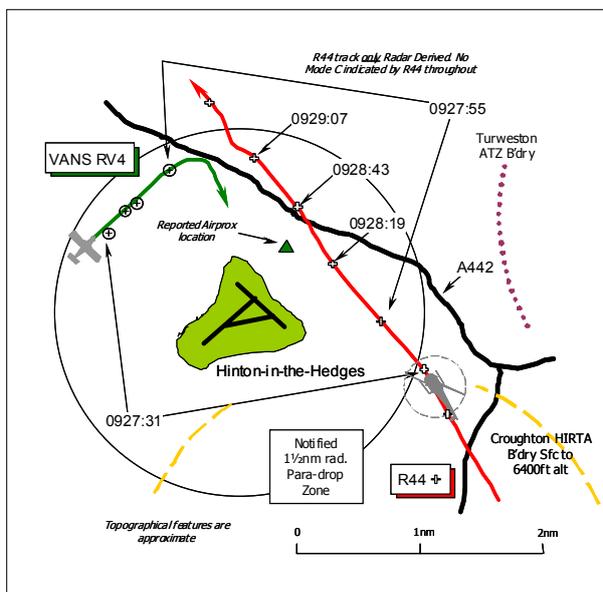
Reported Separation:
Nil ft V/50m H Nil V/500m H

Cause: The Robinson R44 pilot flew through a notified free-fall parachute drop zone, glider winch launch site & aerodrome cct into conflict with the Vans RV4.

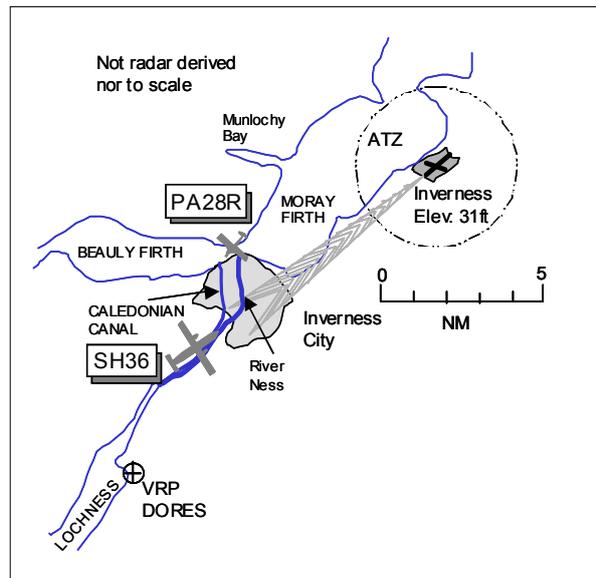
AIRPROX REPORT NO 076/07

Date/Time: 16 Jun 1431 (Saturday)
Position: 5726N 00416W (9nm FIN APP RW05
Inverness - elev 31ft)
Airspace: SFIR (Class: G)
Reporting Ac Reported Ac
Type: SH36 PA28R
Operator: CAT Civ Pte
Alt/FL: 2700ft 1500ft
(QNH 1005mb) (QNH 1005mb)
Weather IMC KLWD VMC CLBC
Visibility: 10km
Reported Separation:
NR 1400ft V/2.8nm H
Recorded Separation:
NR

Cause: Sighting report (TCAS) in Class G.

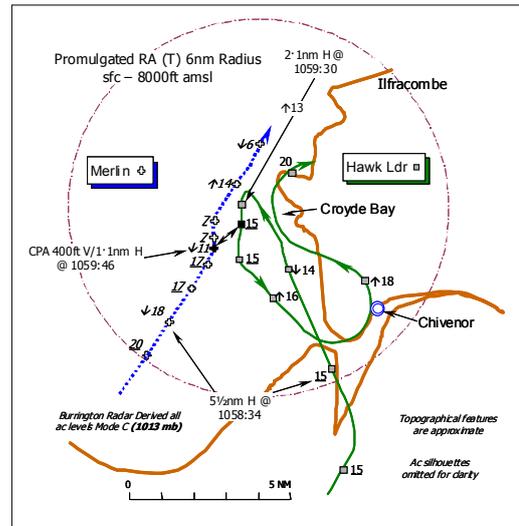
AIRPROX REPORT NO 077/07

Date/Time: 15 Jun 1059
Position: 5107N 00415W (Croyde Bay Devon)
Airspace: London FIR/RA(T) (Class: G)
Reporting Ac Reported Ac
Type: Hawkx9 Form Merlin HM Mk1
Operator: HQ AIR (Trg) C-in-C Fleet
Alt/FL: 500ft 800ft
 asl RPS (994mb)
Weather VMC RASH VMC RASH
Visibility: 15km 2km
Reported Separation:
 200ft V/?nm H Nil V/1000m H
Recorded Separation:
 400ft V/<1.1nm H

Cause: Following inadequate pre-flight planning, the Merlin crew flew into the active Restricted Area (Temporary) and into conflict with the Hawk Formation.

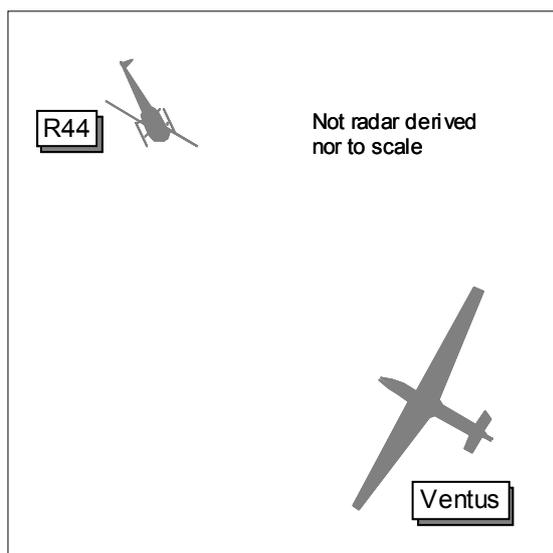
AIRPROX REPORT NO 078/07

Date/Time: 21 Jun 1412
Position: 5158N 00122W (2nm SSW Barford St John)
Airspace: Oxford AIAA (Class: G)
Reporting Ac1 Reporting Ac2
Type: Ventus2CT Glider R44
Operator: Civ Pte Civ Pte
Alt/FL: 1335ft 1500ft
(1013mb) (QNH)
Weather VMC CLBC VMC CLBC
Visibility: 25km >10km
Reported Separation:
10ft V 100ftV&H
Recorded Separation:
NR

Cause: Late sightings by both pilots.
