UK AIRPROX BOARD

Analysis of Airprox in UK Airspace

**Report Number 18
January 2007 – June 2007**

‘Analysis of Airprox in UK Airspace’

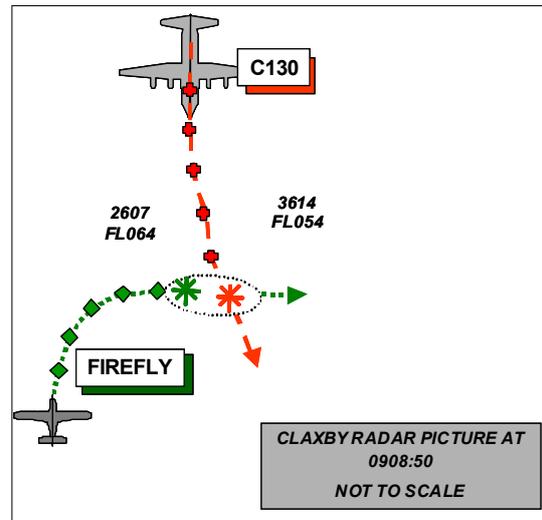
Reported Separation:
50ft V/250m H 500ft V/1000m H

Cause: Sighting report.

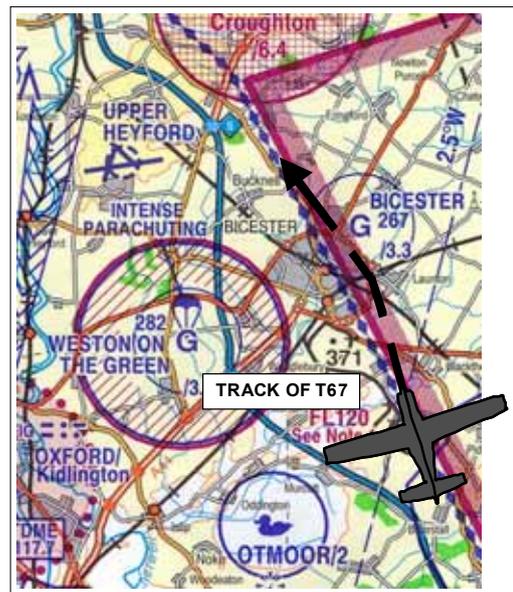
Cause: The T67 pilot flew through a notified and active glider launch site and into conflict with a glider which he did not see.

Recommendation: The CAA should review the depiction of glider launch sites on VFR charts with a view to making them more conspicuous.

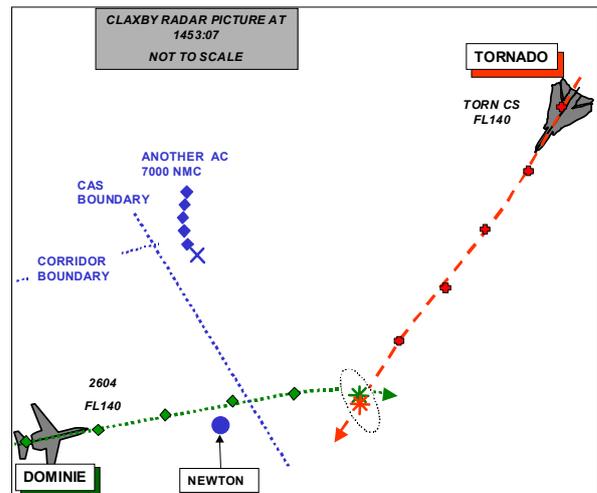
Date/Time: 26 Jun 1453
Position: 5257 N 00057W
 (20nm W of Cranwell)
Airspace: London FIR (Class: G)
Reporting Ac Reporting Ac
Type: Tornado F3 Dominie
Operator: HQ AIR (Ops) HQ AIR (Trg)
Alt/FL: FL140 FL140

Weather: VMC CAVOK VMC CAVOK
Visibility: Unlimited NR
Reported Separation:
 150-200ft V/Nil H 200FT V/0 H
Recorded Separation:
 100ft V<0.1nm H

Cause: Having vectored both ac into conflict, LJAO LIC did not comply with the provisions of a RIS in that TI was not passed to the Dominie crew nor acknowledged by the Tornado crew.

Recommendation: The MoD should direct a review of the ATC procedures for the entry/exit into/from the Lichfield Radar Corridor.

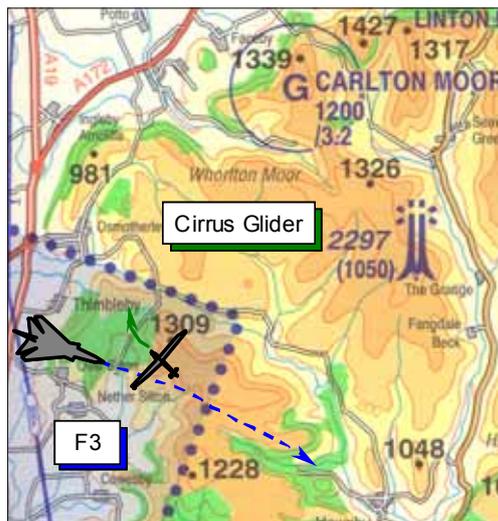
AIRPROX REPORT NO 087/07

Date/Time: 29 Jun 1404
Position: 5420N 00116W (9nm ENE of Leeming)
Airspace: UKDLFS-LFA11 (Class: G)
Reporting Ac Reported Ac
Type: Cirrus Glider Tornado F3
Operator: Civ Club HQ AIR (Ops)
Alt/FL: 1466ft 250ft
QNH Rad Alt
Weather VMC CLBC VMC CLBC
Visibility: 50km+ >10km
Reported Separation:
Nil V/20m H 150ft V/700m H
Recorded Separation:
Not recorded

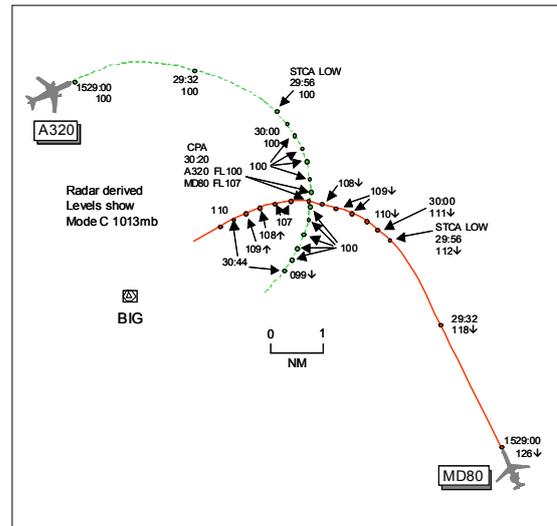
Date/Time: 22 Jun 1530
Position: 5122N 00008E (4nm NE BIG)
Airspace: LTMA (Class: A)
Reporting Ac Reported Ac
Type: A320 MD80
Operator: CAT CAT
Alt/FL: FL100 FL110↓

Weather VMC CLOC IMC NR
Visibility: 8km NR
Reported Separation:
500ft V 700ft V
Recorded Separation:
700ft V/0.2nm H
