UK AIRPROX BOARD

Analysis of Airprox in UK Airspace

Report Number 21
July 2008 – December 2008

Twenty-First Report by the UK Airprox Board:

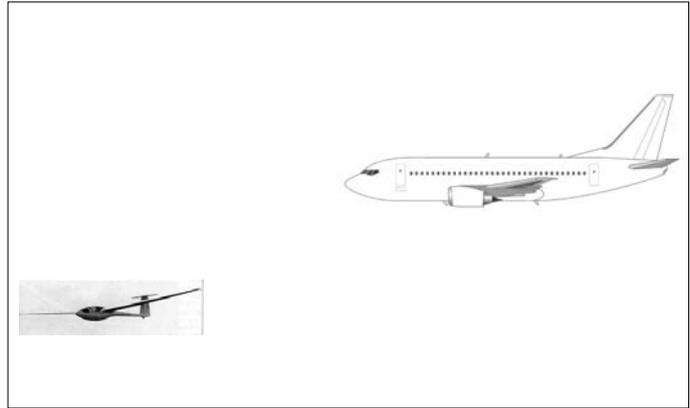
THE B737 PILOT reports that they were inbound to East Midlands in contact with APR, squawking as directed with Mode C and on a radar heading of 300° at 180kt to intercept the localiser for RW27 from the S when he saw a low-winged glider in his 12 o'clock, passing N to S between 300ft and 500ft beneath them. He did not take any avoiding action but assessed the risk as being high.

The relatively late visual acquisition of the glider by the B737 crew was thought by airline pilot Members to have most likely been due to their high workload as they were coming onto the final approach and preparing the ac for landing. In addition, it is well known in the aviation community, that modern, low profile, gliders are very difficult to acquire visually, particularly in good gliding conditions when there is a significant amount of white cloud present.

Cause: A conflict with an untraced glider.

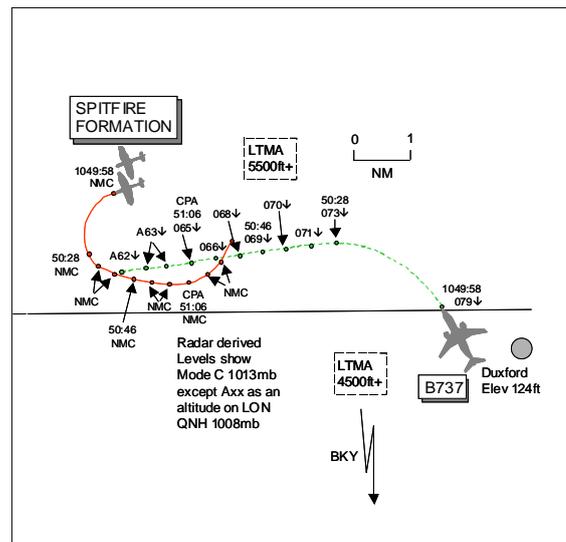
THE B737 PILOT reports inbound to Luton IFR and in receipt of a RCS from Essex Radar on 120.62MHz squawking with Modes C and S. Heading 260° at 220kt level at 6000ft, he thought, QNH 1007mb, they saw - on TCAS, showing NMC, and visually - a pair of camouflaged Spitfires 5km away. The pair were flying in echelon formation, passing from R to L ahead, climbing and turning. The Spitfires passed 500m away on their L at the same level before passing behind. Essex Radar was informed. He assessed the risk as low.

Members noted that the Spitfire Formation Leader was operating on the RPS whilst flying below the LTMA. This was contrary to the procedures set out in the UK AIP [ENR 1-7-1] which states that airspace within and under TMAs do not form part of the Altimeter Setting Region. Moreover, when flying below TMAs and CTAs, pilots should use the QNH of an adjacent aerodrome when flying below the Transition Altitude. This is to ensure that pilots of such flights are able to operate safely, cognisant that their indicated altitudes flown are placing their ac below the promulgated CAS base level. It was also noted that although the Spitfire Leader had reported squawking Modes A and C in line with the guidance in the UK AIP [ENR 1-6-2-1], NMC was evident from the radar recording. Members reiterated the importance of squawking Modes A and C, when fitted, to ensure that ATC conflict alert systems and ACAS 'safety nets' are able to function fully.

Cause: Sighting report.

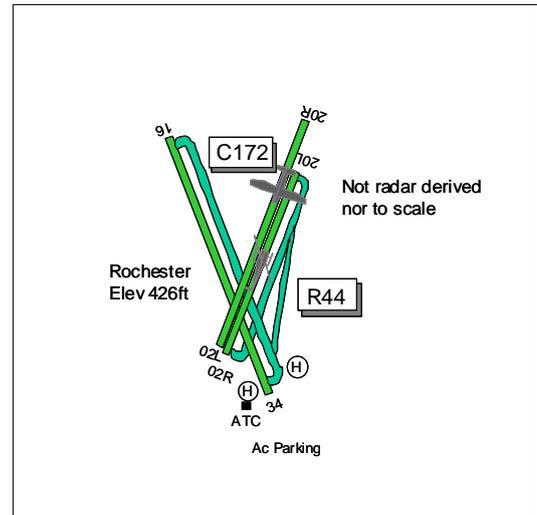
THE C172 PILOT reports flying a dual training sortie with a student and in receipt of an AFIS from Rochester Information on 122.25MHz; the transponder was switched off. The visibility was 10km in VMC and the ac was coloured white with strobes and anti-collision lights switched on. He was conducting a cct detail on RW20 and was on final approach having already reported 'final'. On short final he heard a request being made by an R44 student pilot to taxi (not using 'student' c/s but he had heard the pilot when inbound 1hr earlier when he had become temporarily unsure of his position and needed guidance) to which the Tower responded with 'hover taxi to 20'. The R44 pilot did not appear to understand this call and asked for it to be repeated which the Tower did, annunciating more slowly to 'hover taxi to 20'. By now there was another ac on finals behind his C172, a PA28 being flown by a solo student pilot who had also called final. At this point the R44 pilot commenced take-off on RW02 relief RW [RW02R] towards them, accelerating and then climbing to about 20ft passing close to their L. He had had the R44 in sight at all times but was concentrating on its manoeuvres rather than his student's landing for a touch and go. At the closest point they were in the flare and float at 3-4ft above the RW heading 200° at 65kt whilst the R44 passed 20ft above them and 10m clear to their L flying at about 50-60kt. During this phase they did experience some turbulence from the R44 but it was minimal. They continued with their touch and go and understood that the R44 at some point turned W across the path of the PA28 student on final. He called the Tower to state that they were on RW20 but made no further comment as he did not want to distract the R44 student. After completion of the sortie, he discussed the matter with the AFISO who said she would be contacting the R44 student's instructor and that she would be reporting the incident. He assessed the risk as medium.

Cause: The R44 student pilot took off on the wrong runway and flew into conflict with the C172.

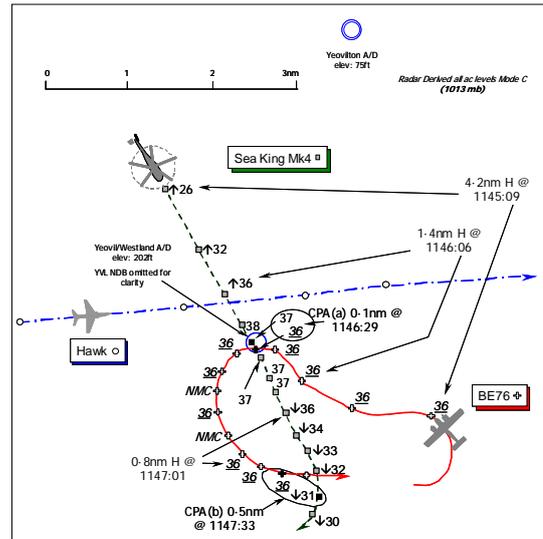
AIRPROX REPORT NO 103/08

Date/Time: 21 July 1146
Position: 5057N 00240W (Overhead the YVL)
Airspace: London FIR (Class: G)
Reporting Ac Reporting Ac
Type: Sea King Mk4 BE76
Operator: HQ JHC Civ Trg
Alt/FL: 4000ft 4000ft
RPS (1023mb) QNH (1026mb)
Weather IMC IBCL IMC IBCL
Visibility: 30 km 0.5 NM
Reported Separation:
300ft V/200m H 300ft V/300m H
Recorded Separation:
100ft V/0.1nm H

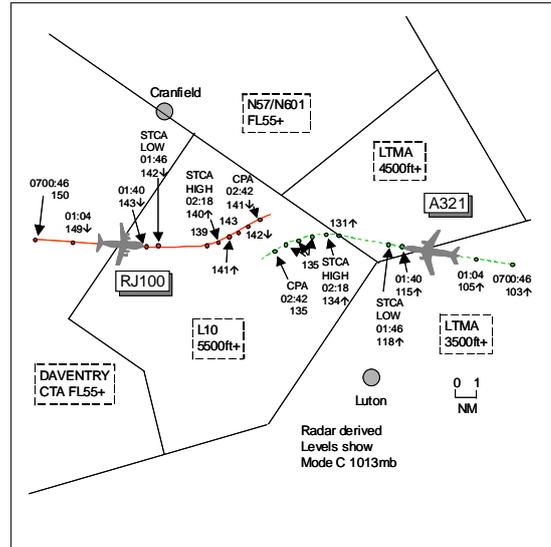
Date/Time: 22 Jul 0703
Position: 5159N 00029W (8nm NW Luton)
Airspace: L10 (Class: A)
Reporting Ac Reported Ac
Type: A321 RJ100
Operator: CAT CAT
Alt/FL: FL135↑ ↓FL140

Weather VMC CLNC VMC
Visibility: >10km
Reported Separation:
 500ft V/NR H Nil V/1nm H
Recorded Separation:
 600ft V/1.5nm H

THE A321 PILOT reports outbound from Stansted IFR and in receipt of a RCS from London on 119.775MHz squawking 2235 with Mode C. Climbing towards BKY, their initial clearance was to turn L heading 280°. They were cleared to FL160 and on passing FL115 at 250kt they were told to expedite through FL120 and again shortly afterwards through FL130. A TCAS TA was received at about FL125 on traffic about 5nm away followed by an RA 'descend' passing FL135. Avoiding action was taken in accordance with TCAS demands until clear of conflict. Shortly before the RA the controller gave an 'avoiding action' L turn onto heading 220° which was executed. He was not sure of the exact geometry of the Airprox as one pilot was taking avoiding action whilst the other was making RT calls but he believed the other ac passed 500ft above at the CPA with a high risk of collision. He was concerned because when he advised ATC of their TCAS descent the controller had said 'negative climb climb' which, had they complied, could have been catastrophic.

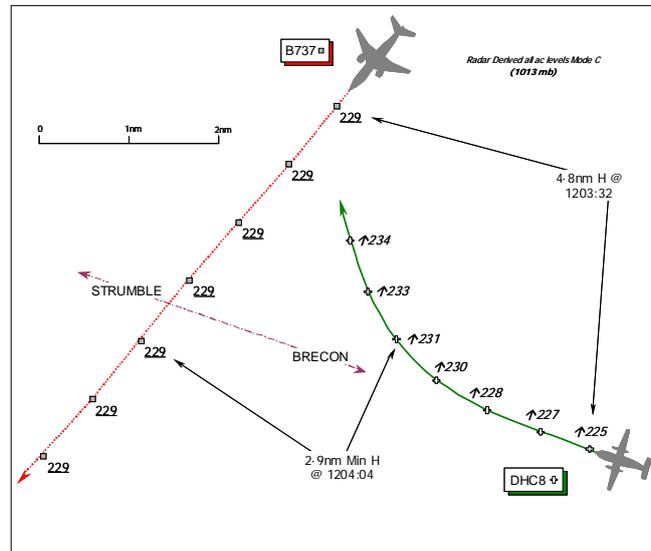
THE LAC COMBINED SECTOR 8 & 35 TACTICAL CONTROLLER (S8/35 TAC) reports that the DHC8 was outbound via BCN (BRECON) and STU (STRUMBLE). His PLANNER had co-ordinated a climb with S23 but no level restriction was mentioned so he annotated the paper fps accordingly. After the DHC8 turned westbound at BCN, STCA activated between it and a background track - the B737. Avoiding action was issued to the DHC8 crew to turn R onto a heading of 360°. The DHC8 crew reported having the other ac displayed to them on TCAS but no report of an RA was received. Once clear of the B737, the DHC8 was turned L onto a heading of 300° and the crew instructed to resume their own navigation toward STU.

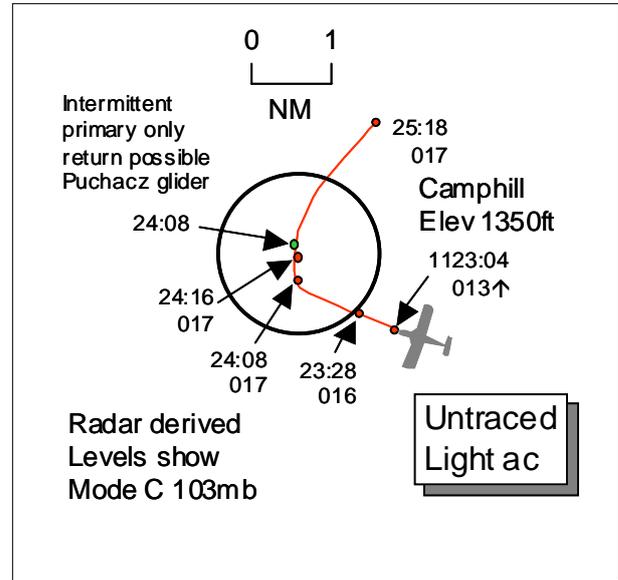
AIRPROX REPORT NO 106/08

Date/Time: 20 Jul 1125 (Sunday)
Position: 5318N 00144W (0.5nm SW Camphill
 G/S - elev 1350ft)
Airspace: FIR (Class: G)
Reporting Ac Reported Ac
Type: Puchacz Glider Untraced
 Light ac
Operator: Civ Club NK
Alt/FL: 700ft NK
 (QFE)
Weather VMC CLBC NK
Visibility: >30km NK
Reported Separation:
 200ft V/100yd H NK
Recorded Separation:
 NR

THE PUCHACZ GLIDER PILOT reports flying a dual training sortie from Camphill and was in communication with the gliding club on 129.975MHz. The visibility was >30km flying 1300ft below cloud in VMC and the ac was coloured white. The wind was 280/15-20kt with several gliders soaring on the ridge on the Western boundary of the airfield as well as picking up thermals and drifting downwind; heights varied between 600ft to 1000ft. Launches were via winches placed halfway along the Western boundary. He was instructing and soaring at 700ft QFE over the Southern end of the Western boundary heading 330° and tracking 350° at 45kt. He first saw the other ac, a low wing single engine ac coloured cream/navy as it appeared from under his starboard wing about 200ft below and 100yd to his E. The ac was flying straight and level at about 100kt N'bound, just W of the C/L of the airfield. This course was held for about 3-4km and he then turned his attention back to his student's progress. As the other ac passed over the Northern end of the airfield it was seen to give a brief wiggle to indicate its pilot had seen other traffic and was reacting suddenly. He opined that had he been flying S'bound such that he could see the approaching ac he would have taken precautionary evasive action. He believed that there was a high risk of collision with his glider and with several others. Also, had the ground crew been unaware of its presence and initiated a launch, as they were ready to do at that moment, there was every likelihood of a collision with the launch cable.

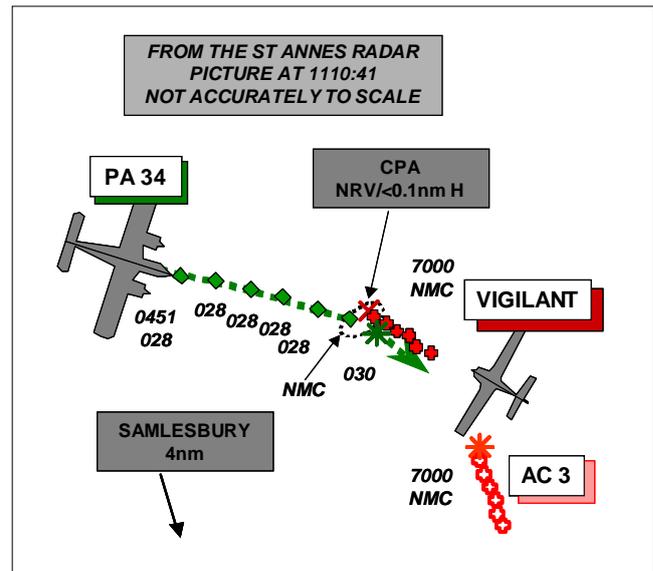
AIRPROX REPORT NO 107/08

Date/Time: 27 Jul 1105 (Sunday)
Position: 5349N 00233W (4nm NNW of Samlesbury)
Airspace: Lon FIR (Class: G)
Reporting Ac Reported Ac
Type: PA 34 Seneca Vigilant TI
Operator: Civ Pte HQ Air (Trg)
Alt/FL: 3000ft NR
 (RPS 1015 mb) (N/K)
Weather VMC HAZE VMC CLOC
Visibility: 5 Km >5nm
Reported Separation:
 150ft V/300m H 800-1000ft V
 /3000m H
Recorded Separation:
 NR V/<0.1nm H

THE PA34 SENECA PILOT reports flying solo with a passenger in a blue and white ac with strobes, nav lights and the anti-coll beacon switched on, on a private IFR flight from Ronaldsway to Gamston. He was in the cruise at 3000ft on RPS 1015mb, heading 107° at 162kt in receipt of a RIS from Blackpool and squawking as directed with Mode C when he was informed of traffic at 4nm in his 12 o'clock with no height displayed. He replied that he was good VMC on top and looking but he could not see the ac. Slightly later Blackpool said the traffic was then at 2nm still in the 12 o'clock with no height and there was a further ac to the south also with no height, probably Samlesbury based gliders. He continued to scan and caught sight of an ac about 500m away straight ahead so he immediately disengaged the autopilot and turned right and climbed. The other ac did not manoeuvre and passed below his port wing. He specifically noted that the other ac had no lights on [see Vigilant pilot's report below]. He reported the incident to Blackpool and after landing telephoned them to inform them that he would be filing an Airprox. He assessed the risk as being very high.

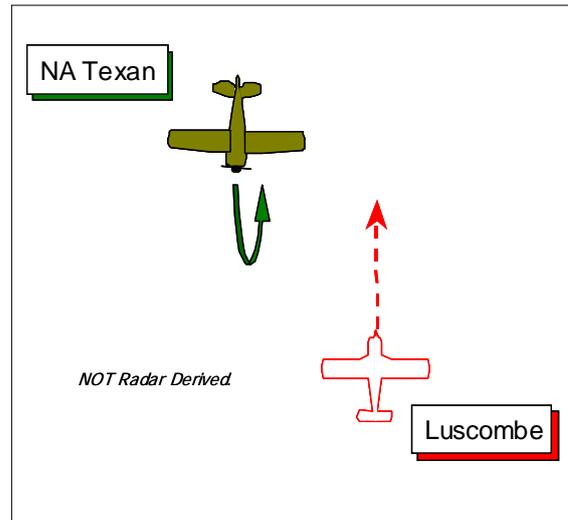
AIRPROX REPORT NO 108/08

Date/Time: 27 July 1310 (Sunday)
Position: 5048N 00107W (Portsmouth Harbour)
Airspace: London FIR (Class: G)
Reporting Ac Reported Ac
Type: NA AT6D Texan Luscombe Silvaire
Operator: Civ Pte Civ Pte
Alt/FL: 1500ft 2000ft
 QNH (1017mb) QNH (1019mb)
Weather VMC Sunny VMC CLNC
Visibility: 10km 10Km
Reported Separation:
 300ft V/200m H Not seen
Recorded Separation:
 Not Recorded

THE NORTH AMERICAN AT6D TEXAN PILOT provided a very full account reporting that his ac has a vintage Dark Green USAAC colour scheme but the anti-collision beacon was on whilst participating in a flying display over Portsmouth Dockyard. Operating VFR in VMC, he was in communication with HMS ILLUSTRIOUS through FLYCO on 122.1MHz and the Flying Display Director (FDD) - the controlling & co-ordinating authority for the display. A squawk of A7000 was selected with Mode C 'on'.

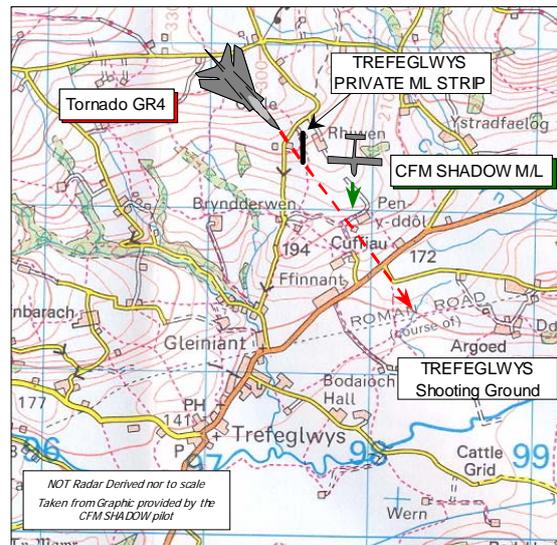
AIRPROX REPORT NO 110/08

Date/Time: 23 Jul 1906
Position: 5231N 00330W (Vicinity of private strip at Trefeglwys)
Airspace: London FIR/LFA7 (Class: G)
Reporting Ac Reported Ac
Type: CFM Shadow Tornado GR4
Operator: Civ Pte HQ Air (Ops)
Alt/FL: 300ft 250ft
agl agl
Weather VMC CLOC VMC CLOC
Visibility: 15km 10km
Reported Separation:
100ft V/250ft H 1000ft V/500m H
Recorded Separation:
Not recorded

THE CFM SHADOW MICROLIGHT PILOT reports he was inbound to his private airstrip at Trefeglwys [OS Grid SN 977 923] in his red and white coloured 2-seater machine in VMC with “good” visibility. A radio is not fitted but the 2 strobe lights were on.

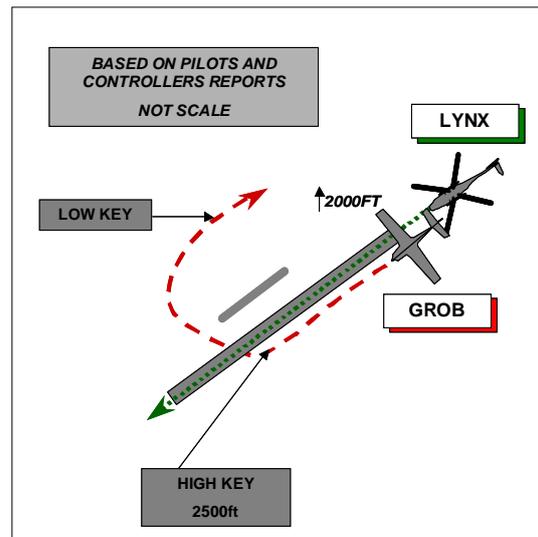
THE LYNX AH7 PILOT reports flying a training sortie with another QHI in a camouflage grey/green ac with nav lights and the anti-coll beacon switched on. He was in receipt of a RIS from Boscombe Down, squawking 2634 with Mode C, and was overshooting from RW23 at 100kt on a radar climbout. Upon commencing level off at 2000ft QFE, the reported ac, a white and blue 2 seat light ac with RAF roundels, appeared from above and slightly left about 150ft away, drifting to the right across their track right and directly in front of them. His ac was closing from their rear. He estimated that his avoiding action climbing turn away was made when the ac were about 100ft apart.

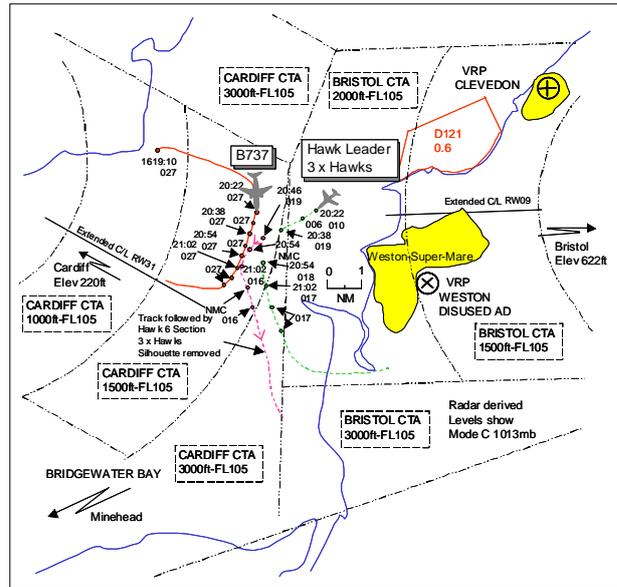
AIRPROX REPORT NO 112/08

Date/Time: 9 Aug 1621 (Saturday)
Position: 5121N 00304W (13nm WSW Bristol Airport - elev 622ft)
Airspace: FIR/CTA (Class: G/D)
Reporting Ac **Reported Ac**
Type: 9 x Hawks B737-800
Operator: HQ AIR (Trg) CAT
Alt/FL: 1000ft↑ 2500ft
 (QNH 1007mb) (QNH)
Weather VMC CLBC IMC CLOC
Visibility: 5000m
Reported Separation:
 1000ft V/0-5nm H NR
Recorded Separation:
 Leader 900ft V/0-7nm H
 Hawk 6 1100ft V/0-2nm H

THE HAWK FORMATION LEADER reports inbound to Bristol VFR and in receipt of a RIS from Bristol on 136-075MHz squawking 7003 with Mode C. Following a low level transit and during the recovery phase, he decided that a VFR approach could not be flown owing to poor weather at Bristol Airport. Maintaining VMC in 5000m visibility at low-level over the Bristol Channel, the formation was split into 3 elements of 3 ac. ATC were requested to allocate squawks for the 2 trail elements with Lead element retaining the discrete code 7003. The Lead element was identified, he thought, and was cleared to climb to 2500ft. Heading 260° at 360kt and climbing through 1200ft QNH, the Leader noticed an airliner, a B737, through a gap in the clouds and subsequently levelled-off at 1500ft, the B737 passing 1000ft above and 0-5nm clear. At no point was he informed of the conflicting traffic and had the Lead element been IMC at the point of visual contact he felt that the risk of collision would have been extremely high. Owing to the proximity of the airliner to the formation, an Airprox was filed on landing.

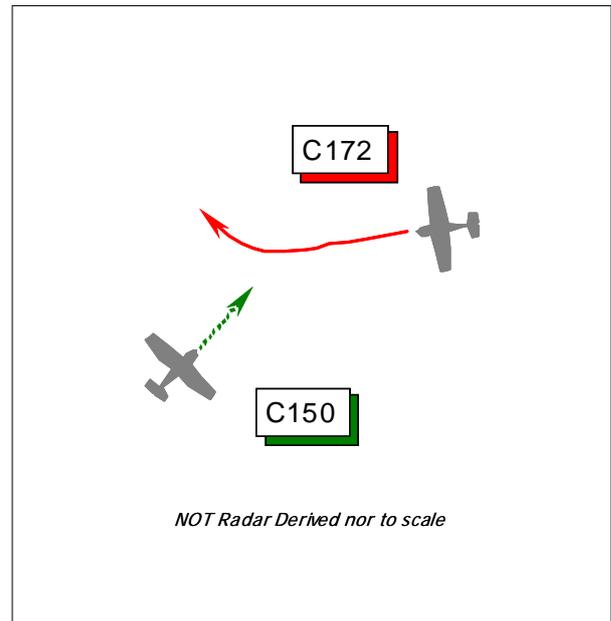
AIRPROX REPORT NO 113/08

Date/Time: 30 Jul 0944
Position: 5242N 00207W (14nm WSW of Tatenhill)
Airspace: London FIR (Class: G)
Reporting Ac Reported Ac
Type: Cessna 150 Cessna 172
Operator: Civ Pte Civ Com
Alt/FL: 1800ft 1700ft
 QNH (1015mb) QNH
Weather VMC CLBC VMC CLBC
Visibility: 25km 15-20km
Reported Separation:
 300ft V/0.2nm H 800m H
Recorded Separation:
 Contacts merged in azimuth
 (Birmingham ASR)

THE CESSNA 150 PILOT reports he was en-route from Wolverhampton/Halfpenny Green to Tatenhill under VFR in VMC some 3000ft clear below cloud. He was neither under any form of ATS nor listening-out with any ATC unit. A squawk of A7000 was selected with Mode C; Mode S was not fitted.

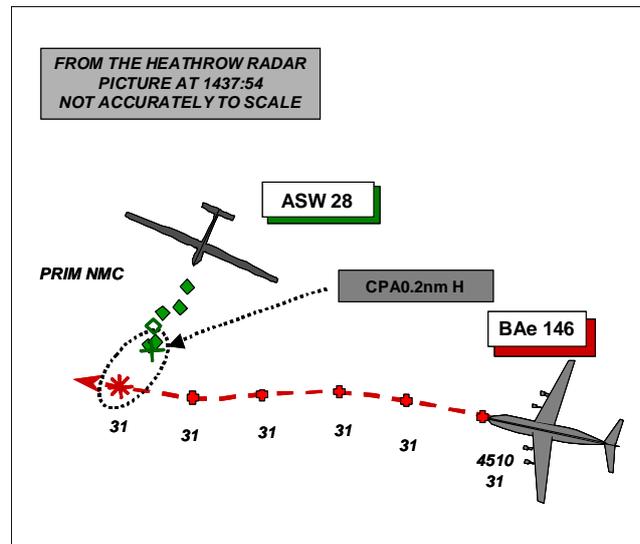
THE ASW28 GLIDER PILOT reports flying a local soaring flight from Lasham in a white glider when he saw a white BAe146 500m away crossing from left to right about 200m ahead of him and just below his altitude; at the time he was heading 220° at 65-70kt. Immediately on sighting the other ac, he turned abruptly towards it which reduced the collision risk. He turned back as the other ac passed ahead and beneath him and he returned to his original heading about 15sec after initiating the avoiding action turn. While the original trajectories of the 2 ac probably did not merge [in altitude], had the other ac climbed slightly, or had he flown through sinking air, they would have. He did not assess the risk, reporting the incident to his CFI on landing back at Lasham.

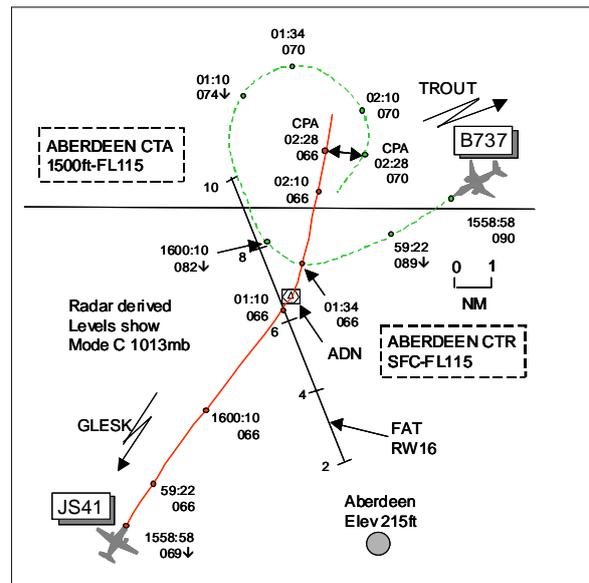
Date/Time: 12 Aug 1602
Position: 5722N 00214W (4nm NNE ADN)
Airspace: Aberdeen CTA (Class: D)
Reporter: Aberdeen INT DIR

<u>First Ac</u>	<u>Second Ac</u>
<u>Type:</u> B737-600	JS41
<u>Operator:</u> CAT	CAT
<u>Alt/FL:</u> FL70	6000ft (QNH 990mb)
<u>Weather</u> IMC KLWD	IMC IICL
<u>Visibility:</u>	>10km
<u>Reported Separation:</u> 400ft V/1nm H	400ft V/2.5nm H
<u>Recorded Separation:</u> 400ft V/1.1nm H

THE ABERDEEN INTERMEDIATE DIRECTOR reports working during a reasonably busy session with a number of inbound ac all arriving at the same time. He formulated a plan in conjunction with the FIN DIR to route a number of the fixed wing inbound ac to the ADN hold, allowing the rest, including a number of helicopters, to make an approach. With 4 fixed wing ac in or approaching the hold he allocated vertically separated levels before speaking to Leuchars regarding 2 military squawks operating from the S right up to the CTA boundary as he had a S'bound departure to pass through the area. He monitored all the ac that were in or approaching the ADN hold to ensure they were at the correct levels and following coordination with FIN, he descended each ac 1000ft above all others as the levels became vacant. One flight, the subject B737, queried the level of the ac below him in the hold, the subject JS41, as he could see it. As he, INT, was certain it was 1000ft below he checked his radar display to confirm this and told the flight that it was. The JS41 crew then stated that they had the B737 visual and that it was showing on TCAS 400ft above. He then realised a loss of separation had occurred and immediately issued headings to fly as he felt this was the quickest means of reinstating separation.

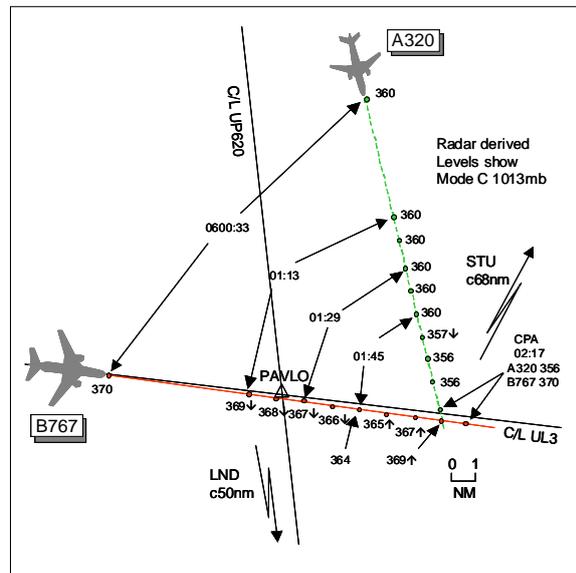
Cause: The LAC S6/9/36 Tactical descended the B767 into conflict with the A320.

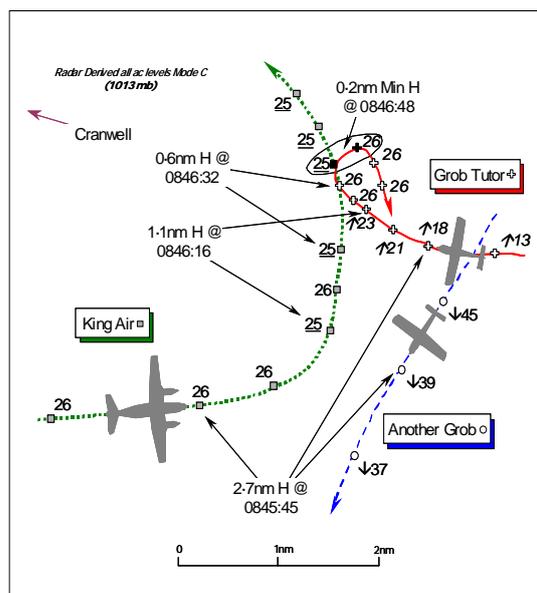
AIRPROX REPORT NO 118/08

Cause: A conflict resolved by the King Air pilot.

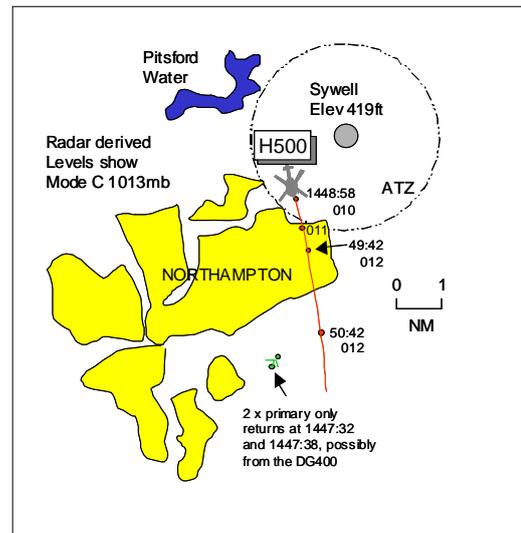
AIRPROX REPORT NO 119/08

Cause: A non-sighting by the H500 pilot and a late sighting by the DG400 pilot.

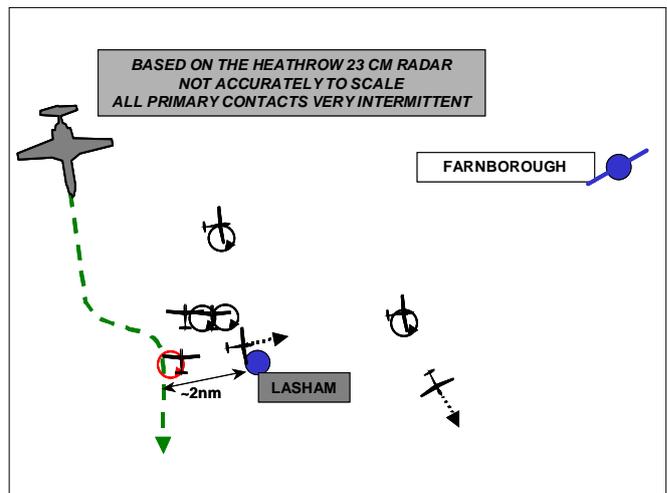
AIRPROX REPORT NO 120/08

Cause: Sighting report (TCAS).

The Unit investigation also made a number of recommendations including setting up two working groups: one between LTC and Farnborough and the other between Lasham and Farnborough. Each is tasked to review inter-Unit procedures which, in the case of Lasham and Farnborough, will include improving communications facilities. Another recommends that the airport authority at Farnborough install radar recording equipment in accordance with the ICAO standards and detailed in ATSD ATSN 127: ‘Automatic Recording of Surveillance Data by ATS Units’. A final recommendation asks the Farnborough GM to review the requirement to display the Lasham gliding area on the Farnborough radar displays (as that installed at LTC).

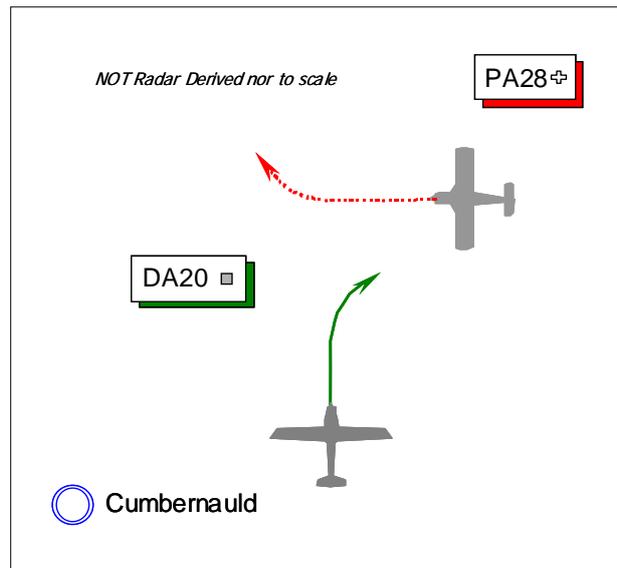
Cause: The PA28 pilot did not integrate into the cct correctly and caused the DA20 pilot concern.

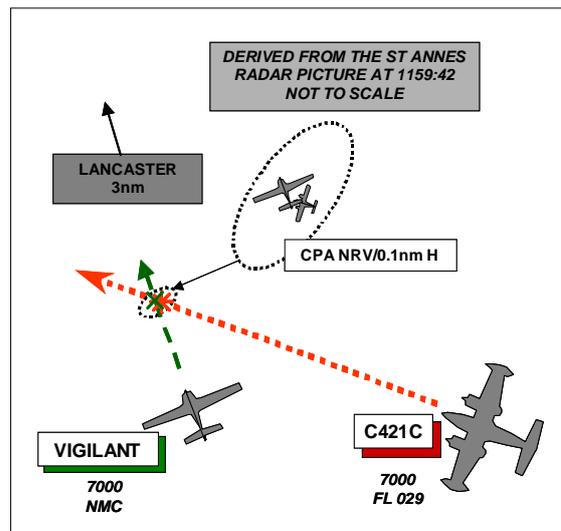
AIRPROX REPORT NO 123/08

Cause: A non-sighting by the C421C pilot.

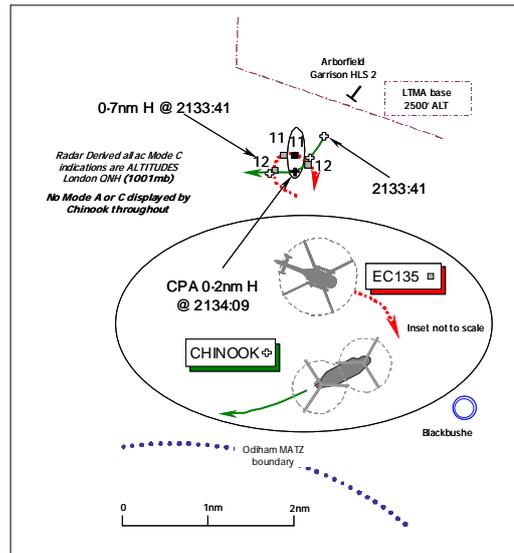
AIRPROX REPORT NO 124/08

Cause: A late sighting by the EC135 pilot and the Chinook crew.

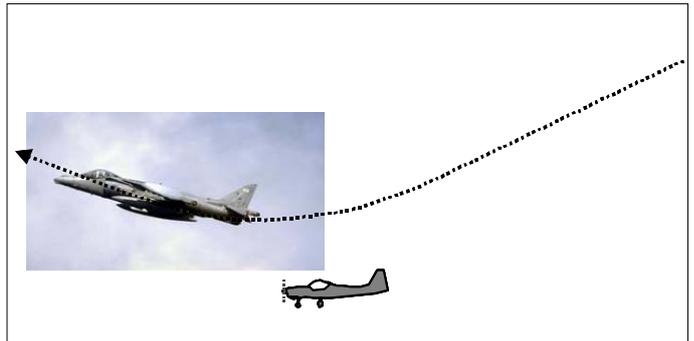
AIRPROX REPORT NO 125/08

Cause: A non-sighting by the Harrier pilot.

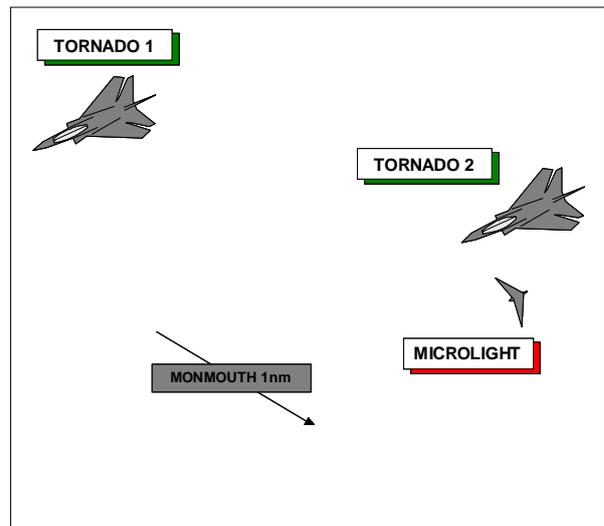
Cause: Effective non-sighting by the Tornado crews.

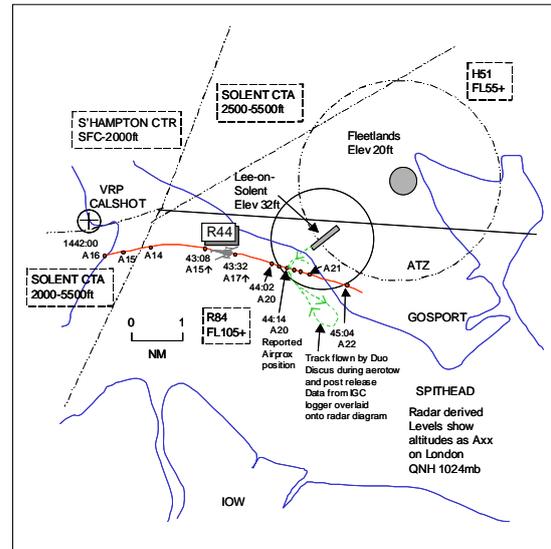
AIRPROX REPORT NO 127/08

Cause: Non-sighting by the Chipmunk pilot and an effective non-sighting by the R44 pilot.

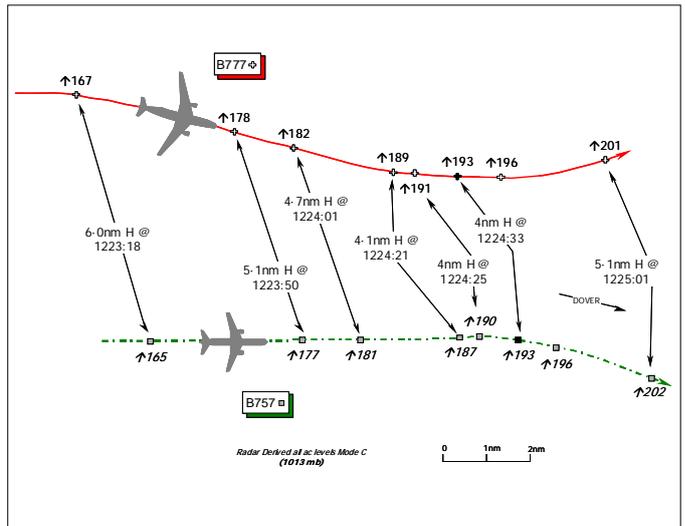
controllers to spot level errors. It is unfortunate that this valuable tool is not yet available to area controllers at LAC Swanwick. Nevertheless, the Members agreed unanimously that S15/16 TAC's prompt response to the deviation that he observed on radar and the swift reaction of both crews, coupled with the minimum horizontal separation evident here of 4nm, had removed entirely any risk of a collision.

Cause: The B777 crew deviated from their assigned heading and turned into conflict with the B757.

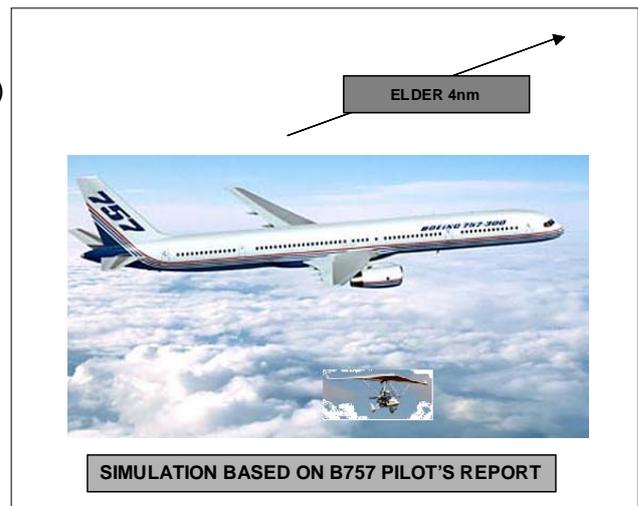
THE B757 PILOT reports inbound to London Gatwick in receipt of a RCS from LACC, squawking as directed with Modes C and S and heading 010° at 270kt. As he approached the S coast of the Isle of Wight, while descending through FL200 [see UKAB Note (3)] he glanced out of his left hand window and saw a blue and yellow weight-shift microlight disappearing from sight under their left wing about 1000ft below them. He had no TCAS indication so he assumed [confirmed by the radar recording] that the microlight was not SSR equipped.

Cause: Conflict in Class C Airspace with an untraced Microlight

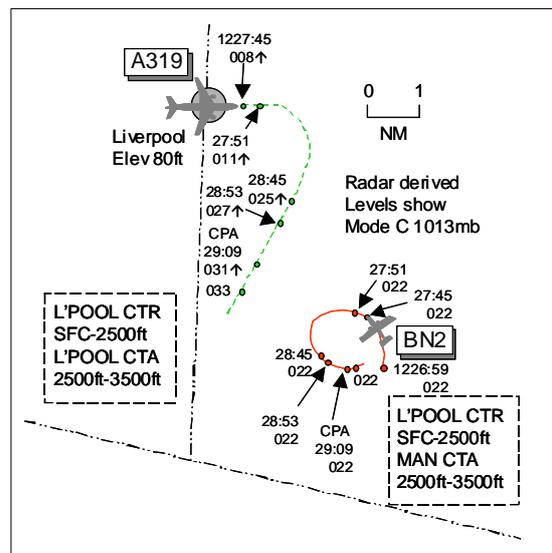
Cause: Without the benefit of TI, the proximity of the BN2 caused concern to the A319 crew.

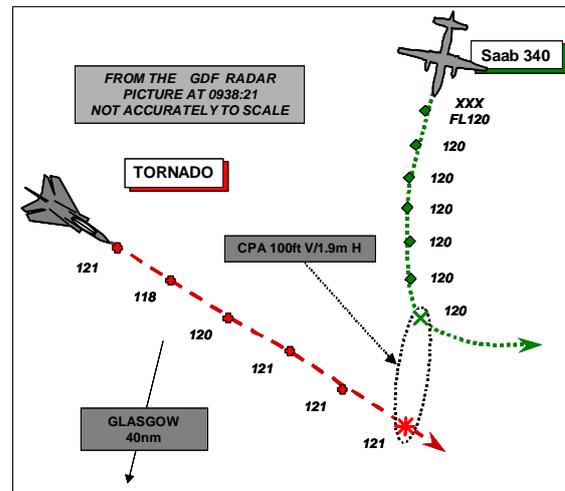
AIRPROX REPORT NO 143/08

Both the controllers involved in the sector handover observed unknown traffic (the subject Tornado) to the W of the ADR. The Stornoway radar photograph of 0936:54 shows a 4715 squawk, at FL90, about 10nm W of the Saab 340, on a conflicting track; the squawk changes from 4715 to 7000 and fades from the display. It next appears 25sec later at 0937:19, 7nm WSW of the Saab 340, showing a 7000 squawk and climbing through FL108. Shortly afterwards, the oncoming controller passed TI about the Tornado *“C/S traffic information right hand two o’clock range of six miles fast moving jet traffic showing Flight Level One Two Two climbing”* and the pilot reported looking; the controller then continued *“C/S if nothing sighted turn left heading Zero Nine Zero degrees”*. At the time, the ac were 5.3nm apart and the Tornado was 100ft below the Saab. As soon as the Saab pilot read back the turn instruction, the controller transmitted *“C/S (flight number only) traffic right hand two o’clock range of four miles Flight Level One Two Zero avoiding action turn left immediately heading Zero Seven Zero degrees acknowledge”*. The pilot reported the traffic in sight and was given a further left turn heading 030°. At 0938:20, just after this turn was issued, the closest point of approach occurred, as the Tornado passed 1.9nm ahead of the Saab 340 and 100ft above it. The Tornado then continued tracking away to the SE.

Cause: A conflict in Class F airspace resolved by the ScACC Westcoast Controller.

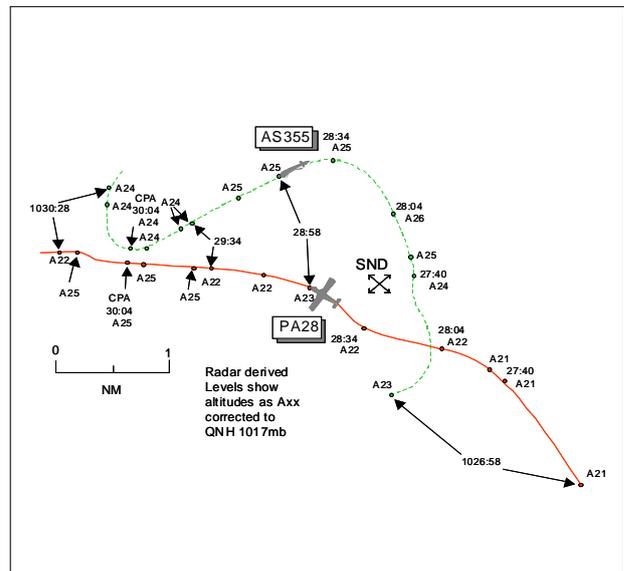
AIRPROX REPORT NO 144/08

Cause: The PA28 pilot did not inform Southend ATC of his change in flight conditions or altitude and flew into conflict with the AS355.

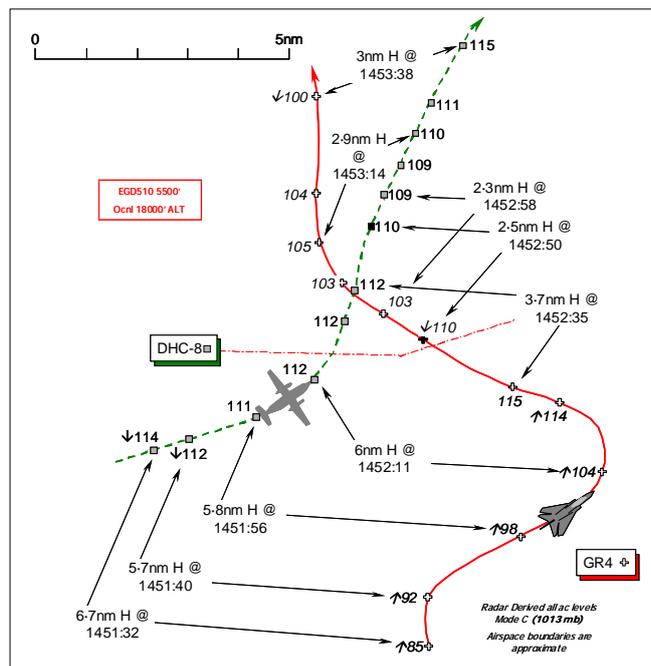
In summary, the TCAS RA stemmed from the unintentional entry of the airliner into Spadeadam Range as a result of the avoiding action issued by NEW RAD1 whereupon the DHC-8 crew detected the presence of the jet whilst the GR4 crew were actively avoiding their airliner. The Board therefore concluded that the Cause of this Airprox was a sighting report (TCAS) with no inherent Risk of a collision.

Cause: Sighting report (TCAS).

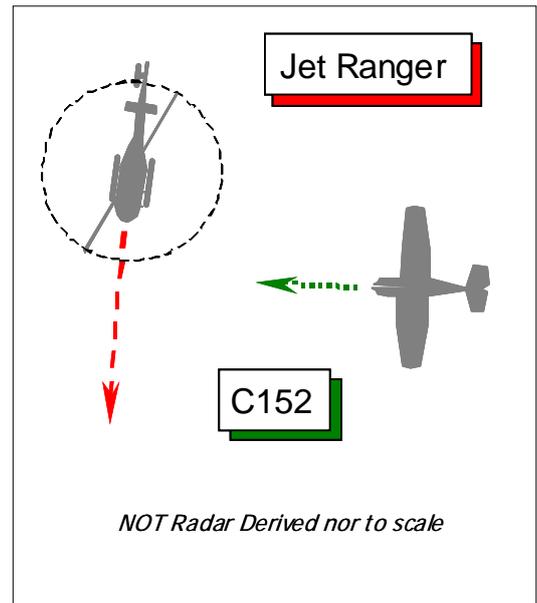
AIRPROX REPORT NO 146/08

Cause: The B206 JetRanger pilot flew close enough to the C152 to cause its pilot concern.

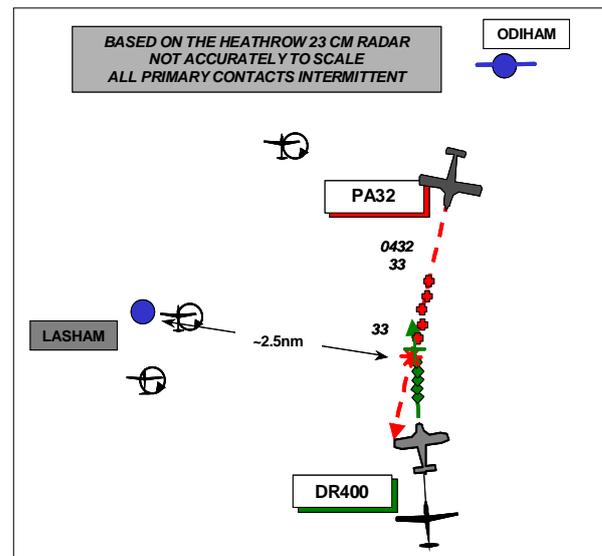
AIRPROX REPORT NO 147/08

That being the case, the Board considered that the PA32 pilot had flown close enough to the DR400 (combination) to cause its pilot concern. While such a Cause would often attract a Degree of Risk of C, since in this case it had not been a single ac but a combination and the tug's intentions were totally unknown to the PA32 pilot, following specialist advice Members agreed that there had been a degradation of the standard of safety normally expected.

Cause: The PA32 pilot flew close enough to the Robin DR400 to cause its pilot concern.

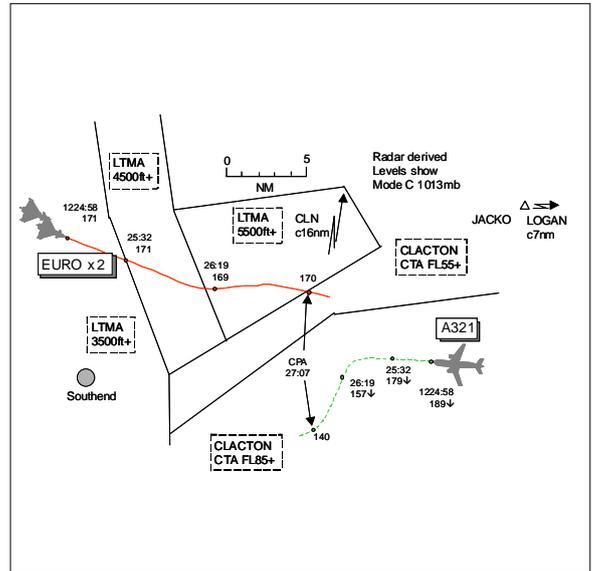
AIRPROX REPORT NO 148/08

Cause: The Eurofighter formation did not comply with the recovery procedures specified in the TLP ACN and entered CAS without clearance.

During the Board's discussion, many shortcomings, from the planning stages of the TLP right through to the incidents highlighted on the day, were identified from the comprehensive reports received. Members agreed that all deficiencies needed to be identified and addressed to mitigate the risk of these circumstances reoccurring and the Board agreed to make this a Safety Recommendation to the MoD.

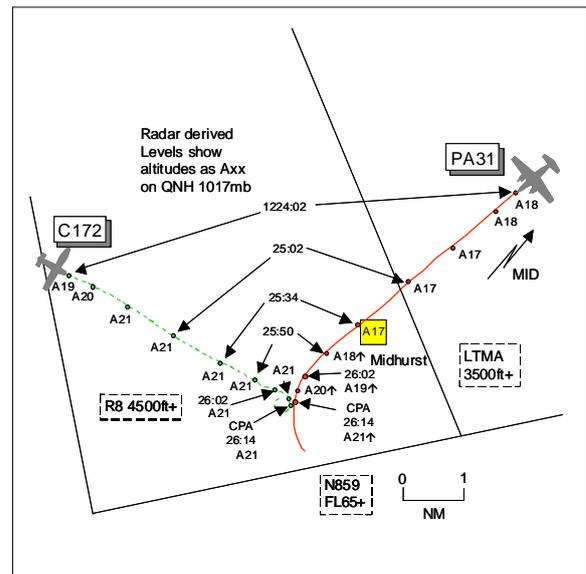
AIRPROX REPORT NO 159/08

Date/Time: 12 Nov 1226
Position: 5058N 00046W
 (2nm SW Midhurst Town)
Airspace: LFIR (Class: G)
Reporting Ac Reported Ac
Type: C172 PA31
Operator: Civ Pte Civ Surv
Alt/FL: 2000ft 1800-3500ft
 (QNH 1018mb) (QNH)
Weather VMC CLNC VMC NR
Visibility: >10km NR
Reported Separation:
 Nil V/200m H Not seen
Recorded Separation:
 Nil V/0.1nm H

Cause: A non-sighting by the PA31 pilot and a very late sighting by the C172 pilot.

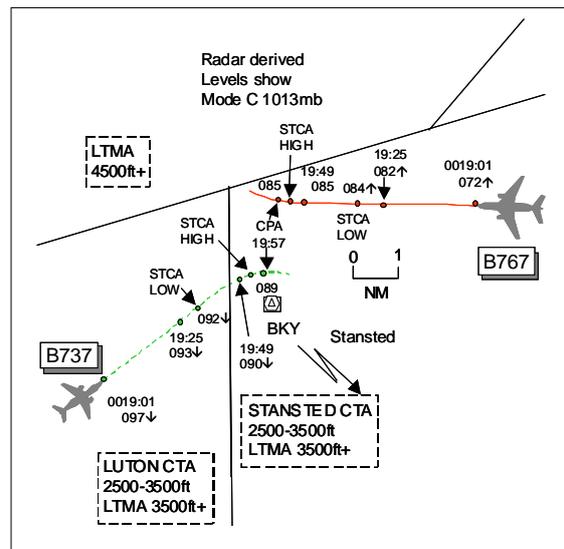
Reported Separation:
250ft V/1nm H 400ft V/1nm H

Recorded Separation:
400ft V/1.6nm H

Cause: The B767 crew did not set SAS and climbed above their cleared level.

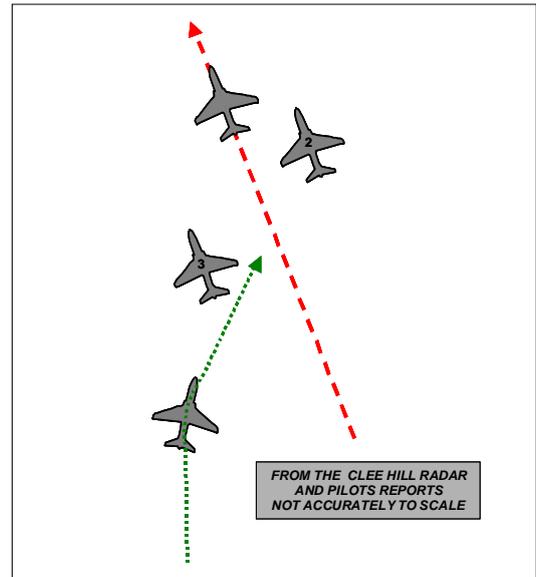
AIRPROX REPORT NO 161/08

Date/Time: 3 December 1532
Position: 5303N 00413W (16nm SE RAF Valley)
Airspace: Valley ATA (Class: G)
Reporting Ac Reported Ac
Type: Hawk TMK1 Hawk TMK1
Operator: HQ Air (Trg) HQ Air (Trg)
Alt/FL: 7600ft 5000ft
(RPS 998mb) (QFE 1001mb)
Weather VMC CAVOK VMC CAVOK
Visibility: 25km >10km
Reported Separation:
30ft V/0m H 30ft V/30-50m H
Recorded Separation:
Est <100ft/<100m (See Note 5)

Cause: An effective non-sighting by the singleton crew and late sightings by the Hawk formation crews.

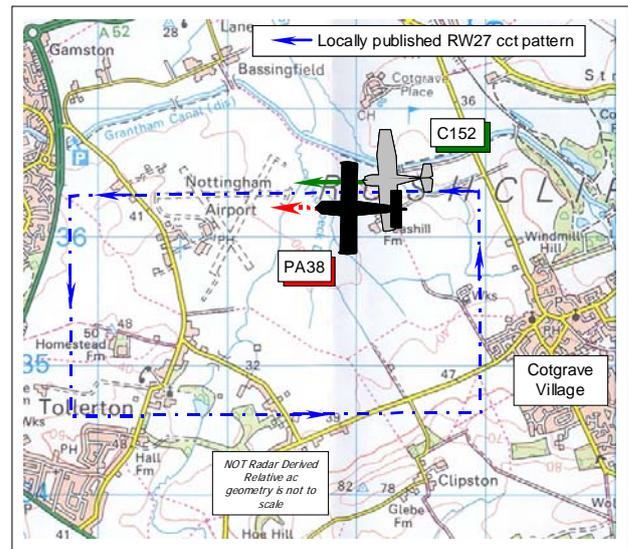
AIRPROX REPORT NO 162/08

Date/Time: 5 Dec 1333
Position: 5255N 00105W (½nm FINALS to RW27 at Nottingham)
Airspace: Nottingham ATZ (Class: G)
Reporting Ac Reported Ac
Type: C152 PA38
Operator: Civ Trg Civ Trg
Alt/FL: 300ft↓ FINALS↓
 QFE QFE
Weather VMC CLOC VMC CLOC
Visibility: >10km 10km
Reported Separation:
 6ft V/1m H Not seen
Recorded Separation:
 Not recorded

Cause: The PA38 student pilot flew into conflict with the C152 on final approach which she did not see.

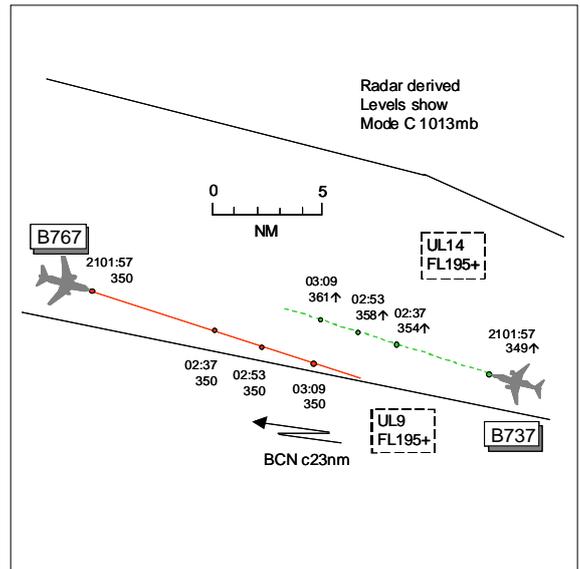
AIRPROX REPORT NO 163/08

Date/Time: NIGHT 5 Dec 2103
Position: 5146N 00238W (23nm E BCN)
Airspace: UAR UL14/UL9 (Class: C)
Reporting Ac Reported Ac
Type: B737-800 B767-300
Operator: CAT CAT
Alt/FL: FL352↑ FL350
Weather VMC CLAC VMC
Visibility: 50nm Unltd
Reported Separation:
 600ft V/3nm H 700ft V/>5nm H
Recorded Separation:
 800ft V/4-4nm H
 OR 1100ft V/2nm H

Cause: The LAC S5/6/8/9/23/35/36T did not take the B767 into account when climbing the B737.

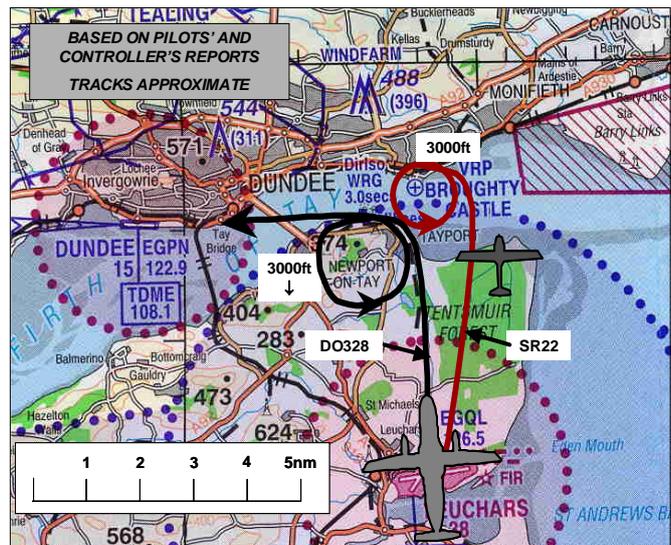
AIRPROX REPORT NO 164/08

Date/Time: 3 Dec 1522
Position: 5627N 00252W (4.5nm E Dundee)
Airspace: Scottish FIR (Class: G)
Reporting Ac Reported Ac
Type: Dornier 328-100 Cirrus SR22
Operator: CAT Civ Pte
Alt/FL: 1400ft 3000ft
(QNH 1002 mb) (QNH NR mb)
Weather VMC CAVOK N/R
Visibility: CAVOK 10 km
Reported Separation:
<500ft V/<1nm H 500ft V/1-1.5nm H
Recorded Separation:
NR

The Board noted that in the absence of any radar information, this had been a very difficult incident to analyse with any degree of certainty. Also, since the diagram (above) was based only on the various reports, rather than on radar-verified data, a Member of the Secretariat briefed the probable sequence of events pointing out that both ac had been handed over to Dundee relatively late (probably coasting out on Northerly tracks) and high. He also explained why the Leuchars transcripts had not been requested until well after the incident and noted their cooperation when it emerged later that transcripts would greatly assist the investigation.

Cause: Whilst orbiting on final approach in a busy traffic situation, the Do328 experienced a TCAS RA against the SR22.

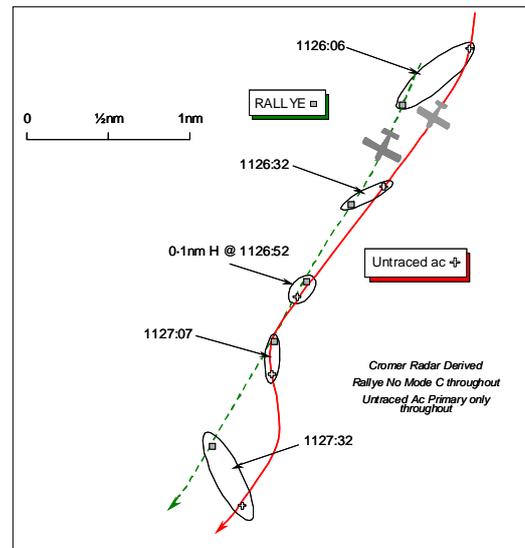
AIRPROX REPORT NO 166/08

Date/Time: 6 Dec 1126 (Saturday)
Position: 5221N 00106E (1½nm SSW of Diss)
Airspace: London FIR (Class: G)
Reporting Ac Reported Ac
Type: Rallye 893 Untraced Ac
Operator: Civ Pte N/K
Alt/FL: 1500ft NR
QNH (1014mb) NR
Weather VMC CAVOK NR
Visibility: >10km NR
Reported Separation:
25-50ft V/150m H
Recorded Separation:
~0.1nm H

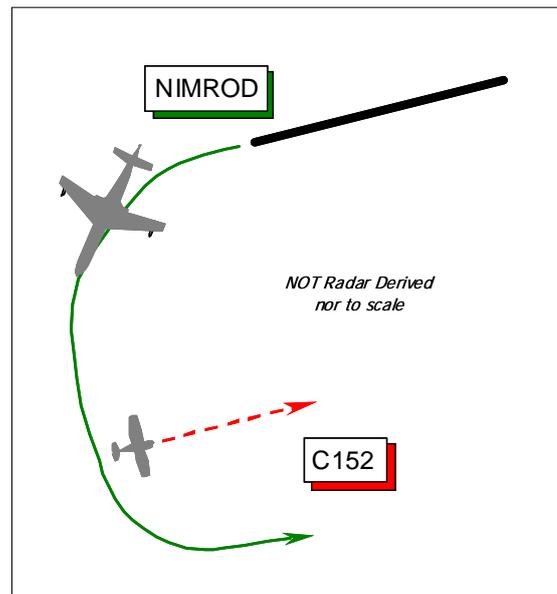
AIRPROX REPORT NO 167/08

Date/Time: 8 December 1449
Position: 5739N 00334W (RW26 cct Kinloss
- elev 22ft)
Airspace: Kinloss ATZ/MATZ (Class: G)
Reporting Ac Reported Ac
Type: Nimrod MR2 Cessna 152
Operator: HQ Air (Ops) Civ Trg
Alt/FL: 750ft↑ 800ft
QFE (1012mb) QFE (1012mb)
Weather VMC CLOC VMC COCISS
Visibility: 30nm >10km
Reported Separation:
Nil V/500m H Nil V/500m H
Recorded Separation:
Not recorded

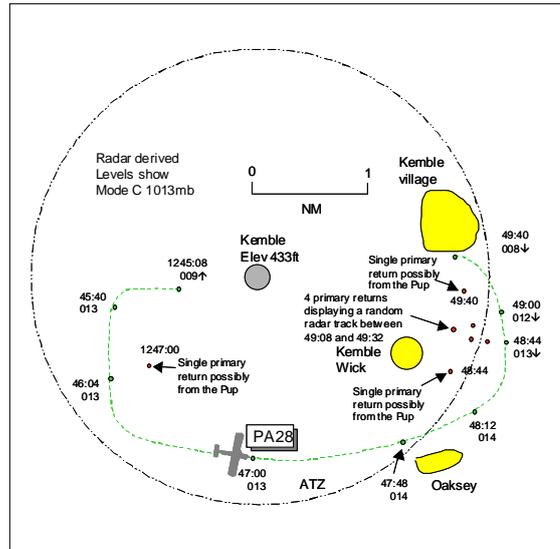
AIRPROX REPORT NO 170/08

Date/Time: 17 Dec 1250
Position: 5140N 00203W (0.25nm FIN APP
RW26 Kemble - elev 433ft)
Airspace: ATZ (Class: G)
Reporting Ac Reported Ac
Type: PA28 Beagle Pup
Operator: Civ Trg Civ Trg
Alt/FL: 200ft 200ft↓
(QFE 1000mb) (QFE)
Weather VMC CLNC VMC CLBC
Visibility: >10km >10km
Reported Separation:
50ft V Not seen
Recorded Separation:
NR
