UK AIRPROX BOARD

Analysis of Airprox in UK Airspace

**Report Number 17
July 2006 – December 2006**

Seventeenth Report by the UK Airprox Board:

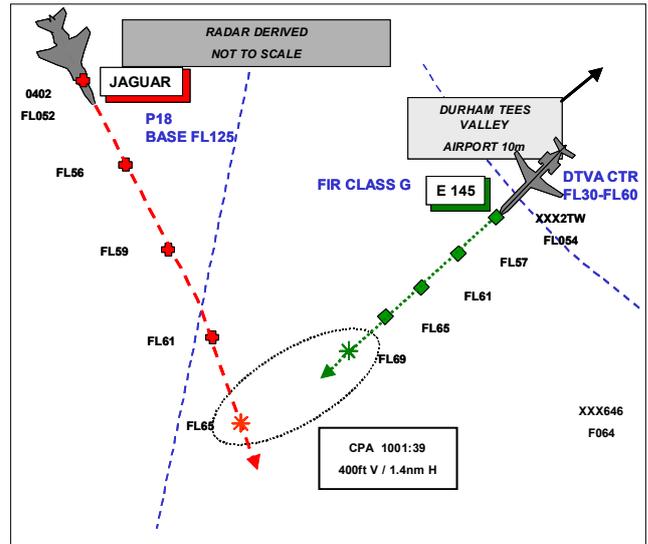
Date/Time: 04 Jul 1056
Position: 5425N 00135W(12 nm SW Teesside)
Airspace: London FIR (Class: G)
Reporting Ac Reported Ac
Type: E145 Jaguar
Operator: CAT HQ STC
Alt/FL: FL075↑ FL50↑

Weather: VMC CLAC VMC CLAC
Visibility: 8km >10km
Reported Separation:
 0ft V/1nm H NR
Recorded Separation:
 400ft V/1.4nm H

THE E145 PILOT reports flying a scheduled passenger flight from Durham Tees Valley Airport (DTVA). After departure from RW23 and climbing ahead to GASKO, at 220-240kt and passing FL075, traffic was observed on the TCAS to the R which was quickly followed by a TCAS RA with an aural message to maintain vertical speed. A vertical speed in excess of 3000ft/min was required to maintain the green band. The First Officer (FO) became visual with a military ac at very close proximity passing at high speed directly from R to L; it was also climbing past them with no vertical separation. The military ac remained at their level, within -100ft to +100ft relative altitude. The horizontal distance was difficult to judge but was less than 2nm – the First Officer was virtually able to see the other pilot. The FO reported the conflict to ATC who identified the ac as a Jaguar from RAF Leeming. After passing, the Jaguar climbed steeply. He assessed the risk as being medium/high and added that a contributory factor had been the ‘excessive speed of the military ac in civil airspace’.

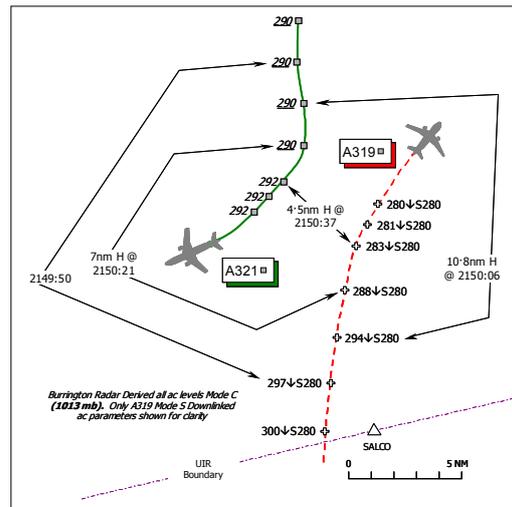
AIRPROX REPORT NO 090/06

Date/Time: 4 Jul 2150 NIGHT
Position: 4954N 00336W (10nm NNW of SALCO)
Airspace: UAR UN26 (Class: C)
Reporting Ac Reported Ac
Type: A321 A319
Operator: CAT CAT
Alt/FL: FL290 ↓FL280
Weather VMC NR VMC NR
Visibility: 10km+ 10km+
Reported Separation:
400ft V/4-5nm H 400ft V/4-5nm H
Recorded Separation:
900ft V/4-5nm H [Burrington Radar]

THE A321 PILOT reports that he was outbound from Bristol and was executing an en-route climb S of BERRY HEAD VOR (BHD), approaching SALCO on the UIR boundary, whilst in receipt of a RCS from LACC on 126-075MHz. A squawk of A2210 was selected with altitude reporting; Mode S is fitted.

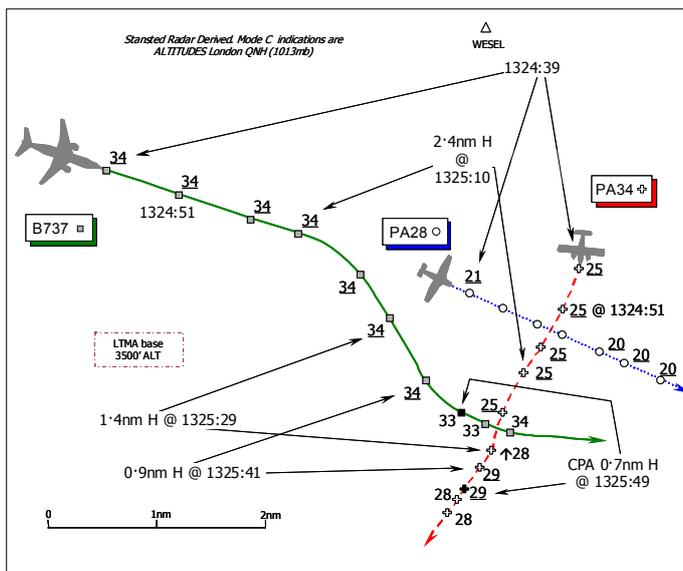
AIRPROX REPORT NO 091/06

Date/Time: 4 Jul 1325
Position: 5136N 00026E (10nm WNW of Southend-on-Sea)
Airspace: London FIR (Class: G)
Reporting Ac **Reported Ac**
Type: B737-300 PA34
Operator: CAT Civ Club
Alt/FL: ↓3400ft (QNH 1014mb) (N/K)
Weather NK CAVOK VMC CAVOK
Visibility: >10km NR
Reported Separation:
800ft V/2-2½nm H Not seen
Recorded Separation:
400ft V/0.7nm H

THE B737-300 PILOT reports that he was inbound on an IFR FPL to Southend Airport for maintenance on a 'gear-down' ferry flight and was in receipt of a RIS from Southend ATC whilst positioning left hand downwind for RW06 at 210kt. Heading 190°, he thought, descending to an altitude of 3400ft (1014mb), RADAR advised of a PA28 Cherokee that was 1400ft below them some 3nm away and of another ac. The other ac, which had showed as a contact on TCAS from a range of 5-6nm commenced a climbing wing-over directly in front of them – this was actually the PA34. Avoiding action was taken immediately. As the Captain of the ac, he took control from the 1st Officer PF and initiated a L turn at which point TCAS enunciated an RA 'CLIMB' instruction. The climb was initiated whereupon TCAS then enunciated 'CLEAR OF CONFLICT' almost immediately. Visual contact was maintained with the PA28 Cherokee at all times which passed about 2 – 2½nm away at the closest point some 800ft below his ac. By then, however, they had turned 90° to the L in a slight climb and the other ac was in their 3 o'clock being watched by his 1st Officer. Southend APPROACH was informed of the TCAS RA on RT. He added that it was only as they were being vectored by Southend that the PA34 started his manoeuvres which triggered their avoidance and the TCAS RA.

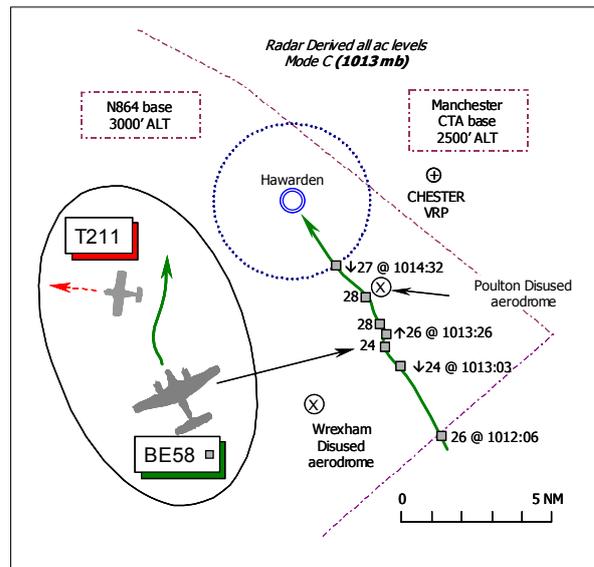
AIRPROX REPORT NO 093/06

Date/Time: 6 Jul 1013
Position: 5306N 00253W (6nm SSE of Harwarden - elev 45ft)
Airspace: London FIR (Class: G)
Reporting Ac Reporting Ac
Type: BE58 T211
Operator: Civ Pte Civ Pte
Alt/FL: 2300ft↓ 2000ft
 QNH (1014mb) RPS (1009mb)
Weather VMC NR VMC HAZE
Visibility: 20nm 5nm
Reported Separation:
 30ft V/100m H 50ft V/50ft H
Recorded Separation:
 NR

THE BEECH BE58 PILOT reports his ac has a white/blue colour scheme and the HISLS were on whilst inbound to Woodvale from Blackbushe flying solo under VFR. TCAS is fitted.

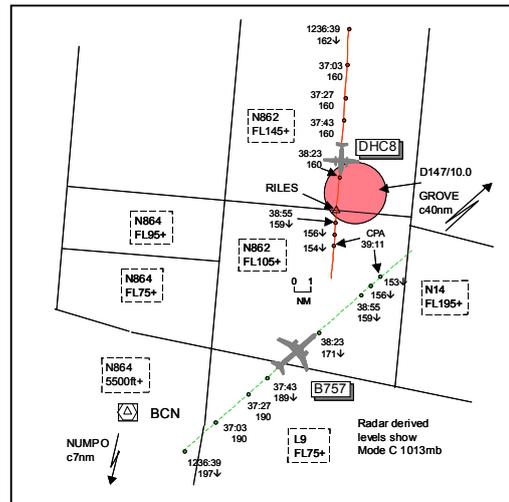
AIRPROX REPORT NO 094/06

Date/Time: 8 Jul 1239 (Saturday)
Position: 5153N 00253W (17nm NE BCN)
Airspace: AWY N862 (Class: A)
Reporting Ac Reported Ac
Type: B757 DHC8
Operator: CAT CAT
Alt/FL: FL158↓ NR
Weather IMC CLOC NR
Visibility: 5nm NR
Reported Separation:
100ft V/2.5nm H Not seen
Recorded Separation:
100ft V/3.6nm H

THE B757 PILOT reports heading 060° at 300kt inbound to Birmingham IFR routing NUMPO to GROVE under a RAS, he thought, from Swanwick (Mil) and squawking 6402 with Mode C. Passing FL158 descending, with a moderately high ROD - they had been kept high earlier - to FL70 to be level 15nm before GROVE, a TCAS 'traffic, traffic' aural alert was heard with TCAS displaying traffic on the VSI, off-scale in their 10 o'clock and 300ft below. Whilst looking for this traffic and when passing FL155, Swanwick (Mil) called "B757 c/s stop descent FL160". They replied "...unable passing FL155". TCAS now displayed the traffic 9 o'clock 3nm and 100ft above. As Swanwick (Mil) gave them TI, they saw the traffic, a white coloured twin turboprop, passing 2.5nm away just above their level. No TCAS RA was received during the encounter and their descent was continued towards GROVE. He assessed the risk as medium.

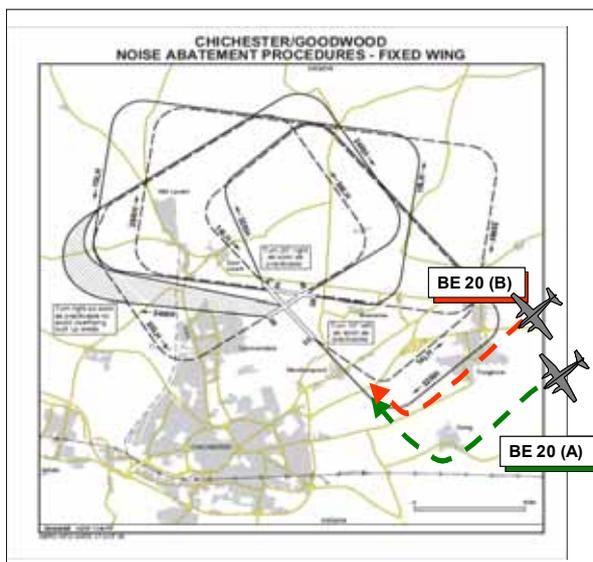
AIRPROX REPORT NO 095/06

Date/Time: 7 Jul 0756
Position: 5152N 00045W (Goodwood Circuit - elev 110ft)
Airspace: ATZ (Class: G)
Reporting Ac Reported Ac
Type: BE20 BE20
Operator: Civ Com Civ Exec
Alt/FL: 700ft↓ 700ft↓
(QNH 1017mb) (QNH 1014mb)
Weather VMC CLBC VFR CLBC
Visibility: >10km 10km
Reported Separation:
0 V/ 100ft H 300ft V/ 1-2nm H
Recorded Separation:
NR

THE BE20 (A) PILOT reports flying a non-scheduled passenger flight into Goodwood and in receipt of an AFIS from them. All lights were switched on and they were squawking 7000, he thought, but with Mode C selected off. They and another BE20 were joining the traffic pattern for RW32. They joined right base and heard a call from the other ac reporting wide left base; on hearing this call they turned onto a 2nm final. At 1.8nm the other ac called '2nm final 32'. Their TCAS alert at this time began flashing red with an associated audio warning. There was no traffic seen on their left but they then saw the other ac in their 2.30 position at about 100ft horizontal separation so he initiated a go around. Goodwood radio called the other ac to ask why he had called left base when actually he was on right base. Its pilot then apologised. He assessed the risk as being very high.

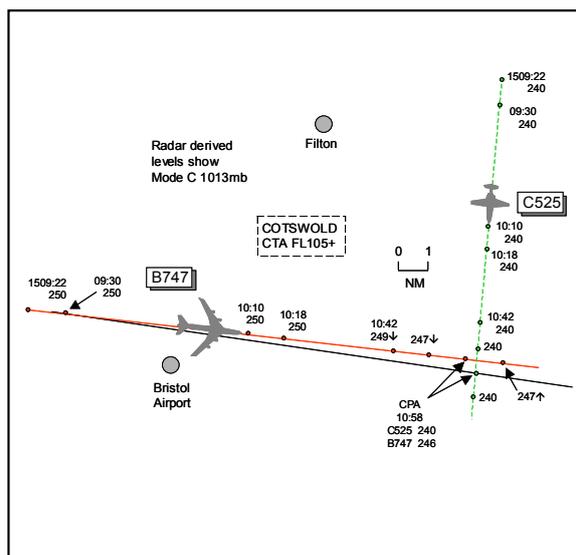
Date/Time: 9 Jul 1511 (Sunday)
Position: 5123N 00227W (3nm W Bath)
Airspace: Cotswold CTA/UP2 (Class: A/C)
Reporting Ac Reported Ac
Type: C525 Citation B747-400F
Operator: Civ Pte CAT
Alt/FL: FL240 ↓FL180

Weather VMC CLAC VMC NR
Visibility: >100km NR
Reported Separation:
500ft V/nil H 500ft V
Recorded Separation:
600ft V/0.6nm H

THE C525 PILOT reports heading 185° at 380kt and FL240 en route to the Channel Islands and in receipt of a RCS from Swanwick Mil squawking 6401 with Mode C. The visibility was >100km flying 10000ft above cloud in VMC and TCAS 1 was fitted (no RA warnings). ATC told him about other traffic, the B747, descending to FL250 to pass 1000ft O/H: it was clearly visible at 10nm range in his 1 o'clock. TCAS sounded a TA alert as the B747 moved to his 2 o'clock position showing +700 on his display. The B747 was seen to continue its descent to +500 before climbing again. No avoiding action was taken as he only realised that the B747 was not levelling at FL250 when O/H and the risk of collision had passed. ATC gave him an 'avoiding action' descent but this was as the B747 was just behind his tail and diverging. The time between the TA alert and the B747 crossing O/H was 1-2sec. He assessed the risk as medium.

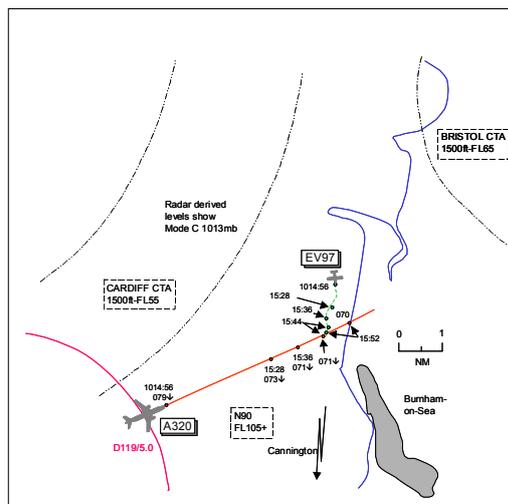
Date/Time: 11 Jul 1016
Position: 5117N 00303W (13nm SE Cardiff)
Airspace: LFIR (Class: G)
Reporting Ac Reporting Ac
Type: EV97 Eurostar A320
Operator: Civ Pte CAT
Alt/FL: FL74↓ FL70↓

Weather VMC CLAC VMC CLAC
Visibility: >20km 'excellent'
Reported Separation:
200ft V/200m H 500ft V/200m H
Recorded Separation:
0.2nm H

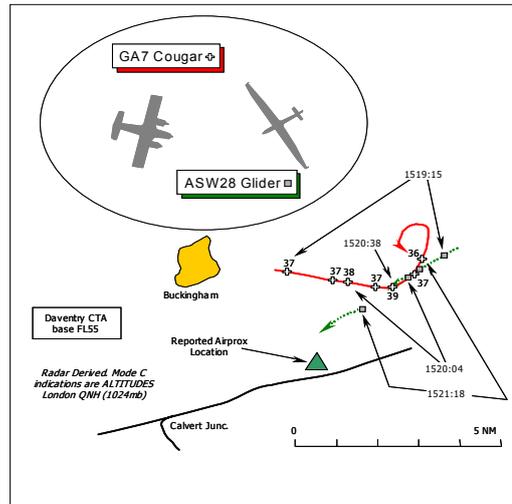
AIRPROX REPORT NO 099/06

Date/Time: 11 Jul 1520
Position: 5159N 00051W (4nm E of Buckingham)
Airspace: London FIR (Class: G
Reporting Ac Reported Ac
Type: ASW28 Glider GA7 Cougar
Operator: Civ Pte Civ Trg
Alt/FL: 3800ft NR
(QFE NR) (NR)
Weather: VMC CLEAR VMC NR
Visibility: 40km NR
Reported Separation:
50ft V/nil H NR
Recorded Separation:
Not recorded

THE ASW 28 GLIDER PILOT reports that she had departed from Dunstable Down in her white/red glider and was flying towards Bicester Airfield from Milton Keynes. Her last climb had enabled her to ascend to a height of 4700ft Dunstable QFE (unspecified) – Dunstable Down Glide Site elevation 500ft amsl - and she was now descending slowly through about 3800ft QFE – about 4300ft amsl. A white low-wing twin with red markings was first seen 10nm away to starboard flying at the same level and closing rapidly. She waggled her glider's wings in an attempt to make her glider more conspicuous as she was at the same level, but without any response from the other aircraft. Then she put a wing down so that her glider presented a 'plan-form' and could be seen, but still with no reaction. Approaching a position about 4nm SE of Buckingham (51°57'N 000°54'W) heading 256° at 95kt, she realised that the other pilot had not seen her glider so she opened the airbrakes and executed an avoiding action dive, bottoming out at an altitude of about 1200ft. It seemed to her that the pilot of the other ac noticed her glider only as she passed directly beneath his ac, as only then did the other ac climb suddenly, but it never changed course. Minimum vertical separation was 50ft and the risk assessed as "high". After climbing back to an altitude of 3000ft, she set course for Calvert junction and then returned to Dunstable Down. She added that she had been visual with the other ac for a good 2min in a visibility of 40km+ with no cloud, albeit that she was flying into the sun.

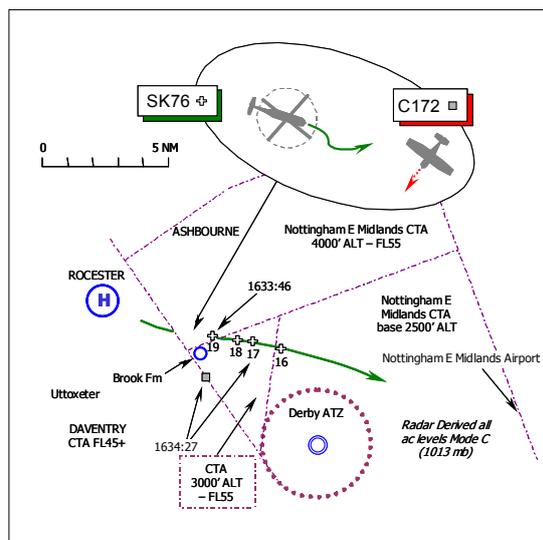
AIRPROX REPORT NO 100/06

Date/Time: 7 Jul 1633
Position: 5257N 00145W (14nm WNW East Midlands Airport)
Airspace: London FIR (Class: G)
Reporting Ac SK76 Reported Ac C172
Type: SK-76 Helicopter Cessna 172
Operator: Civ Exec Civ Pte
Alt/FL: 1600ft↑ NR
QNH (1016mb) (N/K)
Weather VMC NIL VMC NR
Visibility: 10+km 40km
Reported Separation:
50ft V/75m H Not seen
Recorded Separation:
NR

THE SK76 HELICOPTER PILOT provided a very comprehensive account reporting that his ac has a white & yellow/red striped colour-scheme and the HISLs were on. He was outbound VFR from a company HLS at Rocester, some 5nm N of Uttoxeter, to Nottingham East Midlands Airport (EMA) at 130kt and had just contacted E Midlands ATC on 134.175MHz although they were not yet identified on radar. A squawk of A7000 was selected, he thought, with Mode C; Mode S and TCAS 1 are fitted.

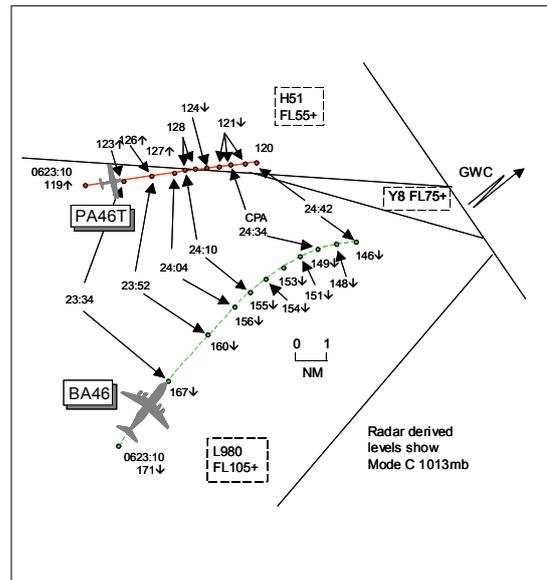
Weather VMC CLOC VMC NR
Visibility:
Reported Separation:
 Not seen Not seen
Recorded Separation:
 2800ft V/3·8nm H

THE LACC S19/20/21T reports descending two BA46s (the subject BA46 is 8nm ahead of the second BA46) to FL130 to be level by GWC when she noticed a PA46T at FL126. She immediately stopped both BA46s at FL140 and turned the subject BA46 R onto heading 100°. Her Planner telephoned LTCC SW to find out what they were doing with the PA46T and inform them of her actions. TC informed them that the PA46T flight was a 'level bust' and that they were happy to take her traffic at FL140. The PA46T was seen to descend to FL120 and she transferred both BA46 flights to LTCC.

Cause: The PA46T pilot climbed above his cleared level causing the LACC and LTCC controllers concern.

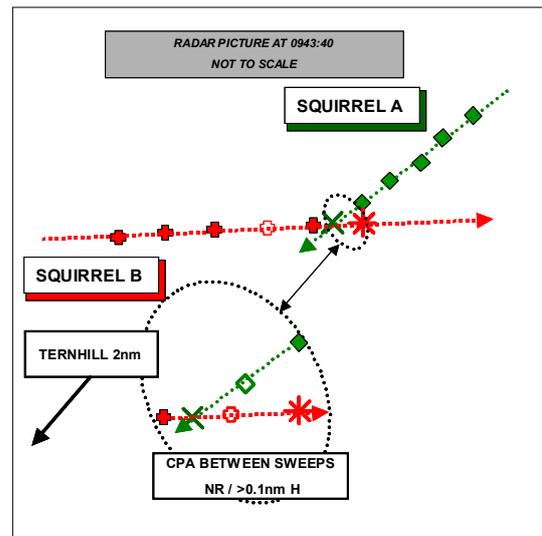
AIRPROX REPORT NO 102/06

Date/Time: 11 Jul 0944
Position: 5254N 00230W (2nm NE of Ternhill - elev 272ft)
Airspace: Ternhill MATZ (Class: G)
Reporting Ac Reporting Ac
Type: Squirrel Squirrel
Operator: HQ PTC HQ PTC
Alt/FL: 1250ft 1500ft
(QFE 1014mb) (QFE 1014mb)
Weather: VMC NR VMC NR
Visibility: 25km 999km
Reported Separation:
250ft V/100m H 50ft V/100m H
Recorded Separation:
NR V/<0.1nm H

Cause: Conflict in the Shawbury CMATZ resolved by Squirrel (A) pilot.

The Board noted the HQ PTC comments and that a full internal inquiry into this incident had already been conducted, its recommendations implemented. Members also noted that the Ternhill ATZ RT procedures had been aligned with the civilian rules at the Rules of the Air, Rule 39.

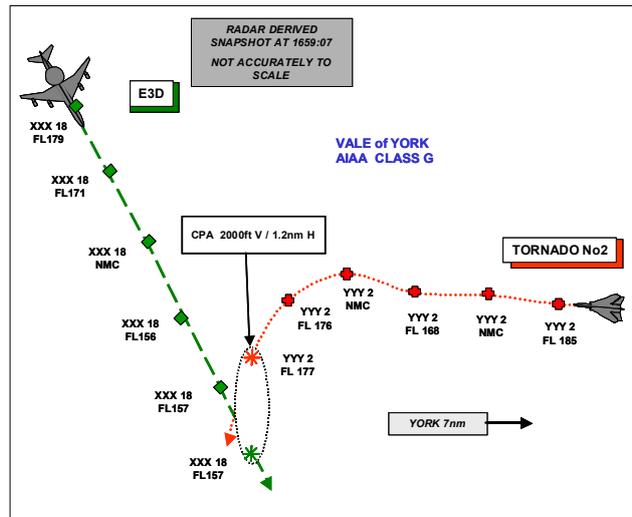
AIRPROX REPORT NO 103/06

Date/Time: 13 Jul 1659
Position: 5400N 00054W (7nm E York)
Airspace: Vale of York AIAA (Class: G)
Reporting Ac Reported Ac
Type: Sentry AEW Mk1 Tornado GR4
Operator: HQ STC HQ STC
Alt/FL: FL160↓ 14000ft
(RPS)
Weather VMC CAVOK VMC CAVOK
Visibility: 50km 20km
Reported Separation:
0ft V/1/2nm H 1000ft V/3nm H
Recorded Separation:
2000ft V/1.2nm H

Cause: Sighting report.

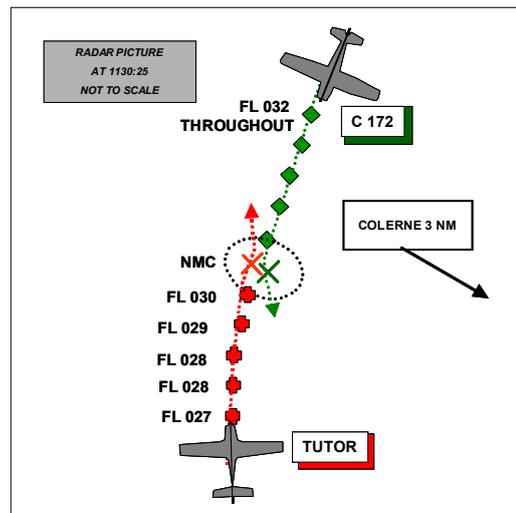
AIRPROX REPORT NO 104/06

Date/Time: 11 Jul 1133
Position: 5126N 00222W (3nm West of Colerne)
Airspace: London FIR (Class: G)
Reporting Ac Reported Ac
Type: Cessna 172 Grob Tutor
Operator: Civ Pte HQ PTC
Alt/FL: 3200ft FL33
(RPS 1020mb)
Weather VMC CLBC VMC NR
Visibility: >10km >10km
Reported Separation:
0ft V/300m H 100ft V/100ft H
Recorded Separation:
NR V/0.1nm H (See UKAB Note 3).

Cause: Conflict in the FIR resolved by both pilots.

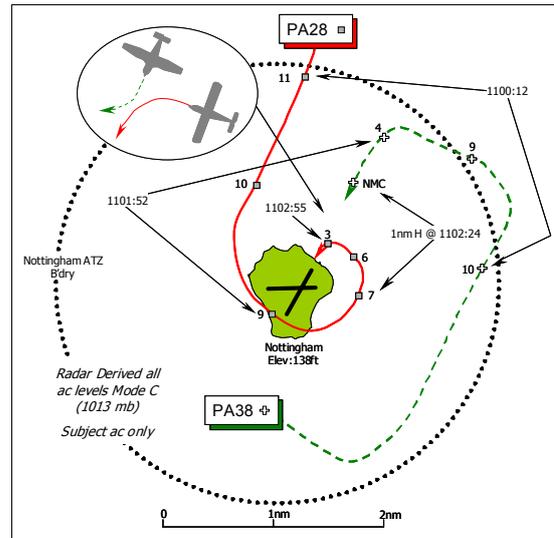
AIRPROX REPORT NO 105/06

Date/Time: 8 Jul 1112 (Saturday)
Position: 5256N 00104W (Finals RW21
 Nottingham - elev 138ft)
Airspace: Nottingham ATZ (Class: G)
Reporting Ac **Reported Ac**
Type: PA38-112 PA28
Operator: Civ Trg Civ Club
Alt/FL: 200ft↓ NR
 QFE (1011mb) (NR)
Weather VMC CAVOK VMC CAVOK
Visibility: >10km >10km
Reported Separation:
 50ft V/nil H NR
Recorded Separation:
 Not recorded

Cause: The PA28 pilots did not integrate safely into the Nottingham A/D cct in accordance with Rules 17 (5) & (6) of the Rules of the Air Regulations 1996 and flew into conflict with the PA38 on final approach, which they did not see.

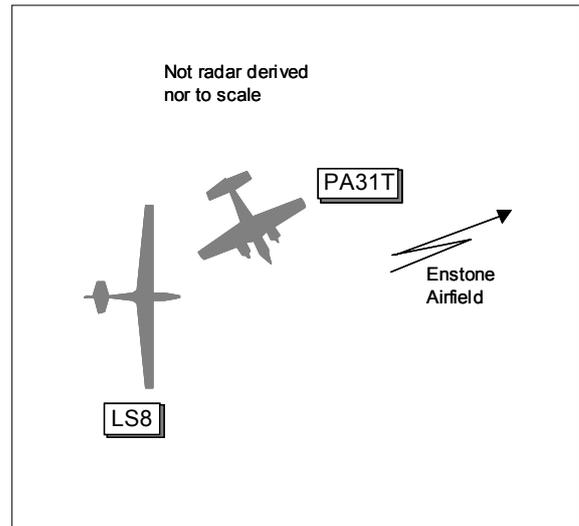
AIRPROX REPORT NO 106/06

Date/Time: 14 Jul 1616
Position: 5156N 00128W (1.5nm WSW Enstone
 - elev 550ft)
Airspace: Oxford AIAA (Class: G)
Reporting Ac Reported Ac
Type: LS8 Glider PA31T2
Operator: Civ Club Civ Comm
Alt/FL: 3000ft↓ 2800ft↓
 (amsl) (QNH 1032mb)
Weather: VMC CLNC VMC SKC
Visibility: 35km >40km
Reported Separation:
 5ft V/5m H Not seen
Recorded Separation:
 NR

Cause: Non-sighting by the PA31T pilot and an effective non-sighting by the LS8 pilot.

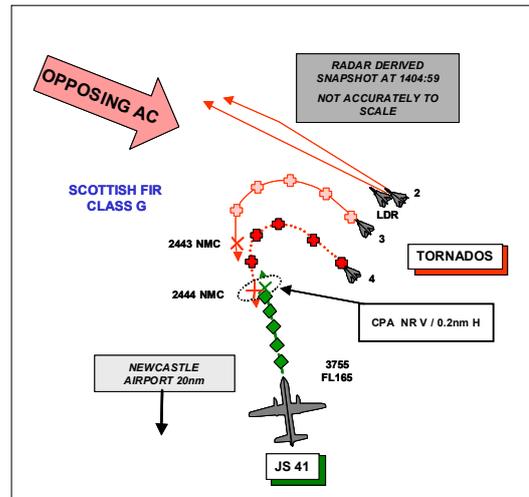
AIRPROX REPORT NO 107/06

Date/Time: 17 Jul 1405
Position: 5520N 00135W (16nm N NEW)
Airspace: Scottish FIR (Class: G)
Reporting Ac Reported Ac
Type: Jetstream 41 Tornado F3
Operator: CAT HQ STC
Alt/FL: FL165 16000ft
(RPS 1020mb)
Weather: VMC NR VMC NR
Visibility: 50km 50km
Reported Separation:
500ft V/500ft H 800ft V/30m H
Recorded Separation:
NR V/0.2nm (370m) H

Cause: Conflict in Class G airspace resolved by both crews.

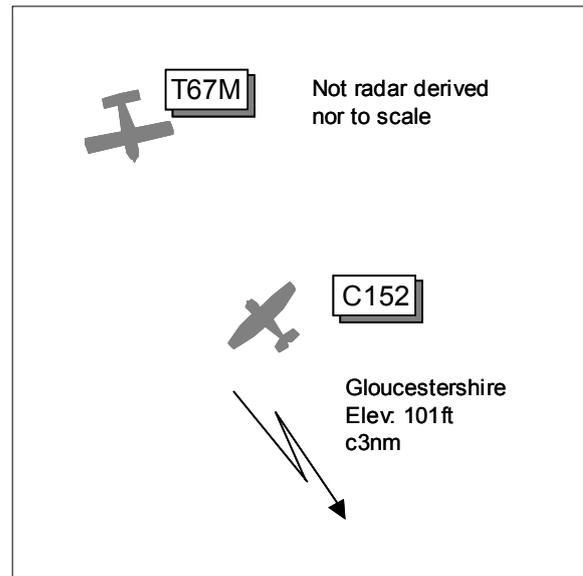
AIRPROX REPORT NO 108/06

Date/Time: 19 Jul 1318
Position: 5156N 00212W (3nm NW
 Gloucestershire - elev 101ft)
Airspace: LFIR/ATZ (Class: G)
Reporting Ac Reporting Ac
Type: C152 Slingsby T67M
 Firefly
Operator: Civ Trg Civ Trg
Alt/FL: 2200ft[↑] 2100ft
 (QNH 1014mb) (QNH)
Weather VMC NR VMC CLNC
Visibility: NR >30km
Reported Separation:
 30ft V/100m H 'above' V/200m H
Recorded Separation:
 NR

Cause: Conflict in Class G resolved by both pilots.

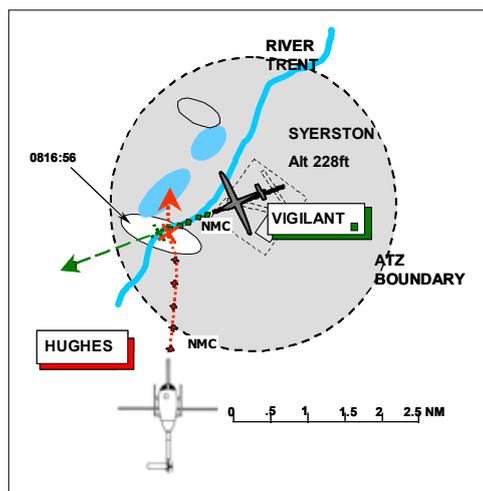
AIRPROX REPORT NO 109/06

Date/Time: 21 Jul 0817
Position: 5301N 00056W (1nm SW Syerston - elev 228ft)
Airspace: Syerston ATZ (Class: G)
Reporting Ac Reported Ac
Type: Vigilant Glider Untraced Helicopter
Operator: HQ PTC NR
Alt/FL: 800ft↑ NR
(QFE) (NR)
Weather VMC CLBC NR
Visibility: 8km NR
Reported Separation:
0ft V/150m H NR
Recorded Separation:
NR V/ approx 150m H (from projected position)

Cause: The helicopter pilot entered the Syerston ATZ without complying with Rule 39 of the Rules of the Air and flew into conflict with the Vigilant whose pilot saw it late.

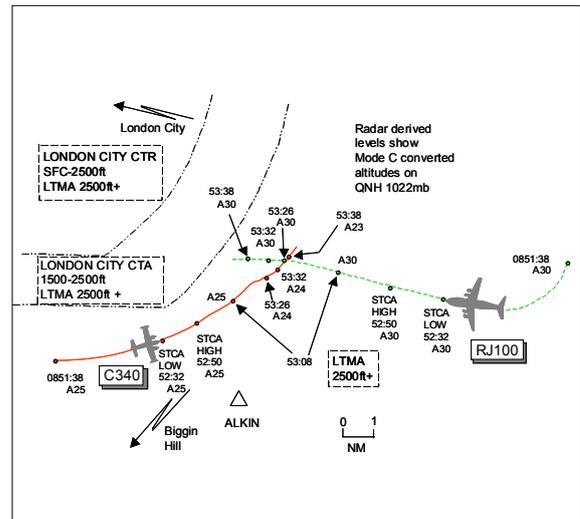
AIRPROX REPORT NO 111/06

Date/Time: 24 Jul 0854
Position 5126N 00013E (7nm SE London/City - elev 19ft)
Airspace: LTMA/FIR (Class: A/G)
Reporting Ac Reported Ac
Type: RJ100 C340
Operator: CAT Civ Pte
Alt/FL: 3000ft 2300ft
 (QNH) (QNH 1022mb)
Weather VMC NR VMC CAVK
Visibility: NR >25km
Reported Separation:
 400ft V/nil H 500ft V/nil H
Recorded Separation:
 600ft V/0.2nm H

Cause: Sighting report.

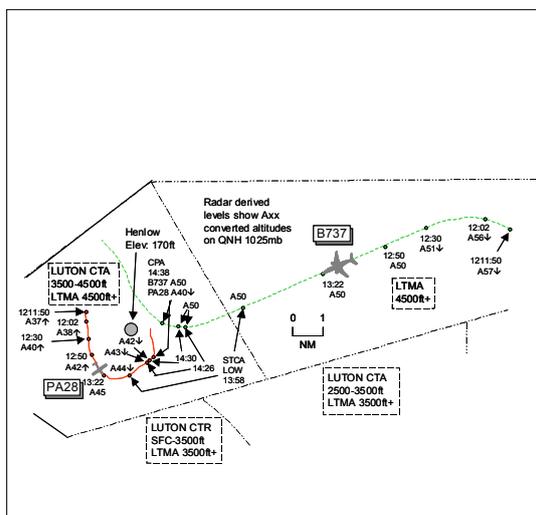
AIRPROX REPORT NO 112/06

Date/Time: 17 Jul 1215
Position: 5201N 00016W (1nm SE Henlow
- elev 170ft)
Airspace: LTMA/FIR (Class: A/G)
Reporting Ac Reported Ac
Type: B737-700 PA28
Operator: CAT Civ Trg
Alt/FL: 5000ft 3400ft
(QNH) (QNH)
Weather VMC CLNC VMC CLOC
Visibility: 30km >10km
Reported Separation:
300ft V/3000m H 1500ft V/250m H
Recorded Separation:
1.3nm H

THE PA28 OPERATOR reports the transponder encoder was tested 'in situ' by a local avionics engineer, when requested by the CFI, and was found to have a gross error which changed when the unit was vibrated. The AR580 Encoder was subsequently bench tested by the operator's Engineering Company which provided a Workshop Test Report dated 3rd August stating that the unit was faulty and beyond economical repair; it was subsequently replaced.

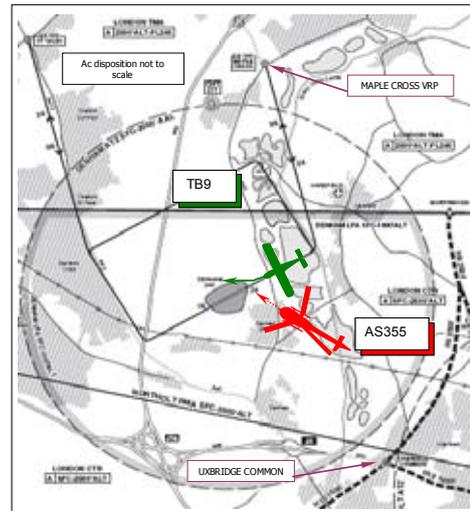
AIRPROX REPORT NO 113/06

Date/Time: 23 Jul 1230 (Sunday)
Position: 5135N 00031W (Final approach RW24
Denham - elev 249ft)
Airspace: Denham ATZ (Class: A)
Reporting Ac Reported Ac
Type: TB9 AS355
Operator: Civ Pte Civ Comm
Alt/FL: 350ft 50ft↓
(QFE 1011mb) (QFE 1011mb)
Weather VMC CLBC VMC CAVOK
Visibility: >10km 10km+
Reported Separation:
Nil V/30m H Nil V/60m H
Recorded Separation:
Not recorded

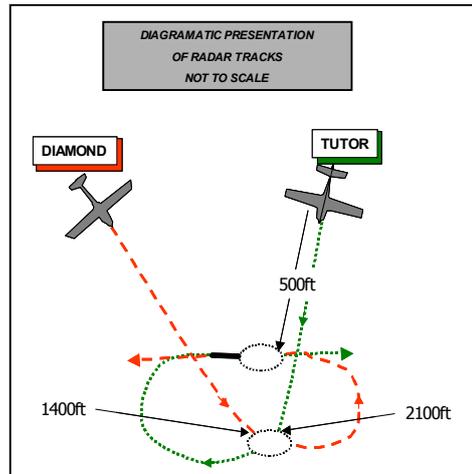
AIRPROX REPORT NO 115/06

Date/Time: 26 Jul 0940
Position: 5224N 00017W(10nm W Wyton)
Airspace: London FIR (Class: G)
Reporting Ac Reported Ac
Type: Grob Tutor Diamond DA40
Operator: HQ PTC Civ Trg
Alt/FL: 500ft↓ 1000ft↓
(RPS 1013mb) (QNH 1017mb)
Weather VMC CLBC VMC HAZE
Visibility: 20km 5-6km
Reported Separation:
50ft V/O H 250ft V/150-200m H
Recorded Separation:
NR

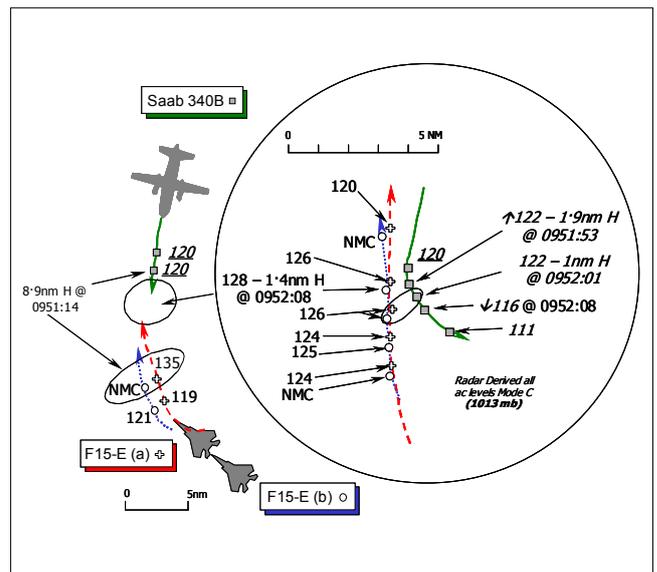
Date/Time: 31 Jul 0952
Position: 5653N 00412W (11nm N by E of RANOK)
Airspace: ADR W3D (Class: F)
Reporting Ac Reported Ac
Type: Saab 340B F-15E x2
Operator: CAT Foreign Mil
Alt/FL: FL120 FL120

Weather: IMC VMC CLOC
Visibility: 6nm 10-15km
Reported Separation:
 Minimal V/1-2nm H >1000ft V/2-3nm H
Recorded Separation:
 200ft V @ 1.9nm H
 1nm H @ 400ft V

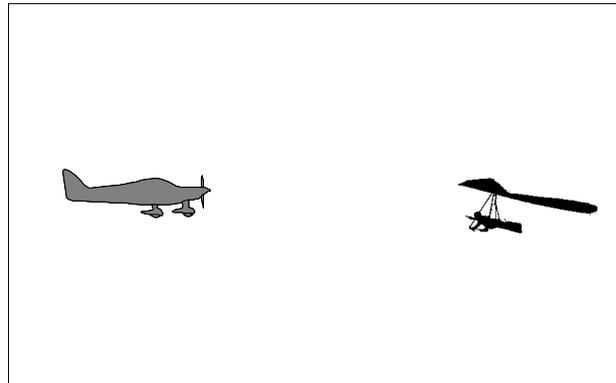
AIRPROX REPORT NO 118/06

Date/Time: 27 Jul 1435
Position: 5455.8N 00651.8W
(12 SE Eglinton)
Airspace: Scottish FIR (Class: G)
Reporting Ac Reported Ac
Type: Hang Glider Untraced
Operator: Civ Club NR
Alt/FL: 2700ft NR
(NR) NR
Weather VMC CAVOK NR NR
Visibility: >20nm NR
Reported Separation:
Nil V/150-200ft H NR
Recorded Separation:
NR

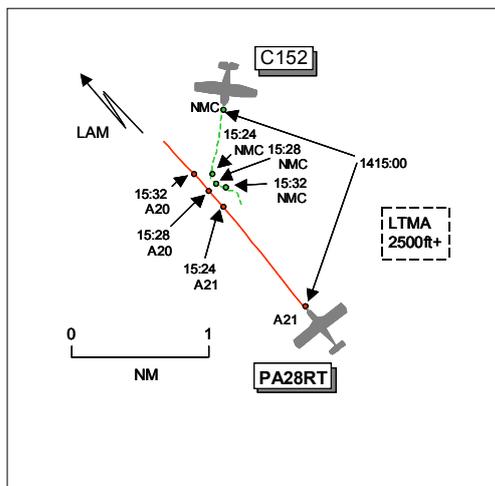
AIRPROX REPORT NO 119/06

Date/Time: 25 Jul 1415
Position: 5135N 00016E (6nm SE LAM)
Airspace: LFIR (Class: G)
Reporting Ac Reported Ac
Type: C152 PA28RT
Operator: Civ Pte Civ Pte
Alt/FL: 2100ft 2000ft
(QNH 1016mb) NR
Weather VMC CAVOK VMC
Visibility: 8km NR
Reported Separation:
Nil V/50m H 'v. close'
Recorded Separation:
<0.1nm

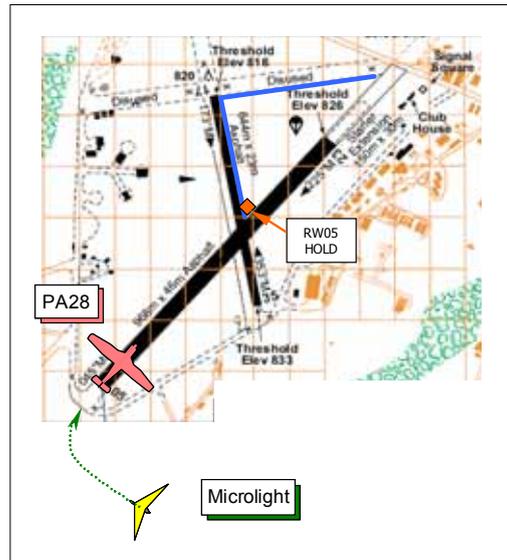
AIRPROX REPORT NO 120/06

Date/Time: 16 Jul 1330 (Sunday)
Position: 5051N 00314W (Dunkeswell Aerodrome - elev 839ft)
Airspace: Dunkeswell ATZ (Class: G)
Reporting Ac Reported Ac
Type: Pegasus PA28
Quantum 912 ML
Operator: Civ Trg Civ Pte
Alt/FL: 100ft↓ Nil
QFE (997mb) (aal)
Weather VMC NR VMC CAVOK
Visibility: 7km 10+km
Reported Separation:
50ft V/10m H NR
Recorded Separation:
NR

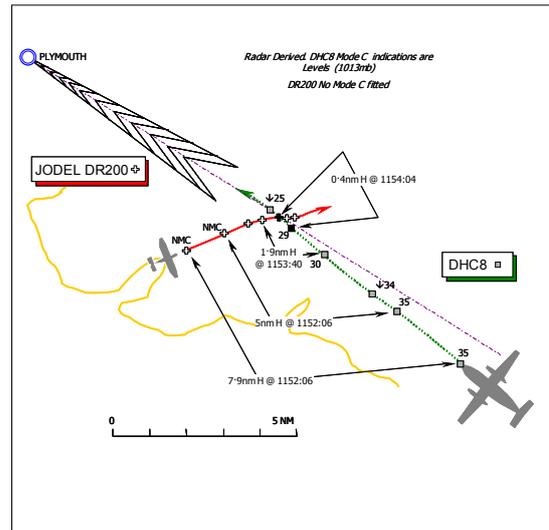
AIRPROX REPORT NO 121/06

Cause: Conflict in Class G airspace resolved by both pilots.

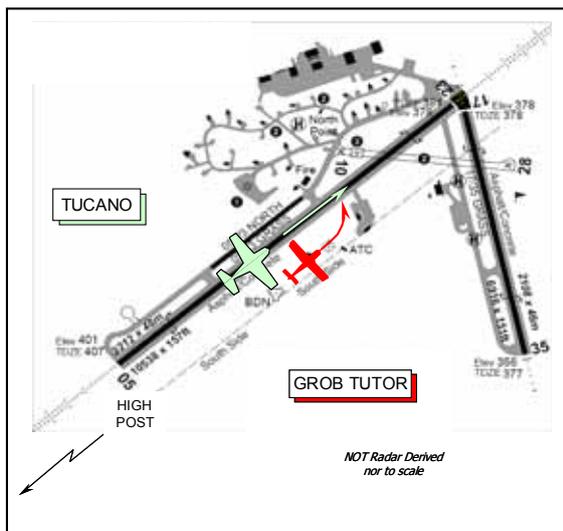
AIRPROX REPORT NO 122/06

TESD MOD DPA/DLO comments that the root cause appears to be the assumptions that both pilots made in the intentions of the other. Having determined that there existed a potential confliction the Tucano Pilot took an action to attempt to resolve the problem. Sadly, this action was not anticipated by the Grob Pilot who had already resolved that no confliction would exist if he turned across the path of the departing Tucano.

Cause: The Tutor pilot turned into conflict with the departing Tucano.

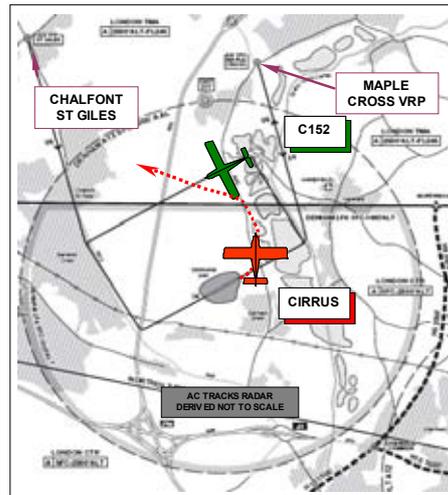
AIRPROX REPORT NO 123/06

The Cirrus SR22 initiated a turn well before Maple Cross and not only caused conflict with circuit traffic but would potentially conflict with ac joining in accordance with the published procedures for RW06 from Chalfont St. Giles [3nm NW].

By not adhering to the Rules of the Air and to Denham published procedures, the Cirrus pilot created an unsafe situation by flying into conflict with the Cessna 152 that was following the correct circuit pattern in the approved manner, the instructor making the recommended RT calls so that other users could be aware of the Cessna's position and its pilot's intentions. Having due regard to the respective pilots' reports, the Board felt that safety had not been assured.

Cause: The departing Cirrus SR22 did not clear the circuit safely and flew into conflict with the Cessna 152.

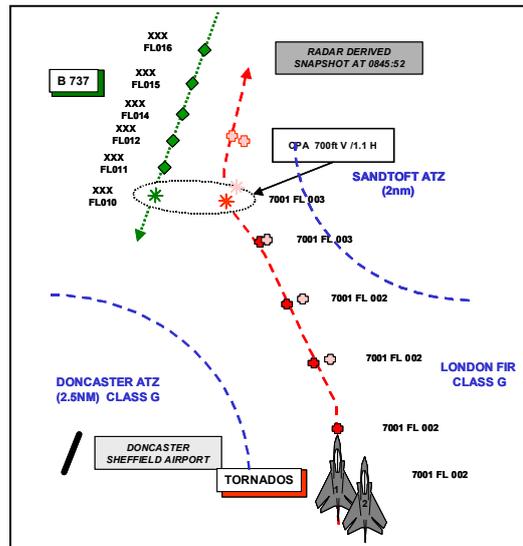
AIRPROX REPORT NO 126/06

The Board noted that the Tornado leader had planned to avoid the Doncaster Sheffield ATZ and final approach by a sizable margin but that that had not been enough to prevent the B737 TCAS from generating a warning to which the Captain had to react and this he did in the approved manner by executing a go-around. Members determined therefore that the closeness of the flightpath of the lead Tornado to the final approach triggered a TCAS RA.

Cause: The Tornado formation's chosen flightpath caused a TCAS RA.

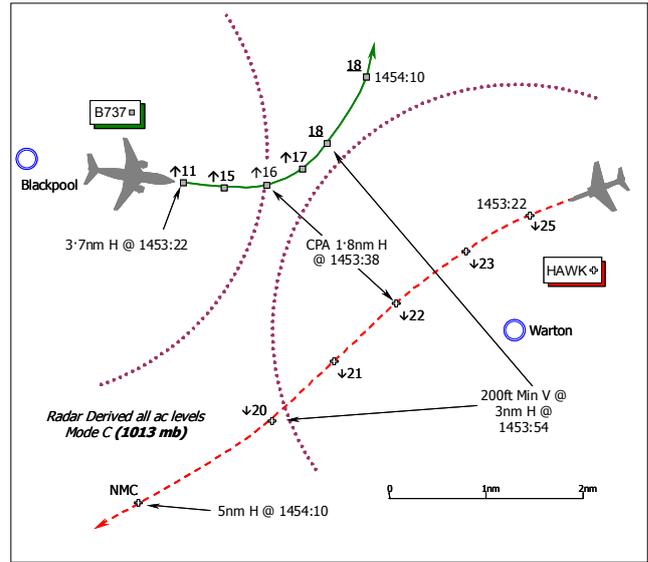
AIRPROX REPORT NO 127/06

It was clear to the Board that the Hawk pilot was operating entirely legitimately whilst in transit through Class G airspace to his display location. Whilst it was unfortunate that the Hawk pilot had been unable to contact Blackpool ATC on this occasion, nevertheless he was operating VFR in reported CAVOK conditions in Class G airspace clear of their ATZ. Furthermore, it had been explained that the Hawk pilot was in communication with Liverpool ATC and Members recognised that the pressures of obtaining relevant CAS entry clearances and passing details for the display had clearly been a priority. The ATSI report made it plain that the Blackpool APR had spotted the Hawk on radar at range whilst still within CAS executing his airways crossing with LJAO. This had subsequently prompted the controller to issue avoiding action and turn the B737 away from the Hawk as the latter's pilot followed his route to the display area. Although this occurred outside the displayed range of the Liverpool SRE and would not have been evident to the Liverpool APR, the Clee Hill Radar recording evinced that the Blackpool APR's avoiding action was entirely successful in turning the airliner away from the Hawk, albeit that standard separation was eroded. Following the B737 crew's prompt compliance with the controller's advice, 1.8nm of horizontal separation was maintained at the closest point when the Hawk was still 600ft above the airliner. By this stage, however, the reported TCAS TA had also alerted the B737 crew to the presence of the jet. With the nimble fast-jet remaining clear of the Blackpool ATZ throughout, horizontal separation had then increased to 3nm before vertical separation had reduced to a minimum as the airliner was drawing rapidly astern. In a controller Member's view this encounter between the IFR B737 and observed VFR traffic had been satisfactorily resolved by the Blackpool APR. Other Members agreed and the Board concluded that this Airprox had resulted from a TCAS sighting report, where the APR's avoiding action instructions had forestalled any close quarters situation and effectively removed any risk of a collision.

Cause: TCAS sighting report.

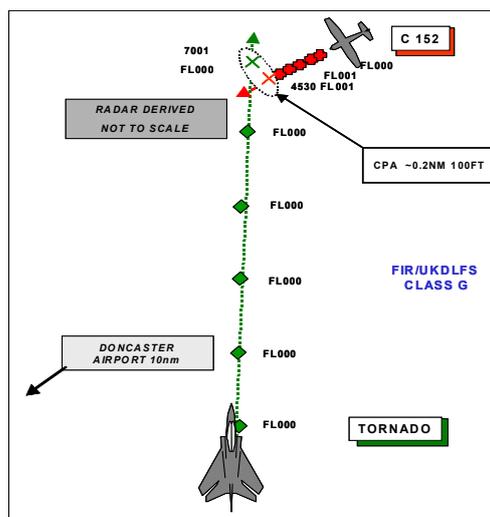
AIRPROX REPORT NO 128/06

The Board noted that both ac had been operating legitimately in Class G airspace; therefore the crews had an equal and shared responsibility to 'see and avoid' other ac. Under the Rules of the Air Regulations, Rule 17 (2), the Tornado had the Cessna on its right so it should have given way. However, the Tornado crew did not see the Cessna until late since for much of the time it was below them, climbing out from a PFL. When the Cessna did emerge from the background, the Tornado crew saw it but too late to initiate any effective avoiding action. Their ability to discriminate the Cessna from the background would have been degraded by its small size, its almost head-on aspect, its light colour and that it had almost no relative movement. The Cessna instructor was in a high workload situation and the Tornado was into sun from his viewpoint, also making it difficult to see. Although late the Cessna avoiding action was probably effective, the lateness of both sightings and the small resultant miss-distance convincing the Board that, although there had been no risk of collision, normally accepted safety margins had been eroded.

Cause: Very late sightings by both crews.

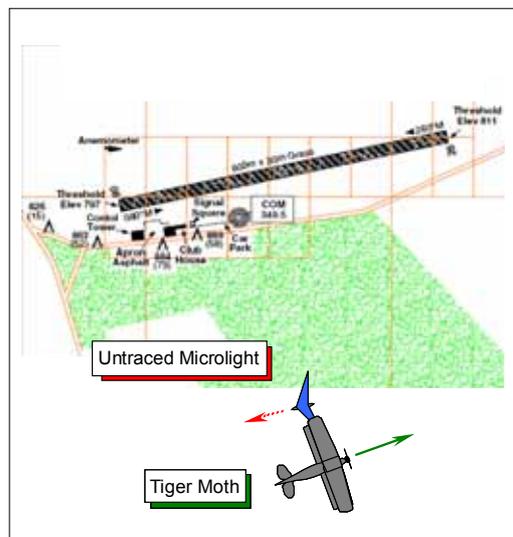
AIRPROX REPORT NO 129/06

Cause: The untraced microlight pilot entered the Compton Abbas ATZ in contravention of Rule 39 to the Rules of the Air Regulations 1996 and flew into conflict with the Tiger Moth.

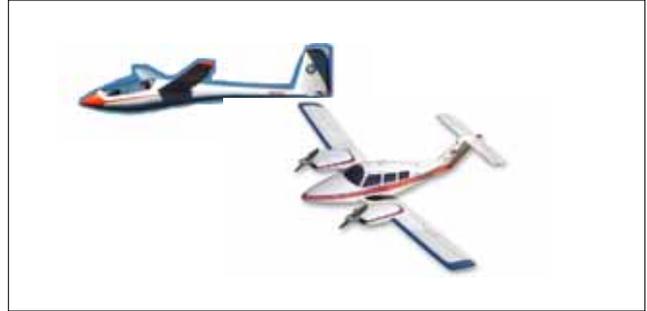
AIRPROX REPORT NO 131/06

Members noted that this encounter had taken place in Class G airspace where both users had an equal right to operate and the 'see and avoid' principle was the prime means of collision avoidance. They also noted that the Gliding competition had been properly NOTAMed, with a telephone contact number, and therefore the BE76 crew should have been aware that their planned routeing was such that they might encounter large numbers of gliders.

Cause: Very late sighting by the pilots of both ac.

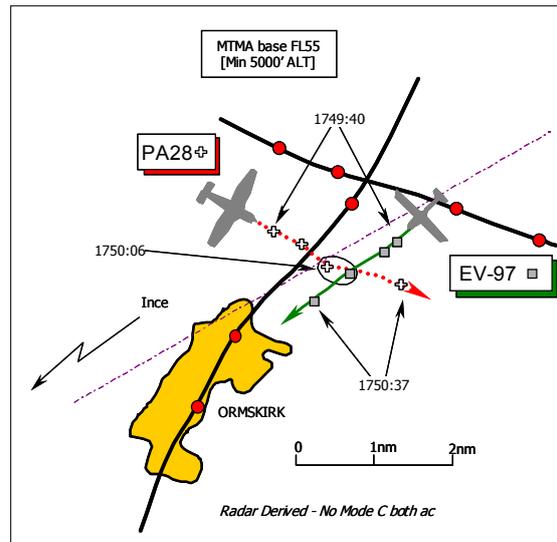
AIRPROX REPORT NO 132/06

Cause: A very late sighting by the Eurostar EV-97 pilot and a late sighting by the PA28 pilot.

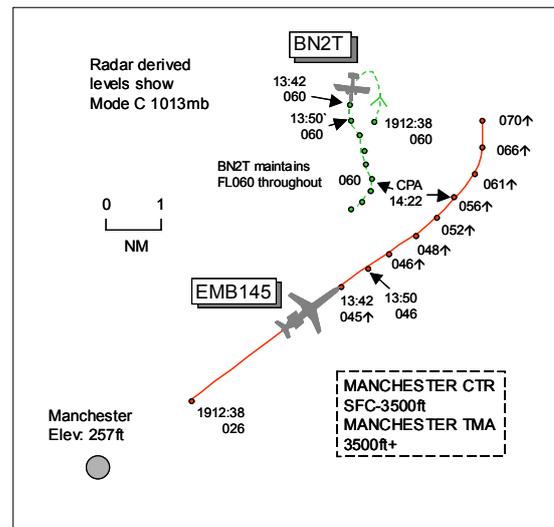
THE MANCHESTER APPROACH S CONTROLLER reports that the BN2T was operating on the RW06 climb-out near to Stockport at FL60 with traffic levels medium. She was alerted to a departing EMB145 climbing above 5000ft when conflict alert activated flashing red but by this time the EMB145 had passed the BN2T and was climbing rapidly. She felt that avoiding action and TI was inappropriate as the confliction had passed. Separation had reduced to 100ft and 1.75nm.

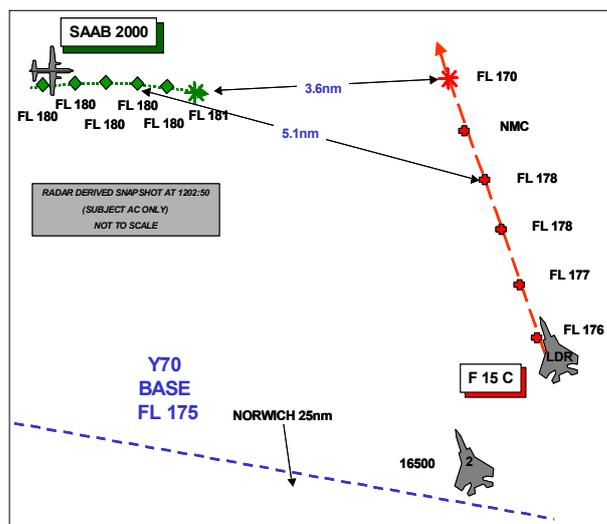
AIRPROX REPORT NO 141/06

Date/Time: 11 Sep 1203
Position: 5310N 00115E(30nm N Norwich)
Airspace: Y70 (Class: A)
Reporting Ac Reported Ac
Type: Saab 2000 F-15C
Operator: CAT Foreign Mil
Alt/FL: FL180 FL175
 (30.09in =1019mb)
Weather VMC Haze VMC CAVOK
Visibility: 5-8km >8nm
Reported Separation:
 0 V/ 5nm H Not seen
Recorded Separation:
 1100ft V/3.6 H (Min V 200ft at 5.1nm)

Cause: The unintended climb by the F15 leader into Class A CAS caused the Saab to receive a TCAS RA.

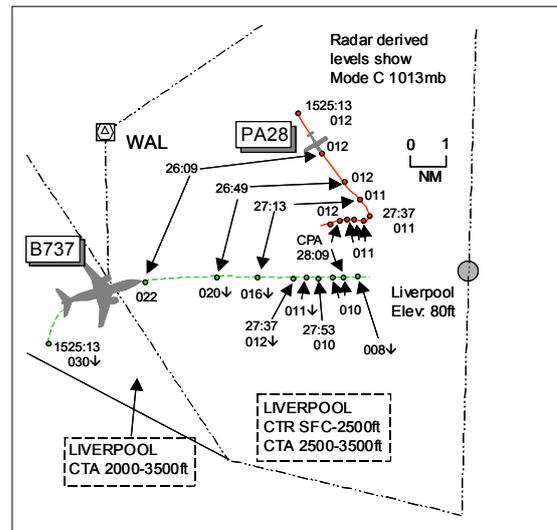
AIRPROX REPORT NO 142/06

Date/Time: 9 Sep 1528 (Saturday)
Position: 5321N 00257W (3-5nm W Liverpool - elev 80ft)
Airspace: Liverpool CTR (Class: D)
Reporting Ac Reported Ac
Type: B737-800 PA28
Operator: CAT Civ Club
Alt/FL: 1160ft↓ 1500ft
(QNH 1022mb) (N/K)
Weather VMC CLBC VMC NR
Visibility: 10km 10km
Reported Separation:
400ft V/just L ahead NR
Recorded Separation:
200ft V/1.6nm H

Cause: Sighting report (TCAS).

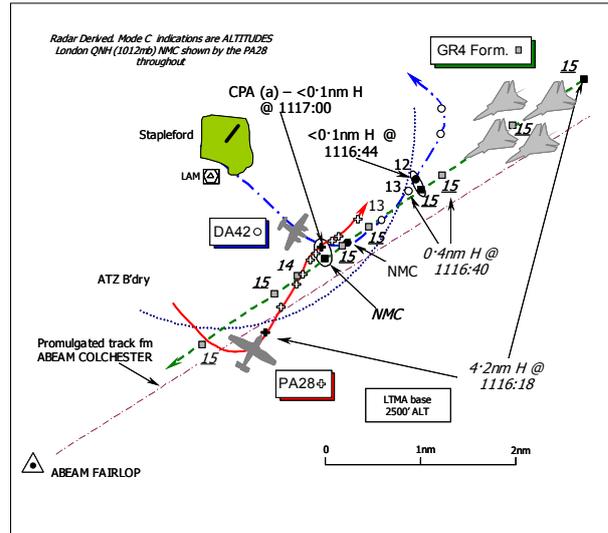
AIRPROX REPORT NO 143/06

Date/Time: 17 Sep 1117 (Sunday)
Position: 5138N 00011E (1.6nm SE of Stapleford A/D - elev 185ft)
Airspace: Stapleford ATZ (Class: G)
Reporting Ac Reported Ac
Type: Tornado GR4 PA28
Operator: HQ STC Civ Club
Alt/FL: 1420ft ↑1500ft
 QNH (1012mb) QNH (1012mb)
Weather VMC In Haze VMC In Haze
Visibility: 6km 6km
Reported Separation:
 <30ft V/50m H 300ft V/100m H
Recorded Separation:
 <0.1nm (200yd)

Cause: The PA28 pilot, whilst trying to avoid a NOTAM'd flypast route, nevertheless flew into conflict with the Tornado GR4 formation, which he saw late.

Safety Recommendation: The MOD and CAA should jointly review the arrangements, safety provisions and notification procedures for formation flights in Class G airspace such as these, so as to minimise the risk of a conflict arising between formations of ac and non-participating flights.

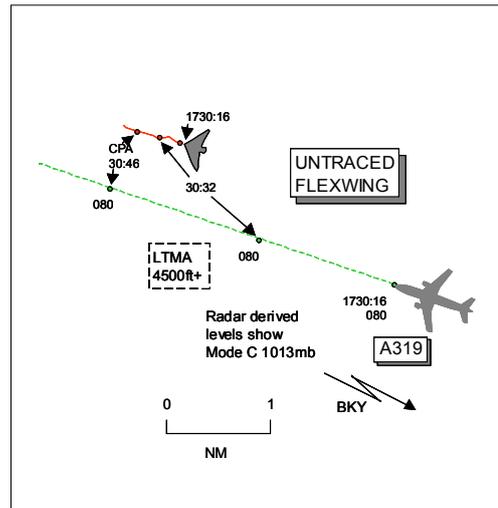
AIRPROX REPORT NO 144/06

Date/Time: 23 Sep 1731 (Saturday)
Position: 5204N 00011W (10nm NW BKY)
Airspace: LTMA (Class: A)
Reporting Ac Reported Ac
Type: A319 Untraced Flexwing
M/Light
Operator: CAT N/K
Alt/FL: FL80 (N/K)
Weather: VMC CLOC NK
Visibility: 10km
Reported Separation:
Nil V/1-2nm H
Recorded Separation:
0.6nm H

Cause: Unauthorised penetration of Class A CAS by the untraced microlight pilot.

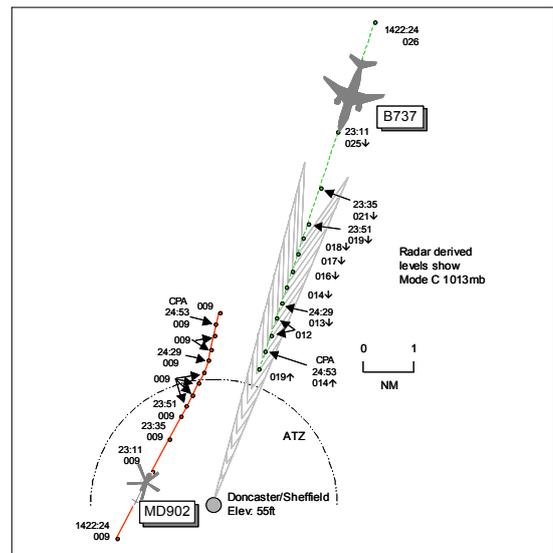
AIRPROX REPORT NO 145/06

Date/Time: 25 Sep 1425
Position: 5332N 00058W (3.5nm FIN APP RW20
 DSA - elev 55ft)
Airspace: LFIR (Class: G)
Reporting Ac Reported Ac
Type: B737-800 MD902
Operator: CAT Civ Comm
Alt/FL: 1450ft↓ 350ft agl
 (QNH 1009mb) (QNH)
Weather IMC KLWD VMC CLBC
Visibility: 6km
Reported Separation:
 100ft V/<1nm H Not seen
Recorded Separation:
 500ft V/1.1nm H

Cause: Sighting report (TCAS).

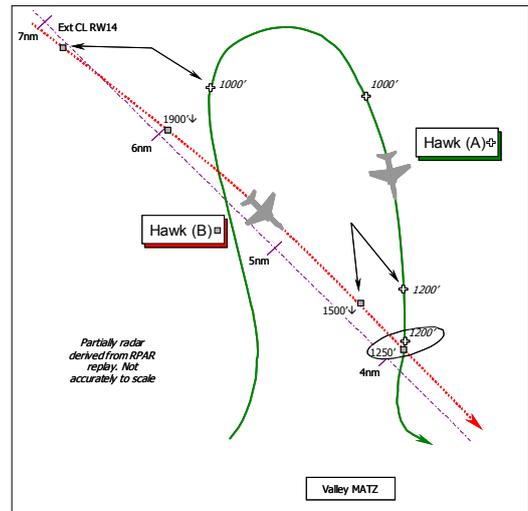
AIRPROX REPORT NO 148/06

Date/Time: 12 Sep 1045
Position: 5317N 00437W (4nm FINALS Valley RW14 - elev 37ft)
Airspace: Valley MATZ (Class: G)
Reporting Ac Reported Ac
Type: Hawk T Mk1(A) Hawk T Mk1(B)
Operator: HQ PTC MoD DPA
Alt/FL: 1000ft 1300ft↓
 QFE (1012mb) QFE (1012mb)
Weather VMC CLBC IMC
Visibility: 10nm NR
Reported Separation:
 50ft V/150m H 300ft V/nil H
Recorded Separation:
 From PAR: 50ft V/nil H @ 1044:54

Cause: The instructor pilot of Hawk (A) on a visual recovery did not maintain safe separation and flew into conflict with the IFR inbound Hawk (B) on an instrument approach.

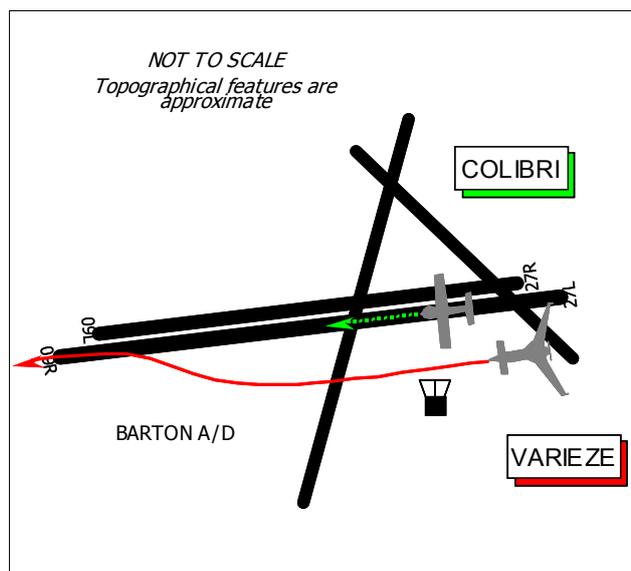
Date/Time: 7 Oct 1608 (Saturday)
Position: 5328N 00223W (RW27L Manchester/
Barton Aerodrome - elev 73ft)
Airspace: ATZ (Class: G)
Reporter: Barton AFISO

<u>First Ac</u>	<u>Second Ac</u>
<u>Type:</u> Colibri MB-2	Rutan Varieze
<u>Operator:</u> Civ Pte	Civ Pte
<u>Alt/FL:</u> Landing (QNH)	Landing (QNH)
<u>Weather:</u> VMC NR	NR CAVOK
<u>Visibility:</u> NR	>10km
<u>Reported Separation:</u> NR	NR
<u>Recorded Separation:</u> Not Recorded

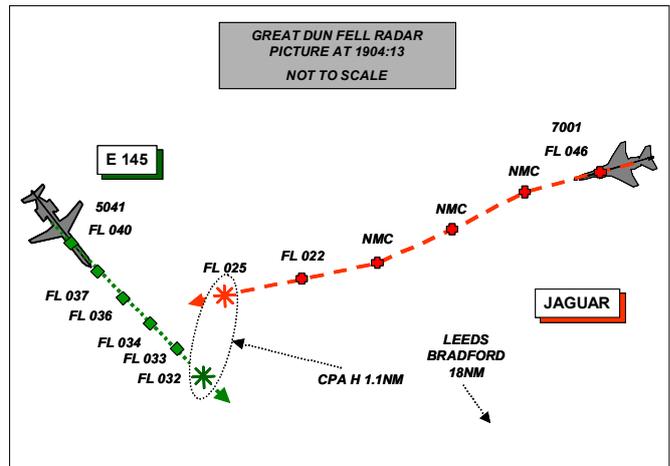
AIRPROX REPORT NO 153/06

Date/Time: 10 Oct 1904 (Night)
Position: 5401N 00206W (18nm NW Leeds Bradford)
Airspace: London FIR (Class: G)
Reporting Ac Reported Ac
Type: Embraer 145 Jaguar
Operator: CAT HQ STC
Alt/FL: 3500ft↓ 4000ft↓
 (QNH) (N/K)
Weather IMC KLWD VMC CLBL
Visibility: ~10km
Reported Separation:
 0ft V/1nm H Not Seen
Recorded Separation:
 700ft V/1.1nm H

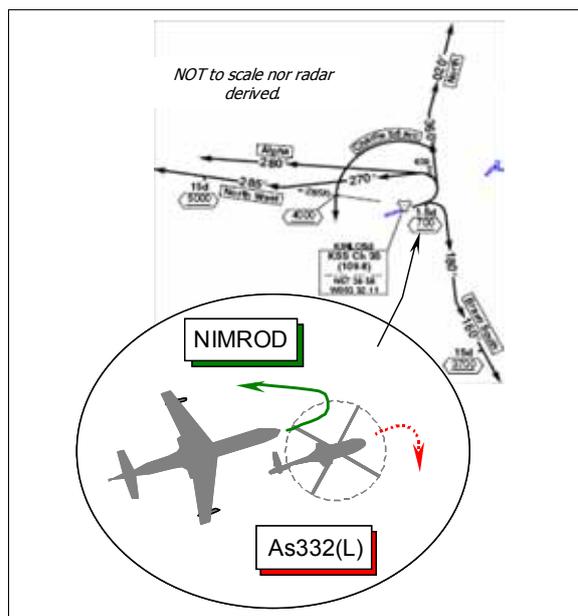
AIRPROX REPORT NO 154/06

Date/Time: 17 Oct 1905 NIGHT
Position: 5739N 00331W (Vicinity of Kinloss Airfield - elev 22ft)
Airspace: Kinloss MATZ (Class: G)
Reporter: Lossiemouth APP
First Ac **Second Ac**
Type: Nimrod MR2 AS332L Puma
Operator: HQ STC Civ Trg
Alt/FL: 1500-2000ft↑ 1000ft↑
QFE (1007mb) QNH (1008mb)
Weather IMC In Cloud IMC In Rain/Cloud
Visibility: NR NR
Reported Separation:
Not seen Not seen
Lossiemouth APP: 200ft V/contacts merged
Recorded Separation:
Not recorded

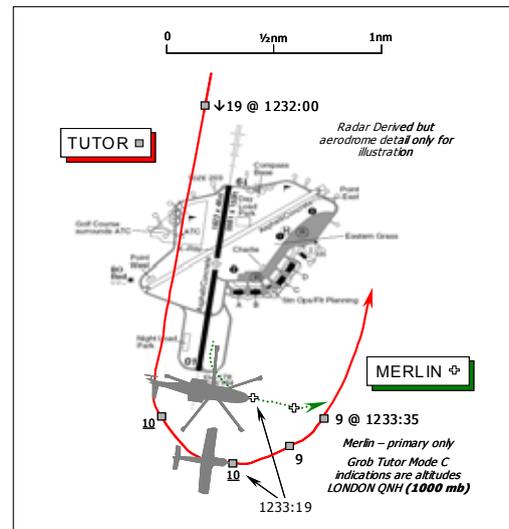
AIRPROX REPORT NO 155/06

Date/Time: 24 Oct 1233
Position: 5137N 00106W (Benson RW19 a/d cct
 - elev 226ft)
Airspace: MATZ (Class: G)
Reporting Ac Reported Ac
Type: Merlin EH101 Grob Tutor
Operator: HQ JHC HQ PTC
Alt/FL: ↑1000ft 800ft
 QFE (992mb) QFE
Weather: VMC NR VMC NR
Visibility: 40km >10km
Reported Separation:
 100ft V/nil H 200ft V/200m H
Recorded Separation:
 Not recorded
