UK AIRPROX BOARD

Analysis of Airprox in UK Airspace

**Report Number 17
July 2006 – December 2006**

Seventeenth Report by the UK Airprox Board:

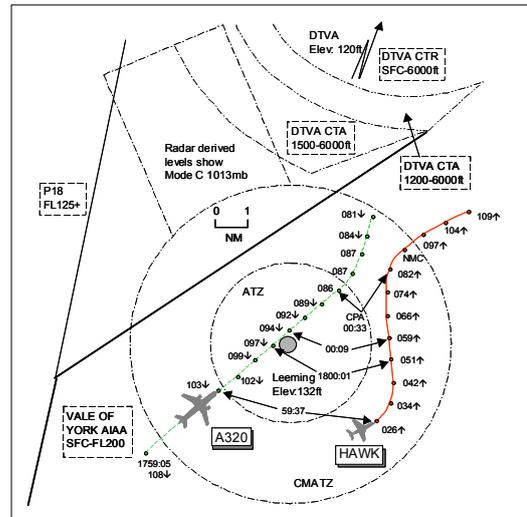
Reported Separation:
 Nil V/3nm H Not seen

Recorded Separation:
 400ft V/1.7nm H

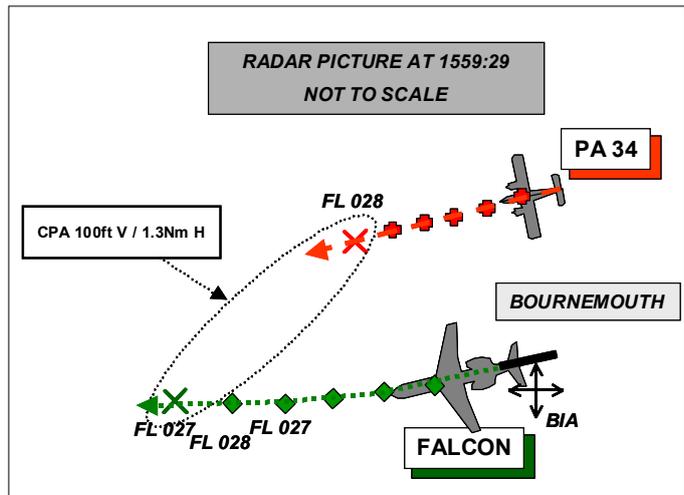
Date/Time: 27 Oct 1559
Position: 5047 N 00152 W (1.5nm W
Bournemouth - elev 38ft)
Airspace: Solent CTA 2 (Class: D)
Reporter: Bournemouth APC

<u>First Ac</u>	<u>Second Ac</u>
<u>Type:</u>	Falcon 900	PA34
<u>Operator:</u>	Civ Comm	Civ Trg
<u>Alt/FL:</u>	2500ft (N/K)	3000ft (QNH NR)
<u>Weather</u>	VMC NR	VMC CLBL
<u>Visibility:</u>	10nm	>10nm
<u>Reported Separation:</u>	NR	1000ft V/1nm H
<u>Recorded Separation:</u>	100ft V/1.3nm H

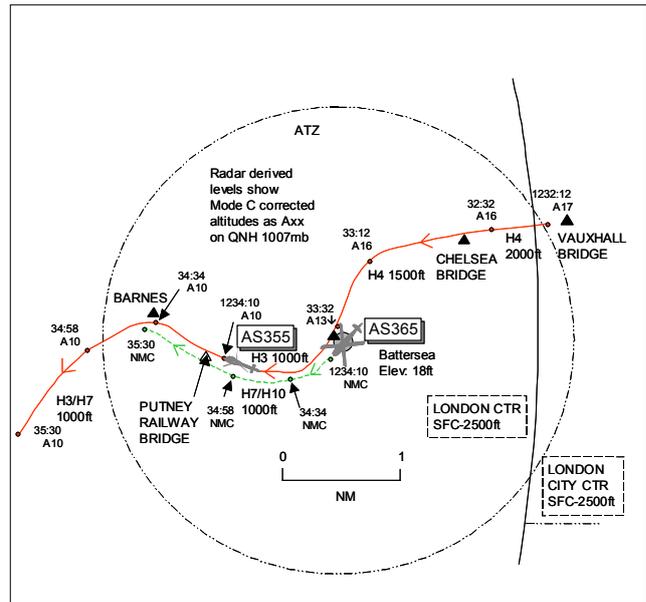
AIRPROX REPORT NO 158/06

Date/Time: 31 Oct 1234
Position: 5128N 00011W (0.25nm SW Battersea Heliport - elev 18ft)
Airspace: Battersea ATZ/ (Class: A)
 Heathrow CTR
Reporter: Battersea ADC
First Ac Second Ac
Type: AS365 AS355
Operator: Civ Pte Civ Pte
Alt/FL: ↑1000ft NR
 (QNH) (QNH)
Weather VMC CLOC VMC NR
Visibility: >10km
Reported Separation:
 Nil V/O-5nm H Not seen
Recorded Separation:
 0.9nm H

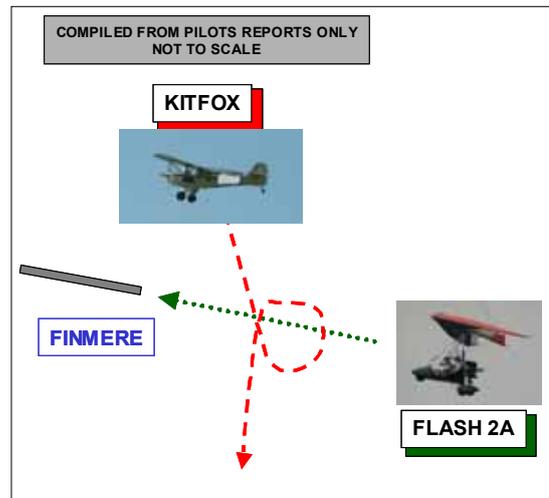
AIRPROX REPORT NO 160/06

Date/Time: 4 Nov 1615 (Saturday)
Position: 5159N 00103W (Finmere - elev 395ft)
Airspace: London FIR (Class: G)
Reporting Ac Reported Ac
Type: Mainair Flash 2A Denney Kitfox
Operator: Civ Pte Civ Pte
Alt/FL: 800ft↓ 1800ft
(QFE NR mb) (QNH 1034mb)
Weather: VMC NR VMC NR
Visibility: >10nm 20nm
Reported Separation:
1-200ft V/50m H 500ft V/0 H
Recorded Separation:
NR

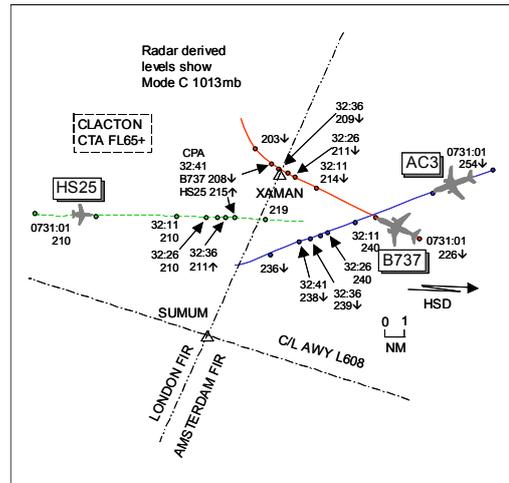
AIRPROX REPORT NO 161/06

Date/Time: 2 Nov 0733
Position: 5145N 00211E (39nm E CLN)
Airspace: Clacton CTA (Class: A)
Reporting Ac Reported Ac
Type: HS25B B737-500
Operator: Civ Pte CAT
Alt/FL: FL210 FL210↓
Weather IMC KLWD IMC KLWD
Visibility:
Reported Separation:
 Nil V/<5nm H Nil V/6nm H
Recorded Separation:
 700ft V/3-5nm H

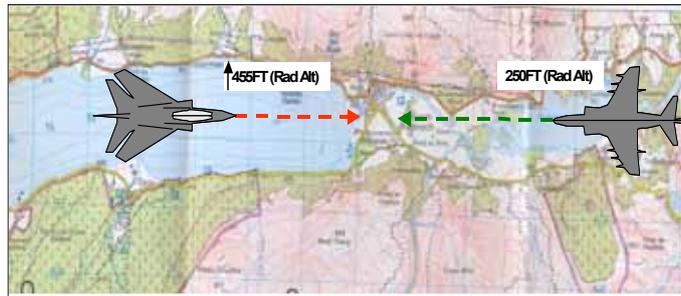
AIRPROX REPORT NO 162/06

Date/Time: 16 Nov 0950
Position: 5642N 00403W (Loch Rannoch)
Airspace: UKDLFS (Class: G)
Reporting Ac Reported Ac
Type: Harrier GR9 Tornado GR4
Operator: HQ STC HQ STC
Alt/FL: 250ft (Rad Alt) 455ft (Rad Alt)
(QNH 980mb) (QNH 971mb)
Weather VMC NR VMC NR
Visibility: 40km 20nm
Reported Separation:
20ft V/0nm H 50ft V/0m H
Recorded Separation:
NR

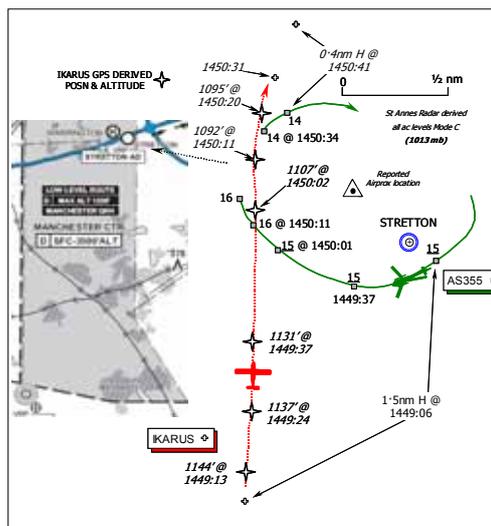
AIRPROX REPORT NO 163/06

Date/Time: 20 Nov 1450
Position: 5321N 00232W (vicinity of Stretton a/d elev: 235ft)
Airspace: Manchester LL Route (Class: D)
Reporting Ac Reported Ac
Type: AS355-F2 Ikarus C42
Operator: Civ Comm Civ Pvt
Alt/FL: 1000ft 1200ft
QNH (997mb) QNH (997mb)
Weather VMC NR VMC NR
Visibility: >10km 20nm
Reported Separation:
Nil V/<100m H Nil V/200m H
Recorded Separation:
Not recorded

Cause: The Ikarus C42 microlight pilot flew close enough to the AS355 to cause its pilot concern.

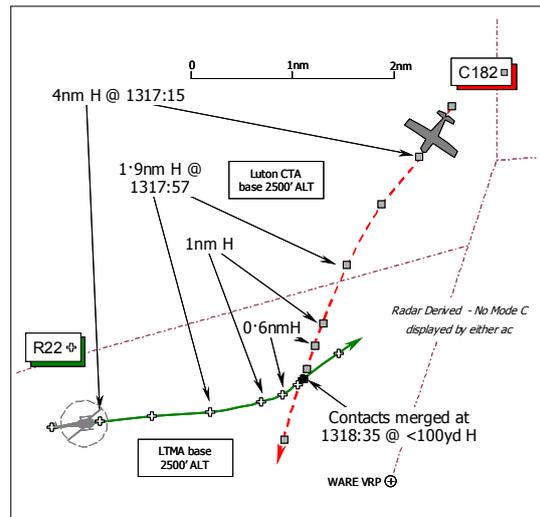
AIRPROX REPORT NO 164/06

Date/Time: 21 Nov 1318
Position: 5149N 00003W (1nm NW WARE VRP)
Airspace: London FIR (Class: G)
Reporting Ac Reported Ac
Type: Robinson R22 Cessna C182
Operator: Civ Trg Civ Trg
Alt/FL: 2000ft 2000ft
QNH (995mb) (QNH 995mb)
Weather VMC CLOC VMC Nil Cloud
Visibility: >50nm 10km+
Reported Separation:
100ft V/<20m H 300ft V/200m H
Recorded Separation:
Contacts merged <100yd H

Cause: Conflict in Class G airspace resolved by the R22 helicopter pilot.

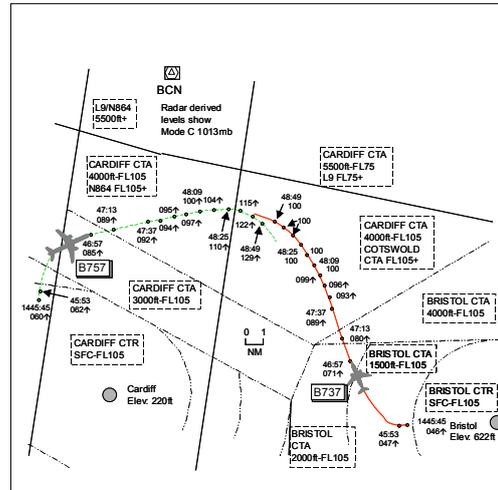
<u>Reporting Ac</u>	<u>Reported Ac</u>
<u>Type:</u> B757-200	B737
<u>Operator:</u> CAT	CAT
<u>Alt/FL:</u> FL100↑	↑NR
<u>Weather:</u> VMC CLOC	VMC CLBL
<u>Visibility:</u> 10km	NR
<u>Reported Separation:</u>	
NR	NR
<u>Recorded Separation:</u>	
Nil V/7.5nm H or 1000ft V/4.9nm H	or 2900ft V/0.8nm H

Cause: The Cardiff APR mentor did not ensure that his trainee transferred the B757 to LACC correctly separated from the B737.

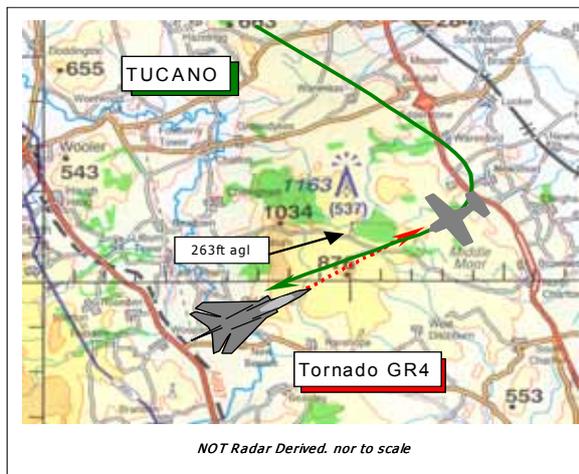
AIRPROX REPORT NO 167/06

Date/Time: 28 Nov 1355
Position: 5531N00148W (12nm NW of Alnwick)
Airspace: UKDLFS (Class: G)
Reporting Ac Reported Ac
Type: Tucano T Mk1 Tornado GR4
Operator: HQ PTC HQ STC
Alt/FL: 270ft 250ft
(agl) (agl)
Weather VMC CLOC VMC NR
Visibility: 8km NR "good"
Reported Separation:
30ft V/nil H NR
Recorded Separation:
Not recorded

Cause: Conflict in the UKDLFS.

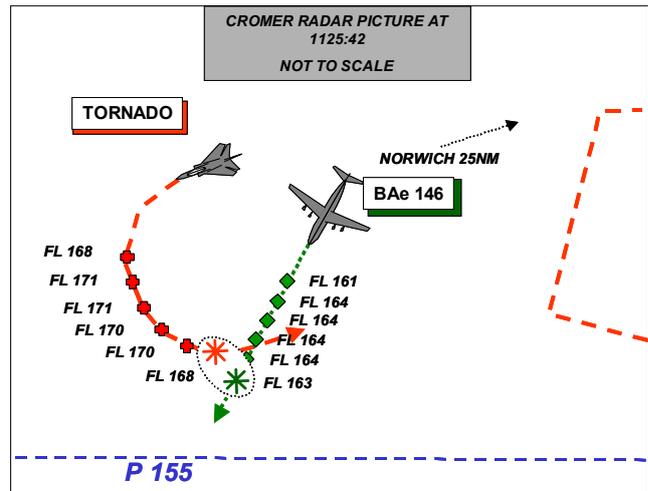
Weather VMC NR VMC NIL WX NR
Visibility: 6-7km 40km
Reported Separation:
NR 0ft V/3nm H
Recorded Separation:
500ft V/0.8nm H

Cause: The Norwich APR climbed the BAe146 above the co-ordinated level and into conflict with the Tornado.

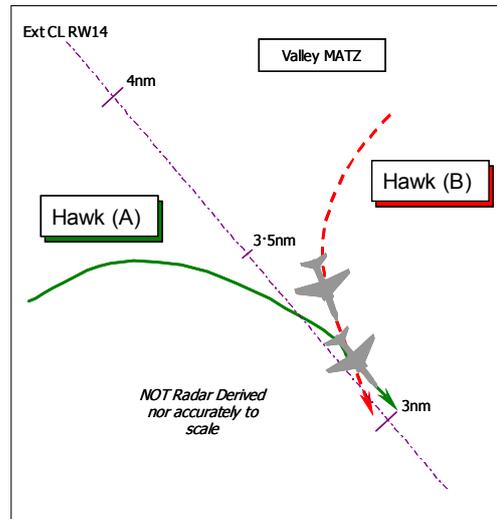
AIRPROX REPORT NO 169/06

Date/Time: 28 Nov 1519
Position: 5316N 00435W (3nm NW of Valley - elev 37ft)
Airspace: Valley MATZ (Class: G)
Reporting Ac Reported Ac
Type: Hawk T Mk1 Hawk T Mk1
Operator: HQ PTC HQ PTC
Alt/FL: 1200ft↓ 1200ft↓
 QFE (1005mb) (QFE 1005mb)
Weather VMC CLOC VMC CLOC
Visibility: 10km+ 10km+
Reported Separation:
 50ft V/Nil H 30ft V/Nil H
Recorded Separation:
 From PAR: Nil V @<200yd

Cause: A very late sighting by the crew of Hawk (B) and a non-sighting by the crew of Hawk (A).

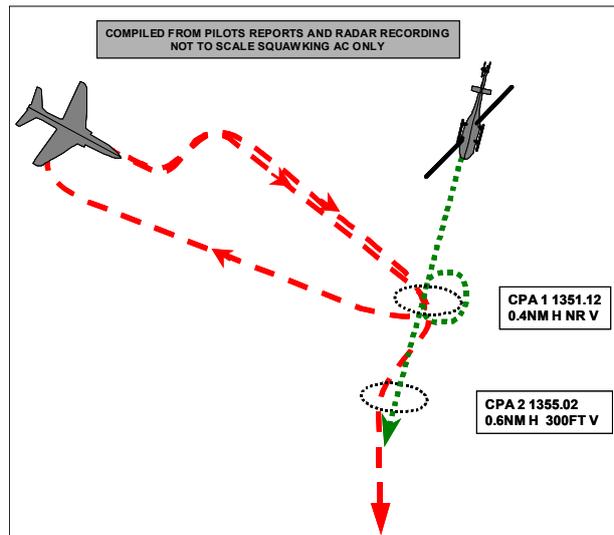
AIRPROX REPORT NO 170/06

Date/Time: 29 Nov 1254
Position: 5201N 00157 W (10nm NE Gloucestershire)
Airspace: Lon FIR/DLFS (Class: G)
Reporting Ac Reported Ac
Type: Bell 206 JetRanger Hawk T1x2
Operator: Civ Comm HQ PTC
Alt/FL: 500ft agl 250ft agl
(RPS) (RPS)
Weather VMC CAVOK VMC NR
Visibility: 30nm 20km
Reported Separation:
200ft V/Nil H 500ft V/400m H
Recorded Separation:
See UKAB Note (3)

Cause: The Hawk pilots flew close enough to the helicopter to cause its pilot concern.

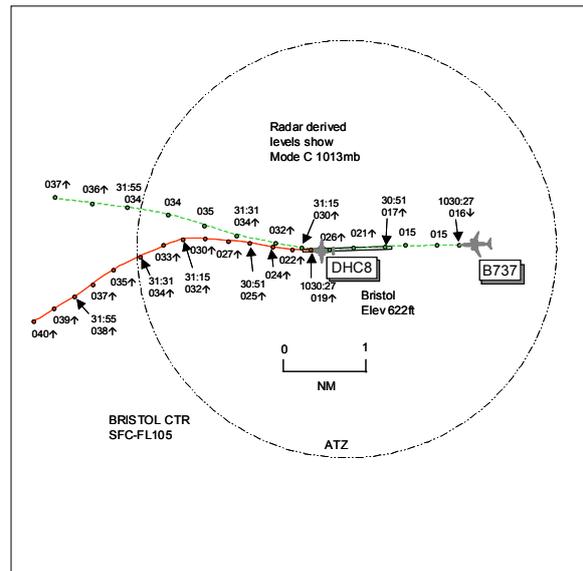
<u>First Ac</u>	<u>Second Ac</u>
<u>Type:</u> B737-800	DHC8
<u>Operator:</u> CAT	CAT
<u>Alt/FL:</u> 2500ftá (QNH 986mb)	(QNH)
<u>Weather</u> VMC CLBC	VMC CLBC
<u>Visibility:</u> 15km	NR
<u>Reported Separation:</u> Nil V/2nm H	Not seen
<u>Recorded Separation:</u> Nil V/1.2nm H

Cause: Following a go-around by the B737 in adverse weather conditions, the Bristol ADC thought that separation had been lost.

The NATS Advisor informed Members that a Safety Notice was issued at Bristol post incident, both to detail the event and to 'roll-out' lessons learnt to all ATCOs. Noteworthy was the implementation of increased spacing between ac, in adverse weather conditions, to mitigate the risk of a similar situation occurring again.

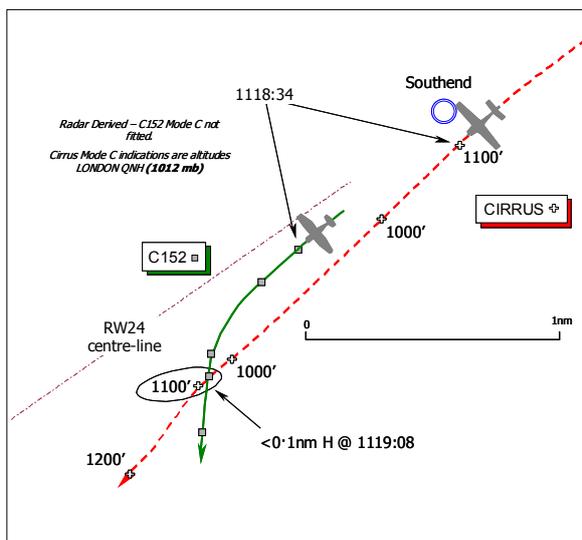
AIRPROX REPORT NO 173/06

Date/Time: 9 Dec 1119 (Saturday)
Position: 5133N 00040W (1.5nm SW of Southend - elev 49ft)
Airspace: Southend ATZ (Class: G)
Reporting Ac **Reported Ac**
Type: Cessna 152 Cirrus SR22 GTS
Operator: Civ Trg Civ Pte
Alt/FL: 1200ft↑ 1100ft↑
QNH (1011mb) QNH (1011mb)
Weather VMC No Cloud VMC NR
Visibility: 10k+ 10nm
Reported Separation:
20-50ft V/<200ft H Not seen
Recorded Separation:
>0.1nm H (~125yd)

Cause: The Southend ADC cleared the C152 to take-off into conflict with the Cirrus SR22 which was executing a go-around.

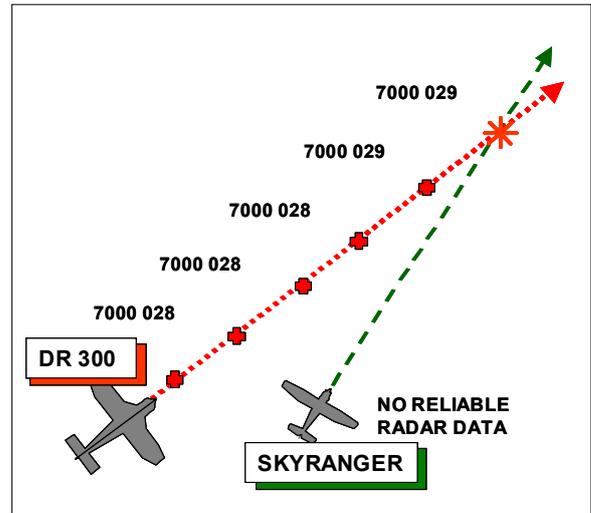
AIRPROX REPORT NO 174/06

Date/Time: 17 Dec 1431 (Sunday)
Position: 5143N 00156W (2nm NNE Cirencester)
Airspace: Lon FIR (Class: G)
Reporting Ac Reported Ac
Type: Skyranger Robin DR300
 Microlight
Operator: Civ Pte Civ Pte
Alt/FL: 2200ft↑ 3200ft
 (RPS 1022mb) (1026mb)
Weather: VMC CAVOK VMC CAVOK
Visibility: >10nm >20km
Reported Separation:
 <100ft V/Nil H 200ft V/200m H
Recorded Separation:
 NR

Cause: The Robin DR300 pilot did not overtake the Skyranger in accordance with Rule17 (4) of the Rules of the Air Regulations and passed sufficiently close to cause its pilot concern.

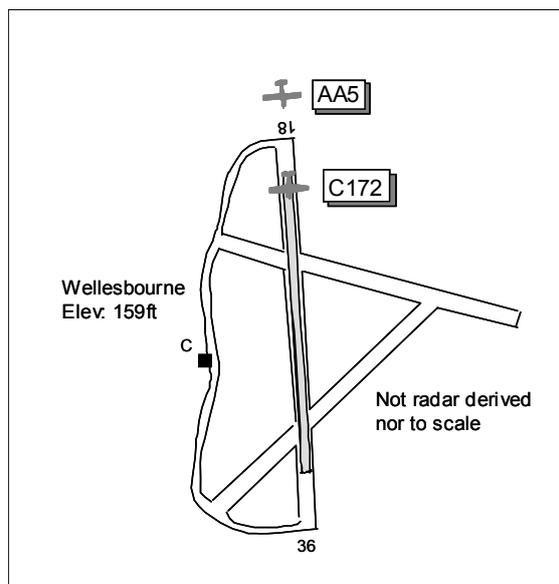
AIRPROX REPORT NO 176/06

Date/Time: 16 Dec 1355 (Saturday)
Position: 5211N 00137W (RW18 Wellesbourne
Mountford - elev 159ft)
Airspace: ATZ (Class: G)
Reporting Ac Reported Ac
Type: C172 AA5
Operator: Civ Club Civ Pte
Alt/FL: 0ft agl 159ft 300-400ft↓
(QNH 1023mb) (QFE)
Weather VMC CAVK VMC CAVK
Visibility: 10km
Reported Separation:
20ft V 200-300ft V
Recorded Separation:
NR

Cause: The AA5 pilot apparently carried out a non-standard go-around and flew close enough to the C172 to cause its pilot and the AFISO concern.

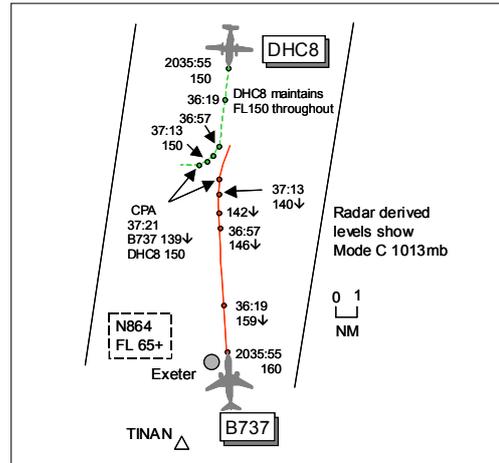
AIRPROX REPORT NO 177/06

Date/Time: 29 Dec 2037 NIGHT
Position: 5054N 00325W (30nm N BHD)
Airspace: AWY N864 (Class: A)
Reporting Ac Reported Ac
Type: DHC8 B737-300
Operator: CAT CAT
Alt/FL: FL150 ↓
Weather IMC NR IMC
Visibility:
Reported Separation:
 Nil V/<2nm H NR
Recorded Separation:
 1100ft V/1.2nm H

Cause: During a busy and complex traffic situation, the Cardiff APR did not take the DHC8 into account when descending the B737.

Since this Airprox, a trial of the use of NAS fps, instead of the Copperchase, has been introduced to reduce workload involved with fps production. It was also recommended locally that the production of two fpss for N/S overflights be mandated; specific training would be introduced for first validations to include holding scenarios, short notice diversions and the use of avoiding action and the Cardiff ATSA Working Practice Agreement would be reviewed and if possible an ATSA would be deployed in Radar until 2100 local during weekdays. It is understood that all these recommendations have been accepted by local ATC Management.

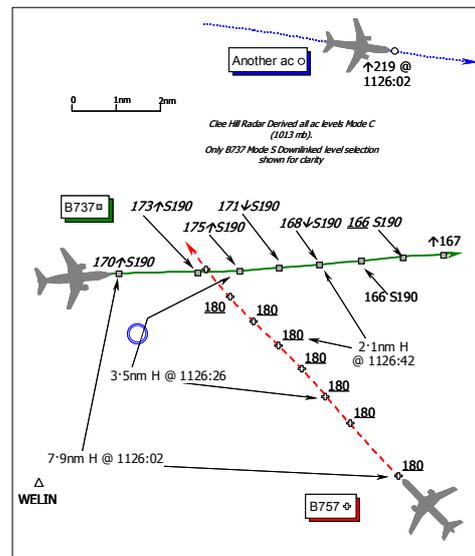
AIRPROX REPORT NO 178/06

Date/Time: 16 Dec 1126 (Saturday)
Position: 5220N 00043W (7nm NE WELIN)
Airspace: DAVENTRY CTA (Class: A)
Reporting Ac Reported Ac
Type: B737-400 B757
Operator: CAT CAT
Alt/FL: ↑FL190 Not reported
Weather VMC NR VMC NR
Visibility: 10km+ NR
Reported Separation:
NR/500m H Nil V/3nm H
Recorded Separation:
500ft Min V @ 3.5nm H
1200ft V @ 2.1nm Min H
