**UK AIRPROX BOARD**

# **Analysis of Airprox in UK Airspace**

**Report Number 16  
January 2006 – June 2006**

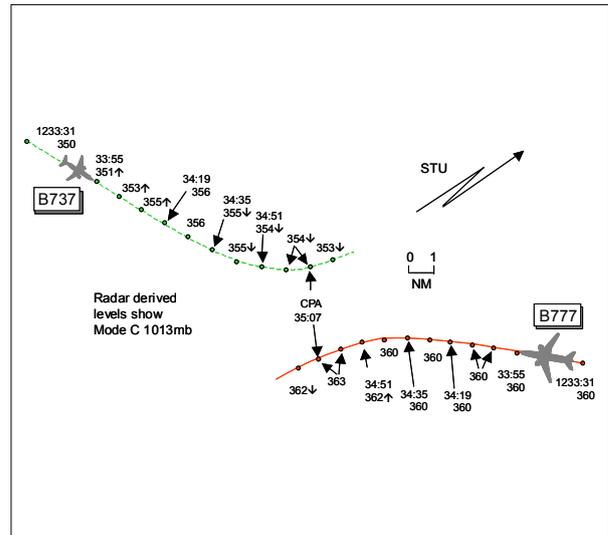
Date/Time: 16 Jan 1235  
Position: 5146N 00525W (20nm SW STU)  
Airspace: UAR UL607 (Class: B)  
Reporting Ac Reported Ac  
Type: B737-800 B777  
Operator: CAT CAT  
Alt/FL: ↑FL360 FL360

Weather: VMC CLAC VMC CLOC  
Visibility: 30km  
Reported Separation:  
800ft V/3-4nm H 400ft V/3nm H  
Recorded Separation:  
900ft V/3-9nm H

**THE B737 PILOT** reports heading 115° at 463kt en route to Germany and in receipt of an ATS from London on 129.37MHz squawking 2001 with Mode C. Shortly after commencing climb, passing through FL350 for FL360, they noticed traffic on TCAS 20nm ahead but slightly R of track, head-on, with a high closure rate and +1000ft. They immediately challenged ATC and were issued descent clearance to FL350 followed swiftly with an avoiding action heading of 360°. During the turn TCAS gave an RA 'descend' so the AP was disengaged and the guidance was followed: ATC were informed of the manoeuvre. The visibility was 30km whilst flying above cloud and the other ac was seen to pass 3-4nm away to their R and 800ft above in level flight but turning L. He assessed the risk as medium as they had seen the potential conflict in advance.

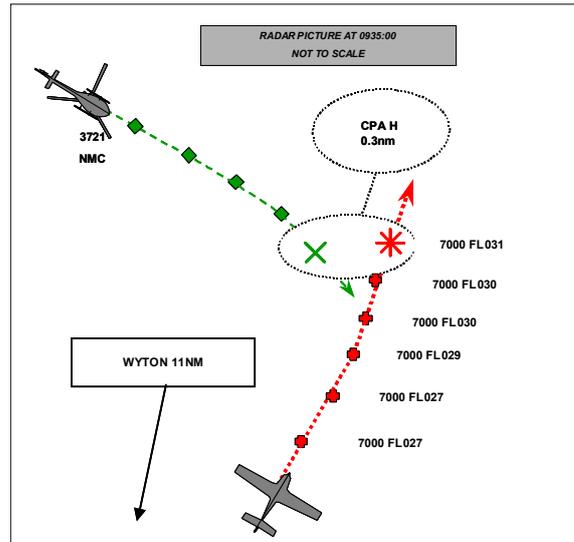
**AIRPROX REPORT NO 004/06**

Date/Time: 17 Jan 0935  
Position: 5231N 00012W (10nm ESE Wittering)  
Airspace: London FIR (Class: G)  
Reporting Ac Reported Ac  
Type: Gazelle x2 Grob Tutor  
Operator: JHC HQ PTC  
Alt/FL: 2500ft 3000ft  
(RPS) (QNH)  
Weather: VMC CLBC VMC CLBC  
Visibility: 15km >10km  
Reported Separation:  
0ft V/100m H 500ft V/0.3nm H  
Recorded Separation:  
NR V/0.3nm H

**THE GAZELLE PILOT** reports leading a flight of two camouflaged Gazelles from Wittering to Wattisham straight and level at 2500ft and heading 120° at 90kt. A solo pilot flew the lead ac with a VIP passenger and the No 2 had a commander, a further pilot and a passenger. They were squawking the Wittering allocated code with Mode C and were in receipt of a FIS from Wittering Departures who passed them TI on an ac in their 2 o'clock at 3nm. The No 2 pilot called visual immediately followed by Lead. The other ac appeared to be about 200ft above the formation so the leader made a slight heading change to ensure that they passed behind it. As the other ac reached a position in the 10 o'clock relative to the No 2, it banked hard L towards the formation and descended, heading straight for No2 who took evasive action by descending and breaking R out of the formation. He later rejoined his leader from the 5 o'clock and, having regained position, visual contact with the other ac was regained as it departed away from their 5 o'clock. He assessed the risk as being high.

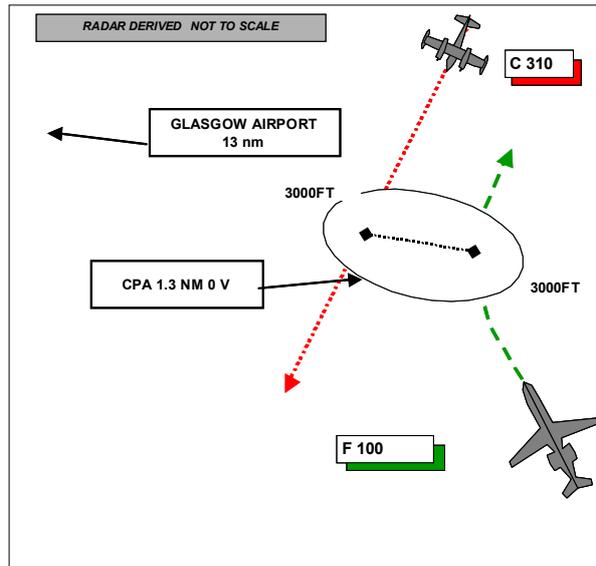
**AIRPROX REPORT NO 006/06**

Date/Time: 20 Jan 14:35  
Position: 5551N 00402W (13nm E Glasgow Intl)  
Airspace: Scottish TMA (Class: E) (2500-6000ft)  
Reporter: Glasgow ATC  
First Ac Second Ac  
Type: Fokker 100 Cessna 310  
Operator: CAT Civ Pte  
Alt/FL: 3000ft 3000ft  
(NR) (QNH 1003mb)  
Weather IMC IMC  
Visibility: 0 0  
Reported Separation:  
Not seen Not seen  
Recorded Separation:  
0 V /1.3nm H  
UKAB Note (1): No climb is seen from the F100 until just after the ac had passed.

**GLASGOW APR** provided a sketchy report stating that a C310 departed Cumbernauld VFR with no pre-warning or flight plan and requested an IFR clearance from him to FL55. Meanwhile an inbound Fokker 100 [F100] was being vectored for an ILS to Glasgow RW23. The C310 climbed to 2500ft VFR and the pilot was instructed to maintain VFR, as there was IFR traffic in his vicinity, cleared to descend to 3000ft. The F100 was initially vectored NW to fly round the C310 which subsequently turned further to the S, so the F100 was turned onto 040° to go round it and TI on the C310 was passed. The ac came within 1.5-2nm at the same level but the F100 called a TCAS RA at 3500ft. It appeared that the C310 had climbed to 3000ft VFR, but after the event the pilot stated that he had been IMC momentarily at 2500ft.

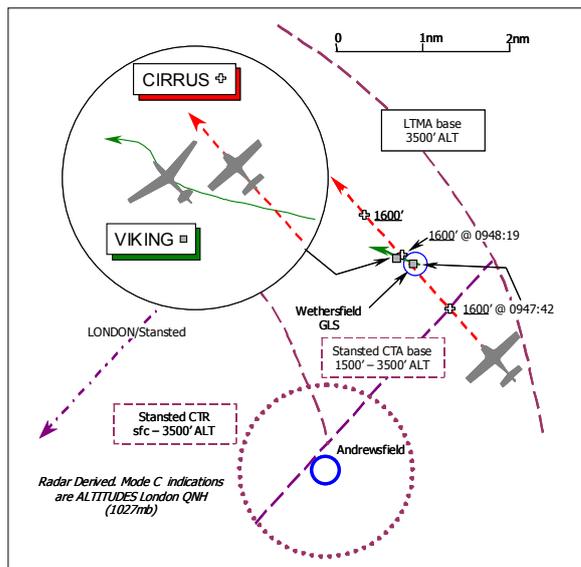
**AIRPROX REPORT NO 007/06**

Date/Time: 21 Jan 0948 (Saturday)  
Position: 5158N 00030E (Overhead Wethersfield elev: 321ft)  
Airspace: London FIR (Class: G)  
Reporting Ac Reported Ac  
Type: Viking Glider Cirrus SR22  
Operator: HQ PTC Civ Pte  
Alt/FL: 1400ft 1500ft  
(QFE 1015mb) (amsl)  
Weather: VMC CAVOK NR CAVOK  
Visibility: >10km >10km  
Reported Separation:  
200ft V/300m H 500ft V/500m H  
Recorded Separation:  
0.2nm H

**THE VIKING GLIDER PILOT** reports that his glider is white with red wingtips and ‘dayglo’ stripes. He was operating from Wethersfield whilst in communication with Glider CONTROL on 128.975MHz and had just executed a winch launch to a height of 1400ft QFE (1015mb) [in the order of 1760ft QNH (1027mb)] on a heading of 280°. After releasing from the cable he turned R into wind onto a heading of 320°, which is when the other ac – a low-wing single engine Cirrus monoplane – was first seen 300m away as it overtook his Viking Glider some 300m to starboard on a parallel course and about 200ft below his glider. No avoiding action was taken as the other ac was passing clear when first spotted so a level cruise at a speed of 50kt was maintained. He assessed the risk as “low”.

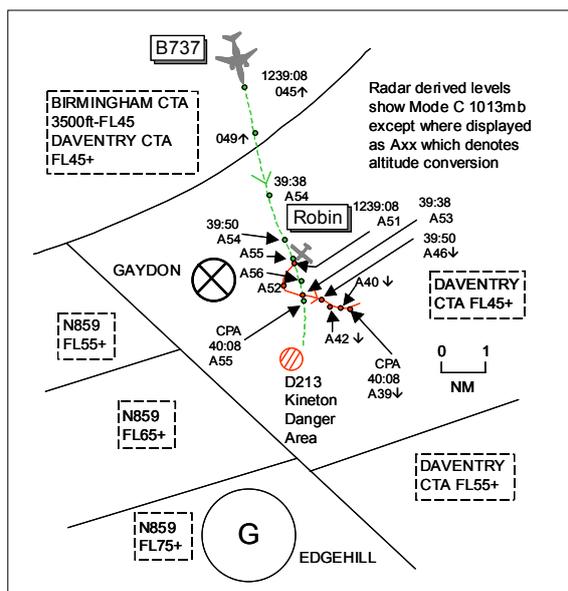
## AIRPROX REPORT NO 008/06

Date/Time: 21 Jan 1240 (Saturday)  
Position: 5210N 00126W (12nm W DTY)  
Airspace: DAV CTA/LFIR (Class: A/G)  
Reporting Ac Reported Ac  
Type: B737-500 Robin 2160i  
Operator: CAT Civ Club  
Alt/FL: FL50 Aeros  
(QNH)  
Weather VMC CLOC VMC CLOC  
Visibility: 10nm NR  
Reported Separation:  
NR 1500ft V/1.5nm H  
Recorded Separation:  
100ft V/2.3nm H OR  
1600ft V/1nm H

**THE B737 PILOT** reports outbound from Coventry IFR and in receipt of an ATS from Birmingham on 118.05MHz squawking 0556 with Mode C. A standard departure route was flown and the flight was transferred from Coventry ATC to Birmingham during the period that the ac was levelled at FL50. Heading 180° at 275kt, traffic was noted on TCAS in their 12 o'clock range 3nm closing from the opposite direction at the same level. When communication was established, Birmingham informed them of traffic with which they were now visual. A short while later an RA 'monitor vertical speed' was received followed by an RA 'climb'. ATC gave them a L turn to avoid a conflict but, as the turn was started, he informed ATC that they would be turning R as the conflicting traffic was going in the same direction. He told ATC of his TCAS manoeuvre and visual contact was maintained until they were clear of the traffic, a light ac coloured blue. He did not report the separation distance but assessed the risk as medium.

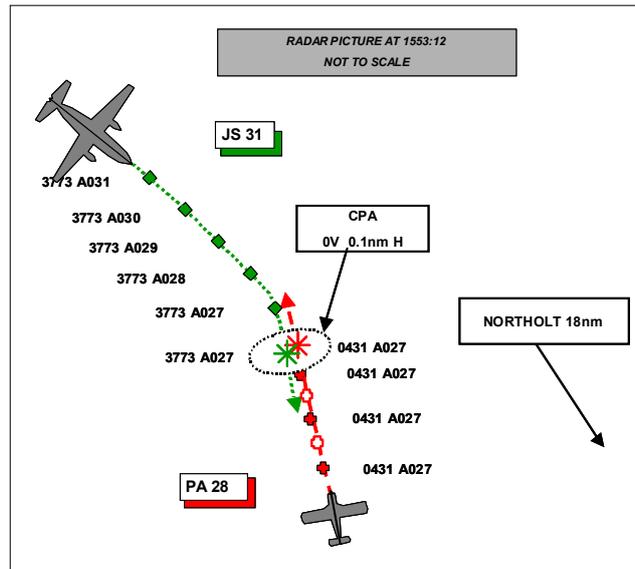
## AIRPROX REPORT NO 010/06

Date/Time: 31 Jan 1553  
Position: 5140N 00051W (2nm W of Princes Risborough)  
Airspace: London FIR (Class: G)  
Reporting Ac Reported Ac  
Type: Jetstream PA28  
Operator: CINC FLEET Civ Pte  
Alt/FL: 2600ft 2700ft  
(QNH 1026 mb) (QNH 1025 mb)  
Weather VMC CLNC VMC CLNC  
Visibility: 6-7km 10km  
Reported Separation:  
20ft V/100m H Not Seen  
Recorded Separation:  
0 V/0.1nm (185m)

**THE JETSTREAM PILOT** reports heading 140° at 200kt on an IFR flight at FL50 from Plymouth for a "Romeo" arrival at Northolt with VHF handovers from Plymouth Military, Yeovilton, Lyneham and Benson. On handover from Lyneham, heading 065°, Benson gave a limited RIS and held them at 3400ft on the London QNH of 1026 while approaching the Romeo arrival entry point (usually 2400ft at that stage). At about 1551 Benson called traffic 2nm S, 900ft below them but with no relative track and later at 1553, about 2nm before the entry point, Benson called "On instructions from Northolt turn R and head 170° and descend to 2400ft"; they complied with the instruction. On passing 2600ft and heading 140° a light ac was observed in the 1130 position about 150yds away, straight and level and flying on a N'y heading. They increased the bank angle to 40° to increase the separation distance and he informed Benson that he had taken avoiding action on a light ac; shortly after they were handed over to Northolt. He assessed the risk of collision as being high.

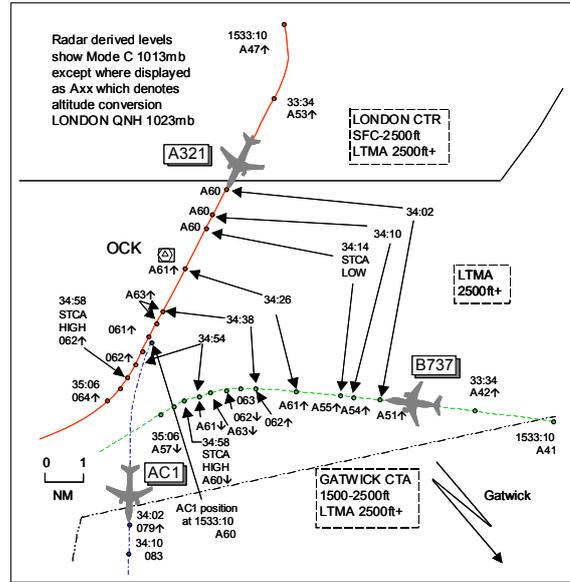
**AIRPROX REPORT NO 012/06**

Date/Time: 27 Jan 1535  
Position: 5114N 00028W (12nm NW Gatwick)  
Airspace: LTMA (Class: A)  
Reporting Ac Reported Ac  
Type: B737-800 A321  
Operator: CAT CAT  
Alt/FL: 6500ft↑ NR  
 (QNH 1023mb)  
Weather VMC CLAC VMC CLBL  
Visibility: 10km 10km  
Reported Separation:  
 NR NR  
Recorded Separation:  
 300ft V/2.8nm H OR  
 1000ft V/1.4nm H

**THE B737 PILOT** reports outbound from Gatwick IFR heading 270° at 250kt and in receipt of a RCS from London on 126.82MHz squawking 4422 with Mode C. Whilst climbing through 6500ft for 7000ft, he thought, ATC told them to descend to 5000ft and to turn onto heading 250°. They then realised that they had a TCAS TA alert on the EHSI on S'bound traffic 300-400ft above them 4nm away to their R. As they started the turn and descent another TA alert was received on traffic to their L so they asked the controller to confirm the required heading, informing him of the other traffic. ATC told them they were clear of that traffic so they continued the L turn onto 250°. They visually acquired the first traffic when given TI by ATC (2 o'clock 2 miles), a B757 or A321, passing clear to their R and above. ATC apologised.

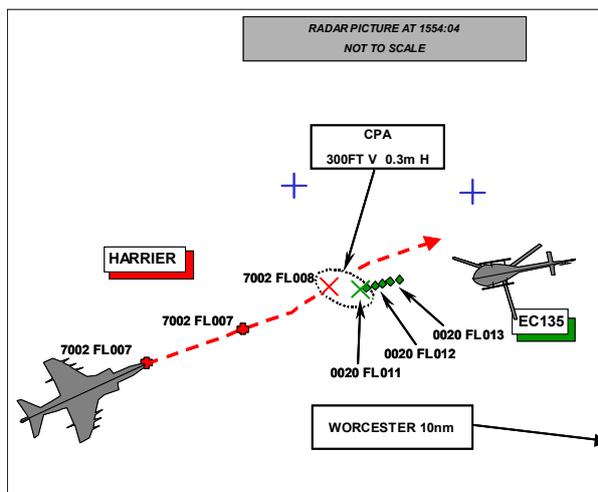
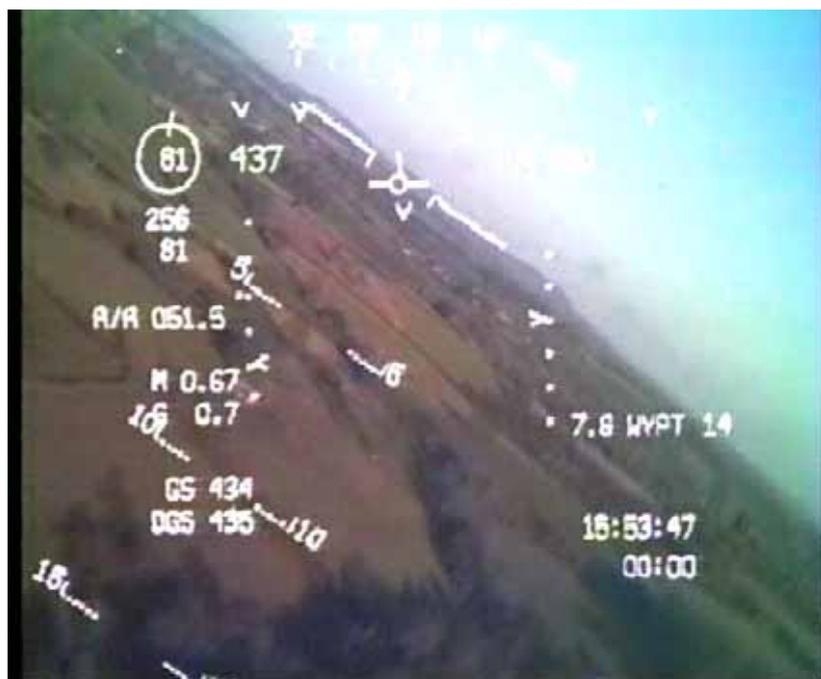
## AIRPROX REPORT NO 013/06

Date/Time: 9 Feb 15:52  
Position: 5214N 00234W (5nm NW Bromyard)  
Airspace: Lon FIR/DLFS (Class: G)  
Reporting Ac Reported Ac  
Type: EC135 Harrier T10  
Operator: Civ Comm HQ STC  
Alt/FL: 600ft 270ft  
(Rad Alt) (Rad Alt)  
Weather VMC CLOC VMC CAVOK  
Visibility: >30km >25km  
Reported Separation:  
200ft V/100m H 1000ft V/1nm H  
Recorded Separation:

300ft V/0.3nm (550M) H (verified by HUD assessment)

**THE EC135 PILOT** reports that his red and yellow ac is operated on behalf of the County Air Ambulance charity and he was operating solo with 2 paramedics. At 15:29 they were tasked to locate and assist an injured horse-rider so departed Strensham at 15:31 towards the position – a farm - passed to them by ambulance control. He was squawking 0020 with Mode C and was in receipt of an FIS from Gloucestershire ATC until just West of Great Malvern whereupon he made blind calls on the Shobdon radio frequency.

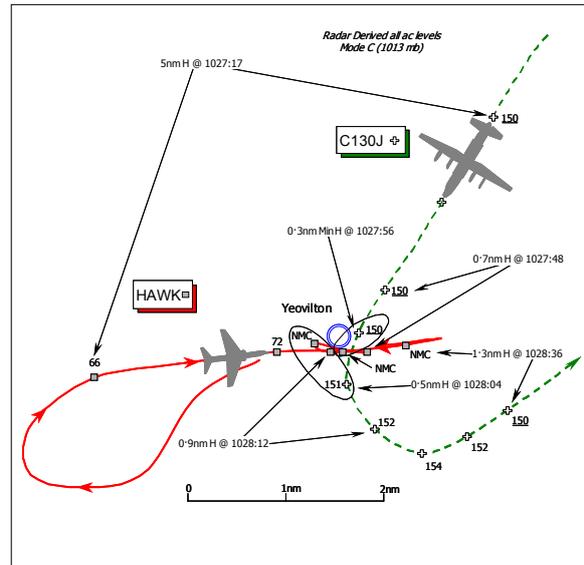
## AIRPROX REPORT NO 014/06

**Date/Time:** 9 Feb 1028  
**Position:** 5101N 00238W (o/h Yeovilton)  
**Airspace:** Boscombe ARA (Class: G)  
**Reporting Ac** **Reported Ac**  
**Type:** C130J Hawk  
**Operator:** MOD DPA CinC FLEET  
**Alt/FL:** FL150 FL50 - 240  
SAS SAS  
**Weather** VMC No Cloud VMC CAVOK  
**Visibility:** 50km+ >10km  
**Reported Separation:**  
Nil V/¼nm H Not seen  
**Recorded Separation:**  
0.3nm H (~600yd)

**THE C130J PILOT** reports that his ac has a grey camouflage scheme but the HISLs were on; the flight deck complement included two pilots and the air load master (ALM). The RHS pilot and ALM were looking out while the LHS pilot was practising the use of the ac's radar and digital map - the ALM having been pre-briefed to take extra care with lookout as is SOP. They were conducting a training flight under VFR and his ac was established in a 10nm racetrack hold, based on the VLN TACAN, turning right [sic] at the VLN and in receipt of a RIS from Boscombe RADAR on 371.82MHz. Flying in a level cruise at FL150 in VMC with nil cloud and an in-flight visibility of 50km+, the weather conditions were "ideal for see & avoid". The assigned squawk of A2601 was selected with altitude reporting, with Mode S and TCAS on. They had completed one 'racetrack' and were inbound to the VLN for the second time, whilst heading 240° at 230kt, with the autopilot engaged. Boscombe RADAR had provided traffic information under the RIS, but they had not previously seen the other ac until the ALM called the Hawk as the RHS pilot saw it appear in the windscreen from below their C130J, "sideways on" just past the vertical about ¼nm away in what appeared to be a loop. To avoid the black Hawk ac, the RHS PF turned the ac rapidly to port, away from the perceived manoeuvre, they then verified with RADAR that the Hawk jet was moving away from them and observed the Hawk complete a further aerobatic manoeuvre before levelling out. Once the Hawk was level they saw the Hawk displayed on the TCAS indicating '-1400ft', but neither pilot saw any TCAS contacts displayed on the large (6" x 8") navigation display, nor was a TA/RA enunciated at all although the ALM believed he might have seen a yellow traffic symbol briefly. He assessed the risk as "low".

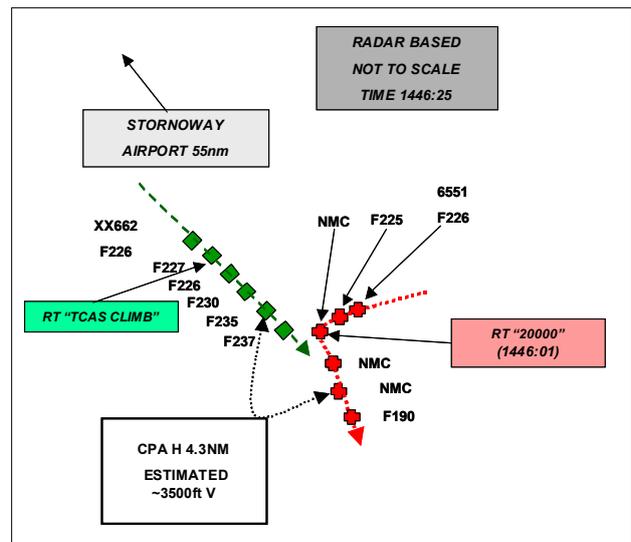
## AIRPROX REPORT NO 015/06

Date/Time: 8 Feb 1446  
Position: 5717N 00515W (65nm NNW Glasgow)  
Airspace: Scottish FIR (Class: G)  
Reporting Ac Reported Ac  
Type: Embraer 145 Tornado F3  
Operator: CAT HQ STC  
Alt/FL: FL210 ~FL220  
(QNH)  
Weather VMC CLBL VMC  
Visibility: 30km 99km  
Reported Separation:  
1000ft V/2m H <2nm  
Recorded Separation:  
(at CPA est ~3500ft) V/4.3nm H

**THE EMBRAER 145 PILOT** reports flying a scheduled passenger flight from Stornoway to Edinburgh heading 155° at 280kt under a RIS and on a direct routing that was accepted after Scottish confirmed that military ATC knew of their routing and intentions. He reported that he believed that the incident had occurred bearing 155° range 65nm from SYY (Stornoway Airport). This placed the ac just outside the lateral limit of the ADR [See UKAB Note 1], in Class G airspace. Scottish then advised them of the position of a contact and they then received a TCAS TA alert. After 10sec they received a TCAS 'monitor vertical speed' followed by a TCAS 'descend'; after following the instruction they then got a TCAS 'climb'. As he initiated the climb he became visual with what appeared to be a Tornado. He informed ATC of their TCAS alerts and they then gave them a heading of 090°. He assessed the risk as being high.

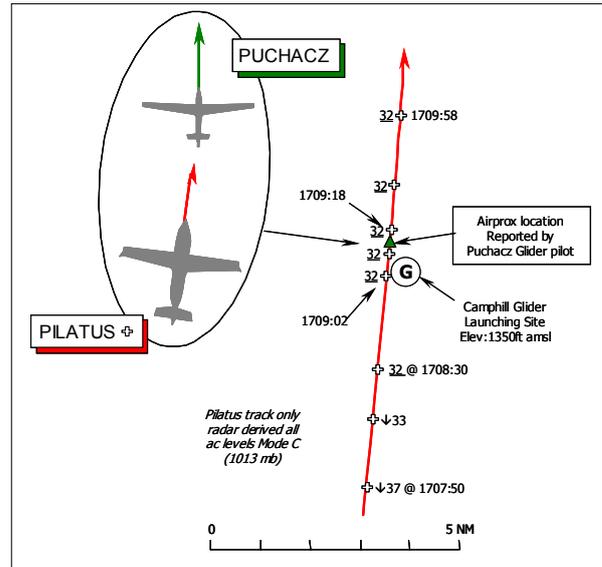
**AIRPROX REPORT NO 016/06**

Date/Time: 9 Feb 1709  
Position: 5318N 00144W (0.7nm NNW of Camphill Glider Site - elev 1350ft)  
Airspace: London FIR (Class: G  
Reporting Ac Reported Ac  
Type: Puchacz Glider Pilatus PC12  
Operator: Civ Club Civ Exec  
Alt/FL: 1200ft FL40  
(QFE) (SAS)  
Weather: VMC VMC  
Visibility: 15km 10km  
Reported Separation:  
4-500ft V/nil H Not seen  
Recorded Separation:  
Not recorded

**THE PUCHACZ GLIDER PILOT**, a gliding instructor, reports that his glider is coloured white with red wingtips/tail. He was in communication with Camphill Glider Site on 129.975MHz whilst winch launching with a student to 1400ft. After the launch they continued to the N of the site with the intention of then joining the Camphill circuit at about 800ft agl. They were flying at 48kt, some 800ft below cloud with an in-flight visibility of 15km. At a position 53° 18' 54"N 001° 44' 27"W - about 0.7nm NNW of the glider site and shown on the diagram by a green triangle - heading 360° (T) in a straight descent through 1200ft QFE above Camphill's elevation of 1350ft amsl [an altitude of about 2550ft amsl], he spotted overhead what he thought was a low-wing business jet, [but actually the PC12] overflying his glider no more than 4-500ft directly above him as it overtook from astern. The other ac disappeared in the direction of Leeds Bradford. Although he did not quantify the risk he added that the other ac was flying within the normal winch launch altitude band of up to 3350ft amsl

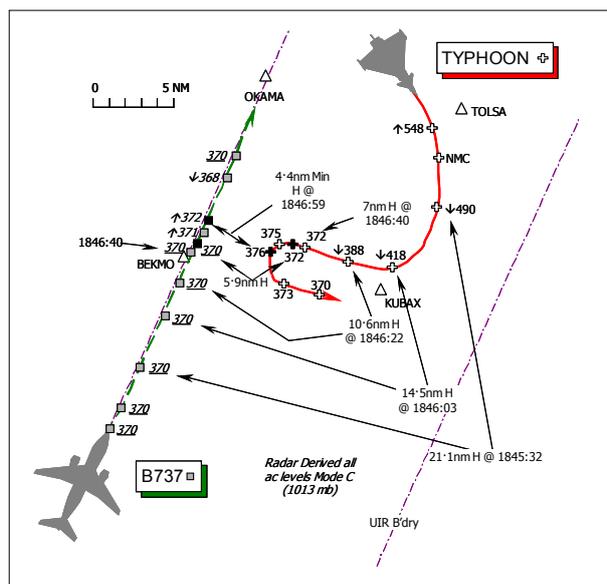
### AIRPROX REPORT NO 017/06

Date/Time: 14 Feb 1846 Night  
Position: 5317N 00252E (10nm S of OKAMA)  
Airspace: UAR/MRSA (Class: B)  
Reporting Ac Reported Ac  
Type: B737-500 Typhoon  
Operator: CAT HQ STC  
Alt/FL: FL370 FL375  
(SAS) (SAS)  
Weather VMC SKC VMC NR  
Visibility: >10km NR  
Reported Separation:  
3-400ft V/1-2nm H 500ft V/5nm H  
Recorded Separation:  
200ft V @ 5.9nm H  
4.4nm H @ 400ft V

Cause: The Typhoon crew initiated a rapid descent without clearance and flew into conflict with the B737.

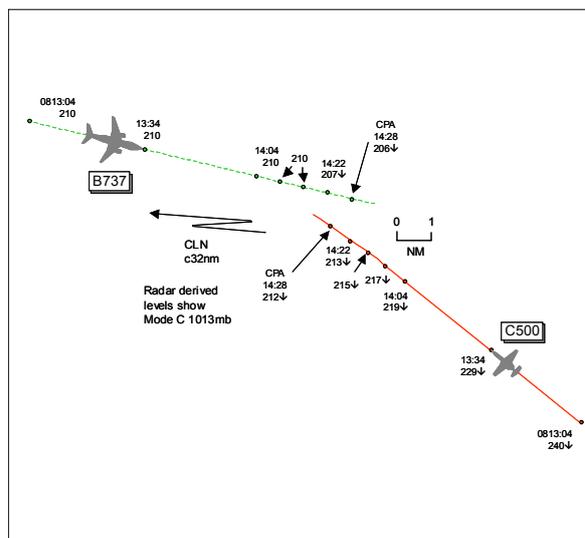
### AIRPROX REPORT NO 018/06

Date/Time: 31 Jan 0814  
Position: 5149N 00200E (32nm E CLN)  
Airspace: AWY L608 (Class: A)  
Reporting Ac Reported Ac  
Type: B737-700 C500  
Operator: CAT Civ Comm  
Alt/FL: FL210 FL220↓  
Weather VMC CLOC VMC CLAC  
Visibility: >10km 15km  
Reported Separation:  
100ft V/<0.5nm H Not seen  
Recorded Separation:  
600ft V/0.9nm H

Cause: The C500 crew descended below their cleared and coordinated level into conflict with the B737.

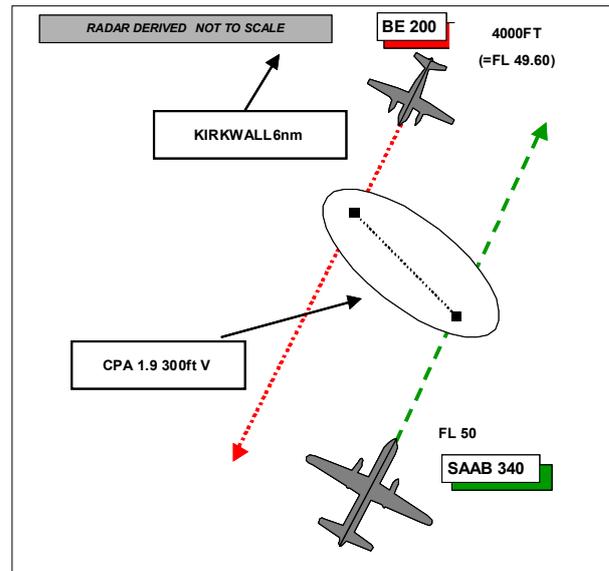
**AIRPROX REPORT NO 020/06**

Date/Time: 17 Feb 13:00  
Position: 5850N 00300W (6nm South of Kirkwall)  
Airspace: W3D (Class: F)  
Reporting Ac Reported Ac  
Type: Saab 340B Beech 200  
Operator: CAT Civ Comm  
Alt/FL: FL50 4000ft  
 SPS (QNH)  
Weather IMC IN CLOUD NR  
Visibility: 0 NR  
Reported Separation:  
 0ft V/1nm H NR  
Recorded Separation:  
 0 V/2.4nm H (becoming 300ft/1.9 nm)

Cause: The Beech 200 crew did not comply with their ATC clearance and climbed into conflict with the Saab 340.

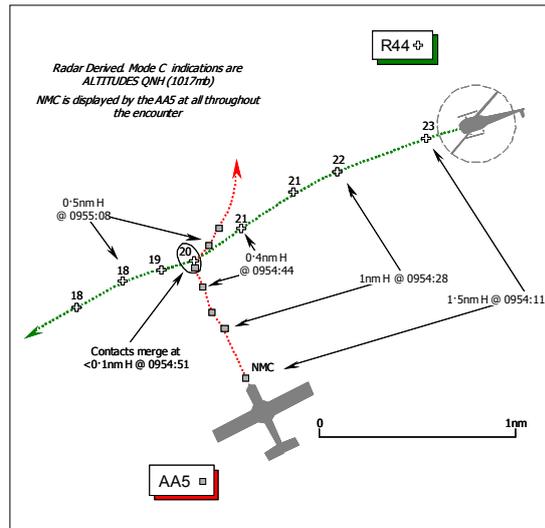
## AIRPROX REPORT NO 021/06

Date/Time: 9 Feb 0954  
Position: 5159N 00057W (2nm E of Buckingham)  
Airspace: London FIR (Class: G)  
Reporting Ac Reported Ac  
Type: R44 AA5A Grumman  
Operator: Civ Comm Civ Trg  
Alt/FL: 2000ft 1900ft  
(RPS 1014mb) (QNH 1017mb)  
Weather VMC CAVOK VMC CAVOK  
Visibility: 40nm >10km  
Reported Separation:  
75ft H 50ft V/600m H  
Recorded Separation:  
<200yd H

Cause: Very late sighting by the AA5 crew and effectively, a non-sighting by the R44 pilot.

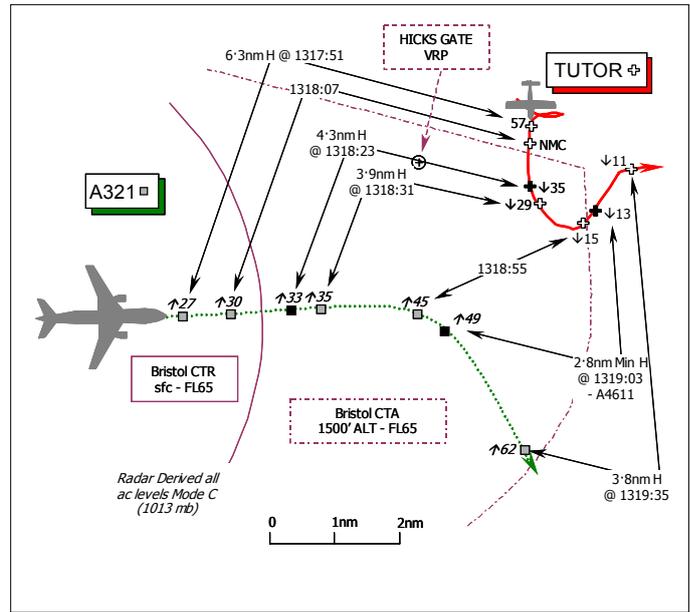
**AIRPROX REPORT NO 022/06**

Date/Time: 26 Feb 1319 (Sunday)  
Position: 5123N 00228W (9nm E of Bristol elev: 622ft)  
Airspace: Bristol CTA (Class: D)  
Reporter: Bristol APR  
First Ac Second Ac  
Type: A321 Grob Tutor  
Operator: CAT HQ PTC  
Alt/FL: ↑FL40 FL60↓  
(SAS) (SAS)  
Weather IMC in Cloud VMC CLOC  
Visibility: NR 5nm  
Reported Separation:  
Bristol APR: 800ft V/2.5nm H  
NR NR  
Recorded Separation:

200ft Min V @ 4-3nm H.2-8nm Min H @ 3600ft V.

Cause: Following an inadvertent penetration of CAS, the proximity of the Grob Tutor to the A321 caused the controller concern.

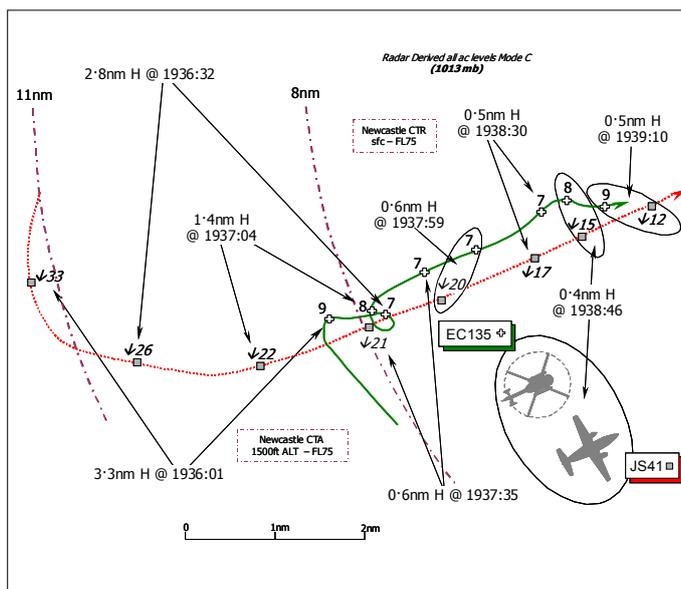
### AIRPROX REPORT NO 023/06

Date/Time: 21 Feb 1938 Night  
Position: 5501N 00150W (5nm FINALS RW07 at Newcastle - elev 266ft)  
Airspace: Newcastle CTR (Class: D)  
Reporting Ac Reported Ac  
Type: JS41 EC135  
Operator: CAT Civ Comm  
Alt/FL: 1500ft↓ 1000ft  
(QNH 1030mb) (QNH 1030mb)  
Weather VMC CLBC VMC CLBC  
Visibility: 10km 10km+  
Reported Separation:  
NR Nil V @ 2nm Min H  
Recorded Separation:  
0.4nm Min H @ 1938:46  
Nil V @ 0.8nm H

Cause: The EC135 pilot did not comply fully with the APR's instruction to hold and flew close enough to the JS41 to cause its pilot concern.

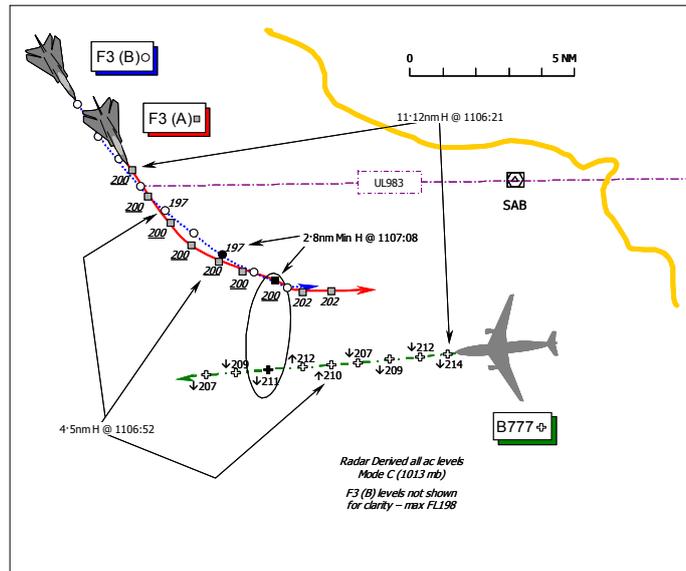
## AIRPROX REPORT NO 025/06

Date/Time: 1 Mar 1107  
Position: 5548N 00222W (8nm SW of ST ABBS VOR)  
Airspace: Scottish FIR (Class: G)  
Reporting Ac Reported Ac  
Type: B777 Tornado F3 pr  
Operator: CAT HQ STC  
Alt/FL: FL210↓ FL200  
(SAS) (SAS)  
Weather VMC NIL VMC  
Visibility: NR >99km  
Reported Separation:  
700ft V/4nm H 4nm H  
Recorded Separation:  
1100ft V @ 2.8nm Min H

Cause: Sighting report (TCAS) in Class G airspace.

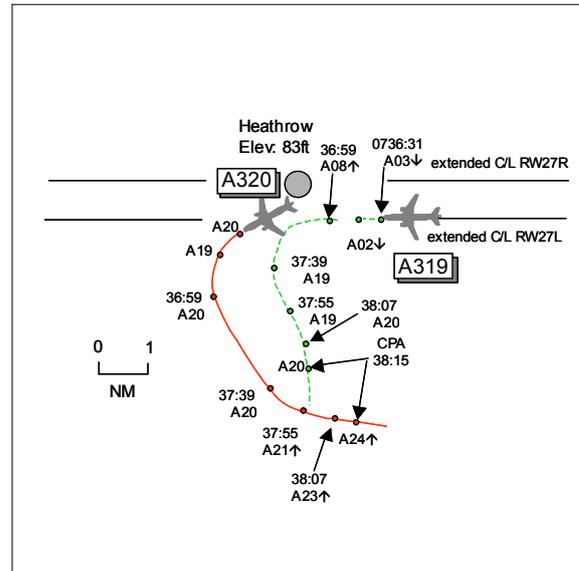
**AIRPROX REPORT NO 026/06**

Date/Time: 4 Mar 0738 (Saturday)  
Position: 5125N 00027W (4nm S Heathrow - elev 83ft)  
Airspace: CTR (Class: A)  
Reporting Ac Reported Ac  
Type: A319 A320  
Operator: CAT CAT  
Alt/FL: 2000ft 2000ft  
 (QNH 1000mb) (QNH 1000mb)  
Weather: VMC CAVK VMC CAVK  
Visibility: 10km  
Reported Separation:  
 Nil V/1nm H Not seen  
Recorded Separation:  
 400ft V/1.4nm H

Cause: The Heathrow Air Arrivals Controller did not ensure separation between the A320 and A319.

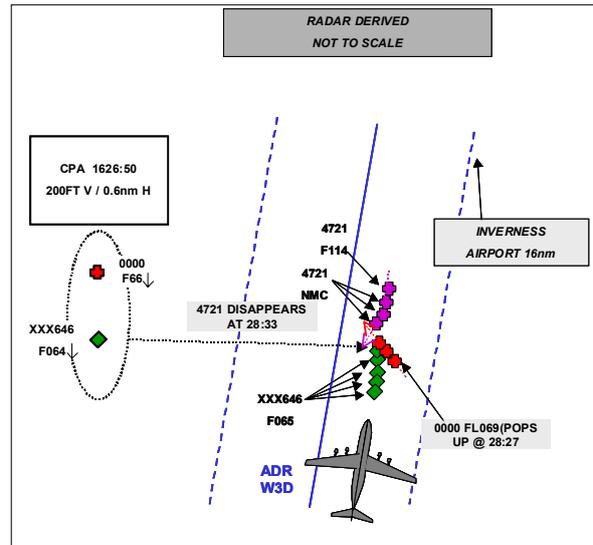
### AIRPROX REPORT NO 027/06

Date/Time: 6 Mar 1630  
Position: 5721N 00405W (16nm S INS)  
Airspace: ADR W3D (Class: F)  
Reporting Ac Reported Ac  
Type: BAe146 Jaguar  
Operator: CAT HQ STC  
Alt/FL: FL65 250 - 10000ft (RPS)  
Weather NR VMC CAVOK  
Visibility: 50nm 50nm  
Reported Separation:  
<400ft V/0.25nm H Not Seen  
Recorded Separation:  
200ft V/0.6nm H

Cause: The Jaguar pilots disregarded the ACN guidance regarding Advisory Routes and flew into conflict with the BAe 146 which they did not see.

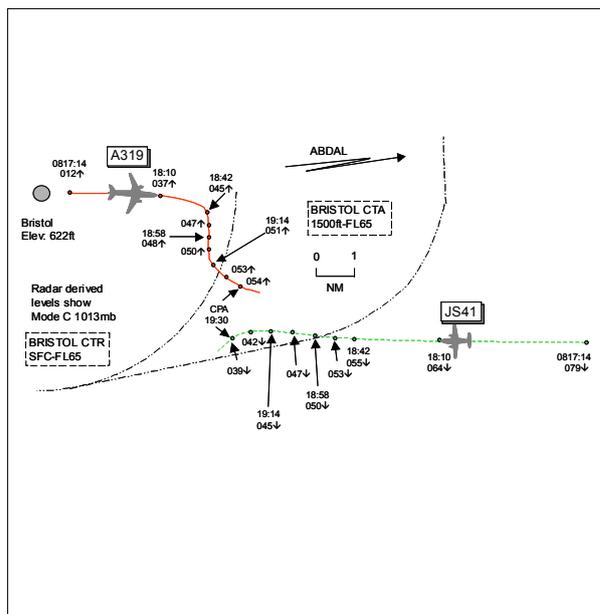
**AIRPROX REPORT NO 028/06**

Date/Time: 7 Mar 0819  
Position: 5120N 00234W (7nm SE Bristol - elev 622ft)  
Airspace: Bristol CTA (Class: D)  
Reporting Ac Reported Ac  
Type: JS41 A319  
Operator: CAT CAT  
Alt/FL: 5000ft↓ ↑FL150 (QNH)  
Weather IMC KLWD IMC NR  
Visibility:  
Reported Separation:  
400ft V/2nm H 3nm H  
Recorded Separation:  
600ft V/2.3nm H OR  
1500ft V/1.3nm H

Cause: The A319 crew did not follow their ATC departure clearance and turned into conflict with JS41.

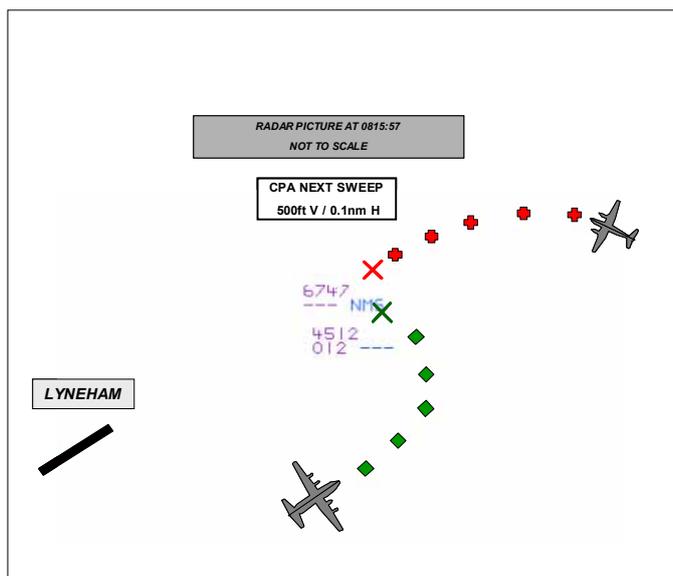
### AIRPROX REPORT NO 029/06

Date/Time: 28 Feb 06 0816  
Position: 5131N 00157W (2nm ENE Lyneham - elev 513ft)  
Airspace: Lyneham CTZ (Class: D)  
Reporting Ac Reported Ac  
Type: C130 Beech 200  
Operator: HQ STC Civ Comm  
Alt/FL: 800ft 700ft  
(QFE N/K) (QFE)  
Weather NR VMC  
Visibility: NR >10km  
Reported Separation:  
300-500ft H NR  
Recorded Separation:  
500ft /0.1nm

It would appear that this incident took place because of the lack of TI being passed to the C130s already in the visual circuit by the ADC as the VHF-equipped light ac joined. The ADC's failure to transmit instructions on both VHF and UHF frequencies exacerbated the situation and prevented the visual circuit traffic from maintaining a higher level of SA. If the crew of the C130 had been aware of the light ac's intentions they may have elected to go around earlier or extend downwind behind that traffic.

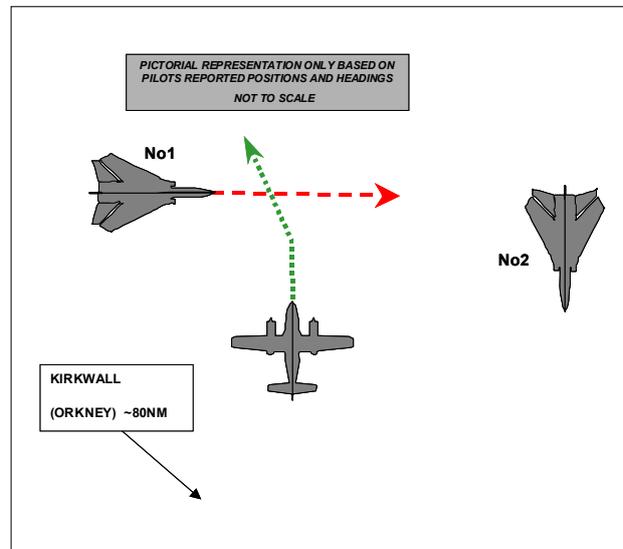
## AIRPROX REPORT NO 030/06

Date/Time: 9 Mar 10:15  
Position: 6002 N 00435 W (82nm NW Kirkwall)  
Airspace: Scottish FIR (Class: G)  
Reporting Ac Reported Ac  
Type: Cessna F406 Tornado F3  
Operator: Civ Comm HQ STC  
Alt/FL: 1200ft 1250ft  
(QNH 995 mb) (Rad Alt)  
Weather VMC CLBL VMC  
Visibility: 40km >10km  
Reported Separation:  
0ft V/0.5nm H Not Seen  
Recorded Separation:  
NR

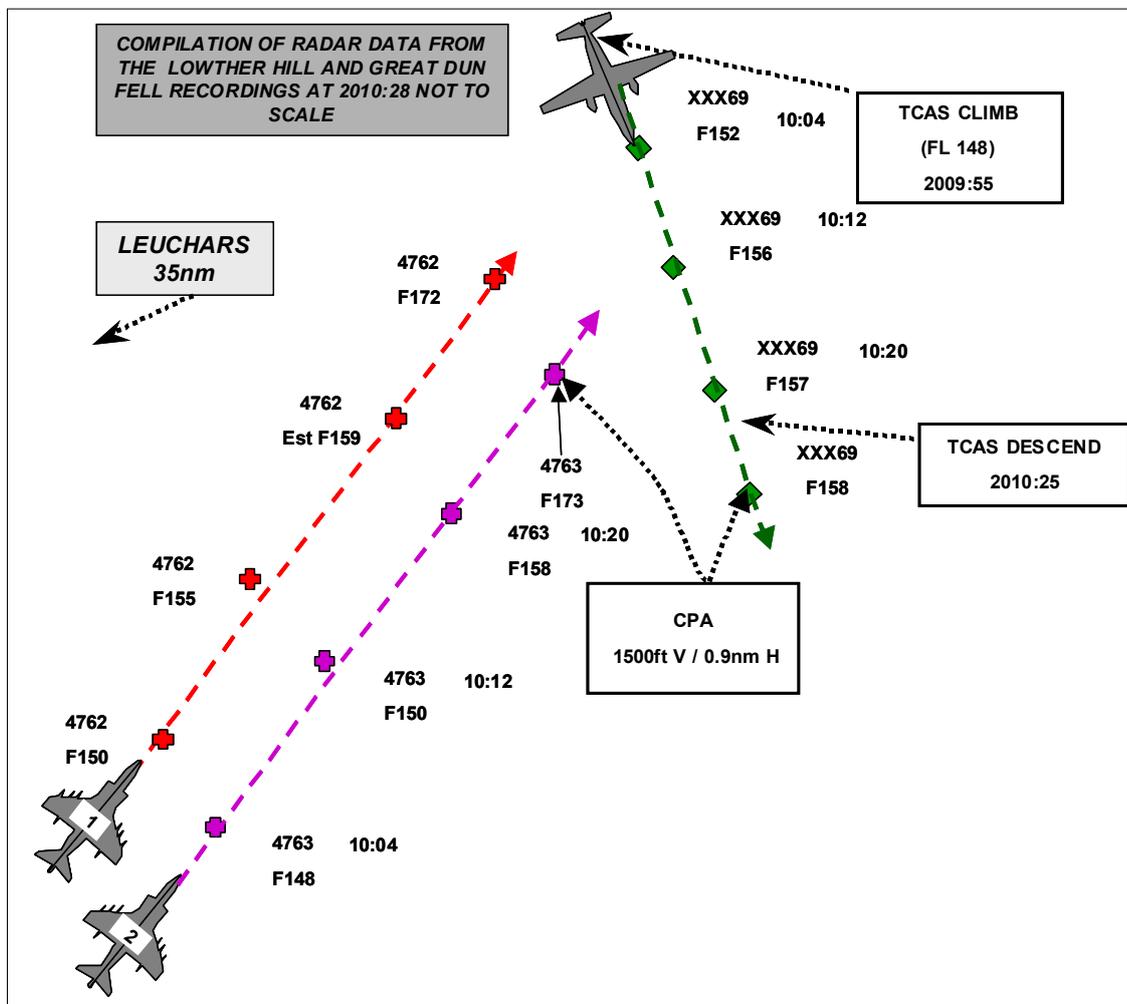
**AIRPROX REPORT NO 031/06**

Date/Time: 15 Mar 2010 NIGHT  
Position: 5640N 00202W (8nm N BALID)  
Airspace: Scottish FIR (Class: G)  
Reporting Ac Reported Ac  
Type: JS41 Harrier x 2  
Operator: CAT HQ STC  
Alt/FL: FL155 FL150↑  
Weather VMC CAVOK VMC CAVOK  
Visibility: 45NM NR  
Reported Separation:  
 Not Seen 1000ft V/ 0.5nm H  
Recorded Separation:  
 1500ft V/0.9nm H (on Harrier No 2)

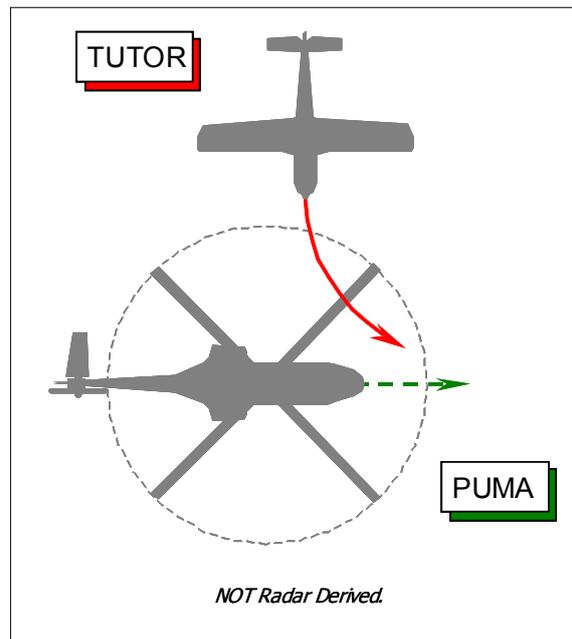
### AIRPROX REPORT NO 032/06

Date/Time: 16 Mar 1505  
Position 5138N 00118W (1nm N Didcot Power Station)  
Airspace: Oxford AIAA (Class: G)  
Reporting Ac Reported Ac  
Type: Puma Grob Tutor  
Operator: HQ JHC HQ PTC  
Alt/FL: 1000ft 1000ft  
(1023mb) QFE (1020mb)  
Weather VMC CLBC VMC N/K  
Visibility: >10km 7km  
Reported Separation:  
Nil V/20m H Nil V/200ft H  
Recorded Separation:  
Not recorded

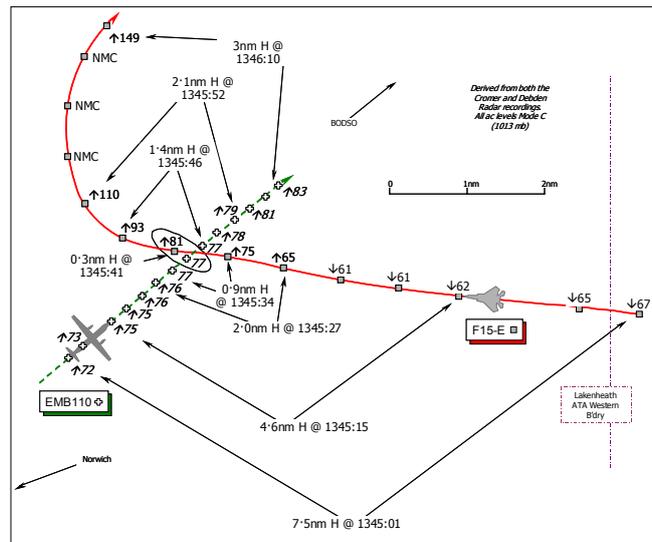
## AIRPROX REPORT NO 034/06

Date/Time: 23 Mar 1345  
Position: 5251N 00141E (18nm NE Norwich)  
Airspace: London FIR (Class: G)  
Reporting Ac Reported Ac  
Type: EMB110 F-15E  
Operator: Civ Comm Foreign Mil  
Alt/FL: FL80↑ FL65  
(SAS) (SAS)  
Weather VMC NIL VMC CAVOK  
Visibility: >10km >10km  
Reported Separation:  
<300ft V/150m H 500ft V/0.5nm H  
Recorded Separation:  
<200ft V @ 0.9nm H

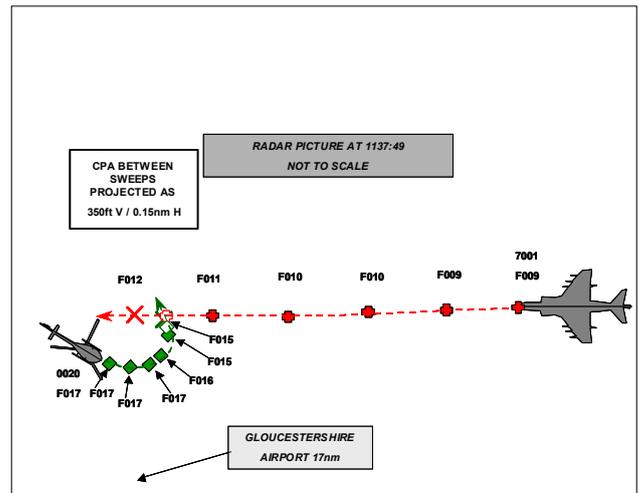
**AIRPROX REPORT NO 036/06**

Date/Time: 29 Mar 1138  
Position: 5200N 00146W (17nm NE Gloucestershire)  
Airspace: Lon FIR/UKLFS (Class: G)  
Reporting Ac Reported Ac  
Type: EC135 T2 Harrier GR9  
Operator: Civ Comm HQ STC  
Alt/FL: 500ft (Rad Alt) 250ft (Rad Alt)  
(RPS 1002 mb) (RPS N/K mb)  
Weather: VMC Showers VMC Rain  
Visibility: >20km 40km  
(reduced in showers)  
Reported Separation:  
~200ft V/0m H 750ft V/0.25nm H  
Recorded Separation:  
350ft V/0.15nm H (both projected)

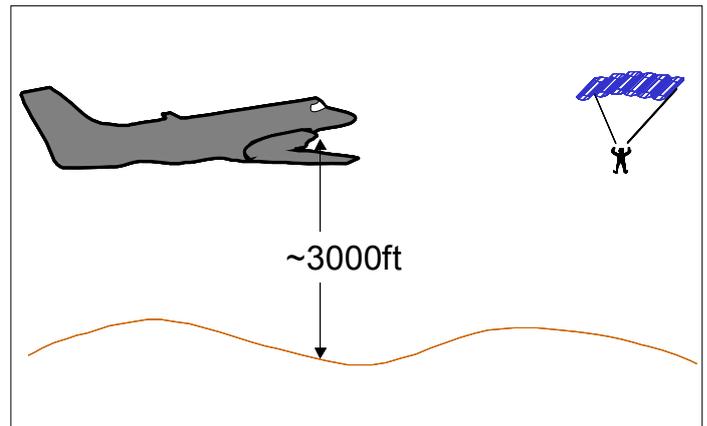
**AIRPROX REPORT NO 038/06**

Although the precise geometry of this incident was not resolved due to differences in the reported altitude and miss-distances, the cause was quite clear to the Board namely the paraglider's unauthorised penetration of CAS. Due to the discrepancies between the two pilots' reports and in the absence of any radar information, the degree of risk was much more difficult to determine with any degree of confidence. After much debate however, the Board considered that the situation had not been entirely safe due to the lack of any effective avoidance by either ac.

Cause: The paraglider entered the Solent CTA without clearance.

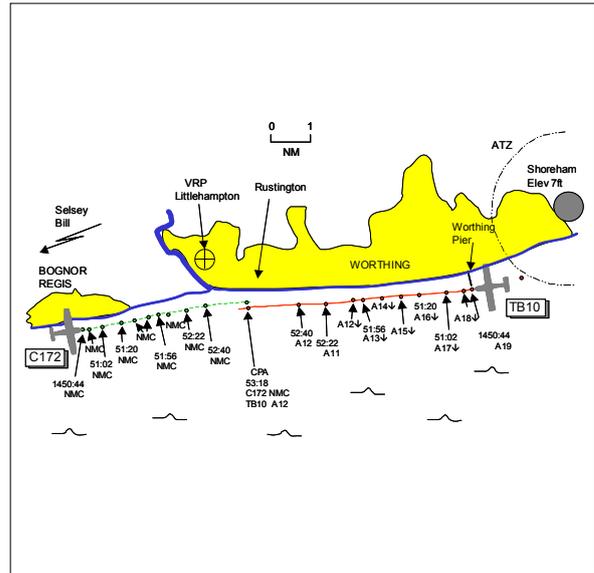
**AIRPROX REPORT NO 039/06**

In the absence of any further information, Board Members were disappointed to note that the C172 pilot had his transponder Mode C selected off, contrary to the recommended procedures promulgated in the AIP. This altitude reporting element provides controllers at radar equipped ATSU's with additional information on displayed traffic thereby assisting them in their provision of an ATS. Moreover, the important flight safety nets of STCA and TCAS are either inhibited or have reduced functionality when Mode C is not carried or not switched on.

Cause: Believing that he had passed the conflicting traffic and without announcing his intentions, the TB10 pilot descended into conflict with the C172.

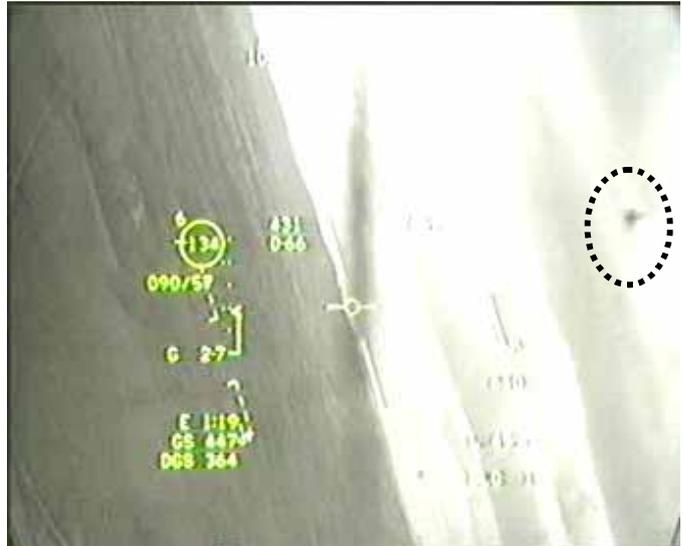
**AIRPROX REPORT NO 040/06**

In the absence of a report from the helicopter pilot and the lack of necessary level and other information - at the time of the Airprox - on the recorded radar data, Members found it difficult to assess events with any degree of accuracy. Small helicopters - particularly Robinsons, if this was indeed the type involved in this Airprox - are notoriously difficult to see when they are encountered head on. In this instance the sighting difficulties would have been temporarily exacerbated by the Tornado's turn through an into-Sun heading. Members assumed that the helicopter pilot had most probably not seen the Tornado and therefore concluded that the cause of this Airprox was an effective non-sighting by the Tornado crew and presumed non-sighting by the helicopter pilot. As regards degree of risk, on the basis of the Tornado pilot's report and assessment of the HUD video, Members agreed that whilst there was no actual risk of a collision, safety had been compromised.

Cause: Effective non-sighting by the Tornado crew and presumed non-sighting by the helicopter pilot.

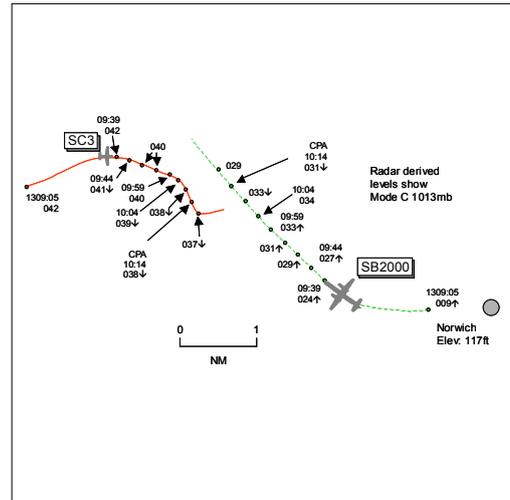
**AIRPROX REPORT NO 041/06**

Cause: Conflict in Class G airspace.

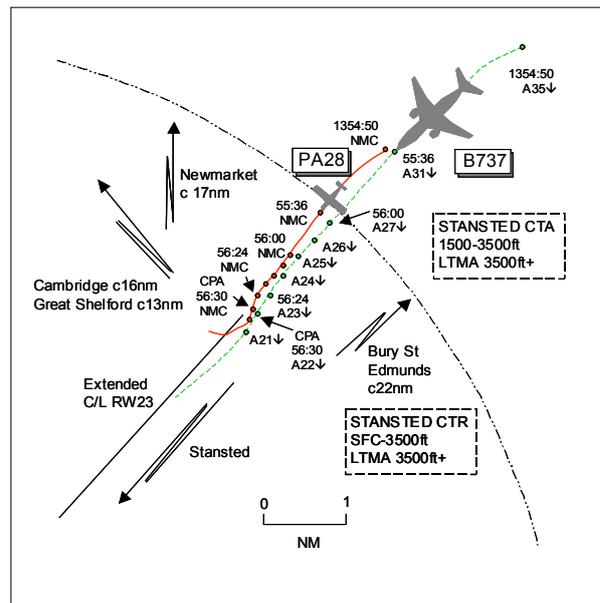
## AIRPROX REPORT NO 042/06

Lengthy discussion ensued as to whether the controller could have intervened any earlier to deconflict the deteriorating situation. Events unfolded during the survey flight's RT exchange, the controller's attention being undoubtedly drawn to that flight such that she would have been looking to the NW of her radar display to assimilate the ac's position during the pilot's transmission. That said, the controller noticed the PA28's CTR entry but did not interrupt the RT exchange with the survey flight. Thirty seconds elapsed after this occurred which became her first opportunity to give the B737 crew immediate avoiding action. Given the controller's interpretation of the MATS Part 1, she then 'resolved' the conflict through giving TI and the B737 crew maintaining their own visual separation. Even so, any ATC action hinged on what the 7000 squawk, the PA28, did with respect to the Stansted CTR as it approached from the NE showing NMC. As seen from the radar recording, as the 7000 squawk crossed the CTR boundary, it was clear that the PA28 pilot had made an unauthorised penetration of Class D airspace which caused the Airprox. Members agreed that even though this had been an inadvertent penetration, through a navigational error, the PA28 pilot then flew into conflict with the B737 as the latter approached from behind. That said, the B737 crew had monitored the PA28's progress; seen it visually and agreed with ATC to take their own separation against it. The B737 crew had deviated slightly to the L and descended through the PA28's level whilst maintaining visual contact. The Board agreed with the ATSI comments in that it was probably the safest course of action given the subject ac's proximity when a positive resolution by ATC was needed. Moreover, the B737 crew were always in a position to manoeuvre further to avoid, if necessary, which allowed the Board to conclude that safety had been assured during the encounter.

Cause: The PA28 pilot made an inadvertent, unauthorised penetration of Class D airspace and flew into conflict with the B737.

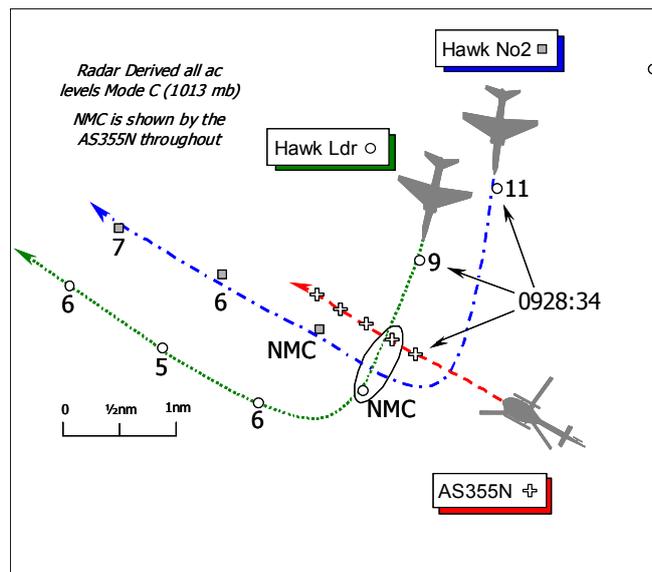
### AIRPROX REPORT NO 043/06

The Hawk pair were undoubtedly there to be seen by the AS355N pilot in the CAVOK conditions but it was evident that both jets had approached at a high closing speed and a near head on aspect to the helicopter (after their earlier battle turn), at a constant relative bearing with virtually no relative motion to draw attention to them on the AS355N's starboard beam. Perhaps not surprisingly this defeated the helicopter pilot's lookout scan - at the stage when he was just about to commence his approach to the landing site - and masked the formation's presence from him until after the lead Hawk had crossed underneath and the No2 had apparently passed astern. In one helicopter pilot Member's view, the Squirrel pilot was not keeping as good a lookout as perhaps he might, as the jets had approached from his side of the ac. The AS355N pilot had reported first sighting of a black Hawk jet at a range of 1nm. However, his perception of the geometry of the encounter was that this single Hawk ac had been about 500m away on the port beam before opening ahead and then crossing into his 12 o'clock from the left. Thus if the helicopter pilot had indeed seen the jet 1nm away, it appeared to the pilot Members that this was as the Hawks departed ahead of him which was after they had crossed respectively underneath and astern of his AS355N. Thus, the AS355N pilot had probably not detected the presence of the Hawk pair before the Airprox occurred and afterwards had only seen one of the jets. The Board therefore agreed that the other part of the cause was a probable non-sighting of the Hawk pair by the AS355N pilot.

Cause: Effectively, a non-sighting by the Hawk leader and a probable non-sighting by the AS355 pilot.

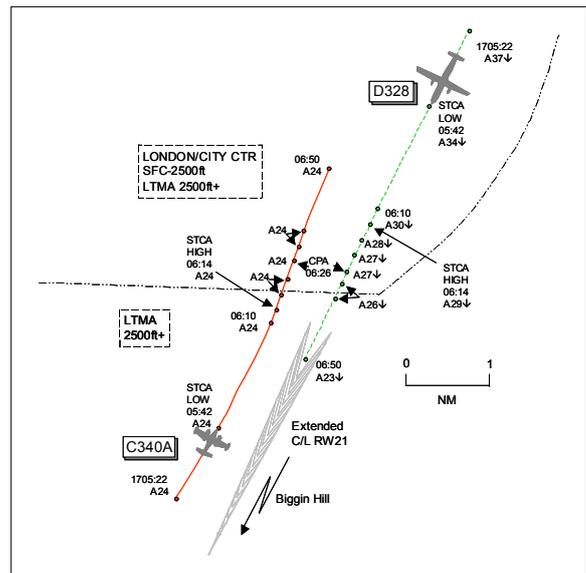
**AIRPROX REPORT NO 045/06**

Cause: Having been advised to keep clear of the ILS C/L, the C340A pilot flew sufficiently close to the ILS to trigger a TCAS RA in the D328.

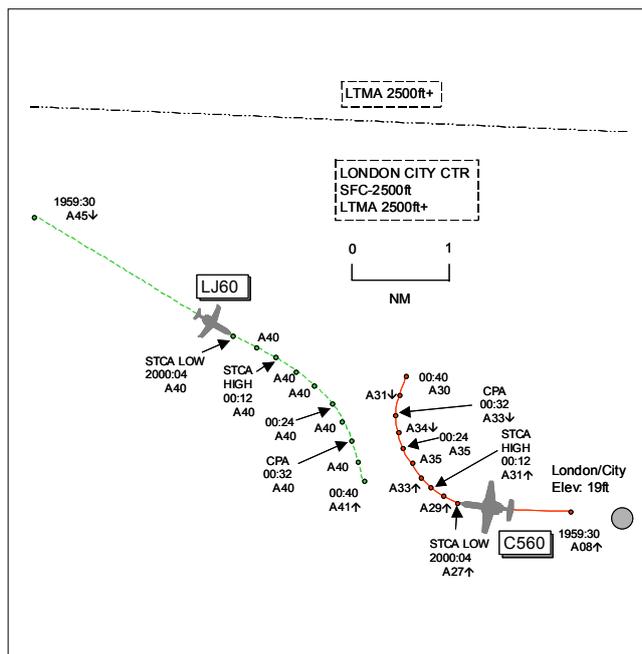
Pilot Members could not understand the C560 crew's rationale for choosing a high ROC when the SID profile requires a step climb with an initial level-off at altitude 3000ft. Careful monitoring of the ac's flightpath is required, especially when not using an A/P, as excursions/deviations can easily result when distracted. It was clear that the cause of this Airprox was that the C560 crew climbed above their cleared level and flew into conflict with the LJ60. It was noted that although the LJ60 crew reported receiving a TCAS RA 'climb', the C560 crew reported receiving no alerts/warnings (TAs/RAs). This seemed inconceivable to pilot Members as STCA warnings were generated on the radar display system. Normally complementary TAs/RAs would be received by both ac during an encounter involving two TCAS II equipped ac. Without the benefit of a post incident TCAS download from the C560, this anomaly could not be resolved.

Cause: The C560 crew climbed above their cleared level and flew into conflict with the LJ60.

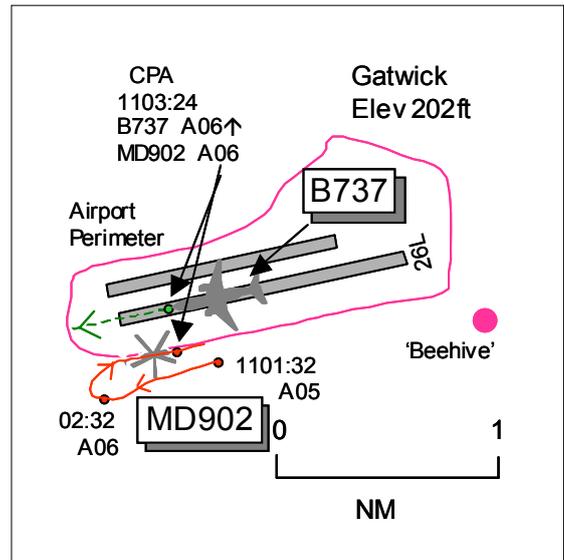
**AIRPROX REPORT NO 047/06**

Cause: In the absence of TI, the B737 crew were unsure of the MD902 pilot's intentions.
