**UK AIRPROX BOARD**

# **Analysis of Airprox in UK Airspace**

**Report Number 16  
January 2006 – June 2006**

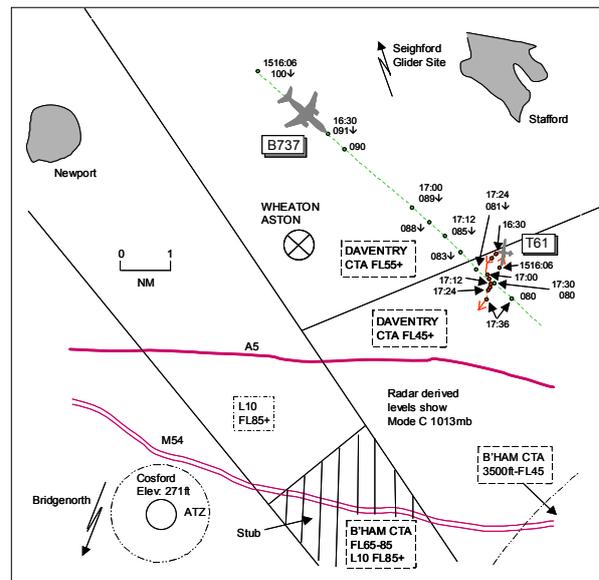
## AIRPROX REPORT NO 048/06

It was noted that this was an unusual flight for a Motor Glider to perform - high altitude GH - and that the incident occurred towards the end of a long sortie. Having planned to operate up to 8000ft to the W and SW of Cosford, near Bridgenorth, with few airspace constraints (CAS base level FL145), the pilot had elected to move to the N and NE of Cosford owing to approaching cloud. Although he had reported being cognisant of the airspace structure in the revised area of operation, careful attention should have been paid to establishing his exact position whilst carrying out GH to ensure that his ac was clear of CAS at all times, particularly where promulgated base levels were below his operating level. It was clear to Members that this was not done and that the T61 pilot operated within Class A airspace and flew into conflict with the B737 which he did not see. This had caused the Airprox.

Cause: The Slingsby T61 M/Glider pilot operated within Class A airspace without clearance and flew into conflict with the B737 which he did not see.

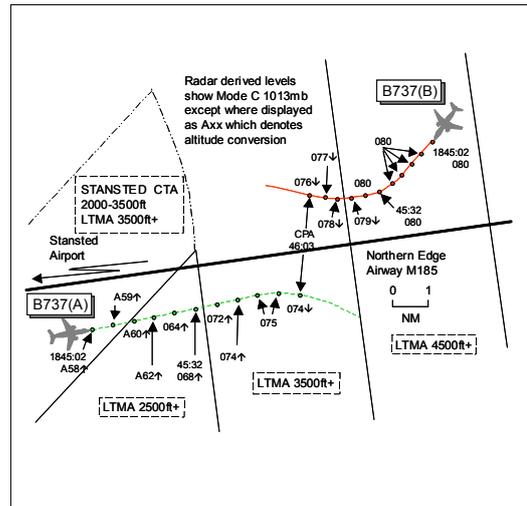
**AIRPROX REPORT NO 049/06**

That said, both controllers saw the deteriorating situation ahead of STCA activating. The NE DEPS SC gave the B737(A) flight a R turn and stopped its climb, albeit after the ac had climbed through the given stop-off level, whilst

Cause: The LTCC Essex Radar and NE DEPS SC did not ensure that standard separation was maintained.

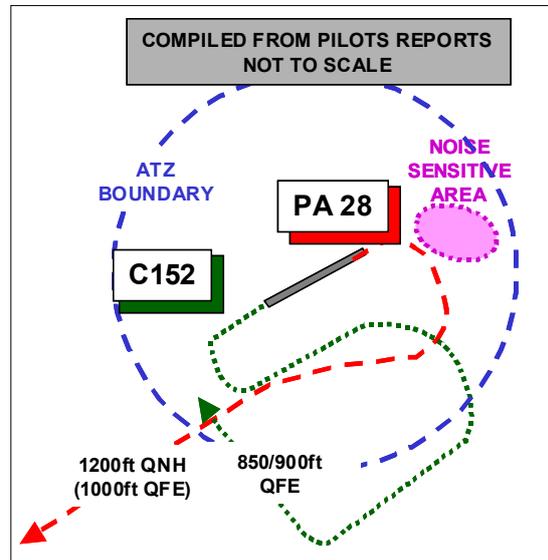
## AIRPROX REPORT NO 051/06

An experienced GA Member observed that this was a serious incident and that at airfields where there is no positive control pilots must be punctilious in observing the correct procedures. He considered that on the change of RW the only safe method of joining the new circuit would have been to conduct a full overhead join and descent into the circuit. Members were also surprised that the PA28 pilot apparently did not manoeuvre his ac to aid his sighting while in the prolonged, shallow bank angle, turn in the circuit area: he seemed to be in a bit of a rush to get away.

Cause: Non-sighting by the PA28 pilot and late sighting by the C152 pilot.

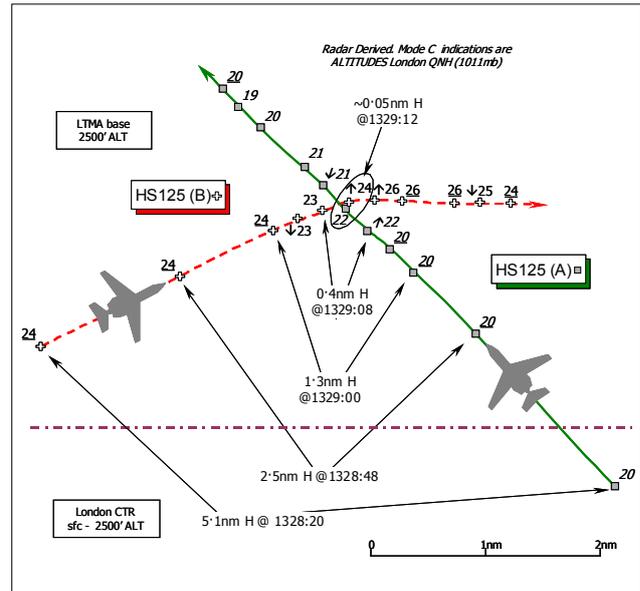
**AIRPROX REPORT NO 056/06**

Date/Time: 8 May 1329  
Position: 5137N 00035W (3nm WNW CHILTERN NDB)  
Airspace: London FIR/LTMA (Class: G/A)  
Reporting Ac Reporting Ac  
Type: HS125-700 HS 125-800B  
Operator: HQ STC Civ Comm  
Alt/FL: 2000ft 2400ft  
 QNH (1011mb) QNH (1011mb)  
Weather IMC CLOC VMC CLBL  
Visibility: 3-5km 10km+  
Reported Separation:  
 200ft V/1/2nm H 200ft V/nil H  
Recorded Separation:  
 100ft Min V @ 0.4nm H  
 200ft V @ ~100yd [0.05nm] Min H

Cause: Whilst in receipt of a RIS, neither crew avoided the other's ac by a sufficient margin.

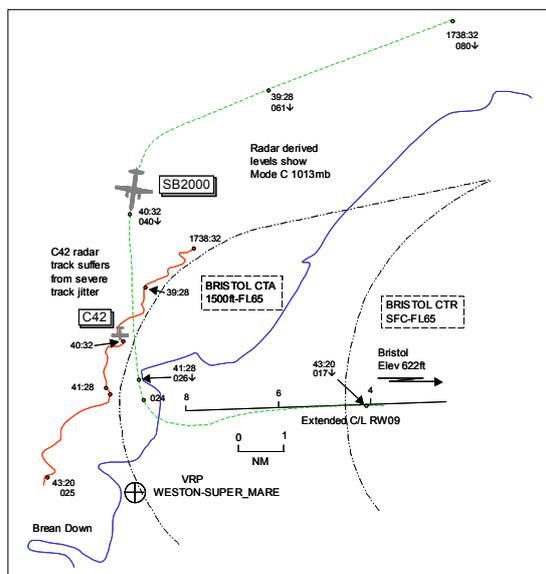
## AIRPROX REPORT NO 057/06

Date/Time: 11 May 1741  
Position: 5123N 00258W (10nm W Bristol - elev 622ft)  
Airspace: CTA/FIR (Class: D/G)  
Reporting Ac Reported Ac  
Type: SB2000 Ikarus C42  
Operator: CAT Civ Pte  
Alt/FL: ↓2500ft 2800ft  
(QNH 1017mb) (QNH 1017mb)  
Weather VMC CLOC VMC CLOC  
Visibility: NR 10nm  
Reported Separation:  
200ft V/1.2nm H Not seen  
Recorded Separation:  
0.7nm H

Cause: The SB2000 was vectored into conflict with the undisplayed Ikarus C42 whose position had not been established by the Bristol APRs during a period of high workload.

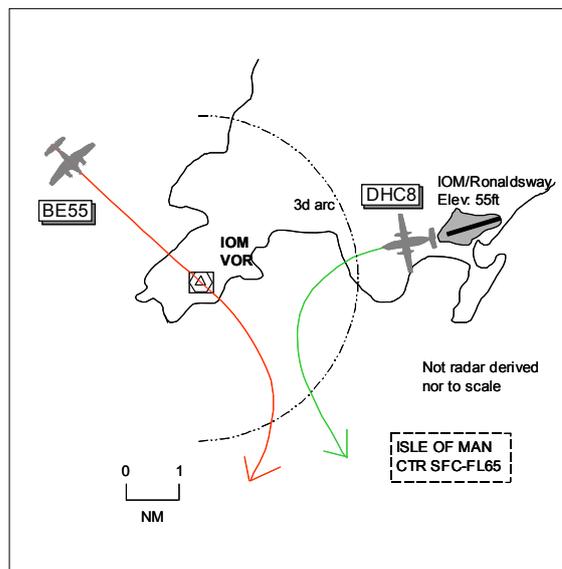
### AIRPROX REPORT NO 060/06

Date/Time: 19 May 1628  
Position: 5403N 00444W (2nm SE IOM VOR)  
Airspace: CTR (Class: D)  
Reporting Ac Reported Ac  
Type: DHC8 BE55  
Operator: CAT Civ Pte  
Alt/FL: 2800ft↑ 3500ft  
(QNH 996mb) (QNH 995mb)  
Weather VMC CLOC VMC CLBC  
Visibility: 10km >10km  
Reported Separation:  
Nil V/800m H 500ft V/1nm H  
Recorded Separation:  
NR

Cause: Having been given TI, the BE55 and DHC8 crews did not fulfil their obligations under the respective flight rules in Class D airspace.

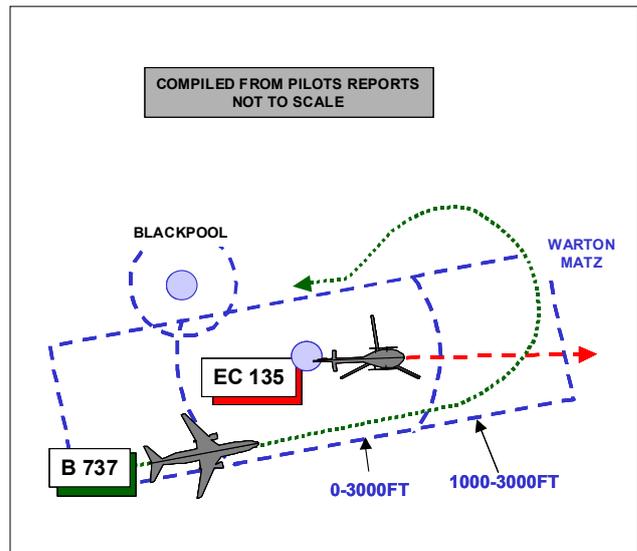
**AIRPROX REPORT NO 062/06**

Date/Time: 23 May 0911  
Position: 5346N 00240W (9nm ESE of Blackpool  
 - elev 34ft)  
Airspace: Warton MATZ (Class: G)  
Reporting Ac Reported Ac  
Type: B737 EC135  
Operator: CAT Civ Police  
Alt/FL: 2000ft 1000ft ↑  
 (QNH) (QNH)  
Weather: VMC CLBC VMC CLBC  
Visibility: 35km >20nm  
Reported Separation:  
 600ft V/2nm H 800ft V/1nm H  
Recorded Separation:  
 NR

Cause: The EC135 pilot climbed above his co-ordinated altitude and into conflict with the B737.

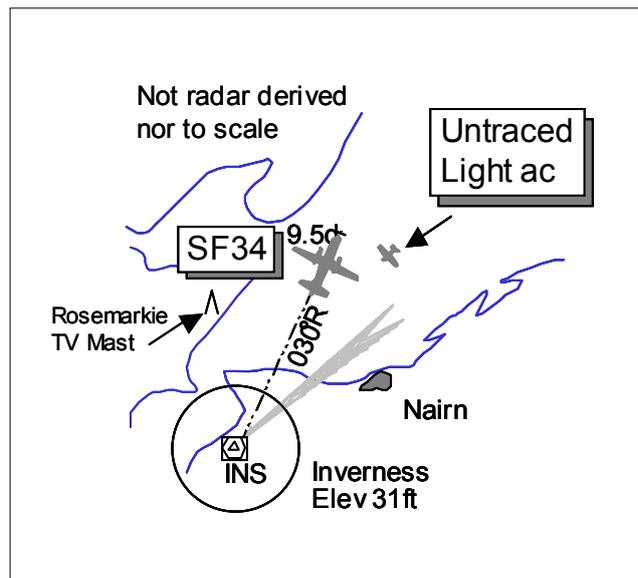
### AIRPROX REPORT NO 063/06

Date/Time: 25 May 1415  
Position: 5714N 00355W (9.5nm NNE Inverness  
- elev 31ft)  
Airspace: SFIR (Class: G)  
Reporting Ac Reported Ac  
Type: SF34 Untraced light ac  
Operator: CAT NK  
Alt/FL: 2000ft NK  
(QNH 1012mb) (NK)  
Weather VMC CLOC NK NR  
Visibility: 15km  
Reported Separation:  
300-400ft V/<1nm H NK  
Recorded Separation:  
NR

Cause: Conflict in Class G with an untraced ac resolved by the SF34 crew.

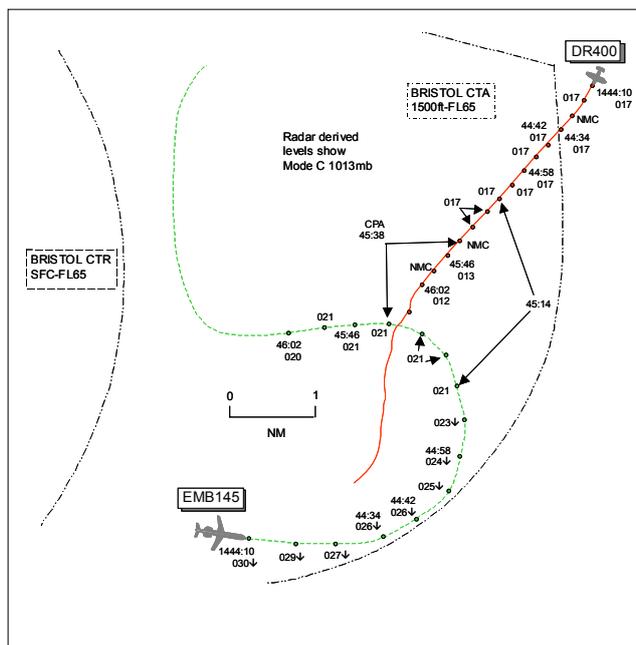
## AIRPROX REPORT NO 064/06

Date/Time: 1 Jun 1446  
Position: 5123N 00230W (8nm E Bristol - elev 622ft)  
Airspace: CTA (Class: D)  
Reporter: Bristol APR  
First Ac Second Ac  
Type: EMB145 DR400  
Operator: CAT Civ Pte  
Alt/FL: 2500ft 1600ft  
(QNH 1028mb) (QNH)  
Weather VMC NR VMC CLBC  
Visibility: 10km 9km  
Reported Separation:  
APR 500ft V/2nm H  
NR 800ft V/3nm H  
Recorded Separation:  
1.3nm H

Cause: The DR400 pilot entered the Bristol CTA without clearance resulting in a conflict with the EMB145 which was resolved by the Bristol APR.

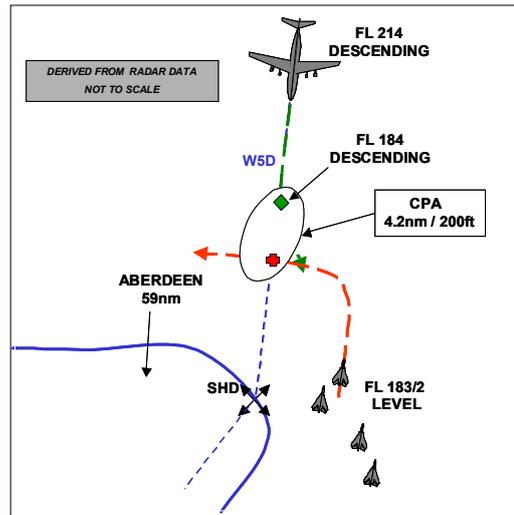
**AIRPROX REPORT NO 065/06**

Date/Time: 6 Jun 1307  
Position: 5814N 00142W (59nm NNE ADN)  
Airspace: ADR W5D (Class: F)  
Reporting Ac Reported Ac  
Type: BA146-200 Tornado GR4  
Operator: Civ Comm HQ STC  
Alt/FL: FL180↓ NR  
 (QNH)  
Weather: VMC NR VMC CAVOK  
Visibility: NR 20km  
Reported Separation:  
 NR NR  
Recorded Separation:  
 200ft V/4.2nm H

Cause: Sighting Report.

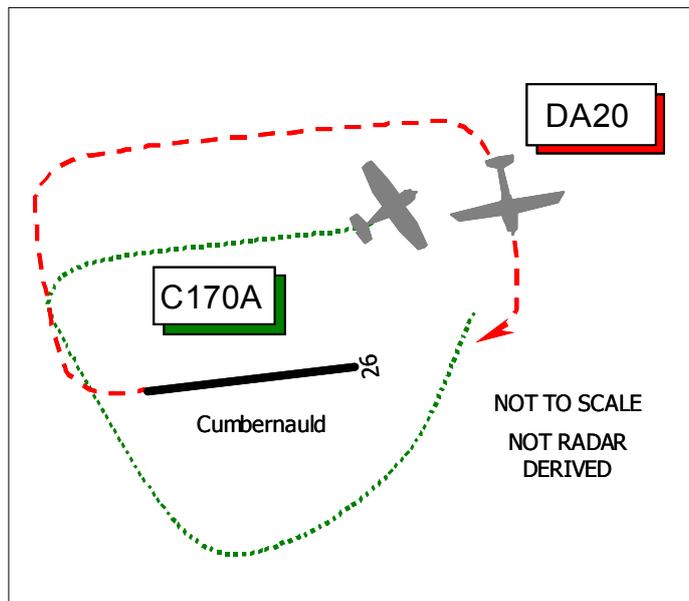
### AIRPROX REPORT NO 066/06

Date/Time: 3 Jun 1411 (Saturday)  
Position 5559N 00358W (RW26RH Cct  
Cumbernauld Aerodrome - elev 350ft)  
Airspace: Cumbernauld ATZ (Class: G)  
Reporting Ac Reported Ac  
Type: Cessna 170A Diamond DA20  
Operator: Civ Pte Civ Trg  
Alt/FL: 1000ft 900ft  
(QFE 1017mb) (QFE 1017mb)  
Weather VMC NK VMC NK  
Visibility: 10+km 30km  
Reported Separation:  
Nil V/300m H 100ft V/500m H  
Recorded Separation:  
Not recorded

Cause: The C170A joined the a/d cct and flew into conflict with the DA20.

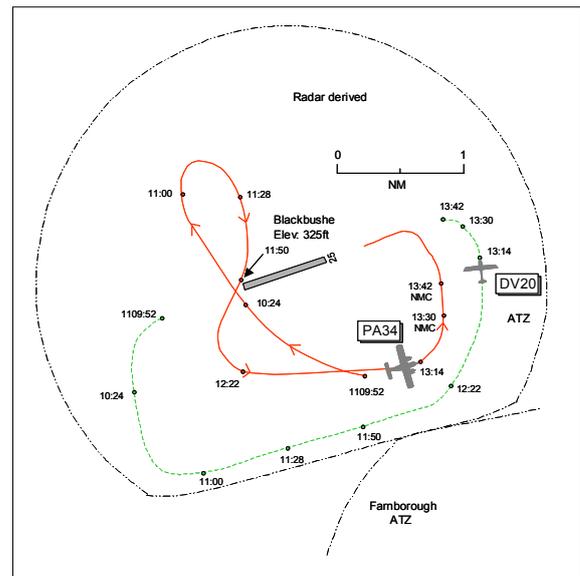
**AIRPROX REPORT NO 067/06**

Date/Time: 2 Jun 1114  
Position: 5120N 00049W (1nm FIN APP  
 RW25 Blackbushe - elev 325ft)  
Airspace: ATZ (Class: G)  
Reporting Ac Reported Ac  
Type: DV20 Katana PA34  
Operator: Civ Trg Civ Pte  
Alt/FL: 500ft↓ NR↓  
 (QFE) (QFE 1018mb)  
Weather VMC CLOC VMC CLOC  
Visibility: >10km >10km  
Reported Separation:  
 100ft V&H not seen  
Recorded Separation:  
 NR

Cause: The PA34 pilot did not integrate safely into the Blackbushe cct and flew into conflict with the DV20, which he did not see.

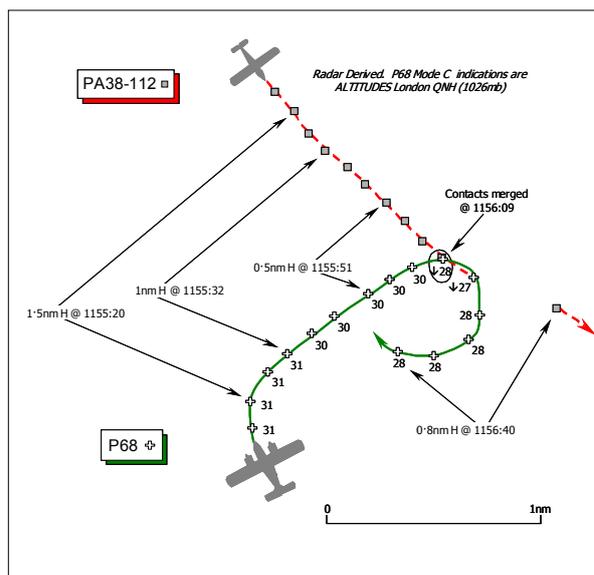
### AIRPROX REPORT NO 068/06

Date/Time: 8 Jun 1156  
Position: 5048N 00010E (3nm NE of SFD VOR near Eastbourne)  
Airspace: London FIR (Class: G)  
Reporting Ac Reported Ac  
Type: Partenavia P68 PA38  
Operator: Civ Comm Civ Club  
Alt/FL: 3200ft 3000ft  
(QNH 1028mb) (QNH 1027mb)  
Weather VMC NR VMC Haze  
Visibility: 10km 10km  
Reported Separation:  
30ft V Nil V/300m H  
Recorded Separation:  
Contacts merged

Cause: Effectively, a non-sighting by the PA38 pilot and a very late sighting by the P68 crew.

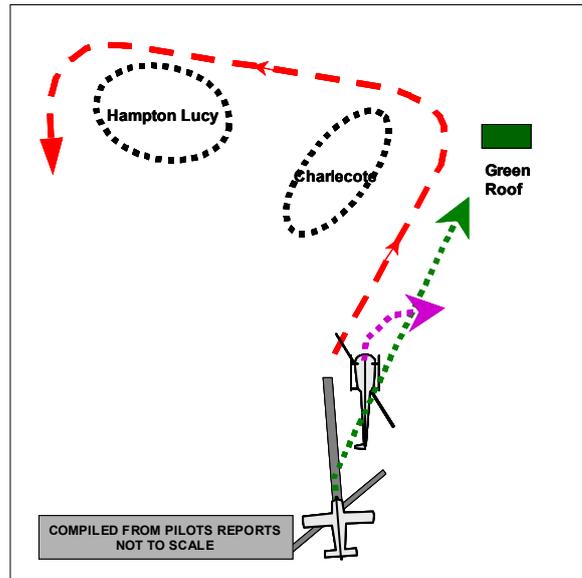
**AIRPROX REPORT NO 069/06**

Date/Time: 8 Jun 1351  
Position: 5212N 00136W (Wellesbourne Mountford Circuit - elev 159ft)  
Airspace: Wellesbourne ATZ (Class:G)  
Reporting Ac Reported Ac  
Type: Robin 2160i Robinson R44  
Operator: Civ Trg Civ Trg  
Alt/FL: 500ft 500 ft↑  
(QFE 1021mb) QNH NR  
Weather: VMC NR VMC NIL  
Visibility: Unl NR  
Reported Separation:  
V 150ft/ H100m Not Seen  
Recorded Separation:  
NR

Cause: The Robin pilot, although aware of the R44, turned into conflict with it.

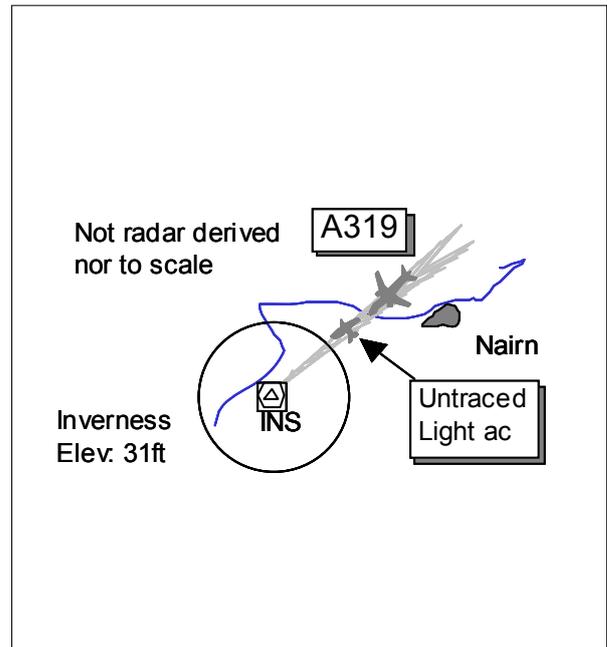
Date/Time: 11 Jun 1406 (Sunday)  
Position: 5735N 00357W (4nm FIN APP  
 RW23 Inverness - elev 31ft)  
Airspace: SFIR (Class: G)  
Reporter: Inverness ADC/APP

<u>First Ac</u>	<u>Second Ac</u>
<u>Type:</u>	A319	Untraced Light ac
<u>Operator:</u>	CAT	N/K
<u>Alt/FL:</u>	1300ft↓ (N/K)	(N/K)
<u>Weather</u>	VMC CLOC	NK
<u>Visibility:</u>	20km	
<u>Reported Separation:</u>		
<u>ADC/APP</u>	500ft V/0.75nm H Nil V/1nm H	NR
<u>Recorded Separation:</u>	NR

Cause: Conflict in Class G airspace on the Inverness FAT.

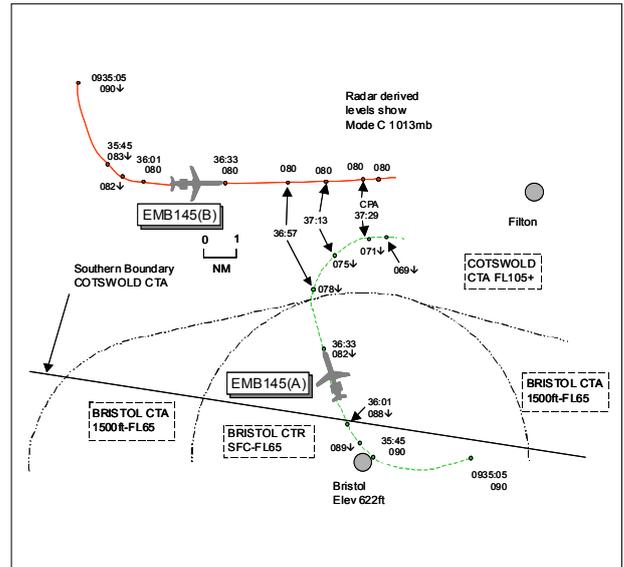
**AIRPROX REPORT NO 073/06**

Date/Time: 12 Jun 0937  
Position: 5131N 00245W (8nm N Bristol - elev 622ft)  
Airspace: LFIR (Class: G)  
Reporting Ac Reporting Ac  
Type: EMB145(A) EMB145(B)  
Operator: CAT CAT  
Alt/FL: ↓FL60 FL80  
Weather IMC NR VMC CLOC  
Visibility: NR >10km  
Reported Separation:  
 Nil V/2nm H Nil V/2nm H  
Recorded Separation:  
 900ft V/1.8nm H

Cause: The Bristol RAD1 vectored EMB145(A) into conflict with EMB145(B).

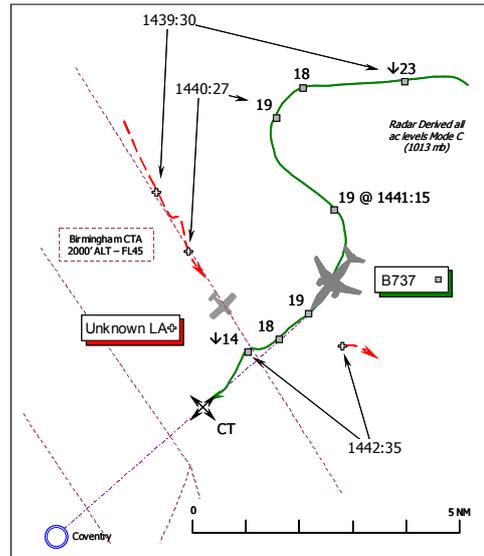
**AIRPROX REPORT NO 074/06**

Date/Time: 12 Jun 1441  
Position: 5225N 00122W (Vicinity of CT NDB)  
Airspace: London FIR (Class: G)  
Reporting Ac Reported Ac  
Type: B737-500 Untraced Light Ac  
Operator: CAT N/K  
Alt/FL: 2000ft NR  
(QNH (1017mb) (N/K)  
Weather VMC NR NK NR  
Visibility: 10km NR  
Reported Separation:  
500ft V/nil H NR  
Recorded Separation:  
Not recorded

Cause: Conflict in the vicinity of the RW23 approach track.

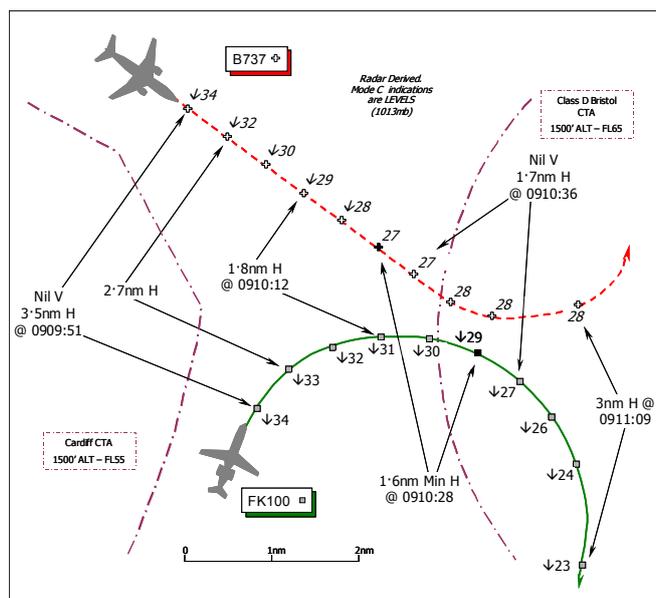
## AIRPROX REPORT NO 076/06

**Date/Time:** 14 Jun 0910  
**Position:** 5133N 00258WW (9½nm W of Bristol - elev 226ft)  
**Airspace:** FIR/CTA (Class: G/D)  
**Reporting Ac** **Reported Ac**  
**Type:** Fokker 100 B737-800  
**Operator:** CAT CAT  
**Alt/FL:** 3000ft NR  
(QNH 1022mb) (N/K)  
**Weather** IMC NR NK NR  
**Visibility:** 10km NR  
**Reported Separation:**  
Nil ft V/<1.5nm H NR  
**Recorded Separation:**  
200ft V @ 1.6nm Min H  
Nil V @ 1.7nm H

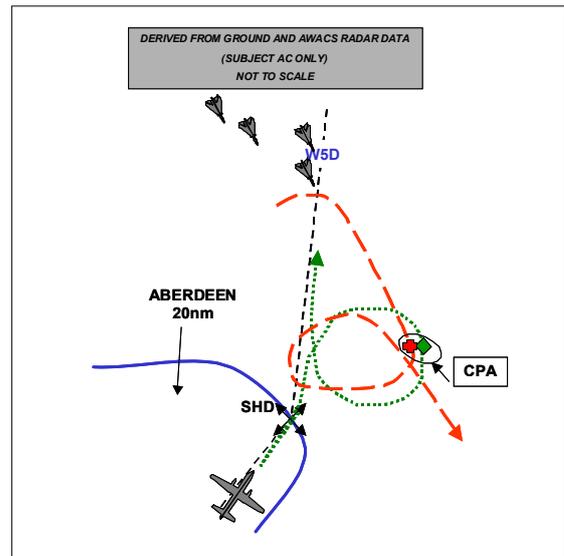
**AIRPROX REPORT NO 078/06**

**Date/Time:** 15 Jun 1318  
**Position:** 5743N 00145W (30nm NE Aberdeen)  
**Airspace:** Scottish FIR (Class: G)  
**Reporting Ac** **Reported Ac**  
**Type:** Saab SF340 Tornado F3  
**Operator:** CAT HQ STC  
**Alt/FL:** FL210 21000ft  
 (QNH 1016)  
**Weather** VMC NR VMC NR  
**Visibility:** >30km NR  
**Reported Separation:**  
 300ft V/ 100m H 0ft V/1nm H  
**Recorded Separation:**  
 1700ftV/0.7nm H

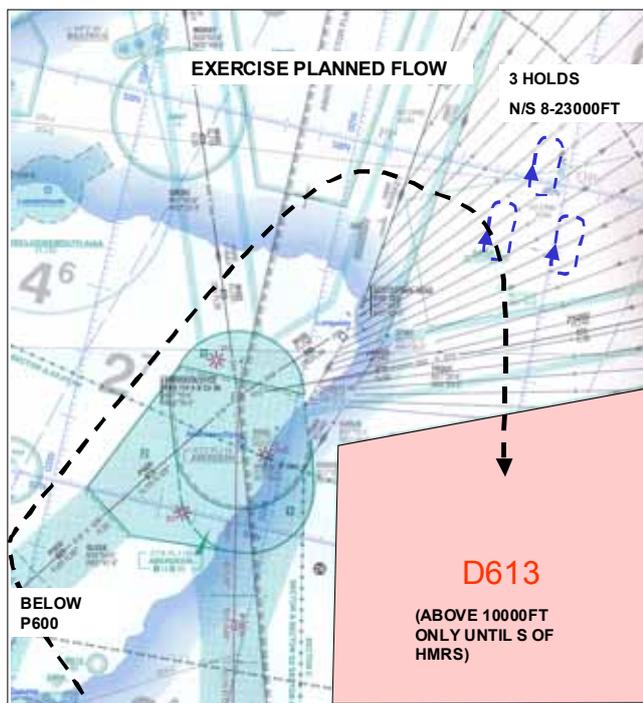
### Disposition of Holds and Routeing to them.

NOTAMed exercise. They were operating in VFR airspace [sic] and were about to enter the area of the holds. Due to the disposition of the three holds (see map below), the vertical deconfliction within them and the proximity of another (planned) 24 fighter ac, the safest avoiding action for his formation of 4 ac was to remain laterally deconflicted from the Saab while also avoiding the other exercise ac and the holds. The AWACS attempted to talk to the Saab ac through ScACC but he was not informed of the result. The civil ac was passed 3 times, the closest being the last occasion when the separation was assessed by all the crews to be about 1nm; on each time they passed, the No 4 ac wing-rocked. All crewmembers remained visual with the reporting ac throughout as they cleared it to the West.

North Hold: Ac at 8-13000ft, 18-19500ft and 24000ft

West Hold: Ac at 8-13000ft, 18-19500ft and planned at 21000ft (4 x F3s concerned)

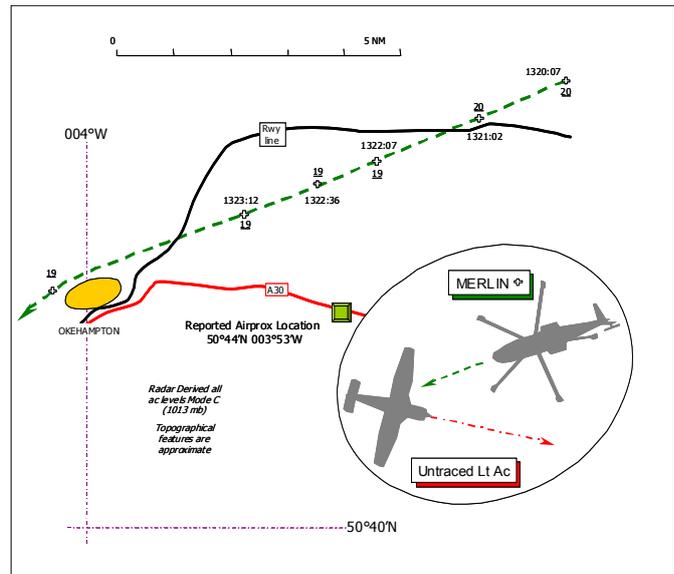
**AIRPROX REPORT NO 079/06**

**THE MERLIN HM Mk 1 PILOT** reports his helicopter has a sea-grey camouflage scheme and the HISLs were on whilst conducting a VFR training NAVEX with a crew consisting solely of himself and his navigator. They were in receipt of a FIS from Exeter APPROACH on 128.975MHz and squawking A7000 with Mode C on. Neither TCAS nor Mode S are fitted.

Cause: Conflict in Class G airspace with an untraced light ac.

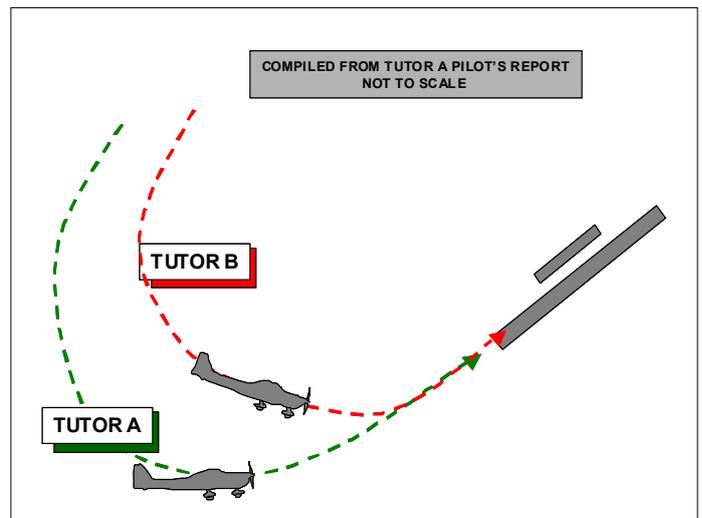
**AIRPROX REPORT NO 080/06**

**GROB TUTOR (A) PILOT** reports that he was in communication with Boscombe ADC carrying out a flapless circuit demonstration with a student as part UAS training syllabus in good weather. The pilot of another Tutor called “(callsign), downwind to roll, request the main” and Boscombe TOWER replied “(callsign), main approved, surface wind \*\*\*/\*\*”, to which he replied, “main approved (callsign)”. The other pilot then called “(callsign) finals, main” and was told, “(callsign) continue”. In the later stages of the finals turn (slightly lower and further out than for a normal circuit), he saw the other Tutor [Tutor B] half way round the finals turn for a normal circuit. He asked on the RT whether the other ac was positioning for the Northern RW but got no reply. At the time the other ac was in an attitude such that it was ‘belly up’ and it would not be possible for the pilot to see them. The other Tutor continued the finals turn to position in front and above of him and at a higher rate of descent. He assumed that the other pilot was positioning to land long and turn a tighter than usual normal circuit. From this position he was about 40ft away from the other Tutor, did not have the option of descending, accelerating or overshooting to avoid conflict and was being pushed closer to the ground so he moved right to the R/W deadside to add lateral separation. Following several calls from ATC both ac executed an overshoot, achieved separation and carried out uneventful landings.

**THE STATION** comments that it seems that the second Tutor pilot did not assimilate the information passed by ATC that he was ‘Number 2’ to a Tutor ahead; thus he turned finals believing that he was ‘Number 1’ and came into conflict with the Tutor already on a slightly extended (flapless) final. The chain was broken by the good lookout of the pilot of the ac already on finals who spotted the second Tutor turning belly-up ahead of him.

**HQ PTC** comments that this incident was caused by a combination of poor lookout, loose R/T discipline and some questionable airmanship. There are no new lessons here and this Airprox illustrates the importance of adherence to well thought out circuit procedures, making clear and correct radio calls and, just as importantly, listening to all the calls and responses to allow an overall picture of circuit traffic to be established.

The Board was briefed on Mixed RW operations at Boscombe and that normally they cause little concern. Members agreed that the principal cause of this incident had been a breakdown of the communication chain between the ADC and the pilot. Although the circuit was busy and many transmissions were made by the agencies involved, the ADC did clearly state that Tutor B had *'one ahead'*; the pilot however apparently did not assimilate this information despite reading back the clearance to use the main [RW] but not reading back that there was one ac ahead. The Mil ATC Advisor informed the Board that there was no requirement to read back the TI, only the clearance. In order to avoid any potential confusion the mentor sensibly stepped in, telling all ac to go around from finals allowing them to reposition in an orderly manner.

Cause: Tutor B pilot did not assimilate the TI and flew into conflict with Tutor A.

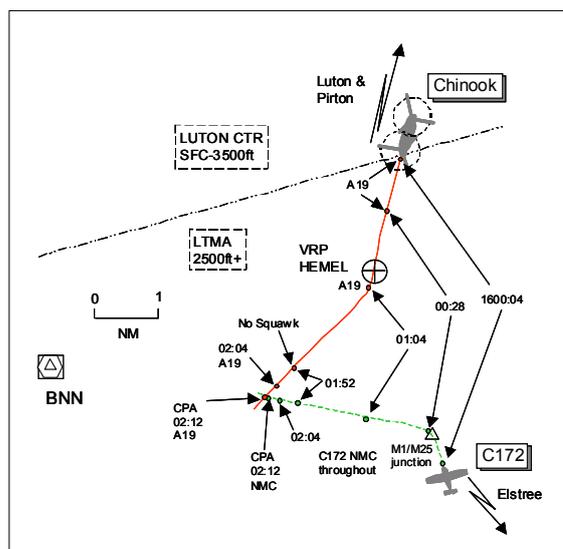
### AIRPROX REPORT NO 081/06

**THE C172 PILOT** reports flying a dual local IMC instructional sortie from Elstree, in communication with Elstree Radio on 122.4MHz and squawking 7000 with NMC. The visibility was >10km in VMC and the ac was coloured white/blue with anti-collision light switched on. After departing Elstree RW26, the student put on 'foggles' to simulate climbing into IMC whilst he, the instructor, took responsibility for lookout. They climbed to 2200ft, their target altitude, before reaching the M1/M25 road junction where they turned L onto heading 270°, into sun. The student carried out the FREADAMI checks whilst he continued to lookout, advising the student to 'do the checks' one at a time and after each one to 'fly the aeroplane' i.e. make sure the ac was still on heading and at the correct altitude. However, during these checks the student lost 200ft, whilst he, the instructor, continued to lookout particularly as they were approaching BNN VOR, a busy area of sky. As he scanned to his R, he noticed a green Chinook helicopter about 300-400ft away which was about to cross their path from R to L, heading 240° at the same level, 2000ft. The Chinook passed very close in front, about 100m ahead, and the student even saw the helicopter as it passed to their L. No avoiding action was taken as they would pass behind the helicopter and he assessed the risk as high.

The C172 pilot's comments on the incident were noted and comprehensively discussed. A Member with specialist knowledge of operations at Northolt said that an ATS may have been available from Northolt if requested, even though it is a non-LARS ATSU. Pilot Members considered that the integration of this additional RT and flight information from ATC into the cockpit-training environment was something that instructors are expected to deal with during pilot training even though workload is increased. ATCO Members commented that within this busy piece of airspace, there were at least 4 ATSUs (Heathrow, Northolt, Luton and London FISO) that could be working traffic so that even whilst receiving a service from one ATSU there would probably still be several unknown ac in the area. The Cessna's high wing configuration is known for its potential to obscure other ac in certain circumstances but airmanship training to students should highlight this issue which can often be alleviated by lifting the ac's wing to scan for other ac which may be flying close-by whilst masked during the usual 'straight and level' cockpit viewpoint. Both crews had turned to fly into sun shortly before the Airprox but had ample opportunity to see each other's ac 'beam on' as they converged. The Chinook SOPs were sound for when a frequency or squawk change was required but, for whatever reason, the C172 passed by unnoticed. Although the Luton RT transcript was not available, under a FIS the Chinook crew could not have expected to be passed TI on conflicting traffic. As this Airprox occurred in Class G airspace, 'see and avoid' prevailed as the primary means of ensuring safe separation. As was seen in this case, this had not worked which led Members to agree that the cause was a non-sighting by the Chinook crew and a late sighting by the C172 pilot.

Cause: Non-sighting by the Chinook crew and a late sighting by the C172 pilot.

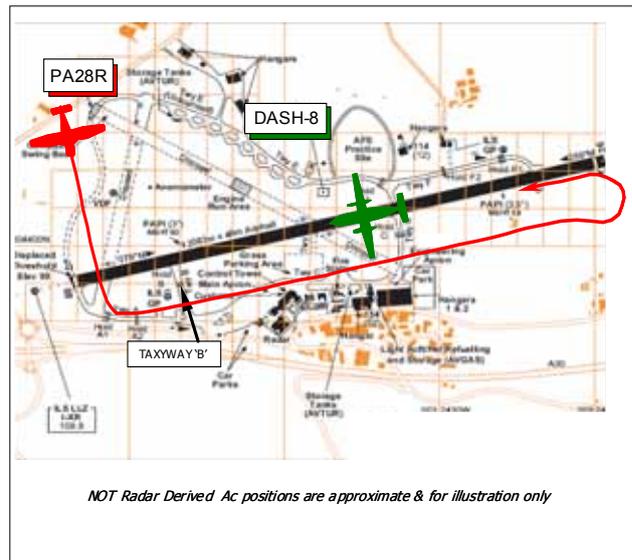
**AIRPROX REPORT NO 083/06**

**THE DHC DASH 8-400 PILOT** reports they were just completing the landing roll on RW26 at Exeter in good VMC, whilst in communication with Exeter TOWER on 119.8MHz. As he decelerated through 100kt to slow his ac to taxiing speed, a low-wing single-engine white ac – the PA28R - overflow his ac on a reciprocal heading some 50ft or less to port, whilst wagging its wings and about 300ft above his Dash 8. The other ac overflow them and the commercial apron in a L turn from the landing direction (RW26) and then manoeuvred to the S of the airport before landing. He assessed the risk as “minimal” but “high” if they had to complete a low go-around – or were a base training ac on a touch & go exercise. ATC was informed on RT when the light ac was sighted initially.

**THE PA28R PILOT** reports his ac is coloured white and he was airborne on a local flight from his base at Exeter. At about 25nm range from the airport, his ac suffered a small electrical wire burn, which resulted in a total electrical failure, so he elected to return to his base at Exeter Airport. Without any RT or an operational SSR transponder, he returned to Exeter VFR from N of the Airport in VMC with a flight visibility of 10km. At a range of 5nm he observed that RW26 was in use because a Dash 8 was approaching to land. He remained N of the runway and ‘go-around’ flight path until after the Dash 8 had landed on RW26 and it was more than halfway along the runway almost at taxiing speed. Crossing 1/2nm ahead of the Dash 8, whilst overflying the RW08 threshold heading S at about 4-500ft aal, he turned L downwind for RW26 and flew past the Tower heading 090° at 100kt rocking his ac’s wings to indicate his emergency of a total electrical failure. Turning inbound to overfly the aerodrome, by this stage the Dash 8 was taxiing in on TAXIWAY BRAVO towards the apron. A sharp L turn was executed DOWNWIND again in front of the Control Tower at the intersection of RW26 and the disused RW. His undercarriage had been lowered using the emergency system and he was hoping that the ADC might be able see whether it had lowered successfully – thinking [erroneously] that any green lamp signal from the Tower might also indicate that it appeared ‘DOWN’ to the ADC. On receipt of a green lamp-signal from the Tower he landed his ac on RW26.

**THE EXETER AERODROME CONTROLLER (ADC)** reports that at about 1222, he observed an unknown light ac over the upwind end of the runway in use - RW26. The ac flew eastbound down the runway at approx 300-400' rocking its wings, and over the DASH 8 that had just landed. The unknown ac then lowered its undercarriage before making a R turn, followed by a L turn and flew down, or close to, the runway heading W. Near the end it turned L into the Cct. The ac was given a green Aldis light and blind transmissions were made to the PA28's pilot on RT. The ac landed on RW26 at 1228.

To the GA pilot Members present it seemed that the PA28R pilot had acted appropriately when he returned to Exeter after having suffered a total electrics failure. It was clear from his account that he had foreseen the potential for conflict with other aerodrome traffic; had spotted the Dash 8 whilst it was approaching to land and had, he believed, taken appropriate measures to keep safely out of its way. Whilst the PA28R pilot had judged there was no likelihood of any 'go-around' by the Dash 8, a CAT pilot Member observed that the PA28R pilot still crossed through the RW26 climb-out unnecessarily and contrary to the established traffic flow. CAT pilot Members considered whether the PA28R pilot might have flown a more conventional cct by joining on R base before overflying the RW, thereby remaining on the DEADSIDE for the initial fly-through of the cct area. However, some thought it might have denied the controller clear sight of the aeroplane and controller Members thought that the PA28R pilot probably wanted to land his aeroplane with the minimum of delay. The tight pattern flown evidently got the Dash 8 crew's attention before the controller spotted the PA28R as it passed over the upwind threshold, but it was clear that the PA28R pilot's aim of drawing the controller's attention to his ac was achieved and subsequently drew the desired response with an Aldis lamp signal from the Tower. Whilst others might have flown wider downwind in conformity with the traffic flow on RW26, it was clear that the PA28R was indeed completely aware of what the Dash 8 was doing and had taken account of it whilst dealing both with his emergency and setting himself up to land. In assessing 'cause' and the 'risk' of collision, the Board only ever considers what actually occurred, not what might have happened in different circumstances. It was clear to the Members from the Dash 8 pilot's report that there was no intention whatsoever to roll for a 'touch & go' neither did a 'go-around' evidently occur. In the Board's view, therefore, this report was a sighting report by the Dash 8 pilot of emergency traffic joining the cct where there was no risk of a collision whatsoever. However, it was important to point-out that the

Cause: Sighting report.

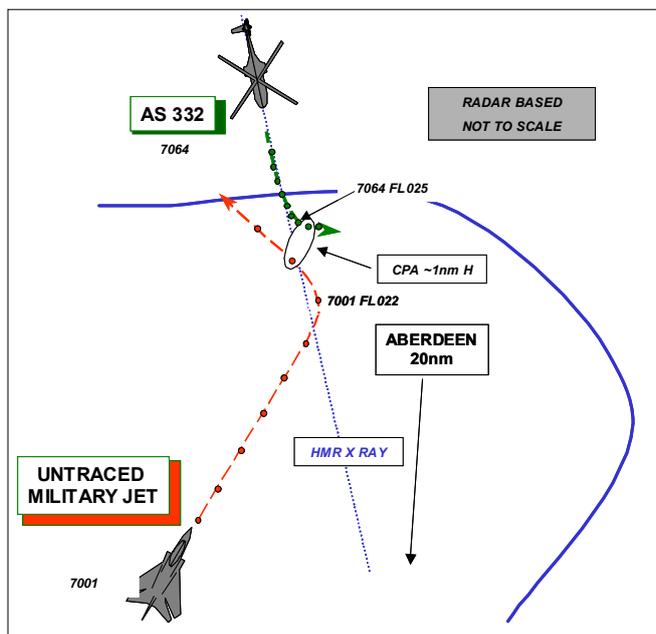
## AIRPROX REPORT NO 084/06

**THE AS332 PILOT** reports flying a non-scheduled passenger flight from an Oil Rig to Aberdeen with all available lights on, heading 160° along HMR X-RAY at 2000ft on the Aberdeen QNH and at 140kt. He was squawking as directed and in receipt of a FIS from Aberdeen Radar when pop-up military traffic was reported by ATC in their 1 o'clock position at 3nm and he became visual with it in the reported position at about 2nm. The other ac commenced a steep climbing left hand turn and passed up through their level at less than 1nm, before descending away to the W. Immediately after they became visual they commenced a 30° turn left to avoid the ac that they identified as a Tornado GR4. He assessed the risk as being moderate.

As he scanned the radar, he noticed a fast moving contact appear to the S of the helicopter by about 5nm, heading toward it at a similar level. He immediately passed TI to the helicopter and the pilot reported that he was visual with the other ac. As the fast jet entered the helicopter's 12 o'clock position at about 1nm, the pilot of the helicopter informed him that he was turning left to avoid it and the controller acknowledged this. The fast jet then made a turn to the left and was approximately 400ft below the helicopter with the radar returns almost merging. Once the fast jet was observed about 3nm away from the helicopter and continuing away from it in a W direction, he informed the helicopter pilot who resumed course for Aberdeen.

Cause: Conflict on HMR X-RAY resolved by the AS332 crew and apparently by the jet pilot.

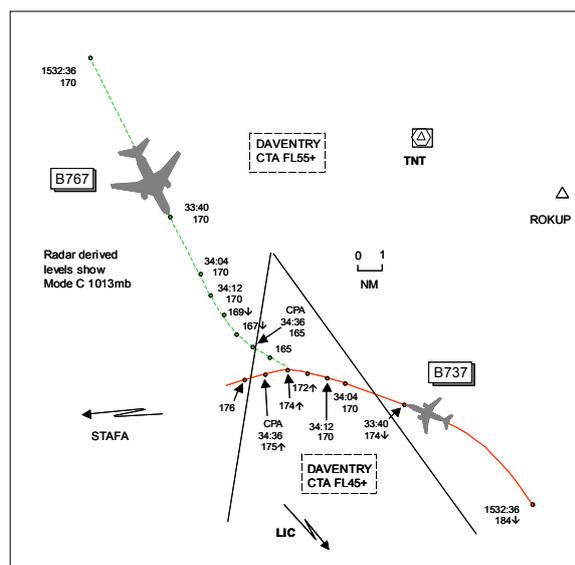
**THE B767 PILOT** reports heading 155° at 300kt en route to Luton IFR and in receipt of a RCS from London, he thought, on 134.42MHz squawking 4377 with Mode C. Whilst N of PEDIG at FL170 in IMC, he observed traffic on TCAS 15nm ahead flying in the opposite direction 800ft above but descending slowly and levelling at his level. ATC were very busy but he reported the traffic and ATC issued avoiding action to the B737 flight and then to them, both ac to turn L. Simultaneously they received a TCAS RA 'descend' with which they complied whilst turning onto the given heading of 120°. The traffic was not seen visually but TCAS indicated that the traffic passed 800ft above. He assessed the risk as high.

Members noted the RC's comments that he found his colleagues shouted warnings distracting when STCA activated. The good intent of other controllers in these circumstances was understandable but to some controllers actually in the 'hot seat' at the time trying to resolve a conflict, it could easily disturb their thought process. However, as shown on previous Airprox, these warnings can be more beneficial rather than detrimental particularly when the controller has not noticed a potential incident and the aural warning has drawn his attention to a traffic situation, sometimes prior to the STCA safety net activating.

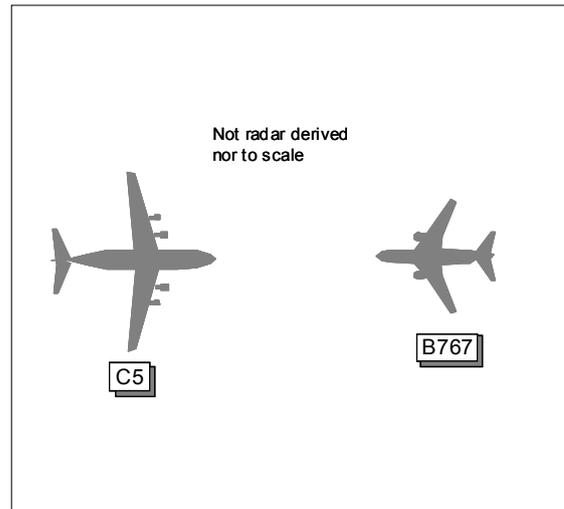
**THE B767 PILOT** reports en route to the USA heading 270° at 450kt and FL300 and in communication with Shanwick squawking with Mode C. At about 0655 he, the Captain, went on a break and another pilot took command. At 0703, the co-pilot told him there was approaching traffic at 12 o'clock and 20nm, 1000ft above, of which – having his camera to hand - he may want to take a picture. At approximately 0704 and position 5005N 02720W they received a TCAS TA on the traffic as it approached the 10nm arc on the TCAS display indicating the ac to be 500ft above. This was followed shortly thereafter by an RA 'descend', commanding a 1500fpm ROD. The A/P was disconnected and a descent was commenced but the RA descent then increased to 2500fpm which was followed until an altitude of 28500ft was reached at which point the opposite direction traffic passed directly O/H 400ft above, showing 28900ft on the display. The TCAS aural alerts/warnings had annunciated 'traffic, descend' followed by 'increase descent'. Since he had his camera out he took a picture to identify the ac which was seen as a high wing 4 engined military ac. They informed Shanwick ATC of a 'near miss' and climbed back to their assigned level of FL300.

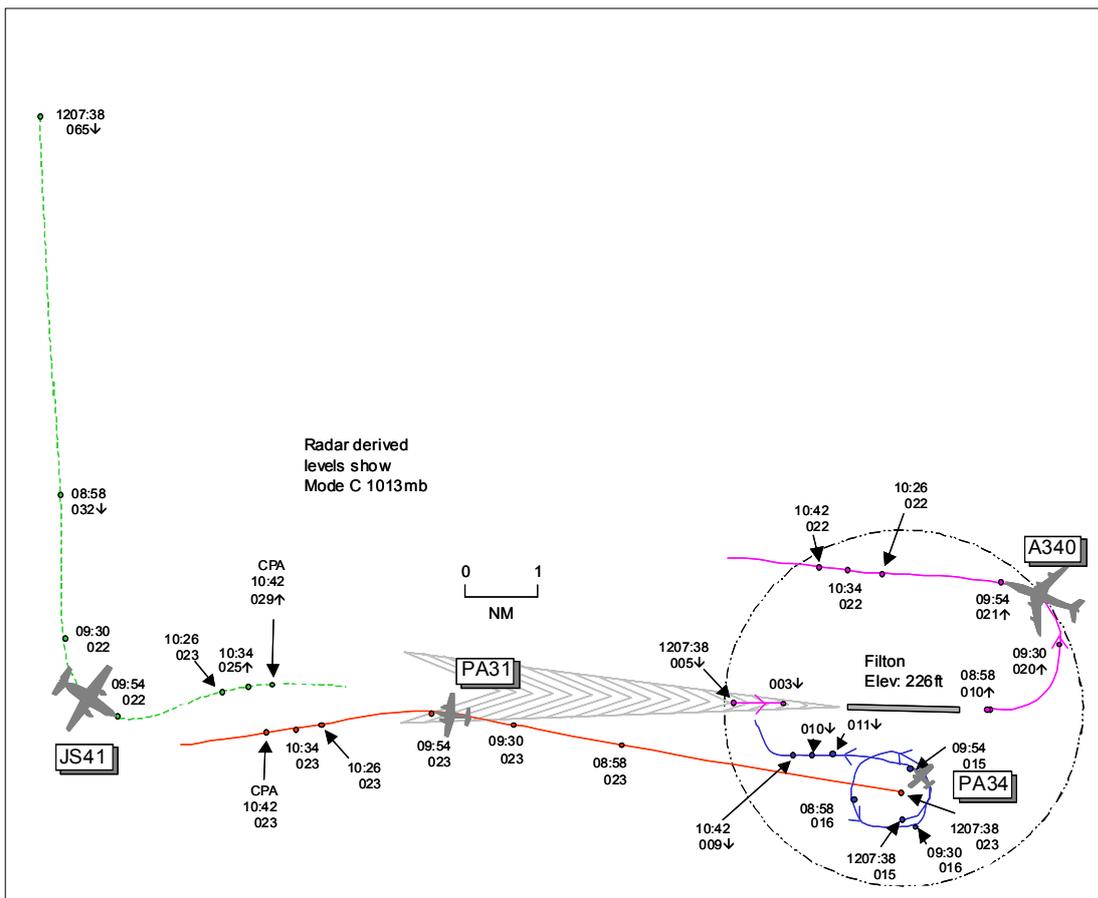
**THE FITLON APR** reports that the JS41 was inbound to Filton under a RAS being vectored for an ILS RW09 whilst the PA31 was a W'bound transit which he understood to be VFR at 2500ft. Other traffic included an A340 carrying out LH visual ccts, a PA34 conducting RH ccts with the Tower and a PA28 [not shown on the diagram] tracking S

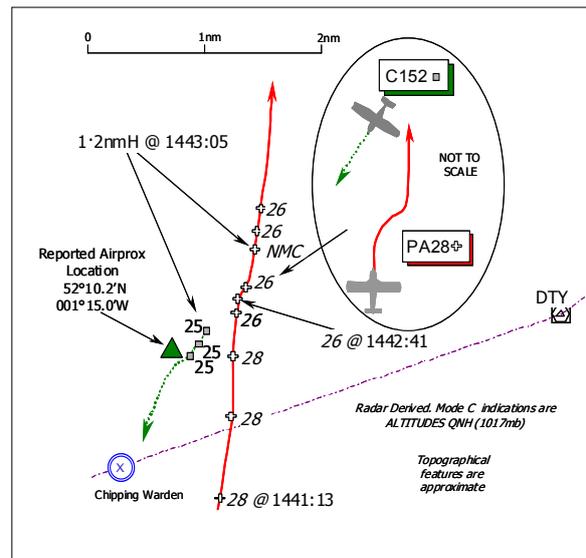
### AIRPROX REPORT NO 092/06

**THE C152 PILOT** provided a very comprehensive account reporting that he was conducting a dual instructional NAVEX with a student pilot under VFR, routing from Sywell to Benson via Chipping Warden, Charlbury and Welford. The planned altitude for the route was 2700ft but his student had 'lapsed' momentarily and allowed the ac to be at 2500ft QNH (1018mb). They were flying in VMC, >2000ft below cloud – there was no cloud at their altitude – with an in-flight visibility of 40km+. A squawk of A7000 was selected with Mode C.

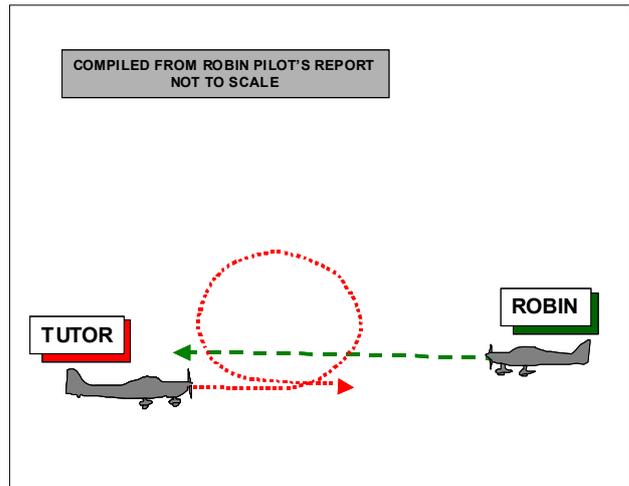
**AIRPROX REPORT NO 096/06**

**THE ROBIN 200/100 PILOT** reports flying a private flight with a passenger from Tibbenham to Gloucester in a white and red ac with strobes selected on, listening out with London Info and squawking 7000 with Mode C. He was heading 240° into sun at 90kt when a Grob Tutor ac was first seen 12.30/1 o'clock, pulling up through his level; it then passed down his starboard side by about 200ft in a nose-up attitude of about 60-70° and he watched it pass into his 5 o'clock completing a looping manoeuvre. It appeared to take no avoiding action and he was too stunned to take any himself. The only time the other pilot could have seen him would have been at the top of his loop as the Robin was flying away. He assessed the risk as being very high.
