UK AIRPROX BOARD

Analysis of Airprox in UK Airspace

**Report Number 22
January 2009 - June 2009**

Twenty Second Report by the UK Airprox Board:

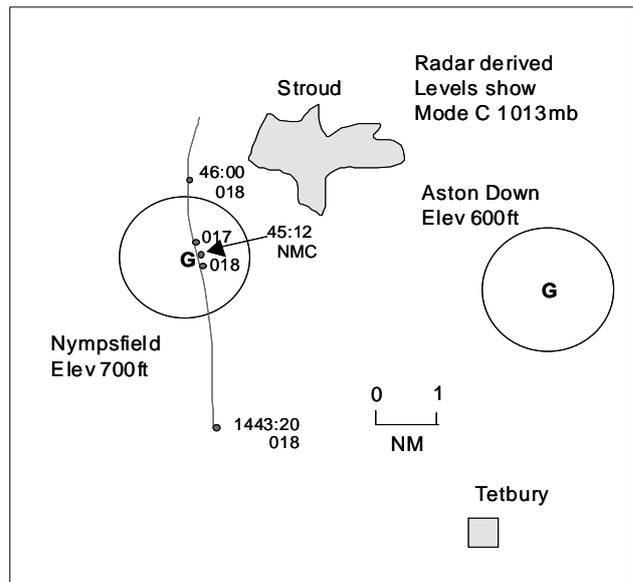
Recorded Separation:

NR

THE GROB G103 GLIDER PILOT reports flying a routine training flight with a student from Nympsfield and listening out on Glider Common frequency 129.975MHz. The visibility was 40nm below cloud in VMC and the ac was coloured white with no lighting or transponder fitted. The intention was to fly a standard winch launch to 1400ft QFE after which the student would complete some training exercises before rejoining for a LH cct to land. At about 800ft on the launch heading 075° whilst climbing rapidly (2600fpm) a white coloured light ac, possibly a PA28 type, coloured white/blue came into view in their 1 o'clock high, some 500ft above their glider, crossing from R to L seemingly travelling towards the winch. Light ac frequently fly O/H the airfield but normally it is, by good fortune, rare to see one at the same time as a launch. They continued with the launch and monitored the situation before aborting at 1300ft QFE by which time the PA28 was some 500ft horizontally away slightly L of the ac's nose at the same level.

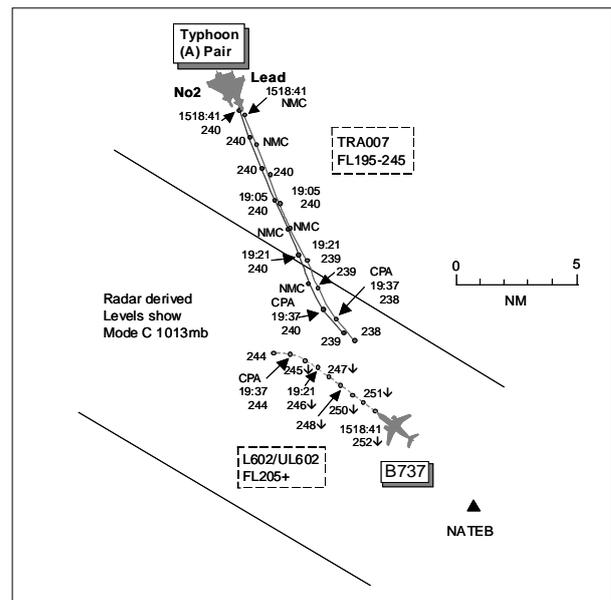
AIRPROX REPORT NO 2009-007

Date/Time: 11 Feb 1519
Position: 5510N 00154W (10nm NW Newcastle)
Airspace: UL602/TRA007 (Class: C)
Reporting Ac Reported Ac
Type: B737-800 Typhoon x 2
Operator: CAT HQ Air (Ops)
Alt/FL: ↓FL210 FL240
Weather VMC CLBL VMC CLNC
Visibility: Unltd 50km
Reported Separation:
NR V/2nm H 700ft V/4.4nm H
Recorded Separation:
400ft V/2.3nm H

THE B737 PILOT reports inbound to Edinburgh IFR at 425kt and in receipt of a RCS from Scottish on 124.5MHz squawking with Modes C and S. Near to NATEB [Newcastle] during an intermediate level-off at FL210, he thought, [actually descending through FL250], ATC told them "...avoiding action L heading 210°". They followed the instruction and during the turn they received a TCAS TA aural warning. The conflict was resolved almost immediately and they were turned back onto their original course. Although they were flying between layers no visual contact was ever made on the other ac which passed, as seen on TCAS, about 2nm away at a similar level. He did not assess the risk.

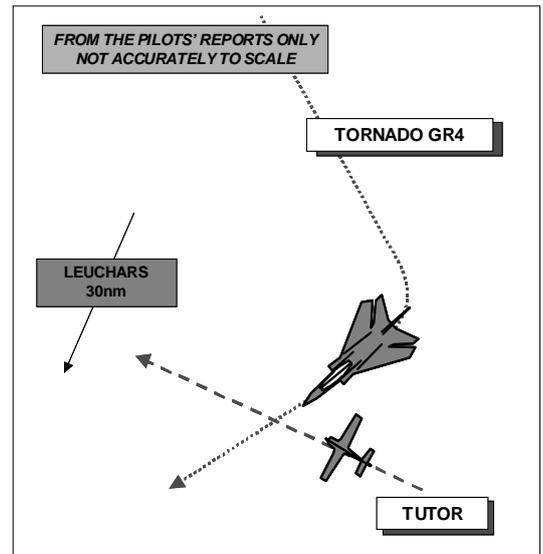
AIRPROX REPORT NO 2009-008

Date/Time: 17 February 1356
Position: 5642N 00238W (5nm W Montrose)
Airspace: UKDLFS (Class: G)
Reporting Ac Reporting Ac
Type: Tornado GR4 Grob Tutor
Operator: HQ Air (Ops) HQ Air (Trg)
Alt/FL: 350ft agl 500ft agl
(RPS 1019mb) (RPS 1019mb)
Weather VMC CLBC VMC CLBC
Visibility: 40km >10km
Reported Separation:
50-100ft V/50ft H 50-100ft V/30m H
Recorded Separation:
NR

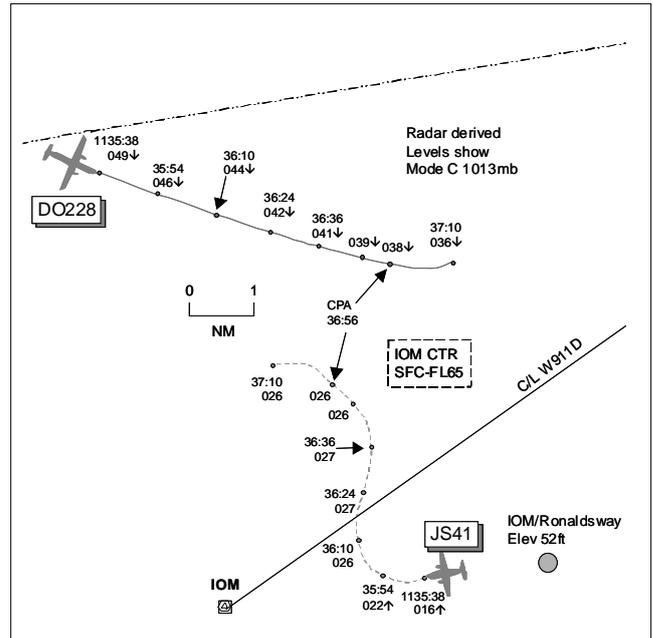
AIRPROX REPORT NO 2009-010

Date/Time: 16 Feb 1137
Position: 5408N 00443W (5nm NW IOM
 - elev 52ft)
Airspace: IOM CTR (Class: D)
Reporter: IOM APR
1st Ac 2nd Ac
Type: JS41 DO228
Operator: CAT CAT
Alt/FL: 3000ft ↓3000ft
 (QNH 1026mb) (QNH 1026mb)
Weather VMC CLOC VMC CLOC
Visibility: 10km
Reported Separation:
 APR: 1000ft V/2. 7nm H
 1000ft V/4nm H Not seen
Recorded Separation:
 1200ft V/2nm H

THE IOM APR reports that at 1133 ADC called him for a release on the JS41 to Newcastle. As he was vectoring the DO228 downwind RH descending to 3000ft, he released the JS41 to climb straight-ahead and stop climb 3000ft as he also had transiting traffic at FL40. At 1136 he called ScACC for further climb on the JS41 and was given FL110. At this time the JS41 flight checked in on frequency and he saw the ac climbing through 1800ft in a R turn towards DCS VOR, the normal routeing for this flight. He immediately gave the JS41 avoiding action, a L turn heading 270°, and the ac was seen to start the L turn with separation at the CPA of 2.7nm horizontally and 1000ft vertically. He also gave the DO228 a L turn onto 050° and was about to stop its descent when it became clear that the turn had resolved the conflict. He did not give TI, as he perceived that neither crew would see each other's ac and the situation was already resolved. Once clear of traffic the JS41 was climbed to FL110 direct to DCS and was transferred to ScACC. The DO228 made a visual approach to RW26 and landed without further incident.

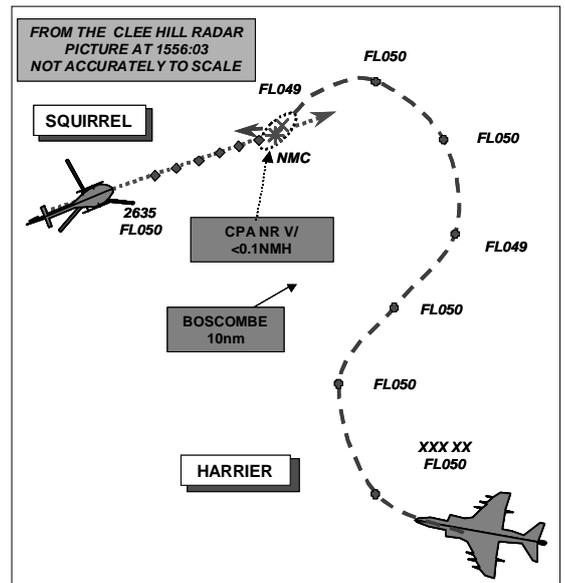
Date/Time: 24 February 1556
Position: 5104N 00206W (10nm SW Boscombe Down)
Airspace: Lon FIR (Class: G)
Reporting Ac Reported Ac
Type: AS350 Squirrel Harrier GR9a
Operator: HQ AAC ATEC
Alt/FL: FL050 FL050

Weather VMC CLAC VMC CLAC
Visibility: >20nm >50km
Reported Separation:
 Nil V/30m H 100ft V/200m H
Recorded Separation:
 100ft V /0.1nm H

THE AS350 SQUIRREL PILOT reports flying a training sortie from Exeter to Middle Wallop in a black and yellow ac with HISLs and Nav lights switched on, in receipt of a RIS from Boscombe Zone and squawking as directed with Mode C. They were in the cruise, heading 070° at 100kt, in very good visibility well above a cloud layer when Zone reported a fast moving contact at 4nm to the S of them in their 3 o'clock; on looking they immediately saw the ac. The fixed wing traffic was heading in a similar direction as themselves and was overtaking them quickly at the same level. One min later the other ac commenced a hard turn to port and they continued to watch it as it continued the turn towards them. The expected roll out of the turn did not happen and the contact, now identified as a grey Harrier, continued to turn directly towards them and it was clear there was about to be a conflict. With a closing speed of about 300kts the ac was very rapidly turning onto a head on collision course at exactly their level. However, just in time the pilot began to ease off the bank sufficiently and passed 50-100ft down their starboard side [UKAB Note (1): the radar recording shows the Harrier passing down the port side as reported by its pilot]. The easing of bank was leisurely and he did not believe that it was to avoid collision but coincidental. Had the turn not been reduced he thought that they would impacted about one second later. It was impossible to predict the ac flight path relative to their own until very late indeed and a break left or right might have made the situation worse. By then a descent would have been too slow and a climb would have obscured their vision. Nevertheless he was about to initiate a rapid flare induced climb when the Harrier eased its bank.

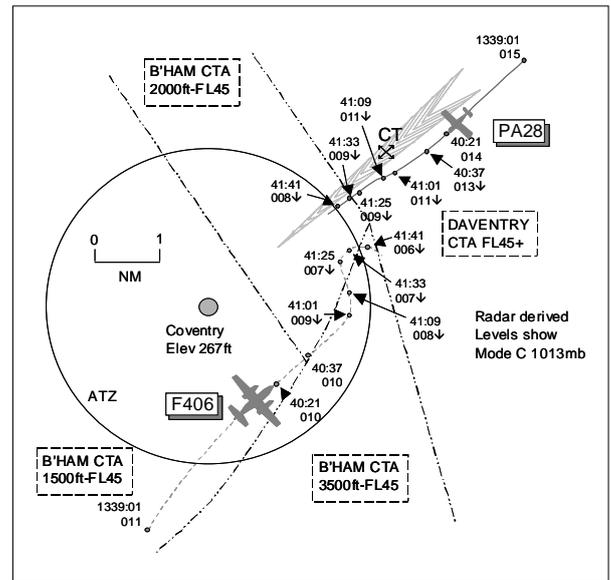
AIRPROX REPORT NO 2009-012

Date/Time: 26 Feb 1342
Position: 5224N 00125W (2nm FIN APP RW23
 Coventry - elev 267ft)
Airspace: ATZ (Class: G)
Reporting Ac Reported Ac
Type: F406 Caravan 2 PA28
Operator: Civ Comm Civ Trng
Alt/FL: 1300↓
 (QNH 1022mb) (QNH)
Weather VMC CLOC VMC CLOC
Visibility: >10km
Reported Separation:
 Not seen Not seen
Recorded Separation:
 200ft V/O-8nm H

THE F406 PILOT reports returning to Coventry from a local sortie and in communication with Coventry Tower on 118.175MHz squawking with Modes C and S. The visibility was >10km in VMC with NSC and the ac was coloured white/green with strobe lights switched on. Joining LH downwind RW23, ATC told her there was PA28 traffic on the ILS at 5nm and she was asked to report ready for L base. Ready to turn base, ATC told her the ILS traffic was at 3nm and she could continue as No 1 in traffic if keeping it tight; the base turn was immediately commenced. Configured at 130kt and in the turn to establish onto L base, ATC said 'This is not going to work' and informed her that the speed of the ILS traffic had been greater than anticipated and she was instructed to orbit. She carried out a RH orbit as she deemed it to be the quickest and safest way to exit the FAT. ATC enquired whether she had turned L or R and she replied R. The Tower controller urged her to tighten the turn to avoid conflicting traffic with which she was not visual at any time. As she was about 1.5nm out approaching the FAT she assumed this is where the Airprox occurred. She was unable to assess the risk as she did not see the other ac.

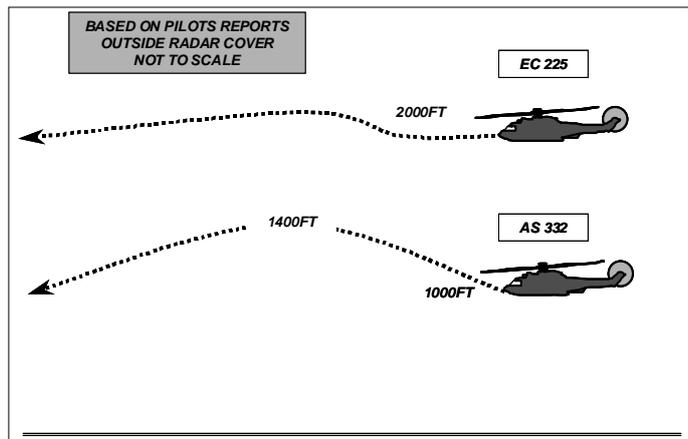
Reported Separation:
~500ft V NK

Recorded Separation:
NR See UKAB Note(2).

THE AS332 PILOT reports flying an offshore support flight recovering to Aberdeen in an ac with no TCAS fitted. Some time after he had taken off from platform SEDCO714, he requested a climb from Aberdeen Information, giving their bearing and range. INFO told them that there was no known traffic to affect their climb. However INFO did not inform them that there was another ac at the same bearing and distance and 1000ft above them. He saw the other ac and stopped his climb with the other traffic crossing about 500ft above them and assessed the risk as being high. He reported the incident to the ATC Supervisor on landing.

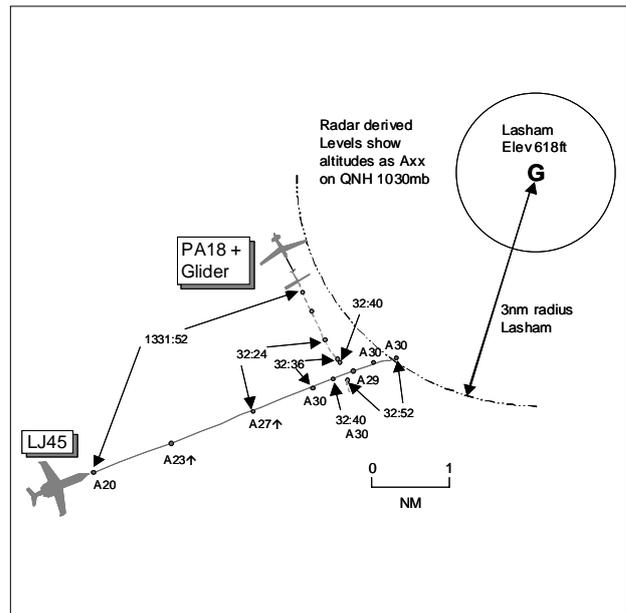
AIRPROX REPORT NO 2009-015

Date/Time: 21 Mar 1333 (Saturday)
Position: 5109N 00106W (3-5nm SW Lasham - elev 618ft)
Airspace: FIR (Class: G)
Reporting Ac Reported Ac
Type: PA18 + Glider LJ45
Operator: Civ Club Civ Pte
Alt/FL: 2700ft↑ ↑3400ft
(QFE) (QNH)
Weather VMC HAZE VMC CAVK
Visibility: 4000m >10km
Reported Separation:
100ft V/25m H NR
Recorded Separation:
<0.2nm H

THE PA18 + GLIDER COMBINATION PILOT reports flying a local aerotow sortie from Lasham and in communication with Lasham on 131-025MHz; no transponder was fitted. The visibility was generally 8km but reducing to 4000m into Sun in VMC and the ac was coloured black/yellow with nav, anti-collision and strobe lights all switched on. He was flying with an experienced tug pilot and undertaking a tug-pilot competency check and biennial training flight. About 3nm SW of Lasham heading 180° climbing through 2700ft Lasham QFE at 70kt with a small amount of R bank, he noticed what he thought was a Citation X jet 500m away heading E and converging. He realised that if the other ac maintained its level and direction then they would miss: however, he felt compelled to take control from the handling pilot to increase separation by pulling back and rolling to the R. His hands had not been close to the controls so this had delayed his response a little. The handling pilot seated in the front had been looking L and did not see the other ac until he took avoiding action. The ac had approached from the sector which was into Sun and where the visibility was poor. The other ac was coloured white or silver with a coloured fin, passing 100ft below and 25m ahead with a high risk of collision. He telephoned Farnborough after landing and established that the other ac was a LJ45 which has a similar wing/fuselage bulge to the Citation X which would account for his misidentification. Lasham was very active with several ac within 3nm of the aerodrome and it is normal for Farnborough to advise flights to bear this in mind when planning how close to fly to Lasham. He opined that with their black paint scheme and being down-Sun to the other ac's crew they would possibly have been easier to see.

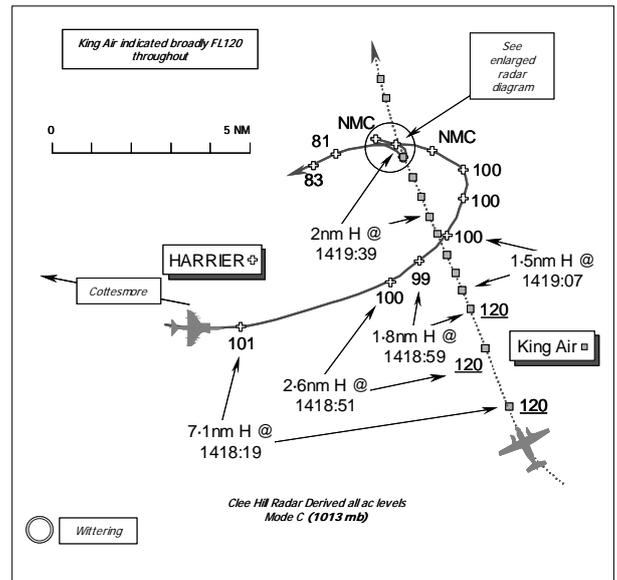
AIRPROX REPORT NO 2009-016

Date/Time: 20 March 1420
Position: 5246N 00013W (14nm NE of Wittering)
Airspace: London FIR (Class: G)
Reporting Ac Reported Ac
Type: BE200 King Air Harrier GR7
Operator: HQ Air (Trg) HQ Air (Ops)
Alt/FL: FL120 FL70-195
Weather VMC Haze VMC Sky Clear
Visibility: NR Unlimited
Reported Separation:
 Nil V/ <100 m H Not seen
Recorded Separation:
 500ft V/ 0.3 nm H
 [Claxby Data @
 1420:06]

THE BEECH BE200 KING AIR PILOT reports he was enroute from Cranwell to Coningsby at FL120 for a pre booked PAR, operating VFR under a TRAFFIC Service from London MILITARY [LATCC (Mil) CON15] on 233.72MHz. The assigned squawk was selected with Mode C on; Mode S and TCAS are fitted.

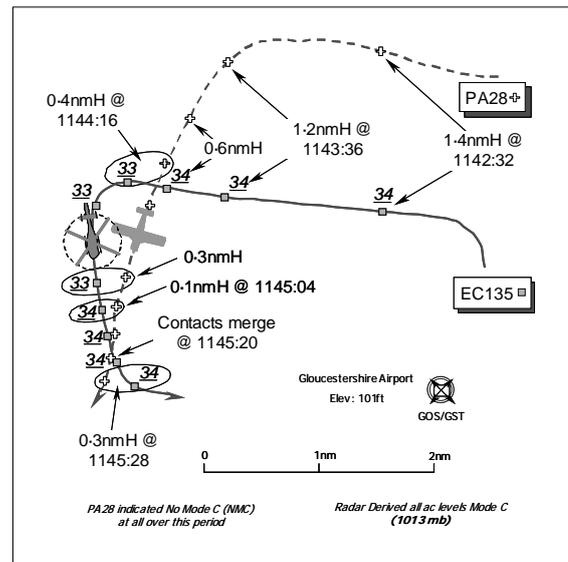
Recorded Separation:
SSR contacts merge

[Min V 260-660ft based on indicated Mode C/pilot's RT report]

THE EC135 T2 HELICOPTER PILOT reports he was instructing a Student flying in the GST [Gloucestershire locator] hold level at 3000ft Gloucestershire QNH (999mb) in IMC under IFR, whilst in receipt of a PROCEDURAL ATS from GLOSTER APPROACH (APP) on 128.550MHz. A squawk of A7000 was selected with Mode C & S on; TCAS is not fitted.

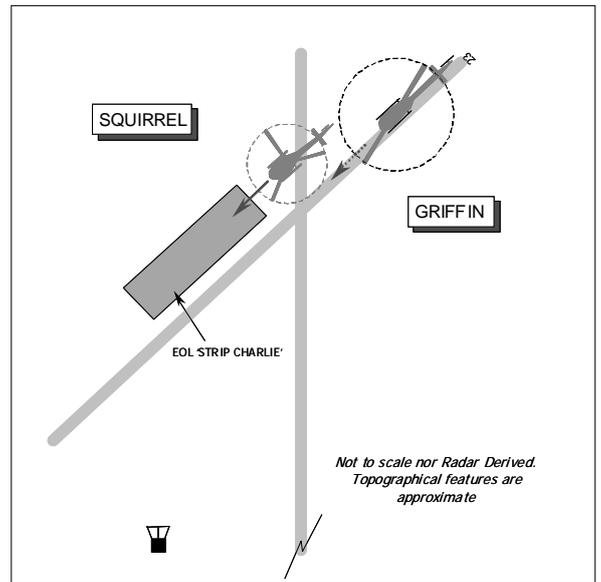
AIRPROX REPORT NO 2009-018

Date/Time: 16 March 1224
Position: 5247N 00240W (O/H RW23 at Shawbury - elev 249ft)
Airspace: MATZ/ATZ (Class: G)
Reporting Ac Reported Ac
Type: Bell 412 Griffin AS350 Squirrel
Operator: HQ AIR (Trg) HQ AIR (Trg)
Alt/FL: 800ft↑ ↓1000ft
 QFE (1022mb) QFE (1022mb)
Weather VMC CLOC VMC
Visibility: 35km 10km+
Reported Separation:
 150ft V/100m H Not seen
Recorded Separation:
 Not recorded

THE BELL 412 GRIFFIN HELICOPTER PILOT, a QHI, reports he was conducting an instrument training sortie with the student pilot flying the helicopter on instruments in the right seat whilst he as the instructor and safety pilot occupied the left seat. They were in receipt of a TRAFFIC Service from Shawbury TALKDOWN on 278-675MHz whilst carrying out a planned practice “go-around” following a Surveillance Radar Approach (SRA) to RW23. A squawk of A0230 was selected with Mode C; neither TCAS nor Mode S is fitted.

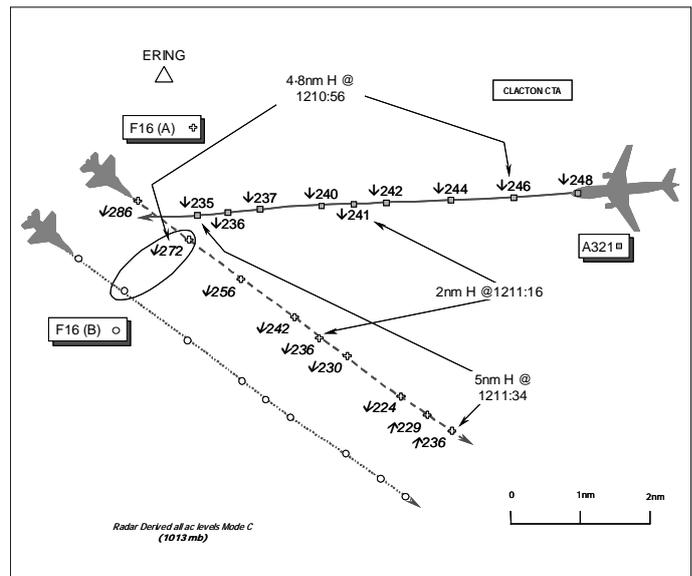
Nil V @ 2.2nm H

2nm Min H @ 500ft V

THE LTCC EAST TACTICAL RADAR CONTROLLER (TC E TAC) reports the Sector was banded and he was operating without a co-ordinator when he took a telephone call from the LJAO SE Sector Tactical Controller (LJAO SE TAC) regarding a pair of F16s, which was at about FL360. Having previously received a pre-note from LJAO SE TAC about the F16s, he already had the squawk, callsign and routeing of the ac, when told that LJAO needed to descend the F16s to FL200 before the FIR boundary. He agreed to the LJAO SE TAC's request to descend the F16 pair taking 1000ft vertical separation based on Mode C above his London inbounds and avoid his overflights.

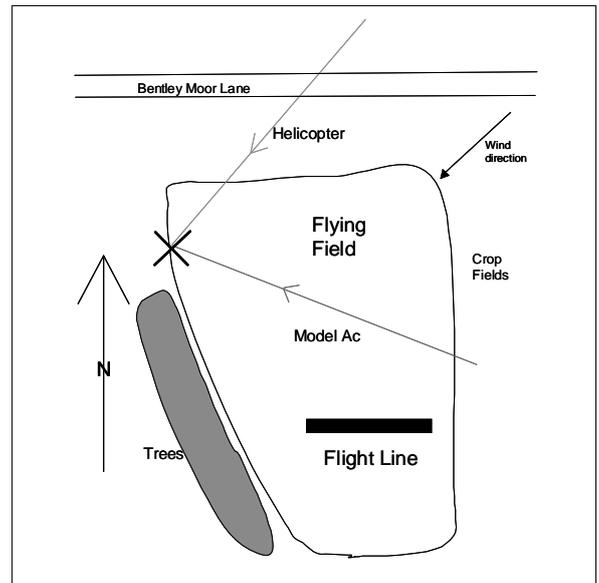
AIRPROX REPORT NO 2009-021

THE R44 PILOT reports flying a local sortie from a private site VFR and not in communication with any ATSU. The visibility was >10km in VMC and the helicopter was coloured black/white; no lighting was mentioned. On departure into wind heading 040° at 60kt climbing through 400ft a model ac flew down his starboard side by 10ft; the other pilot on board said that it almost hit them. Later, on long final approach to land, heading 170° and descending through 600ft, he saw a model climbing straight at them, so he turned R and dived to 100ft out of its path, missing it by 20ft. The model flying field is 0.5nm E of his track and he had never seen models in this position before as the model was being flown into sun and downwind of the model area over the edge of a caravan park. After aborting his landing he landed at the model site to find the operator of the model, which he did. The operator said that he had not seen the R44 helicopter, which the R44 pilot thought was unlikely, as he had approached from the N, upwind. He recovered the wreck of the model ac from a nearby field and returned it to the operator, informing him the incident would be reported.

Cause: Conflict in the vicinity of a model aircraft flying field.

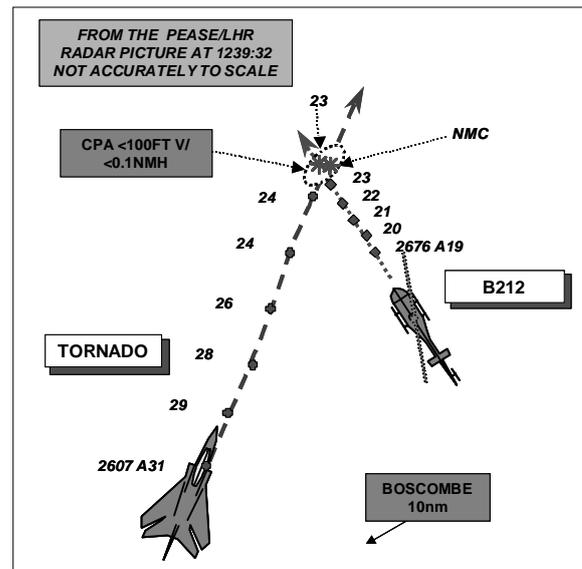
When assessing the risk Members noted that the Tornado had not manoeuvred sufficiently to increase the separation significantly and that the helicopter pilot (seated on the opposite side of the ac from the overtaking Tornado) was not able to see it until too late to take any avoidance. That being the case Members agreed unanimously that it was fortunate that there had been a few feet (less than 100) of vertical separation between the ac. Further, the radar recording confirmed both pilots view that the horizontal separation had been minimal. The Board was therefore unanimous that in this most serious incident there had been an actual risk of collision.

Cause: The Boscombe Down DIR vectored the Tornado into conflict with the Bell 212.

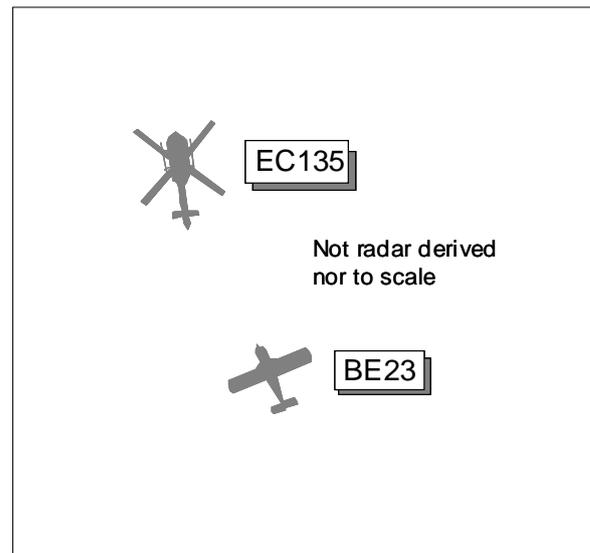
As this encounter had occurred in Class G airspace, both crews were responsible for maintaining their own separation from other ac through 'see and avoid'. The EC135 pilot had been approached from behind and was surprised by the sudden appearance of the BE23 whose pilot had seen the helicopter about 1000m ahead in slow flight. The BE23 pilot monitored the EC135's flightpath and, owing to adjacent high ground and built-up area, elected to fly under the helicopter by 200ft whilst maintaining visual contact with it. In doing so, the BE23 pilot flew close enough to the EC135 to cause its pilot concern and this had caused the Airprox. However, the early visual acquisition and action taken by the BE23 were enough to allow the Board to conclude that any risk of collision had been effectively removed.

Cause: The BE23 pilot flew close enough to the EC135 to cause its pilot concern.

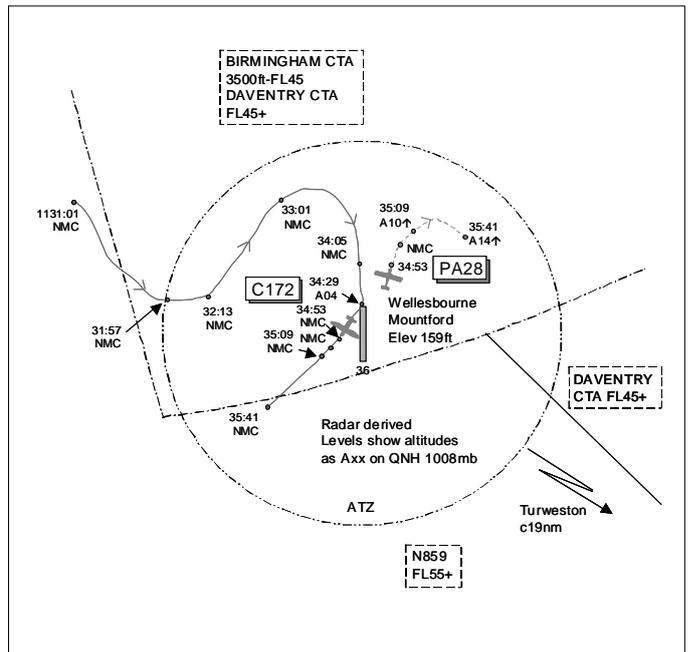
AIRPROX REPORT NO 2009-025

THE WELLESBOURNE AFISO reports that the RW in use was 36 LH cct. The departing subject PA28 had just lifted-off about 600m along the RW when another ac was seen, later identified as the subject C172, having passed the RW18 threshold flying in the opposite direction at about 200ft; this flight was not in RT contact. The PA28 pilot was instructed to make an immediate R turn and the ac passed within 160ft of each other. The C172 was seen to make a climbing R turn out of the cct and then depart to the SE. Turweston telephoned later to say that the C172 had landed there and the PA28 pilot later said that the C172 was recognised at Turweston as being the conflicting ac.

Cause: The C172 pilot did not comply with the requirements of Rule 45 of the ANO and did not integrate safely into the visual cct.

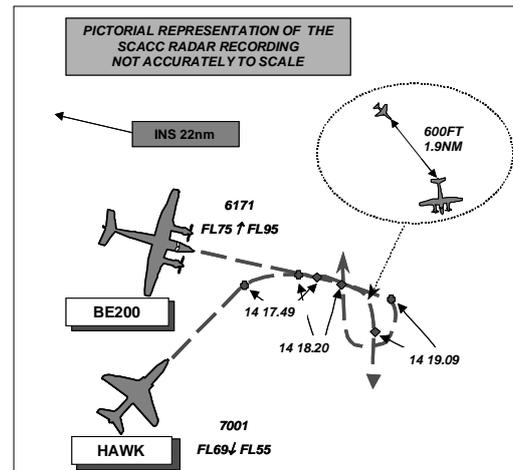
AIRPROX REPORT NO 2009-027

When assessing the cause and degree of risk Members accepted that the BE200 pilot could not see the Hawk and was understandably concerned by his TCAS indicating an ac behind him and closing; however, they agreed unanimously that there had been no risk of a collision at any time during the incident. They also noted that both pilots assessed the risk as being low and that the Hawk captain, who was in visual contact with the BE200 throughout, ensured a minimum separation of about 2nm and 600ft.

Cause: Sighting report (TCAS).

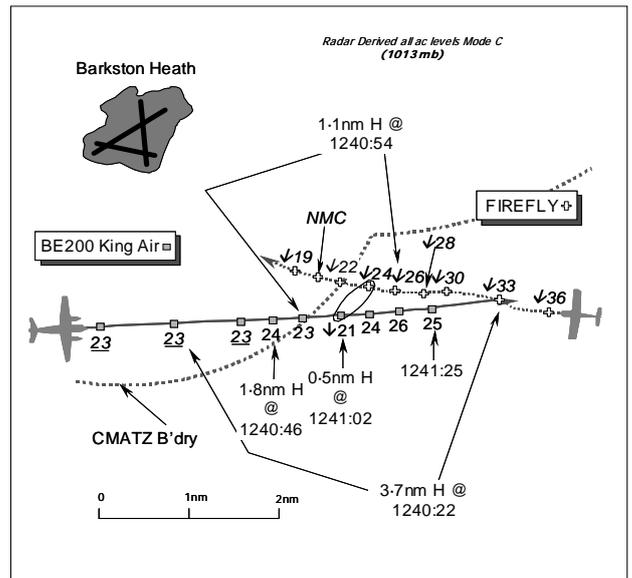
AIRPROX REPORT NO 2009-028

The Firefly pilot had no recollection of the event and believed that he had not passed unduly close to any other ac. However, at the distances revealed by the radar recording the BE200 was there to be seen and, in the Board's view, should have been spotted. However, it was pointed out that the BE200 could have been concealed beneath the Firefly's nose as the latter descended, which would have made it difficult to spot. Nevertheless, the Board concluded that non-sighting of the BE200 by the Firefly crew was part of the Cause.

The APP controller had issued the DOWNWIND vector to the BE200 crew 8sec before the Firefly crew had called. Whereas the Claxby Radar recording did not replicate exactly the picture displayed to APP at the time, the Firefly should have been evident on the Cranwell display when this instruction was issued. For this reason some controller Members were of the view that it was the controllers heading instruction that had set up the conflict between these two ac, with no form of separation being engineered in the first instance. A military controller Member suggested the Cause might be that APP vectored the IFR BE200 into conflict with the Firefly recovering VFR. However, this view did not prevail amongst the other Members. It was plain that the BE200 pilot had requested a TRAFFIC Service and as such the pilots had accepted that they were ultimately responsible for their own separation against other ac. As the BE200 pilots were following the instructions issued by the controller, Members questioned the advisability of being vectored in the pattern under a TRAFFIC Service when the crew were required to 'see and avoid' other ac themselves. It seemed illogical to some that, when following the controller's instructions for sequencing and spacing in the pattern, no consideration was taken of affording separation against other known inbound traffic, within or on the boundary of the CMATZ. Here accurate traffic information was provided to the BE200 crew about the Firefly at a range of 3nm, some 50sec after the latter's crew called. Whether this was in sufficient time for the BE200 crew to assess the situation and react appropriately was debatable, particularly since the BE200 crew were responsible for acquiring the Firefly visually and affording it appropriate visual separation. It was evident from the reporting pilot's account that the Firefly was not seen until after it had crossed ahead and was in his 7 o'clock position, having passed down the port side of his BE200 at a range of 100-200m at a similar height. Thus unseen by the BE200 crew beforehand, with no positive steps taken by ATC to establish separation because under the prevailing TRAFFIC Service none was required, it was left to TCAS to resolve the developing situation. Therefore, the Board agreed that as the Firefly was not seen until after it had passed behind their port wing this was effectively, a non-sighting by the BE200 crew and the other part of the Cause.

Cause: Non-sighting by the Firefly crew and an effective non-sighting by the BE200 crew.

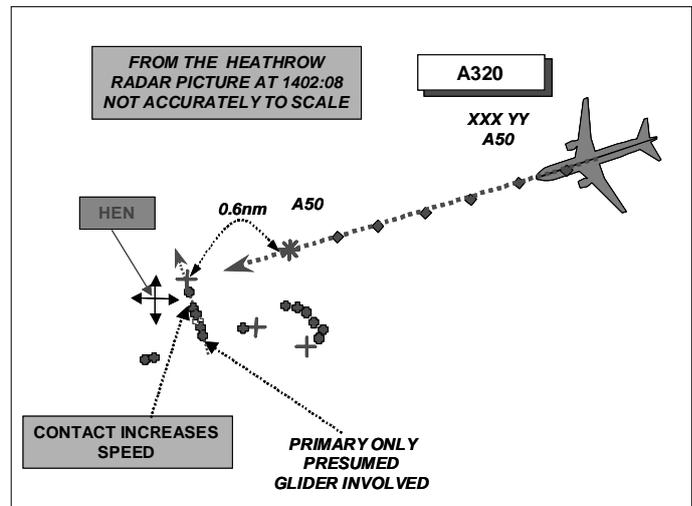
AIRPROX REPORT NO 2009-030

THE A320-200 PILOT reports flying a SID from Luton and while approaching HEN NDB at 250kt and climbing through [actually just levelled at] an alt of 5000ft in slight haze, he saw a glider in a steep (20 degree) descent crossing from left to right across his nose and passing through their alt. He estimated the distance as being between 1 and 2nm. He had no TCAS indication from the glider and reported the incident on the radio to London Control, assessing the risk of collision as being low.

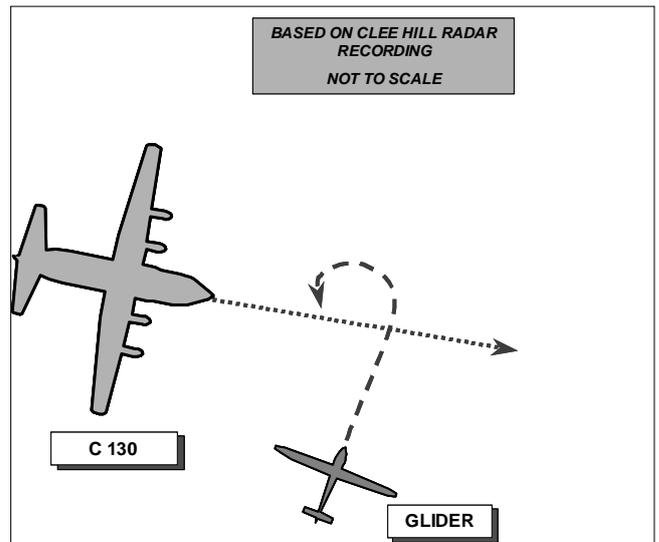
AIRPROX REPORT NO 2009-031

THE C130J PILOT reports on a local training flight from Lyneham squawking 7000 with Modes C and S, not in contact with any ATC unit but with a fully serviceable TCAS. While heading 090° at 145kt and 2000ft agl, just to the W of Newbury, a white glider was seen visually in their 2-3 o'clock, very slightly above them and at very close range (100ft away). The glider was heading roughly 350°, was straight and level, was not displayed on their TCAS and its pilot appeared not to have seen them. The pilot flying [the C130] bunted their ac and descended rapidly to avoid the glider and increase the separation. No avoiding action was seen by the glider and both ac then continued on their respective courses. He assessed the risk as being very high and reported the incident the following morning.

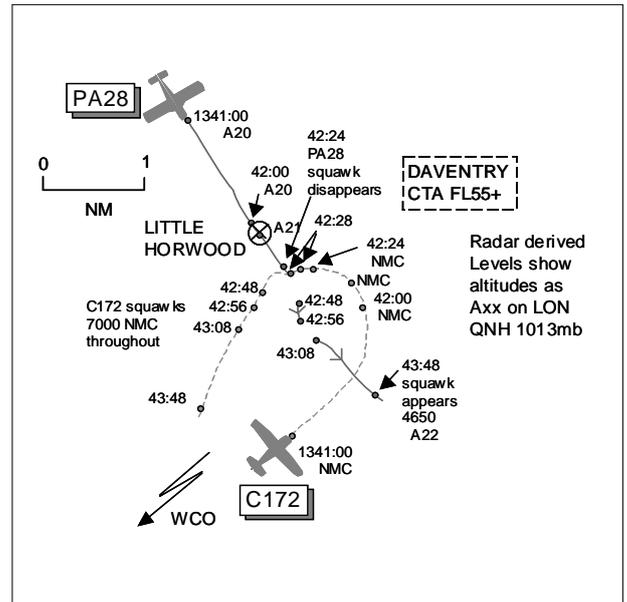
AIRPROX REPORT NO 2009-032

THE C172 PILOT reports flying a dual training sortie from Elstree VFR and in receipt of a AFIS from Elstree Information on 122.4MHZ squawking 7000; he was unsure whether the ac was fitted with Mode C. The visibility was >10km in CAVOK VMC and the ac was coloured white/red with anti-collision beacon switched on. He was instructing a qualified PPL towards an IMC rating and was introducing him to NDB tracking. As this was the PPL holder's first use of the ADF and as he had been flying 'under the hood' for the previous 3 days, they decided not to use a hood so both pilots were looking out. They had tracked away from WCO on the 020° radial and then turned L back towards the beacon heading 200° at 2000ft and 100kt, when suddenly an ac, a PA28, appeared from behind their R wing, slightly above and <100ft away. Immediately prior to this the PPL holder was looking at the DI and RBI and the instructor was looking out to the front towards Westcott disused aerodrome. The instructor immediately took control, pushing forwards on the controls, diving the ac and turning to the R believing the other ac was pulling up and also turning R; he estimated that they passed <50ft vertically and <100ft horizontally. He noted the other ac's registration from his brief glimpse of it and believed it to be another training ac from Elstree [actually Denham]. He opined that the combination of their high wing ac at a slightly lower altitude than the low wing PA28 with both converging had led to their ac being obscured to the PA28's pilot by its engine until very late. Also this would have been further aggravated with both ac having an instructor in the RH seat putting himself close to the wing root and the PA28 instructor's view obscured by the engine cowling. Furthermore, this incident had occurred at 2000ft QNH, an altitude that he usually avoided like the plague, because the PPL holder had drifted down from 2300ft whilst concentrating on the ADF.

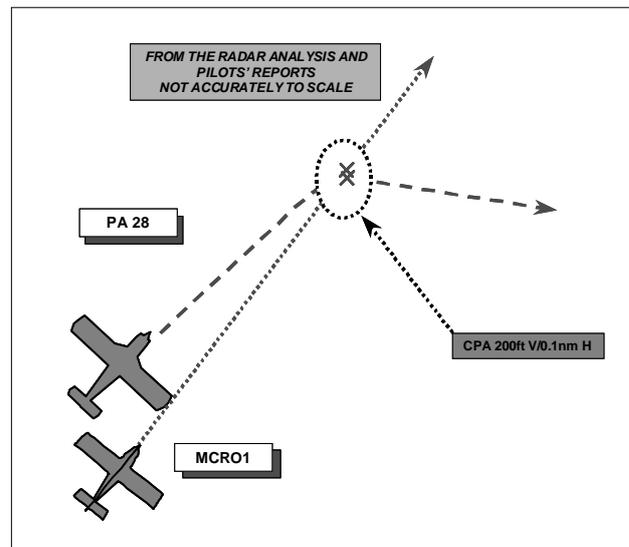
AIRPROX REPORT NO 2009-033

THE PA28 PILOT reports flying in a red and white ac with all lights switched on on a local VFR flight with 2 passengers, squawking 7000 with Mode C and in receipt of a Basic Service from Cosford TWR. The Weekend Procedures for recoveries to Cosford were in force which require that ac report at the unpublished VRP Alpha, a small lake 0.5nm N of the ATZ, not below 1300ft QFE. He had already reminded his passengers about keeping a good lookout, especially when approaching a VRP. He had just reported at point Alpha to Cosford TWR, while level at 1300ft and heading 100° at 90kt, and they replied with “C/S proceed direct to finals”. This required him to track directly to RW24 North side grass and as he was about to commence his right hand turn, he started to scan from left to right but before his head came round to the right, his passenger in the rear right hand seat reported “traffic 5 o’clock”. He looked round and immediately saw an aircraft about 75-100m behind them and about 20ft above them, travelling at about 130kts. He maintained his heading and the other ac passed to their left about 50m away in a descent.

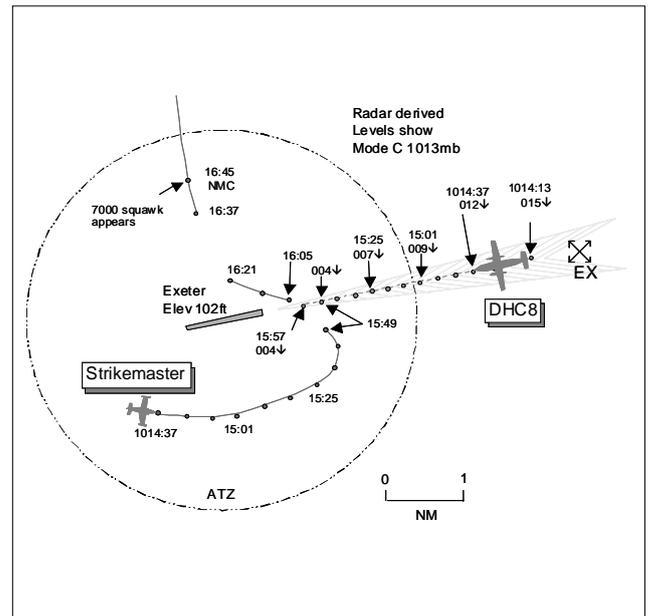
AIRPROX REPORT NO 2009-036

THE DHC8 PILOT reports inbound to Exeter IFR and in receipt of Aerodrome Control Service from Tower on 119.8MHz squawking Mode S and C. Whilst heading 260° at 120kt on the ILS RW26 they were informed by ATC of traffic LH downwind. At this point the Capt reported he thought he had the traffic visual, about 4-5nm away, although he did observe 2 ac on TCAS. The ac which the Capt reported visual with, a low wing small jet coloured white/red, continued downwind and then turned towards their ac and started to descend. It continued towards them and turned towards final approach at which stage its pilot reported going around and it climbed away within 0.5nm of them and above them. The FO, the PF, noted the TCAS show a TA symbol as the other ac passed 500-600ft above. He assessed the risk as medium to high in the event of them having to go-around and at a time when the PNF was having to continuously monitor other ac whilst on final approach in gusty Wx conditions.

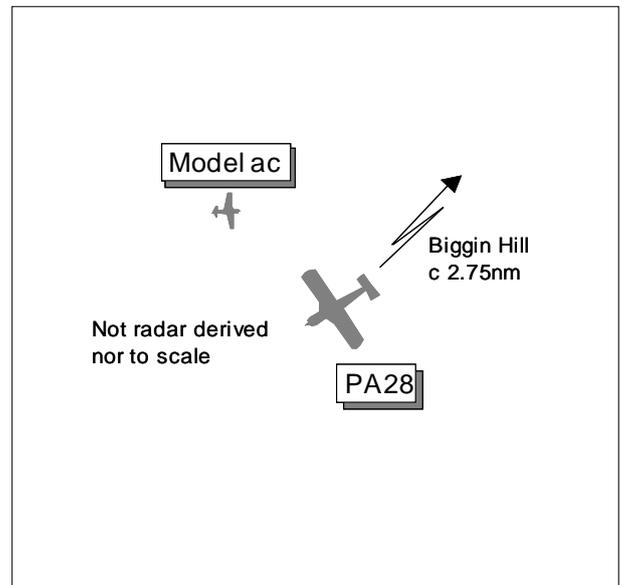
AIRPROX REPORT NO 2009-040

THE PA28 PILOT provided a very comprehensive report including his GPS track superimposed on a 1:500k topographical chart as well a large scale local map showing the same track overlaid with GPS derived altitudes. He reports outbound from Biggin Hill VFR and in receipt of a BS from Biggin on 129.4MHz squawking with Modes S and C. The visibility was >10km in VMC and the ac was coloured white/blue with anti-collision and strobe lights switched on. Prior to departure he had briefed his passengers about the 'see and avoid' principle and the use of the 'clock' code when reporting traffic. They departed RW21 at 1714 enroute to Headcorn via Caterham Motorway junction, Guildford, Goodwood, Selsey Bill and Beachy Head; the departure clearance included a R turn at 1nm. He commenced the R turn slightly later than instructed, about 1.3d and then noted crossing the ATZ boundary on the GPS display. Shortly after this his front seat passenger, seated on the R, reported seeing an ac but instead of using the agreed method he stated '*Here look at this (pilot's name) coming up on the right hand side*'. The pilot, seated on the L, could not see anything and asked his colleague to be more specific. Before any response was made he saw what he thought was a red/white model rocket with smoke trailing from the rear appear just behind the R wing in a vertical or near vertical attitude and climbing rapidly. At the time he was heading 250° at 80kt climbing through about 1800ft QNH and by the time of the sighting there was no opportunity or requirement for avoiding action. The model ac had come from below his altitude, climbed through it and was still climbing. He then realised that it was not a rocket but a low-winged large model ac, which he lost sight of above him. In his RT report to Biggin he stated that the model was <200m away but subsequently he believed that separation was 100-150m. His passenger later said that initially the model ac had been flying below them on a reciprocal heading slightly to their R when first sighted. He did not note his altimeter reading at the time but his GPS recorded his altitude as 1776ft and showed the ground elevation at the incident location as 790ft. The NOTAM narrow route brief retrieved 2hr before the flight did not give any warning of model ac flying on his intended route. He assessed the risk as high. The incident occurred on the portion of the flight between the ATZ and the S edge of the Kennel Farm [Warlingham] notified Hang-Gliding and Parascending launch site, where he turned slightly L. He reported seeing 4-5 cars parked side by side in a field that could have been the model flyer's site but he could not be sure.

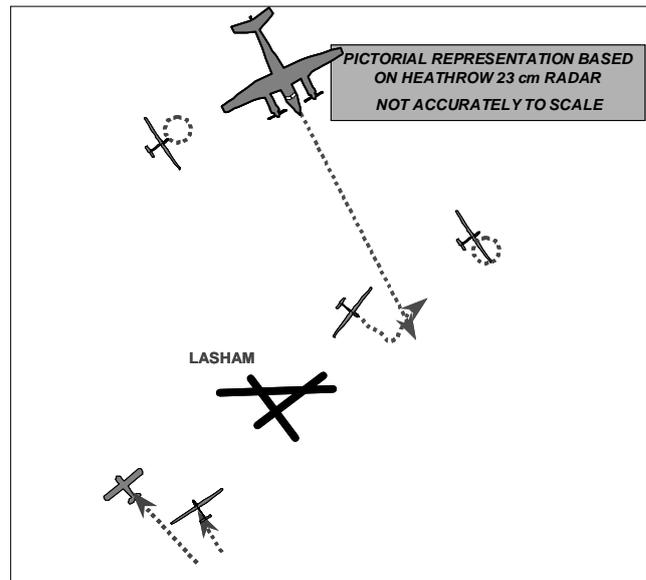
AIRPROX REPORT NO 2009-042

THE GLIDER PILOT reports that she was flying a white and red glider with no radio or transponder fitted and, at the time of the incident, had been soaring locally for about 2hr. She was thermalling in a right turn at 40kt, just to the ENE of Lasham airfield and each turn was taking about 20-25sec to complete. During the course of her lookout she had noticed a glint in the distance to the N, which appeared to be far enough away not to cause any concern and could have been another thermalling glider.

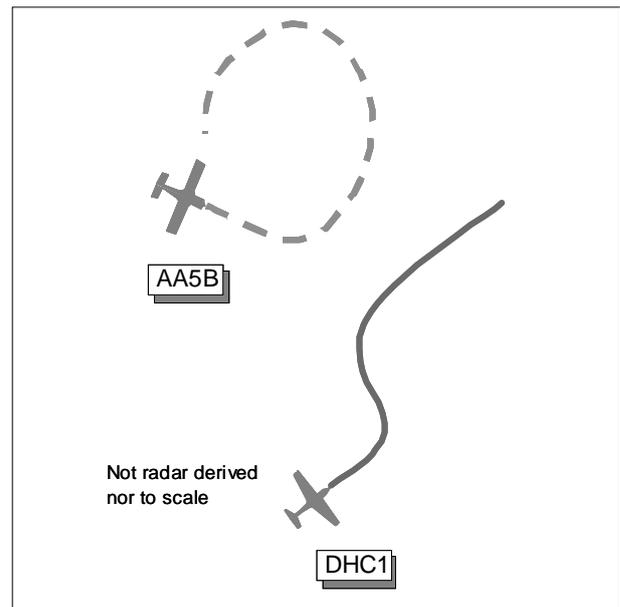
AIRPROX REPORT NO 2009-043

THE AA5B PILOT reports enroute from Dornoch to Aberdeen VFR and in receipt of a BS from Inverness Radar on 122.6MHz squawking 6176 with Mode C. The Wx was CAVOK and the ac was coloured white/blue with strobe lights switched on. Whilst in the cruise at 3500ft, he thought, QNH 1030mb heading 115° at 110kt he received TI on traffic to the W, he thought, at about 1nm range but there was no height information. He looked for the traffic but did not visually acquire it, later believing that it may have been obscured by the starboard canopy arch. After speaking to his passenger he resumed his scan and saw a single engine ac in his 2 o'clock range 0.5nm travelling R to L across his ac's nose at what he thought was the same height, within 30ft vertically. He monitored the situation for a few seconds to determine if the other ac's pilot had seen his ac and what avoiding action he might take. Given the relative positions of the ac, continuation on his present heading would have resulted in a collision so he broke hard L into a 360° orbit. He lost sight of the ac as he turned away to the N but saw it again off to his port side about 0.5nm away as he turned through S to pass behind. The other ac then made a slow turn to the N and commenced a gentle descent. He contacted Inverness Radar and obtained confirmation that the other ac was visible on radar but that it was not on frequency. He thought it might have been a tug ac from the nearby gliding site at Easterton as it appeared to be descending towards the site although he had no evidence for this. He assessed the risk as high.

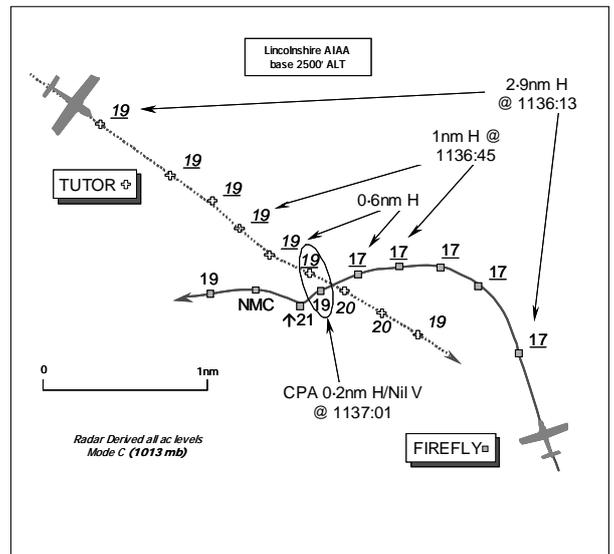
AIRPROX REPORT NO 2009-045

THE T67M FIREFLY PILOT, a QFI, reports conducting an elementary instructional sortie with a student in CAVOK conditions with no cloud. The QFI was demonstrating an emergency handling aspect and the RT was selected to Cranwell APPROACH (APP) although no recovery call had yet been made as they had just switched frequency from Cottesmore LARS (ZONE) on 130.20MHz. A squawk of A2641 was selected with Mode C on; Mode S is not fitted.

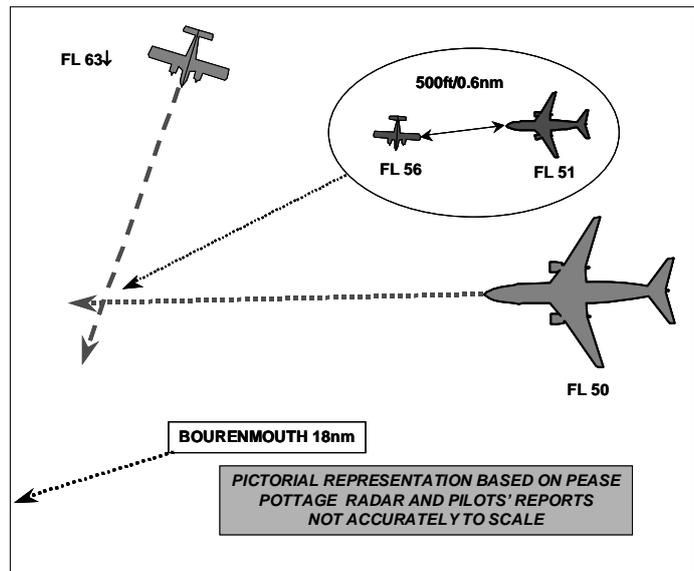
AIRPROX REPORT NO 2009-046

Date/Time: 5 June 1450
Position: 5054N 00128W (7nm SW of SAM)
Airspace: SOLENT CTA (Class: D)
R41 (Class: A)
Reporting Ac Reported Ac
Type: B737 PA34
Operator: CAT Civ Trg
Alt/FL: 5000ft 5500ft
(QNH 1008mb) (QNH 1007mb)
Weather VMC Haze VMC CLAC
Visibility: 10km >10km
Reported Separation:
1000ft V/5m H 7-800ft V/<1nm H
Recorded Separation:
700ft V/0.2nm H

Cause: The PA34 instructor allowed his student to descend below their cleared level into conflict with the B737.

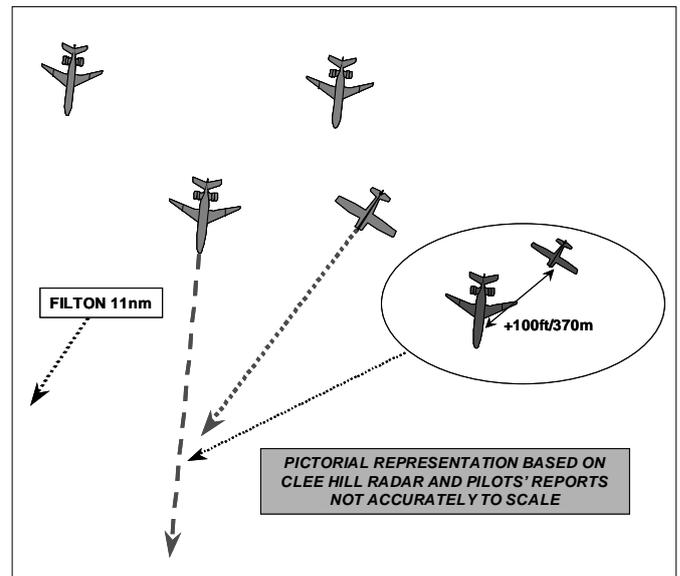
Recorded Separation:

- 100ft V/0.2nm (370m) H (see UKAB Note (2))

Cause: The VC10's flightpath caused the C172 pilot concern.

fault with the C172's SSR equipment that caused it to be undetected by the VC10's TCAS. A specialist GA Member recommends all GA pilots to check the performance of their SSR equipment periodically and regularly by requesting confirmation of squawk and altitude with a radar-equipped ATC unit.

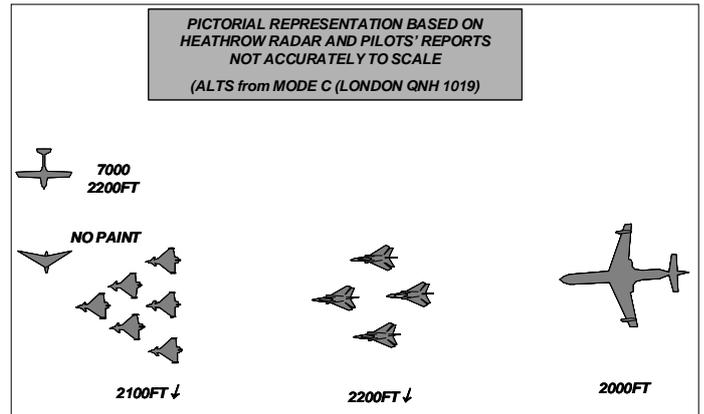
AIRPROX REPORT NO 2009-048

Date/Time: 13 June 1209 (Saturday)
Position: 5147N 00107W (10 nm N Benson)
Airspace: London FIR (Class: G)
Reporting Ac Reported Ac
Type: Typhoon Ikarus C42
Operator: HQ Air (Ops) Civ Pte
Alt/FL: 2000ft 2500ft
(QNH 1019mb) (QNH 1019mb)
Weather VMC CLOC VMC
Visibility: >10km >10nm
Reported Separation:
100ft V/300ft H 1000ft V/1m H

Recorded Separation:
400ft V/ 0.7nm H (700 ft V /0.2nm H against the GR4s -see UKAB Note (2))

Cause: Both microlights penetrated the RA(T) and flew into conflict with the lead elements of the military formation

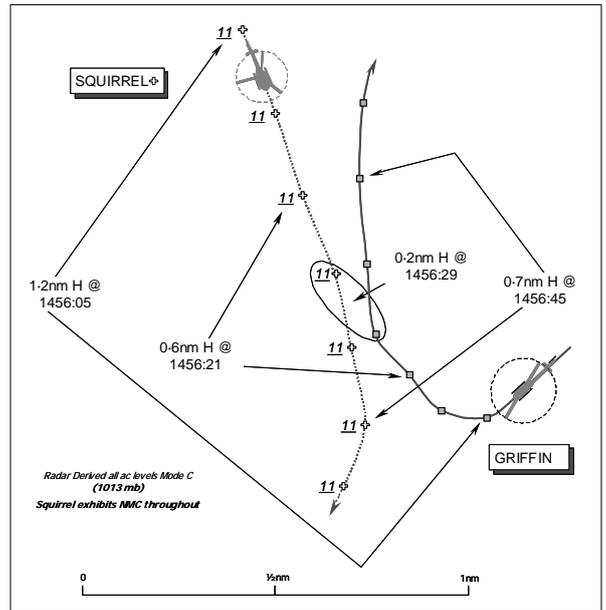
AIRPROX REPORT NO 2009-049

Date/Time: 11 June 1456
Position: 5240N 00254W (11nm SW of Shawbury - elev 249ft)
Airspace: LFA9 (Class: G)
Reporting Ac Reported Ac
Type: Griffin HT Mk1 Squirrel HT Mk1
Operator: HQ Air (Trg) HQ Air (Trg)
Alt/FL: 500ft 1000-1500ft
 agl RPS
Weather VMC CLOC VMC CLOC
Visibility: 50km 50km
Reported Separation:
 Nil V/200m H Nil V/200m H
Recorded Separation:
 By interpolation <0.1nm H

Cause: Late sightings by both the Griffin crew and the Squirrel pilot.

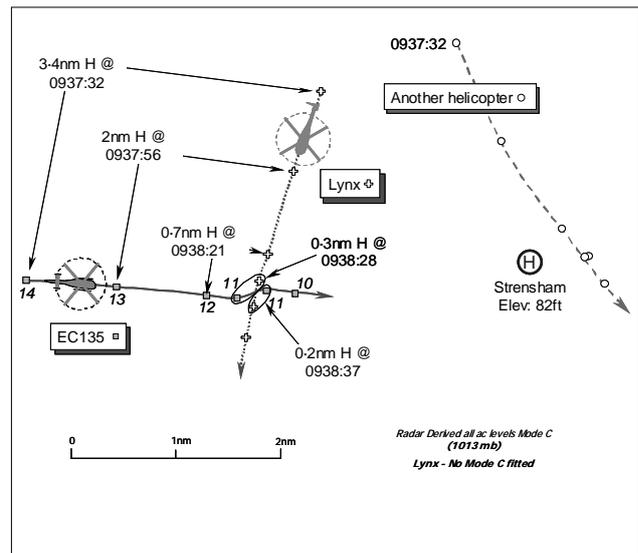
AIRPROX REPORT NO 2009-050

Date/Time: 15 June 0938
Position: 5203N 00214W (2nm W of Strensham)
Airspace: London FIR (Class: G)
Reporting Ac Reporting Ac
Type: EC 135 T2 Lynx Mk3
Operator: Civ Comm HQ FLEET
Alt/FL: 1100ft 1000ft
RPS (1013mb) QNH (1017mb)
Weather VMC VMC
Visibility: >40km >10km
Reported Separation:
50ft V/50m H 20ft V/75m H
Recorded Separation:
Tracks crossed

Cause: Late sighting by the Lynx crew.

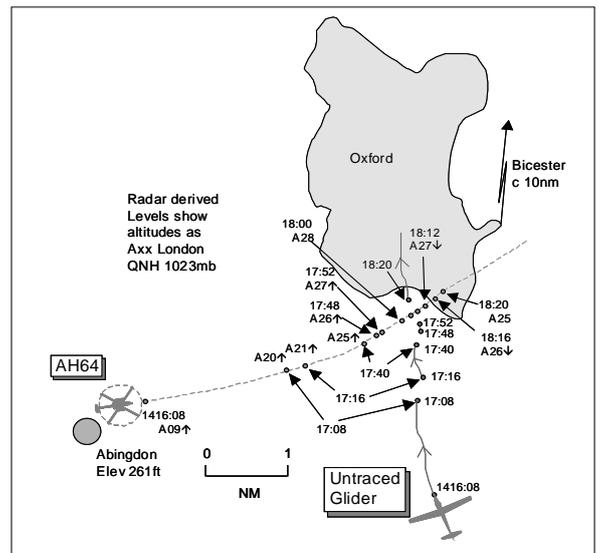
AIRPROX REPORT NO 2009-051

Date/Time: 16 Jun 1418
Position: 5143N 00112W (5nm NE Abingdon)
Airspace: Oxford AIAA (Class: G)
Reporting Ac Reported Ac
Type: AH64 Apache Untraced Glider
Operator: HQ JHC NK
Alt/FL: 2380ft↑
(RPS 1019mb)
Weather VMC CLBC NK
Visibility: 30km
Reported Separation:
50ft V NR
Recorded Separation:
<0.1nm

Cause: Probable non-sighting by the glider pilot and a late sighting by the AH64 crew.

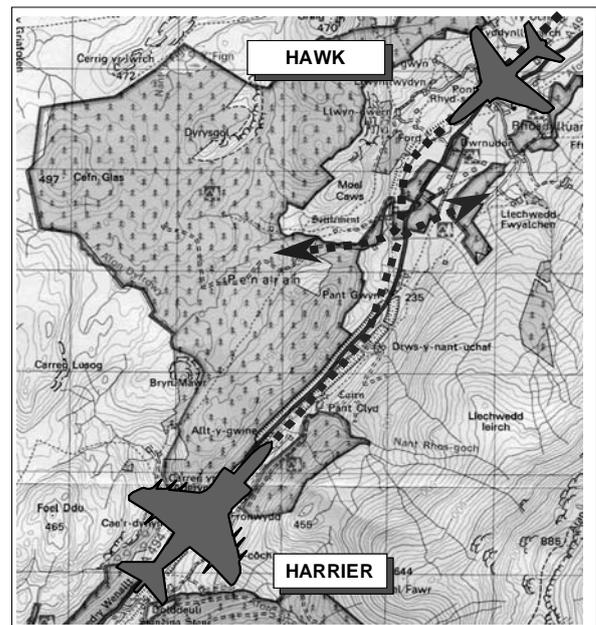
AIRPROX REPORT NO 2009-052

Date/Time: 16 June 1540
Position: 5248N 00344W(4.5nm SW of S end of Lake Bala)
Airspace: UKDLFS (Class: G)
Reporting Ac Reported Ac
Type: Hawk T1 Harrier GR9
Operator: HQ Air (Trg) HQ Air (Ops)
Alt/FL: 250ft agl 400ft
(RPS 1017mb) (N/K)
Weather VMC CLBC VMC
Visibility: 10km untd
Reported Separation:
0ft V/10m H NR
Recorded Separation:
NR

Cause: A conflict in the UKDLFS resolved by both pilots.
