UK AIRPROX BOARD

Analysis of Airprox in UK Airspace

**Report Number 22
January 2009 - June 2009**

Twenty Second Report by the UK Airprox Board:

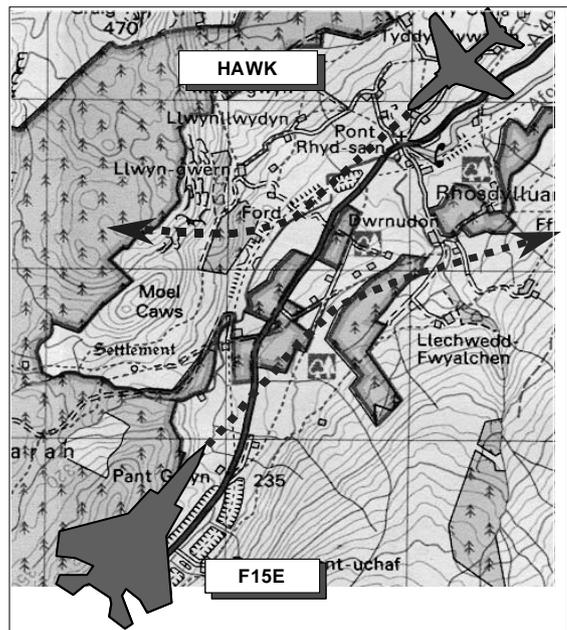
AIRPROX REPORT NO 2009-053

Date/Time: 16 Jun 1205
Position: 5249N 00342W (3.5nm SW of SW End of Lake Bala)
Airspace: UKDLFS (Class: G)
Reporting Ac Reported Ac
Type: Hawk T1 F15E
Operator: HQ Air (Trg) HQ 3AF
Alt/FL: 250ft AGL 500ft AGL
(RPS 1018mb) (QNH)
Weather VMC CAVOK VMC CAVOK
Visibility: >10km Unltd
Reported Separation:
1000ft V /20ft H 500ft V/ 0.75nm H
Recorded Separation:
NR

Cause: A conflict in the UKDLFS resolved by both pilots.

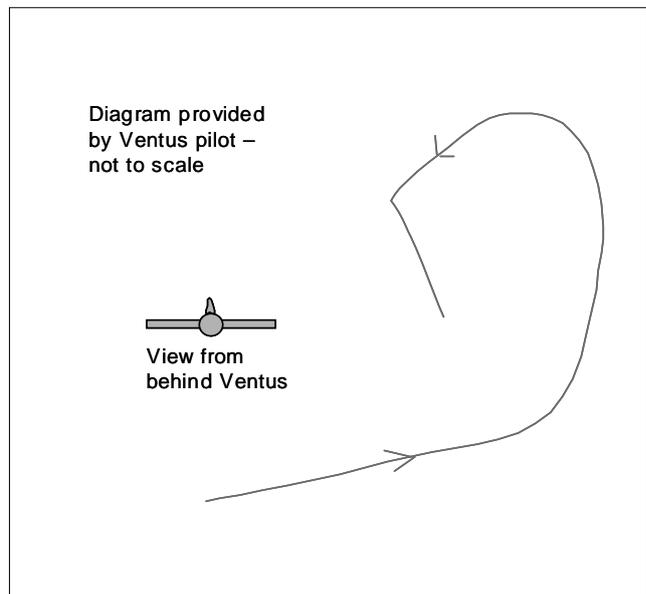
AIRPROX REPORT NO 2009-054

Date/Time: 14 Jun 1242 (Sunday)
Position: 5141N 00113W (4nm NE Didcot)
Airspace: Oxford AIAA (Class: G)
Reporting Ac Reported Ac
Type: Ventus Glider Untraced
Light Ac
Operator: Civ Club NK
Alt/FL: 3700ft NK
(QNH)
Weather: VMC CLBC NK
Visibility: 50km
Reported Separation:
Nil V/150m H
Recorded Separation:
NR

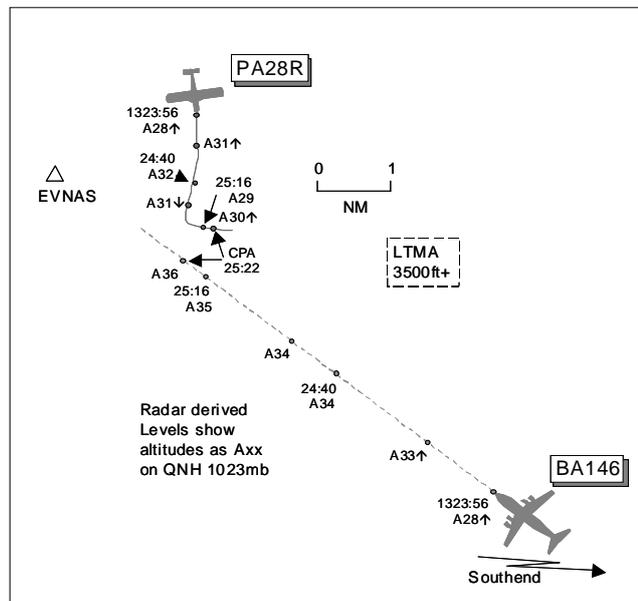
Reported Separation:
500ftV/c1nm H Not seen

Recorded Separation:
600ft V/0.6nm H

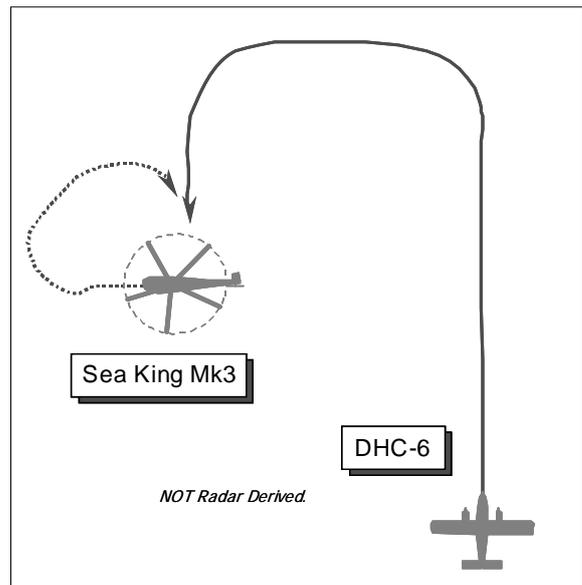
AIRPROX REPORT NO 2009-056

Date/Time: 17 June 1605
Position: 5319N 00441W (1½nm N of South Stack Light)
Airspace: London FIR (Class: G)
Reporting Ac Reported Ac
Type: Sea King Mk3 DHC-6
Operator: HQ Air (Ops) Civ Comm
Alt/FL: 50ft 185ft
Rad Alt Rad Alt
Weather VMC No Sig VMC NR
Visibility: >10km 10km
Reported Separation:
Nil V/100m H Nil V/250m H
Recorded Separation:
Not recorded

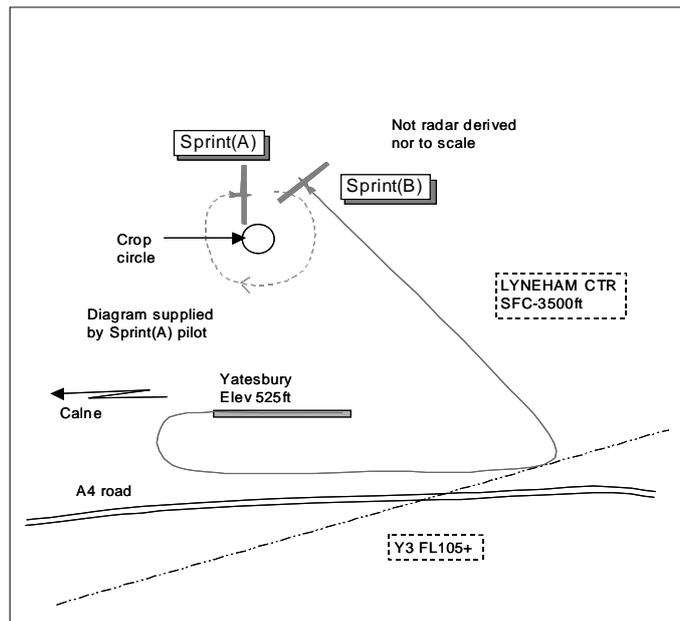
AIRPROX REPORT NO 2009-057

Date/Time: 12 Jun 1134
Position: 5127N 00155W (0.5nm N Yatesbury
Microlight Strip - elev 525ft)
Airspace: Lyneham CTR (Class: D)
Reporting Ac Reported Ac
Type: Thruster T600N Thruster T600N
Sprint(A) Sprint(B)
Operator: Civ Pte Civ Trg
Alt/FL: 800ft QFE NR ↑
(QFE 1004mb) (QFE)
Weather: VMC CLBC VMC NR
Visibility: >10km >50nm
Reported Separation:
Nil V/45m H Nil V/50m H
Recorded Separation:
NR

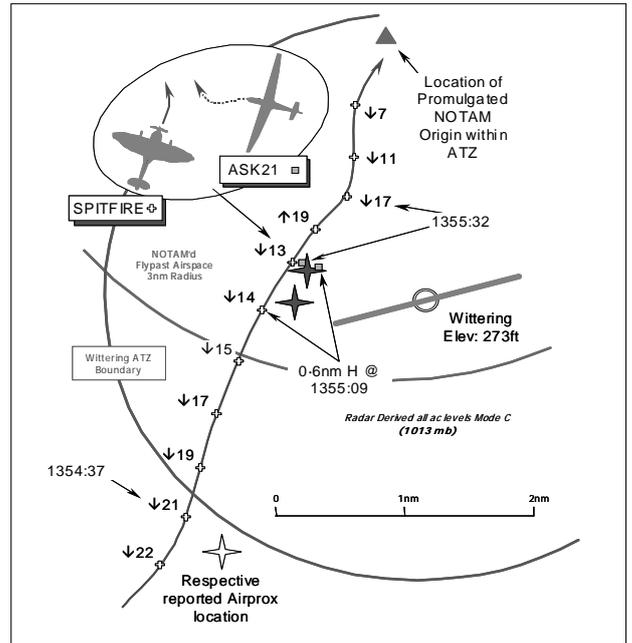
AIRPROX REPORT NO 2009-059

Date/Time: 21 Jun 1355 (Sunday)
Position: 5237N 00030W (1nm WNW of Wittering A/D - elev: 273ft)
Airspace: Wittering ATZ (Class: G)
Reporting Ac Reporting Ac
Type: ASK21 Supermarine Spitfire MkVb
Operator: Civ Pte HQ Air
Alt/FL: 1400ft 1300ft ↓
agl RPS (1021mb)
Weather VMC Sky Clear VMC NR
Visibility: >20km 30km
Reported Separation:
Nil V/50m H 30ft V/200m H
Recorded Separation:
Not recorded

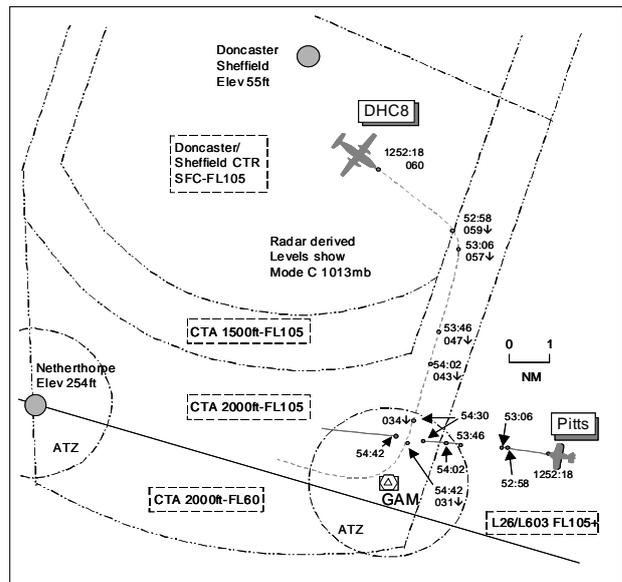
AIRPROX REPORT NO 2009-060

Date/Time: 21 Jun 1255 (Sunday)
Position: 5318N 00056W (10nm SSE Doncaster/
Sheffield - elev 55ft)
Airspace: CTA (Class: D)
Reporting Ac Reported Ac
Type: DHC8 Pitts S1S
Operator: CAT Civ Pte
Alt/FL: ↓3000ft 3500ft
(QNH 1024mb) (QFE)
Weather VMC CLBC VMC CLBC
Visibility: 10km 25nm
Reported Separation:
500ft V/<2nm H 4-500ft V/NR H
Recorded Separation:
c<0.2nm H

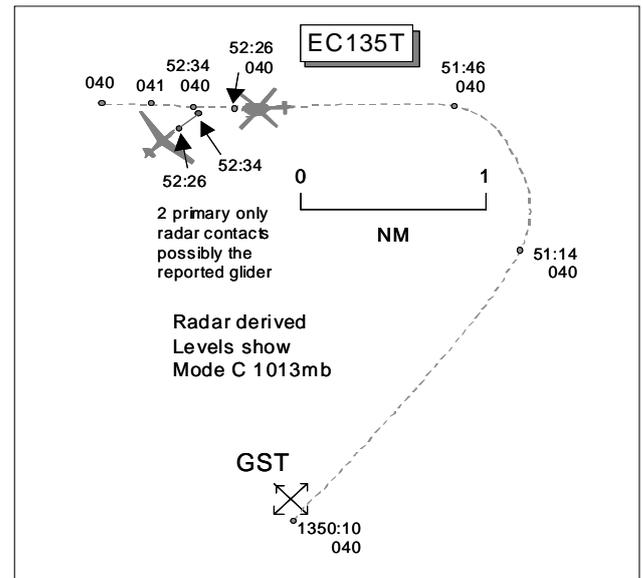
AIRPROX REPORT NO 2009-061

Date/Time: 16 Jun 1353
Position: 5156N 00211W (2.5nm N Gloucestershire)
Airspace: FIR (Class: G)
Reporting Ac Reported Ac
Type: EC135T Untraced Glider
Operator: Civ Trg N/K
Alt/FL: FL40 (N/K)
Weather VMC CLBC N/K
Visibility: >10km
Reported Separation: Nil V/100m H
Recorded Separation: 0.1nm H

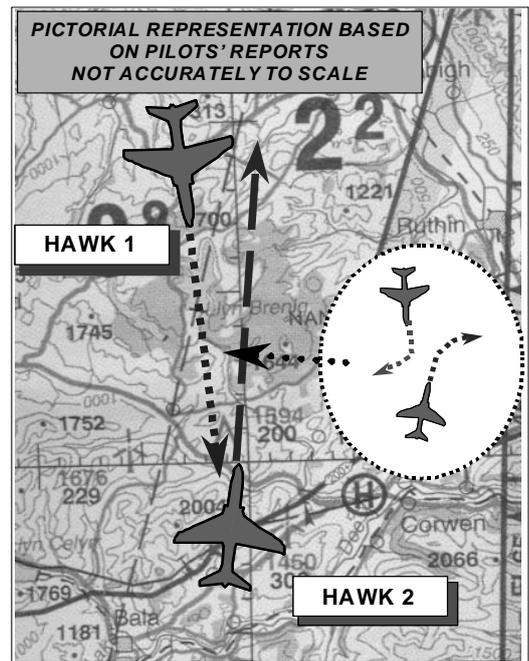
AIRPROX REPORT NO 2009-062

Date/Time: 24 June 1039
Position: 5304N 00332W (13nm S of Rhyl)
Airspace: UKDLFS (Class: G)
Reporting Ac Reporting Ac
Type: Hawk T1 Hawk T1
Operator: HQ AIR (Trg) HQ AIR (Trg)
Alt/FL: 250ft 250ft
(RPS 1019mb) (N/K)
Weather VMC (CAVOK) VMC
Visibility: 50km
Reported Separation:
0ft V/300m H 0V/NRH(300mon
pilot's diagram)
Recorded Separation:
NR

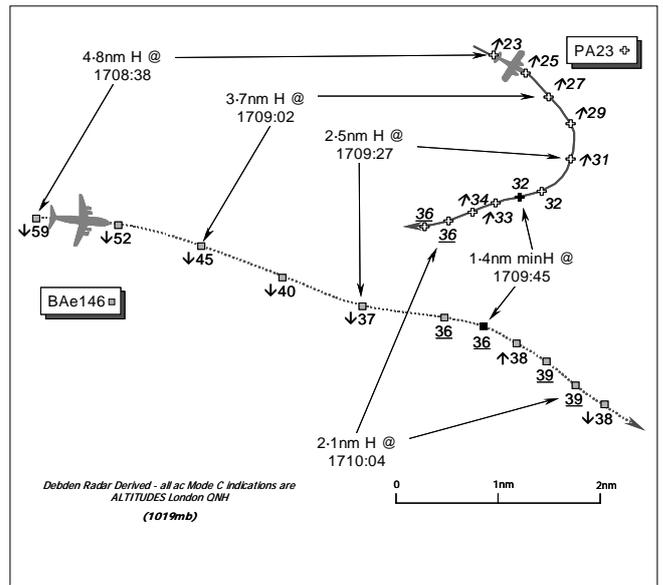
AIRPROX REPORT NO 2009-063

Date/Time: 24 Jun 1709
Position: 5210N 00049W (9nm NWbW of Cranfield - elev: 358ft)
Airspace: London FIR (Class: G)
Reporting Ac Reported Ac
Type: BAe146-301 Piper PA23
Operator: Civ Comm Civ Pvt
Alt/FL: ↓3500ft 2000-3000ft
 QNH (1019mb) QNH (1019mb)
Weather VMC CLBC VMC CLBC
Visibility: 40km 10km
Reported Separation:
 400ft V/0.4nm H NR
Recorded Separation:
 400ft V/1.4nm H

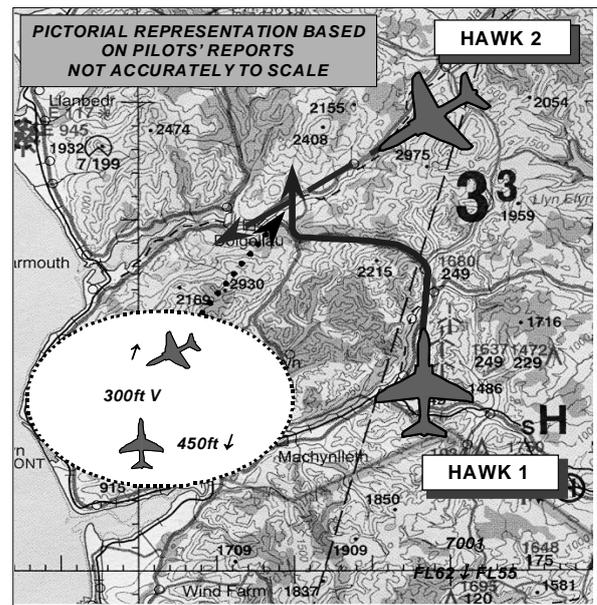
AIRPROX REPORT NO 2009-064

Date/Time: 25 June 0950
Position: 5244N 00350W (5nm West of Dolgellau)
Airspace: UKDLFS (Class: G)
Reporting Ac Reporting Ac
Type: Hawk T Mk1 Hawk T Mk1
Operator: HQ Air (Trg) HQ Air (Trg)
Alt/FL: 450ft agl 250ft agl
(RPS 1009mb) (RPS 1011mb)
Weather VMC CLBC VMC CAVOK
Visibility: >10km 15km
Reported Separation:
300ft V/150m H 300ft V/ 0 H
Recorded Separation:
NR

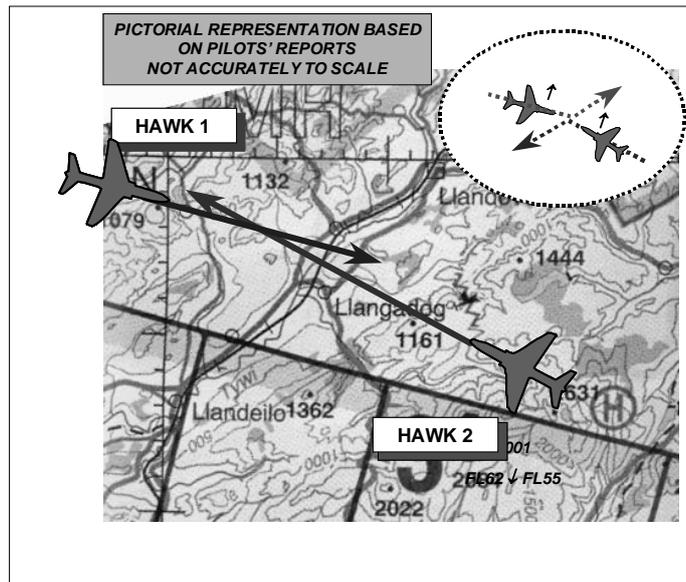
AIRPROX REPORT NO 2009-065

Date/Time: 18 June 1414
Position: 5157N 00353W (8nm W of Sennybridge)
Airspace: UKDLFS (Class: G)
Reporting Ac Reporting Ac
Type: Hawk T Mk1 Hawk T Mk1
Operator: HQ AIR (TRG) HQ AIR (TRG)
Alt/FL: 250ft agl 250ft agl
(RPS 1008mb) (RPS 1008mb)
Weather VMC VMC
Visibility: >10km >10km
Reported Separation:
0ft V/50m H 0ft V/50ft H
Recorded Separation:
NR

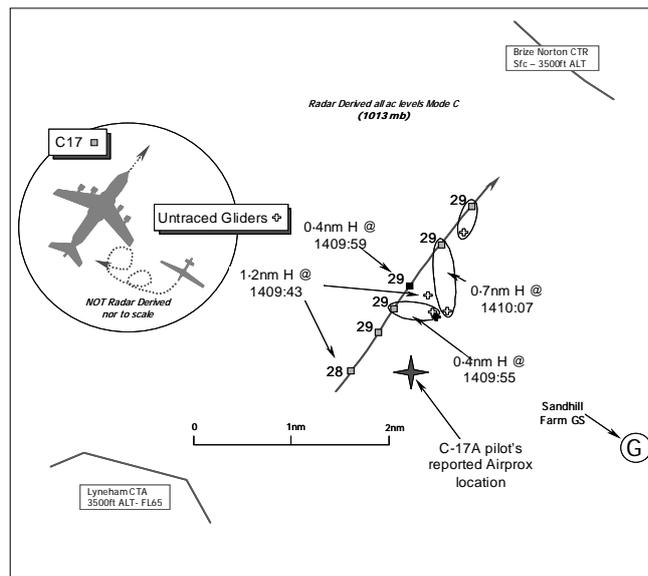
THE BOEING C-17A GLOBEMASTER III pilot reports that he was in transit under VFR from Lyneham to Brize Norton at 3000ft Brize QFE (1013mb) following Operational Tasking. The flight was routed over Swindon at 3000ft in VMC some 1000ft clear below cloud with an in-flight visibility of 35km direct to the BZN TACAN thereby avoiding the Fairford overhead and Shrivenham [Sandhill Farm] gliding site. Prior to departure, Lyneham briefed him of about possible glider traffic en-route to Brize Norton. Once in 2-way RT contact with Brize APPROACH and receiving a TRAFFIC Service, they were again briefed by the controller on contacts that were possibly gliders on his route. The area ahead of his C-17A appeared clear of other aircraft visually and there were no conflicting TCAS contacts on his planned route. Manoeuvring to the R would have taken his ac towards Shrivenham [Sandhill Farm] Glider Site - where he suspected the glider contacts to be - whereas flying to the left of track would have placed the C-17A over the Fairford ATZ and towards some contacts observed on his TCAS display, albeit at a distance.

THE BRIZE NORTON APPROACH CONTROLLER reports that he had been controlling on console for about 1hr 10min. The traffic situation was “light” in VFR conditions with APPROACH, DIRECTOR and ZONE ‘bandboxed’. Other traffic under service included 1 ac on a MALBY departure on 127.250MHz and 1 glider on 119.0MHz outside the CTR around the South Cerney area [not the reported glider]. The C-17A was handed over from Lyneham in receipt of a TRAFFIC Service inbound from Lyneham to Brize at 3000ft QFE (1013mb) for a visual approach. Traffic information was called to the C-17A crew on contacts that were believed to be 2 gliders. The C-17A crew did not mention anything about an Airprox on RT and once they reported visual with Brize Norton they were switched to the TOWER frequency. Upon landing, the C-17A pilot informed the TOWER controller that he had seen gliders; he informed him later that afternoon that he would be filing an Airprox report with respect to the gliders.

Cause: Effectively, a non-sighting by the C-17A crew.

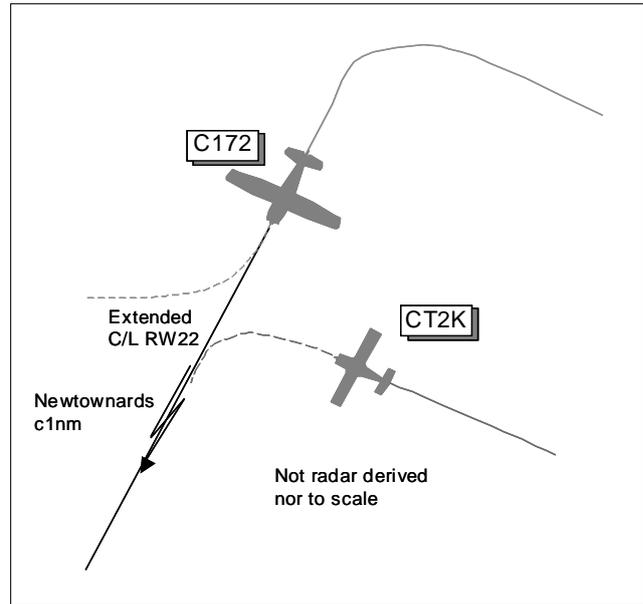
AIRPROX REPORT NO 2009-071

Date/Time: 14 Jun 0850 (Sunday)
Position: 5436N 00540W (1nm FIN APP RW22
Newtownards - elev 9ft)
Airspace: ATZ (Class: G)
Reporting Ac Reported Ac
Type: C172 Flight Design
CT2K
Operator: Civ Trg Civ Club
Alt/FL: 400ft↓ 650ft↓
(QNH 1016mb) (QFE)
Weather: VMC CLOC VMC CAVOK
Visibility: 50km >10km
Reported Separation:
10ft V/50ft H Not seen
Recorded Separation:
NR

THE C172 PILOT reports flying a dual instructional training sortie with a PPL student from Newtownards VFR and in communication with Newtownards Radio on 128.3MHz; transponder was switched off. The visibility was 50km in VMC and the ac was coloured white/blue/grey with anti-collision and strobe lights switched on. This was the student's first time flying a cct having previously had a demonstration cct completed by the instructor. RW22 was in use with a LH cct. On the second cct he was aware of an ac behind him in the cct, another ac departing and 2-3 ac taxiing on the airfield. He thought that the RT frequency loading was medium with the A/G operator passing basic airfield information. The cct was initially uneventful and they turned onto final approach 1nm from the threshold at 500-600ft; the student was coping well and had established on approach close to the ideal flightpath. The instructor, called "C172 c/s final" and then he concentrated on the approach, guiding his student as necessary, and at about 400ft heading 220° at 70kt he indicated to the student to lower the final stage of flap. As the student reached for the flap switch, the instructor looked towards the student to ascertain where his eyes were focussed; not unusually, he was looking at the flap switch. Simultaneously the instructor noticed a high wing ac, a CT2K 3-axis microlight coloured white/black/yellow, approaching from their 10 o'clock displaced by 70-100ft on a constant bearing and very slightly below in a slow descent. He immediately took control and executed a climbing R turn, estimating their ac merged to 50ft laterally and 10ft vertically before their climb took effect. Looking back he saw the microlight turning onto final approach, queried whether the ac was on the frequency and, having noticed its registration, attempted to make RT contact. He assessed the risk as high. He opined that although ccts are all flown in the same direction, because 'Group A' ac fly at 1000ft agl/amsl whilst microlights fly at 700ft, ac tend to fly cct patterns of different sizes. He felt that this conflict occurred because the microlight pilot, whilst concentrating on his own cct pattern, had turned inside their pattern without ascertaining their position. Equally, once established on final, he, the instructor, had focussed on instructing his student and, not hearing any additional radio calls, felt that nothing was amiss. He accepted that if he had recognised the other ac in the cct was a microlight (either visually or by noting a particular c/s) and knowing they tend to fly smaller ccts, he would have been more attuned to establishing its position whilst he was on final. Furthermore, as he was describing the 'picture' of the RW to his student he may well have allowed his overall lookout to diminish. However, he opined that civil RT phraseology does not necessarily lend itself to increased situational awareness in the cct, as either a 'base leg' or 'final' call used by military pilots when an ac turns off the downwind leg would have alerted him to the other ac. As it was, the microlight pilot's previous radio transmission would have been 'downwind' some minutes earlier and he was not obliged to make any further calls until established on final. Having discussed the incident with the other pilot after landing, without doubt they both have learnt a very valuable lesson and it was clear to him that lookout is of paramount importance in the cct. He submitted this report in order that others may be able to learn from it.

Cause: The CT2K pilot did not conform to cct pattern established by the preceding traffic and flew into conflict with the C172 already on final approach, which he did not see.
