ASSESSMENT SUMMARY SHEET FOR UKAB MEETING ON 21 APRIL 2010

AIRPROX REPORT No 2009-109

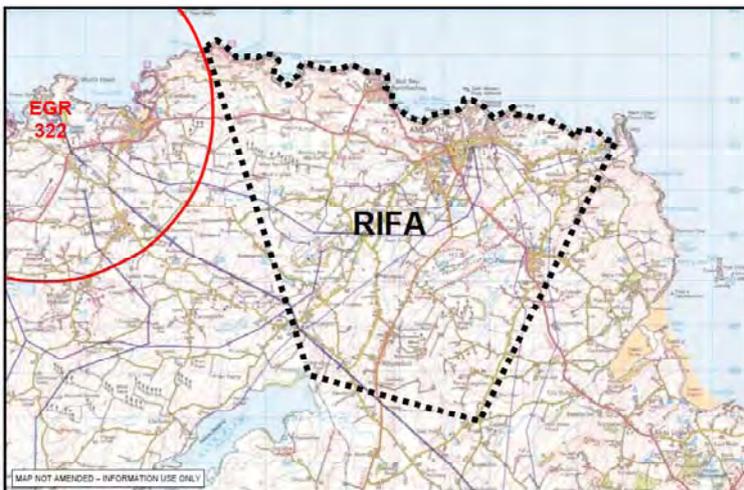
1. **General.** A Rotary Instrument Flying Area (RIFA) may be activated in the area depicted up to 2000ft Valley QFE (1500ft when Rwy 19 is in use). Helicopters intending to operate in the RIFA require a serviceable transponder and are to inform Valley Approach when outbound to the area. Valley Approach is to notify Mona ATC (if appropriate) and any ac that are likely to fly close to the RIFA of its status. Valley-based fixed-wing ac are to avoid an active RIFA laterally or overfly it at a minimum of 2500ft Valley QFE (2000ft QFE when Rwy 19 is in use). Visiting or transit ac will be routed clear of the RIFA whenever it is active. A greater upper limit for the RIFA may be available with the agreement of the ATC Supervisor.

UKAB Note (3): The transcripts show that the Hawk crew was not informed by ATC that the RIFA was active, as required by the FOB procedure above.

Members agreed that this incident occurred because the Hawk crew were not passed the status of the RIFA by RAF Valley ATC iaw the FOB procedure. The Board observed that the FOB requires the APP controller to pass details of the RIFA but outbound traffic does not routinely contact APP, so they would never be in a position to notify pilots of the RIFA status; however, it is understood anecdotally that this information is usually passed by APP to RAD who in turn pass it to departing traffic. Since on this occasion no information was passed to the Hawk crew, they incorrectly assumed that the area was not active and that they could transit through it. On becoming aware of the potential confliction after the Hawk turned left, the RAD Screen controller passed TI to the Hawk crew (at 4nm) that, despite them only partially hearing it due to their listening to the Ronaldsway ATIS on another frequency, enabled them to see the helicopter shortly thereafter at a distance they estimated as 2nm, and avoid it. Specialist military pilot Members agreed, however, that the Hawk crew should have afforded the Sea King greater separation, perhaps by climbing as well as avoiding it laterally; this, they thought, might have avoided the incident and alleviated the Sea King captain's concern. The Board noted that the TI passed by APP to the Sea King had been transmitted after the captain had already seen the Hawk about 1nm away, taken control from the HP and initiated a turn away from it, i.e. too late to have been effective.

<u>Cause:</u>	Having not been informed that the RIFA was active, the Hawk crew flew into conflict with the Sea King.
<u>Degree of Risk:</u>	C.
<u>Recommendation:</u>	RAF Valley procedures for the notification of the RIFA status should be reviewed.
