ASSESSMENT SUMMARY SHEET FOR UKAB MEETING ON 25 APRIL 2012

AIRPROX REPORT No 2011135

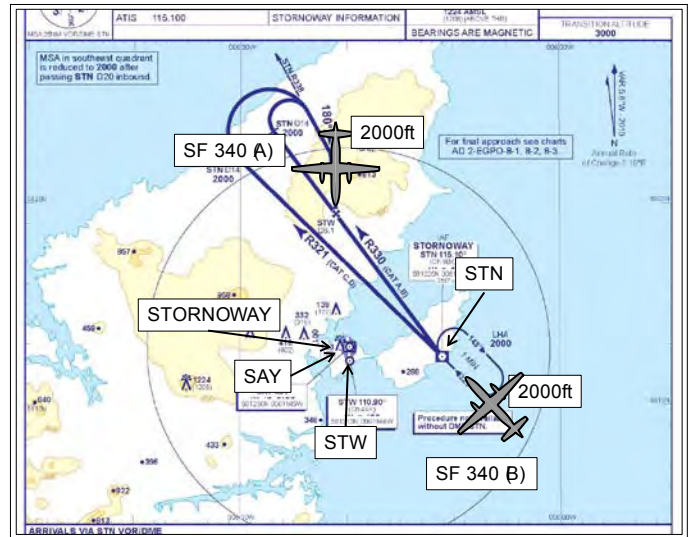
Reported Separation:

200ft V/1nm H 0ft V/NK H

Recorded Separation:

500ft V/0.1nm H

- Cause:
1. Stornoway APP did not reiterate the alt restriction of 3000ft to the crew of SF340 (B) as required by MATS Part 2.
 2. The crew of SF340 (B) descended below 3000ft without clearance.

It is recommended that the CAA's Regional ATS (Northern) Inspectorate in conjunction with the unit should ensure that MATS Part 2 procedures for management of multiple ac in the approach pattern are reviewed and followed as prescribed.

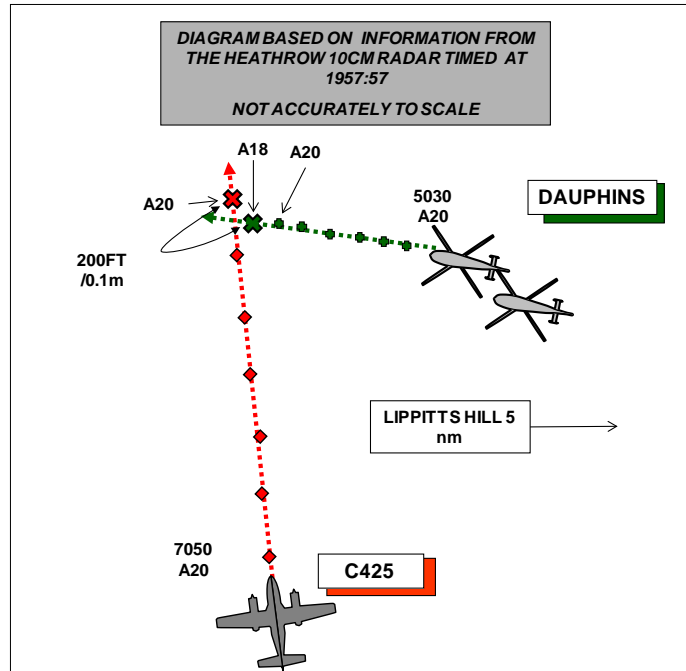
Recorded Separation:

200ft/0.1nm H

Cause: A conflict in Class G Airspace resolved by the Dauphin crews.

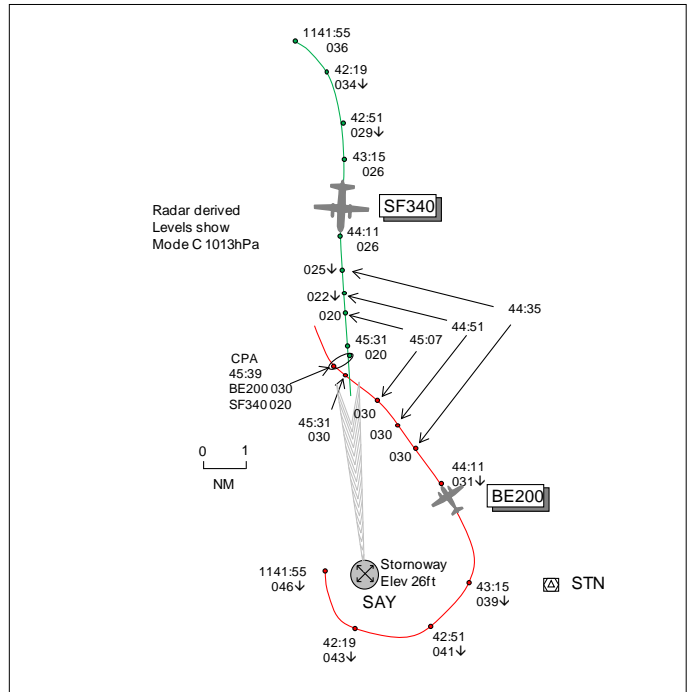
1144:35 400ft V/4-7nm H

OR 1145:39 1000ft V/0-4nm H

Members noted that the BE200 crew had not flown the alternate procedure (extending the downwind leg of the hold) but had erroneously turned L at the NDB instead of turning R; this had the effect of reducing the lateral separation at the CPA but vertical separation would have still been lost.

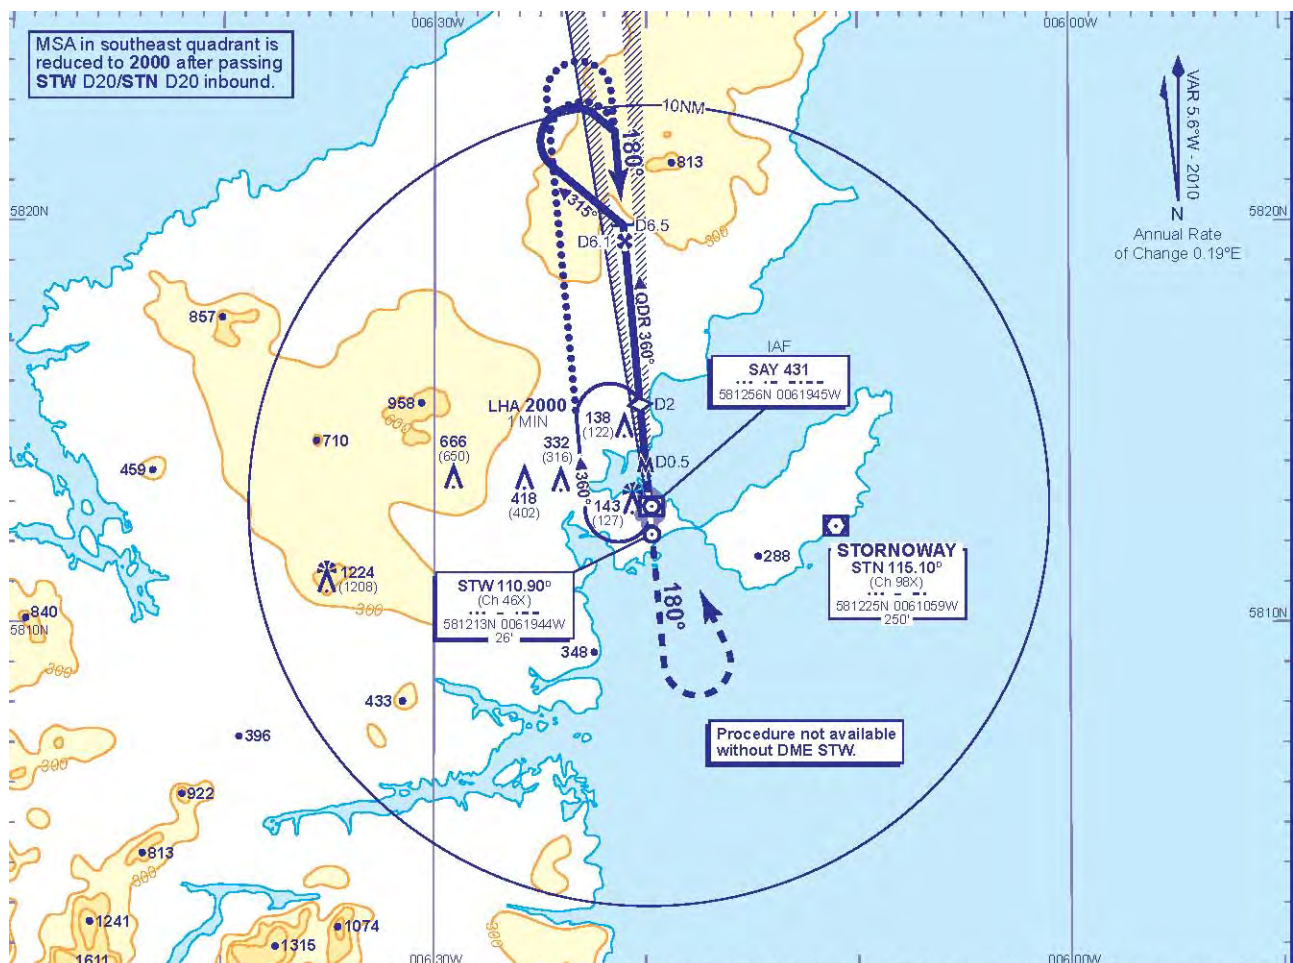
[UKAB Note (1): The UK AIP at AD 2-EGPO-8-1 promulgates the Stornoway LOC/DME/NDB(L) for RW18 as O/H NDB(L) SAY at 3000ft track QDR 360° descending to 2000ft until 6.5D and then carry out a procedure turn L before turning R inbound to establish on FAT 180°. The SAY hold is 1min RH racetrack QDM 180°. The alternate procedure (extended holding pattern) is O/H NDB(L) SAY at 3000ft extend the outbound leg of the RH holding pattern descending to 2000ft, at STW DME 9 (CAT A,B) STW DME 10 (CAT C,D) turn R onto LOC and continue as for the basic procedure.]

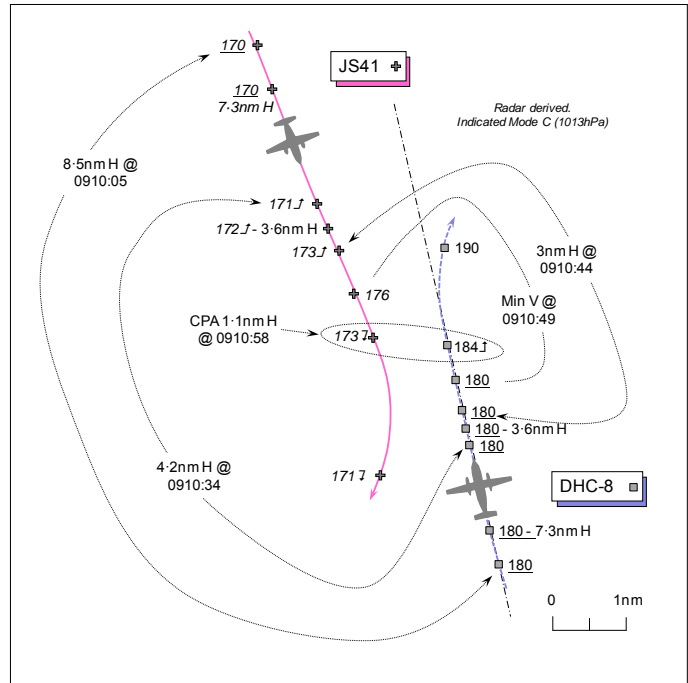
1.1nm Min H @ 1100ft V

400ft Min V @ 1.9nm H

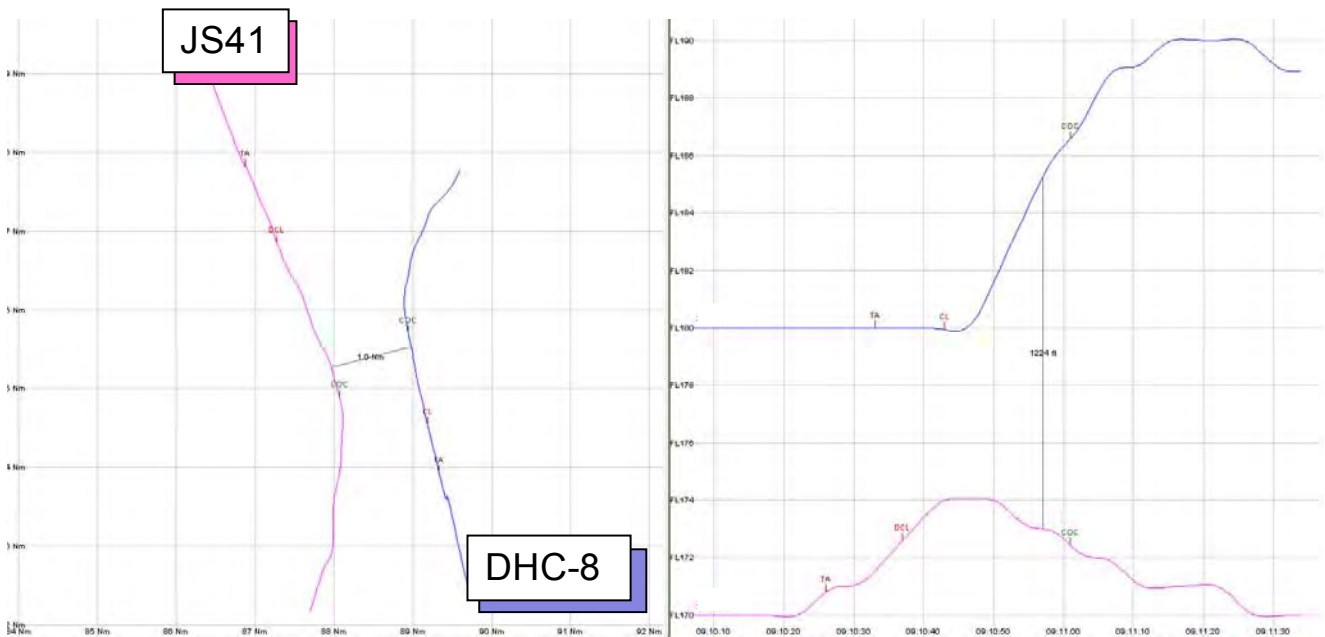
Table 1

TCAS Simulation Data

This gives the closest lateral and vertical points as follows:-
