ASSESSMENT SUMMARY SHEET FOR UKAB MEETING ON 14 DEC 2011

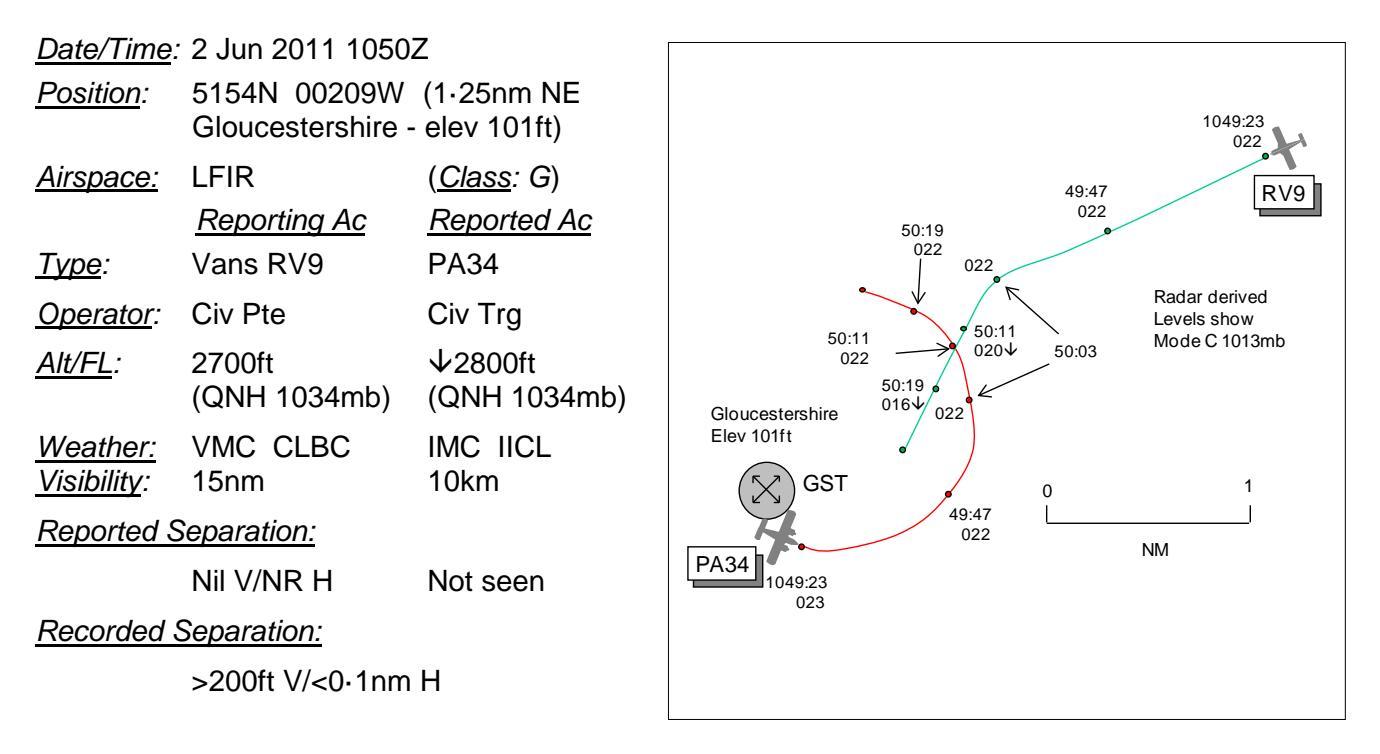
THE VANS RV9 PILOT reports flying VFR en-route to Perranporth via Gloucestershire and in receipt of BS from Gloster Approach on 128-55MHz, squawking 7000 with Modes S and C. The visibility was 15-20km flying 500ft below cloud in VMC and the ac was coloured red with strobe lights switched on. His planned route was via the O/Hs of Gloucestershire, Colerne, Frome and Newquay and, having previously worked Brize under BS and been told that Little Rissington was active, he had routed well to the N and then towards Gloucestershire. He called Gloucester Approach and informed them that it was his intention to route via the O/H at 2700ft QNH1034mb. When well inside the ATZ, he thought, he turned L onto heading 191° towards Colerne at 130kt and, when abeam, his passenger spotted an ac 0.5nm away in their 11 o'clock heading towards them, appearing to be at the same height. He banked sharply to the L and also descended, recovering at 2200ft before turning back onto track and climbing back to 2700ft. After recovering his composure he informed ATC of the Airprox and was told the other ac was a PA34 carrying out an IFR procedure; he queried the relevance of this information. He subsequently changed to Filton but when abeam Yeovilton he encountered low cloud so elected to return to Enstone routeing via Kemble. He assessed the risk as medium to high.

THE PA34 PILOT reports flying a dual IFR training flight from Oxford for an IR and in receipt of a PS from Gloster Approach on 128-55MHz, squawking 7000 with Modes S and C. The visibility was 10km when clear of cloud but they were IMC occasionally in and out of cloud. They had flown an ILS at Birmingham and were then carrying out a practice diversion to Gloucestershire, intending to fly an NDB hold followed by an approach to go-around and then a visual cct to touch and go before departing. As well as the student flying P1 in the LH seat there was another student in the rear acting as an observer. En–route to Gloucestershire on a S'ly track, they were cruising at FL40 and the ATIS information 'India' gave RW09 LH in use with surface wind 040/07kt, visibility 10km, cloud few 3000, temperatures 20/12 and QNH 1034mb. Gloster Approach cleared them to the GST at FL40 and instructed them to report entering the hold, which they did. The hold entry and at least one hold were performed before he advised the student on the outbound leg of the hold to report ready for the NDB procedure. Approach cleared them for the NDB approach for RW09 and asked them to report beacon outbound. Having acknowledged this, the student set 1034mb on altimeter No1 and cross-checked the same setting on altimeter No2 and this now made their altitude approximately 4600ft. This was then followed by a gentle descent being initiated to 2800ft at 120kt on the inbound

THE GLOUCESTERSHIRE APPROACH CONTROLLER reports the RV9 pilot contacted him at 1047 and passed all his details requesting a BS routeing via the O/H from the E and then SW bound at altitude 2400ft, he thought. The PA34 flight was in the GST hold at FL040 ready for an approach under a PS. The PA34 flight was cleared for the NDB/DME approach to RW09 and the pilot called beacon outbound at 1049 which allowed the flight to descend to 2800ft. At 1050 the RV9 pilot reported O/H and wishing to file an Airprox due to the location and relative position of the PA34; its crew was informed of the RV9 pilot's intentions.

confirmed that the RV9 pilot intended to route via the O/H, the controller should have identified the potential for a confliction and passed TI to the PA34 pilot in accordance with CAP774: this was another opportunity lost. Controller Members agreed that the passing of generic TI to the RV9 flight about another ac routeing through the O/H would have been 'good controllership'; it would have given the RV9 the pilot SA on the potential confliction and could have broken the chain. An experienced pilot Member stated that although the PA34 flight was IFR training, this incident was a timely reminder of the crew's need to continue exercising a good lookout for unknown traffic. Also, the PA34 crew's SA would have been improved if they had heard and assimilated the RT exchanges between ATC and the RV9 pilot. As it was, the PA34 flight was descending in IMC through cloud to 2800ft, its crew unaware of the approaching RV9 which passed unsighted during their 'belly-up' turn onto the outbound leg. Similarly, the RV9 pilot was unaware of the PA34's presence; the only clue from the RT would have been the PA34 pilot's call of 'beacon outbound' and this required the pilot to have knowledge of the IF procedures in use at the time. In the event, the RV9 pilot turned on track towards Colerne just before the O/H and saw the PA34 0.5nm away: the Board agreed that his prompt and robust avoiding action had resolved this conflict and removed the risk of collision.

<u>Cause</u>: In the absence of TI, a conflict in Class G airspace resolved by the RV9 pilot.

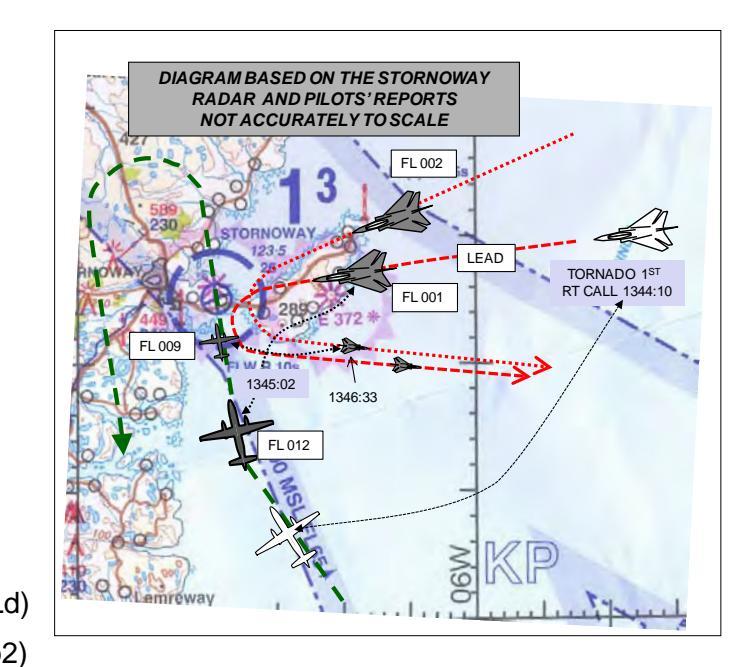
Date/Time:	12 Jul 2011 1346	SZ
<u>Position</u> :	5810N 00610W (2.5nm S Stornov elev 26ft)	way -
<u>Airspace:</u>	Scot FIR	(<u>Class</u> : G)
	<u>Reporting Ac</u>	Reported Ac
<u> Type</u> :	SF340B	Tornado GR4
<u>Operator</u> :	CAT	HQ Air (Ops)
<u>Alt/FL</u> :	1100ft ↓ QNH (1025mb)	600ft RPS (1018mb)
<u>Weather:</u> <u>Visibility</u> :	VMC 60km	VMC 20km
Reported S	eparation:	
	0ft V/0.5nm H	1000ft V/1.5nm (Ld)
		0 V 1.5nm H (No2)

Recorded Separation:

300ft V / 1nm H

The radar recording and pilots' reports show that Leader was first Tornado to turn towards the SF340 and he had therefore caused the TCAS RA; No2 who also turned towards the SF340 but remained about 1nm East of the C/L. Had an RA not already been enunciated, Members believed that this manoeuvre would also have generated one.

- <u>Cause</u>: In prosecuting a simulated attack on a target inside the Stornoway ATZ, the GR4s flew close enough to the SF340 on the approach to generate a TCAS RA.
- Degree of Risk: C.
- <u>Recommendation</u>: HQ Air Command is recommended to review the planning, co-ordination and execution of simulated attacks against targets in the vicinity of civilian airfields to ensure appropriate and effective deconfliction from civilian aircraft.

Members proposed that a recommendation be made to HQ Air to review Exercise procedures.

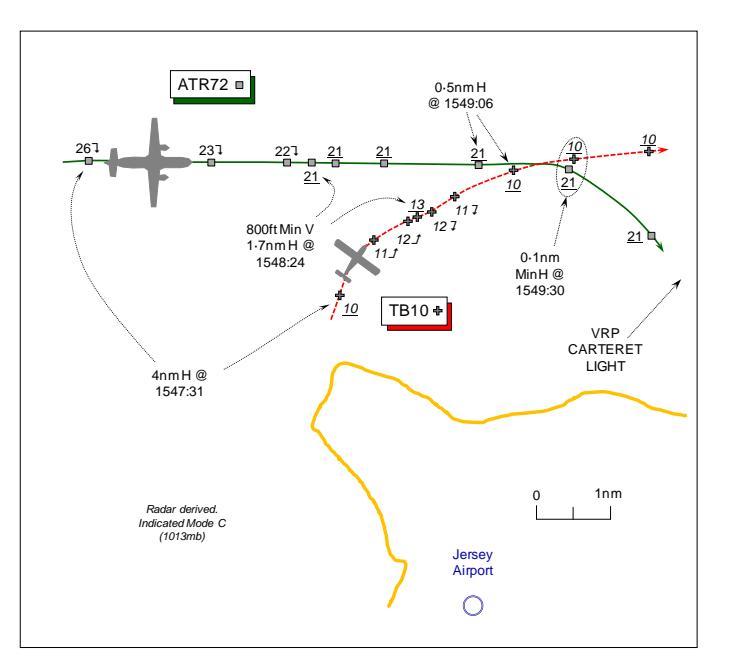
Date/Time:	23 Jul 2011 1548	Z (Saturday)			
<u>Position</u> :	4918N 00214W of Jersey Airport 277ft)	(6nm N · elev			
<u>Airspace:</u>	C. Islands/Jersey	CTR (<u>Class</u> : A/	D)		
<u>Reporter:</u>	Jersey ATC				
	<u>1st Ac</u>	<u>2nd Ac</u>			
<u>Type</u> :	ATR72-500	TB10			
<u>Operator</u> :	CAT	Civ Pte			
<u>Alt/FL</u> :	↓2000ft QNH (1016hPa)	1000ft QNH (1016hPa)			
<u>Weather:</u> <u>Visibility</u> :	VMC NR	VMC NR			
Reported Separation:

Recorded Separation:

800ft Min V @ 1.7nm H

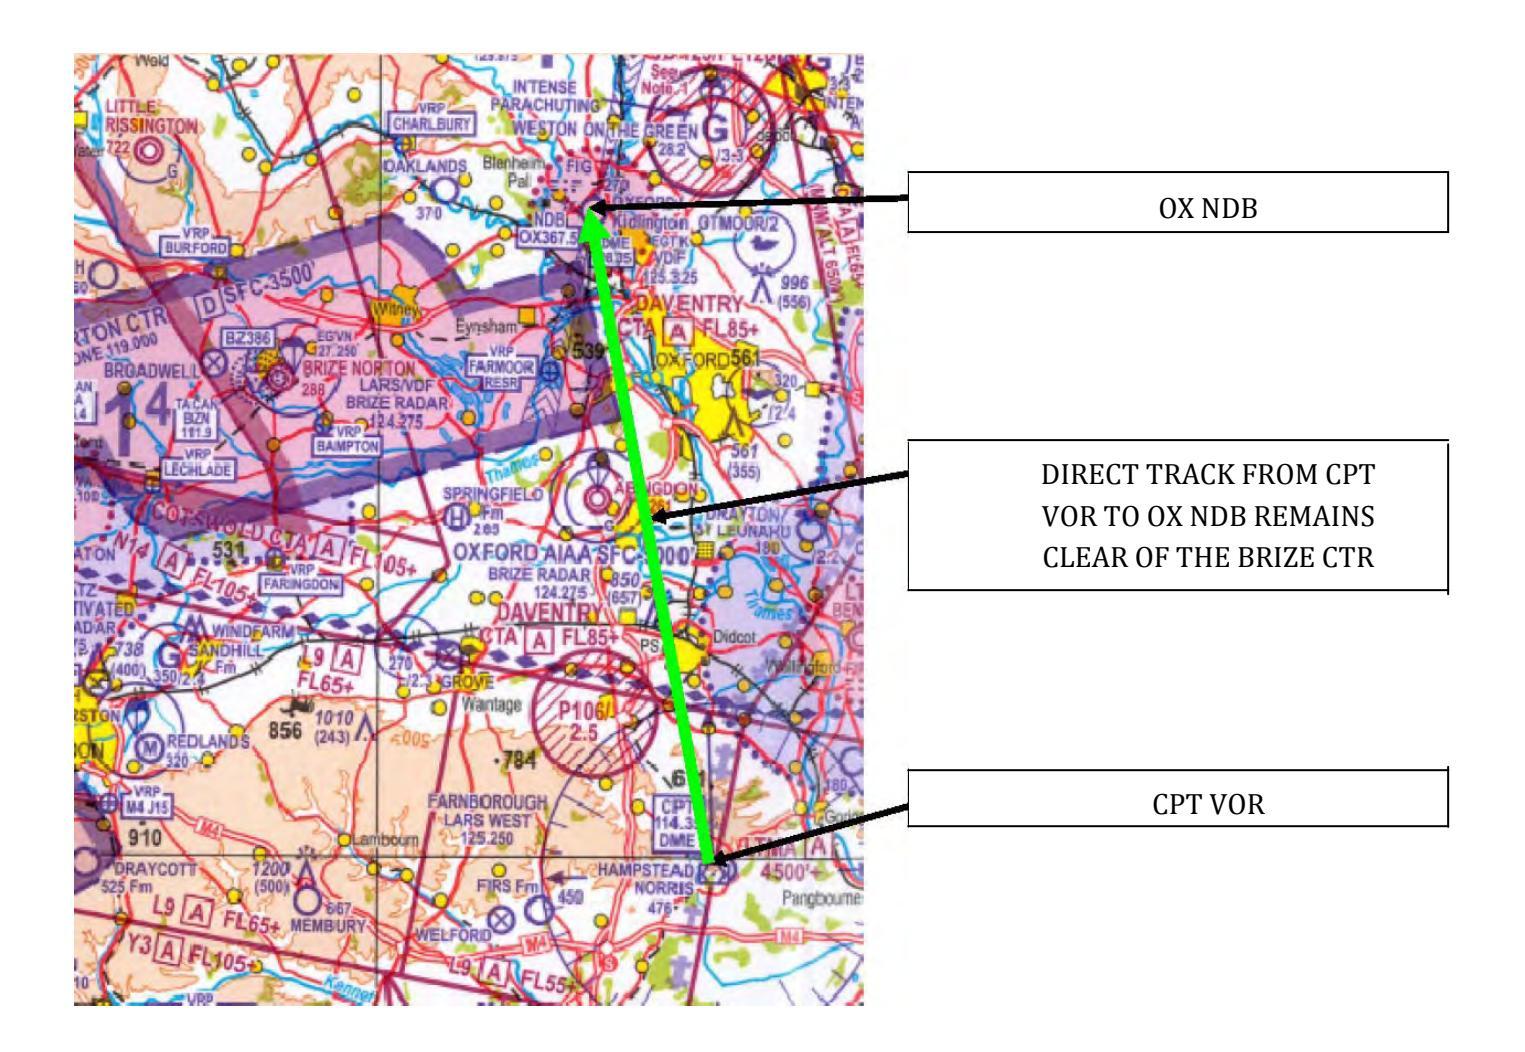
To the SE of Oxford and on tracks between the CPT VOR and Oxford Airport lies the Benson CTR, the location of which creates funnels between Benson and Abingdon and between Benson and P106.

The usual arrivals from the S route via CPT followed by a direct track to the OX NDB. The timing of the turn is determined by release from London Control and may be delayed until the ac is W of CPT or may be prior to the ac reaching CPT. It is seldom at CPT as ac are frequently under radar vectors at this point due to the separation requirements for the Heathrow departures via CPT.

The timing of the release is important to this investigation since the direct track from the CPT VOR to the OX NDB ensures that the ac remains clear to the E of the Brize Norton CTR. If the turn towards the OX NDB is delayed to any degree and the ac passes the CPT VOR to the W then the direct track towards the OX NDB will overfly the Brize Norton CTR and any descent below 3500ft amsl on track to the OX NDB will require a clearance to enter the Brize Norton CTR.

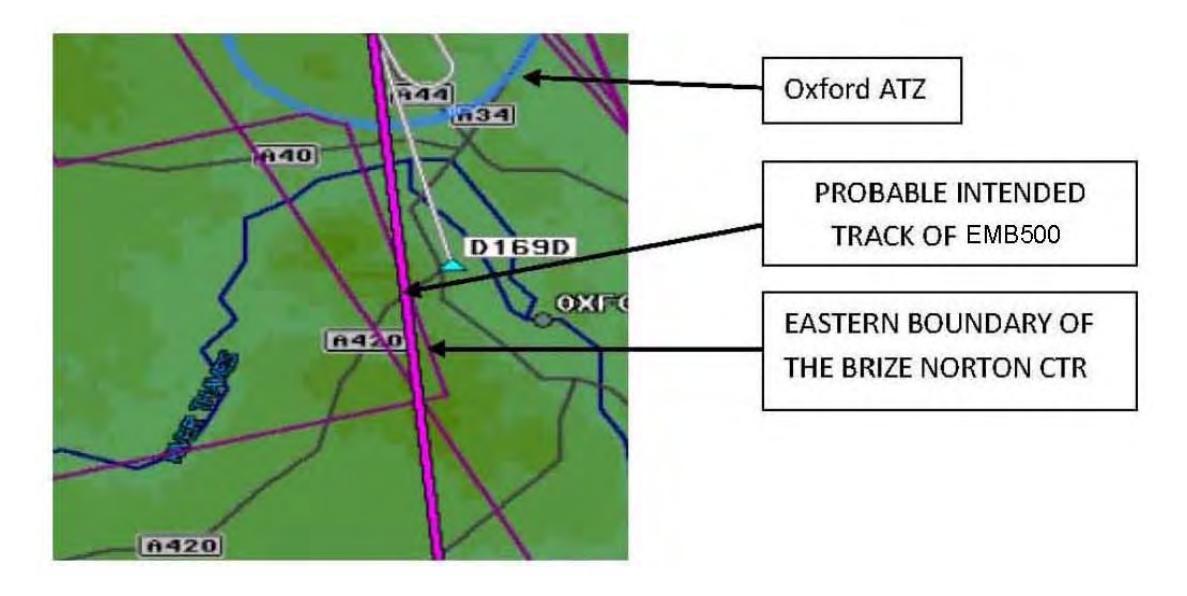
When issued with the requested descent clearance the crew assumed that liaison with Brize had taken place. Had the descent clearance been followed by an instruction to remain clear of the Brize zone then the crew would have adjusted their track by heading to the E of the present track until clear of the zone and then descended to the new cleared level.

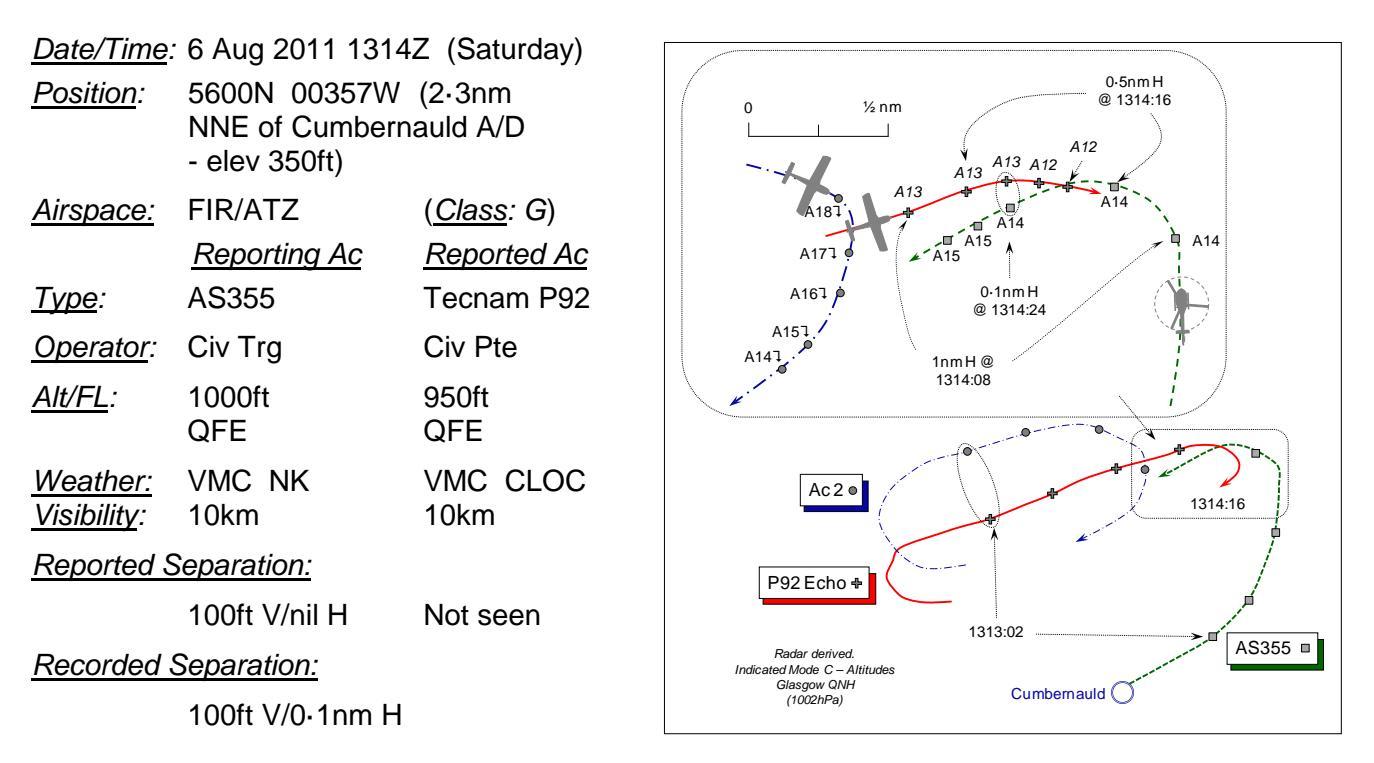
AIRPROX REPORT No 2011106

THE AEROSPATIALE SQUIRREL II (AS355) PILOT reports he was conducting a licence skills test on a company pilot following a course of approved type rating training. The helicopter is coloured blue and the HISLs were on. A squawk of A7000 was selected with Mode C on; TCAS is not fitted.

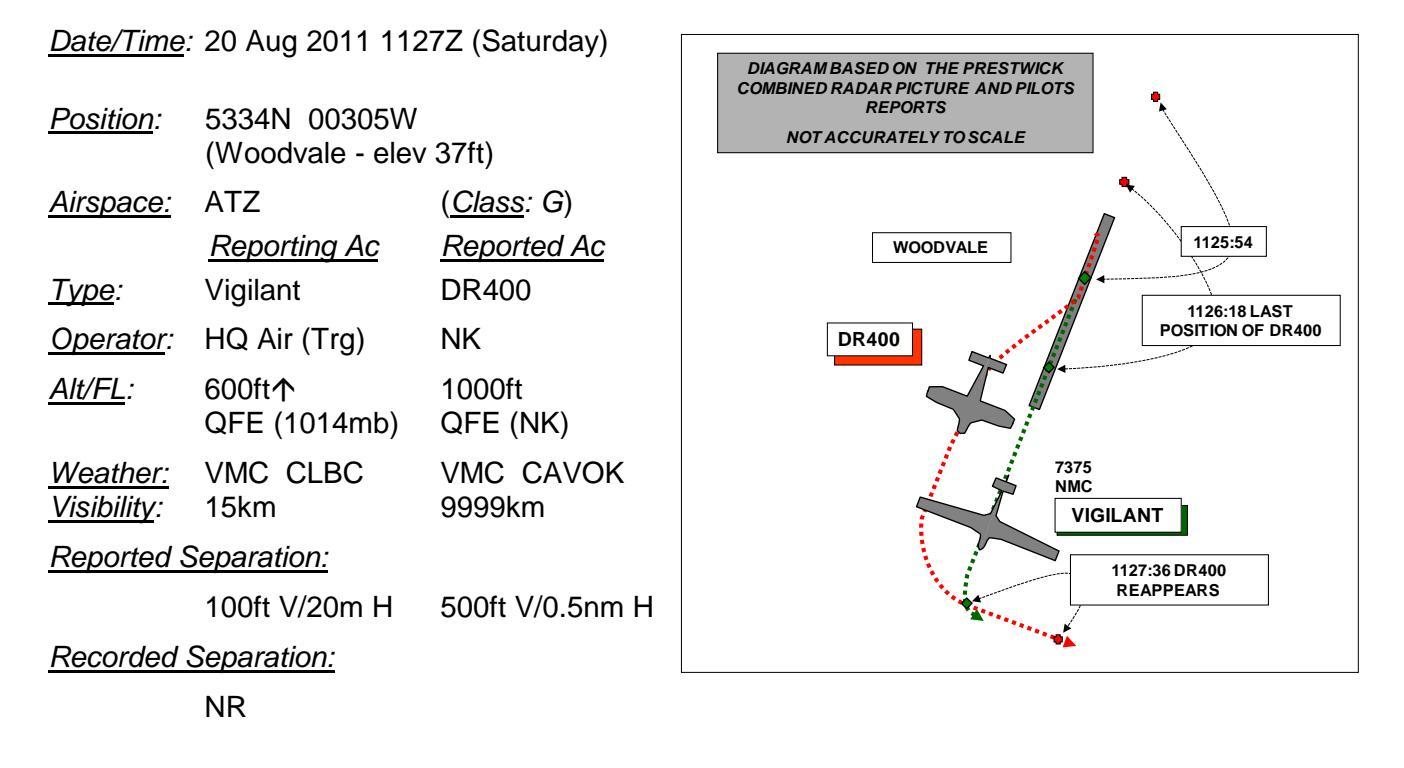
AIRPROX REPORT No 2011111

UKAB Note (1): There were irreconcilable differences in the time of this incident. All times discussed have been changed to UTC where possible. The Vigilant pilot reported the incident as taking place at 1400 and the DR400 pilot as 1230 with his flight times logged as 1235–1335. The flight times were confirmed with the pilot in a later telephone call and he confirmed that the incident had taken place towards the end of the flight. The CAA SRG Transcription Unit listened to many hours of RT tapes and the only time that there was a RT call of the DR400 (C/S) asking the Vigilant (C/S) asking if he was about to roll was at 1226:54; although the Transcription Unit believed this to be a UTC time, further investigation with the unit showed it to be BST so all the times in the ATSI report have been adjusted accordingly. The recording of the Prestwick combined system radar, commencing at 1125, shows tracks corresponding to both the Vigilant, squawking 7375, and a primary only track in the cct flying precisely the profile described by the DR400 pilot. It is thought likely therefore, that the incident occurred just after 1127UTC; at that time the non-squawking DR400 had disappeared from radar, reappearing at 1127:36 ahead of the Vigilant as shown above.

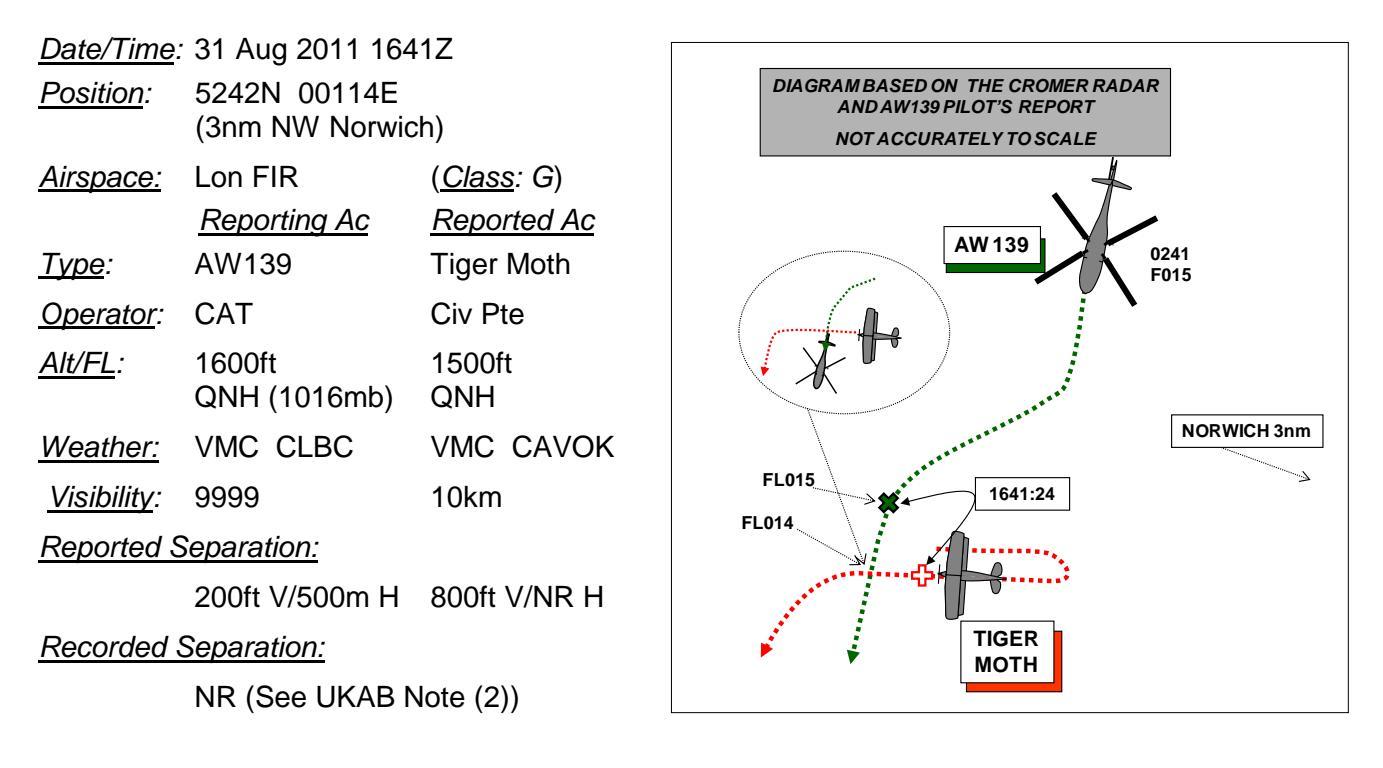
Cause:
AIRPROX REPORT No 2011118

THE AW139 PILOT reports flying a red TCAS 1 equipped helicopter inbound to Norwich with all external lights on and squawking with Modes C and S. They had flown their cleared route direct from Excalibur platform (track 190°) and were in receipt of a TS from Norwich APR who cleared them to join left base for a visual approach to RW09. As they were approaching Aylsham [7nm N of Norwich] Radar informed them that there were two contacts roughly in the Felthorpe area [a light ac strip 3nm NW of Norwich i.e. in their 1 o'clock at 5nm].
