ASSESSMENT SUMMARY SHEET FOR UKAB MEETING ON 22 FEBRUARY 2012

AIRPROX REPORT No 2011125

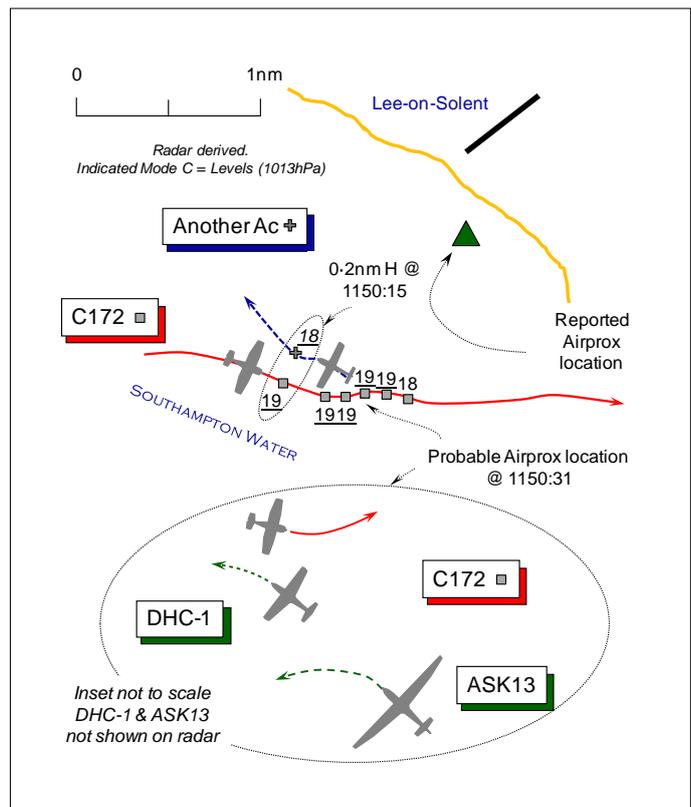
Cause: Late sightings by the DHC-1 and C172 pilots.

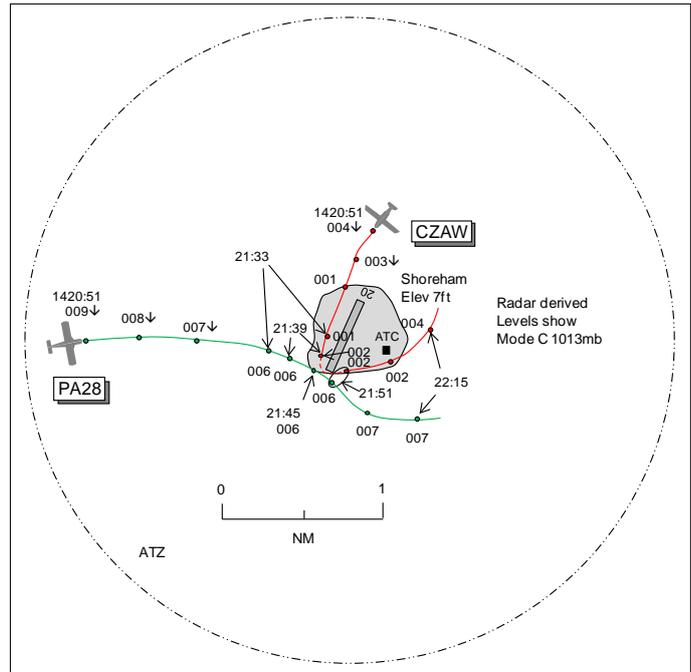
The incident is attributed to the SportCruiser going around and making a non-standard manoeuvre below the PA28, which caused the controller and PA28 pilot to be concerned about the safety and proximity of the 2 ac. The controller passed appropriate TI to the SportCruiser pilot, who in his written report indicated that he was visual with the other PA28 above, with little chance of collision.

Cause: The SportCruiser's flightpath caused the controller and PA28 pilot concern.

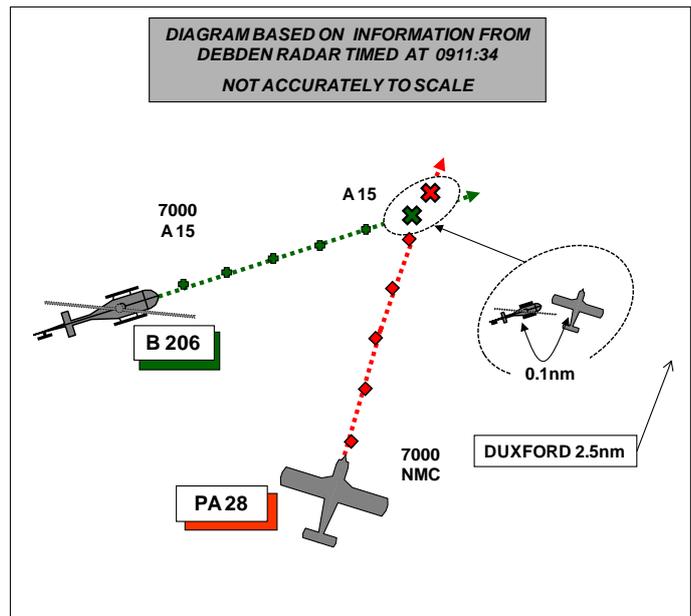
The Board noted that the radar recording showed that the incident took place on the boundary of the ATZ at 0911:34; this, however, was 18sec after the B206 had called 'downwind' at a position about 2.4nm from the ARP. At that time the PA28 was already on frequency but was still in transit from Gate S in the descent from 2000ft. Members agreed that this call would have misled the PA28 pilot into believing that the B206 was much further ahead and not a threat, when in reality it was very close to him closing from off his left wing. Members also agreed that the ac had crossed unseen to the PA28 pilot, who at the time was in a fairly lengthy, largely non-operational conversation with ATC from a point 4 sec before he passed just ahead of the B206. Members found it more difficult to ascertain when the B206 pilot first saw the PA28 on his right descending from above and closing. A helicopter pilot Member familiar with the B206 informed the Board that the view from the right hand seat that the pilot would have occupied to the right and above, is relatively uncluttered and fairly good; that being the case they could not determine why the B206 pilot had not seen the PA28 until it

passed close (reported as 50ft and radar verified as less than 0.1nm) in front of him. Bearing this in mind and that the B206 did not take any avoiding action Members agreed that the B206 pilot had not seen the PA28 (which had right of way under the RoA) until too late to take any avoidance. Members noted that at the CPA the B206 was level at an alt (radar verified) of 1500ft and the PA28 had no Mode C but the pilot reported that he was in the descent from 2000ft to cct height (1000ft); that being the case they could not determine the vertical separation but opined that it was also very close.

Cause: A non-sighting by the PA28 pilot and effectively a non-sighting by the Bell 206 pilot.

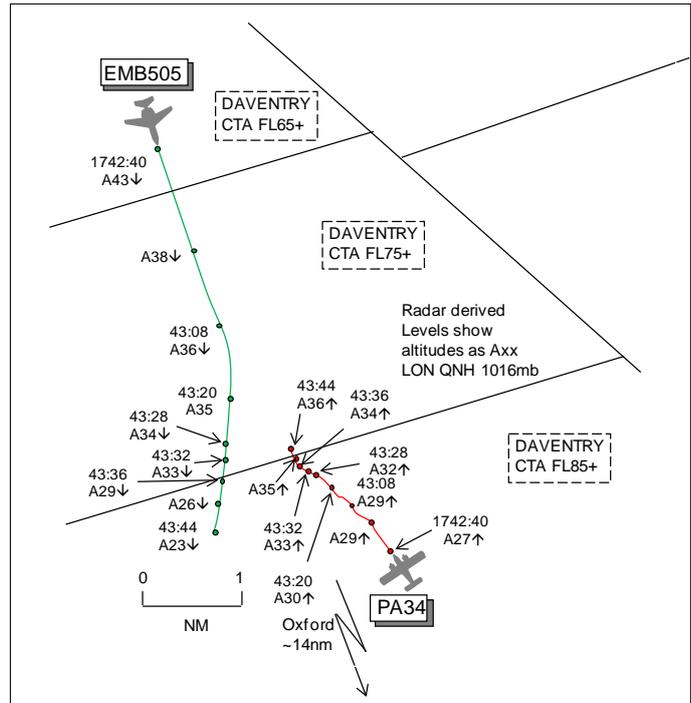
In the end, the PA34 pilot flying VFR did not see the descending EMB505 crossing 1nm ahead. The EMB505 was initially approaching head-on, from above and descending. This would have presented a small target aspect to the PA34 pilot which, when combined with the nose high attitude of the climbing ac would have made visual acquisition more difficult. The EMB505 crew flying IFR only saw the PA34 on TCAS and reacted to the TI given, passing 0.8nm W of and 500ft below the PA34 whilst complying with the RA. Members discussed whether the cause of the Airprox was the failure of both pilots to see the other ac in Class G airspace. However, Members agreed that both crews had discharged their responsibilities appropriately in the circumstances and the sequence of events had led to a conflict. Although the EMB505 passed unsighted to the PA34 pilot, the EMB505 crew had reacted well to the information presented and turned their ac R which had resolved the conflicting flightpaths. The subsequent TCAS RA had increased the vertical separation at the CPA. These elements were enough to persuade the Board that any risk of collision had been effectively removed.

Cause: A conflict in Class G airspace between IFR and VFR traffic.
