ASSESSMENT SUMMARY SHEET FOR UKAB MEETING ON 15 Jun 2011

AIRPROX REPORT No 2010169

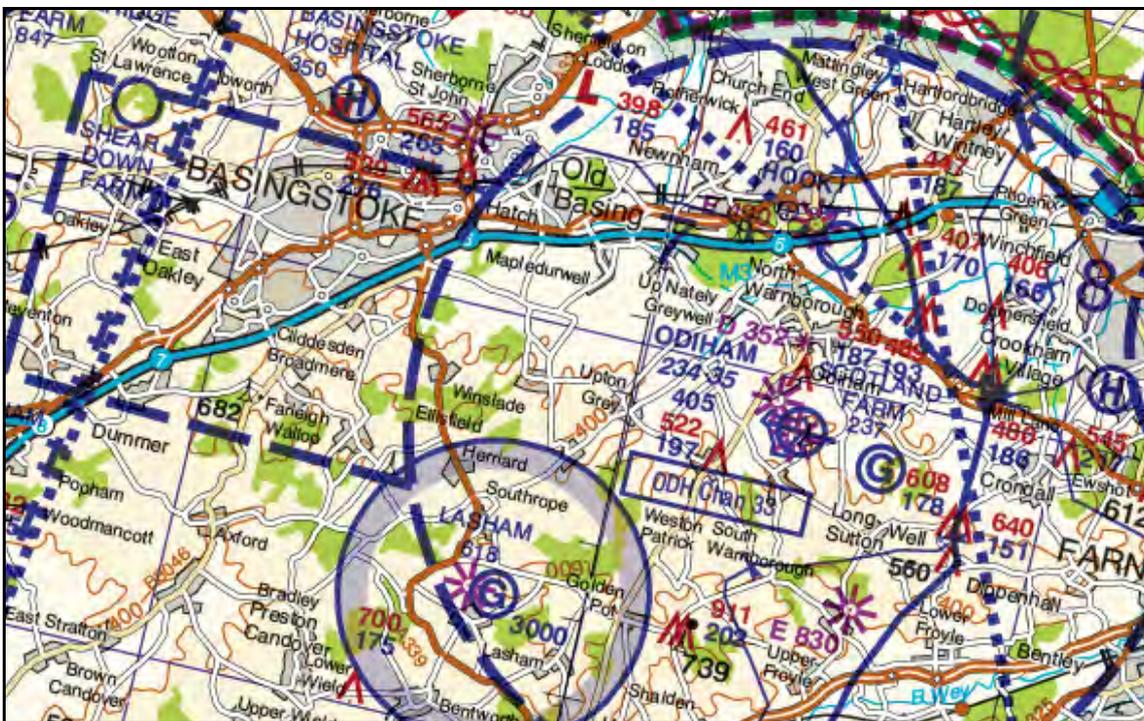
HQ 1GP BM SM reports that this Airprox occurred 4.5nm W of Odiham between a Chinook conducting an SRA in receipt of a TS from Odiham TD and an untraced glider.

Lasham airfield is a notified glider site approximately 4.5nm SW of Odiham, which has a mandatory military avoidance of 2nm radius up to 3000ft agl. The UK Mil LFHB contains a further warning that "intensive gliding activity takes place within 5nm of Lasham." The diagram below shows the local area.

The Chinook free-called Odiham APP at 1402:08 while 8nm WSW of Odiham, was identified and was placed on TS, reduced by APP, stating, "reduced traffic information, you are entering an area of high traffic density with Lasham gliders."

BM SM Spt recommends that Odiham continue to engage with the local flying community to develop awareness of their operations.

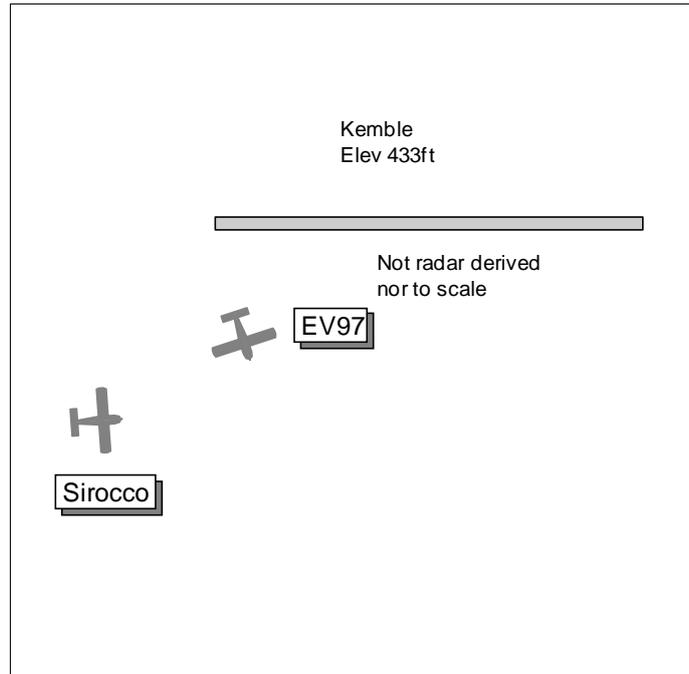
THE EVEKTOR EV97 EUROSTAR PILOT reports flying a dual test flight with a PPL holder for revalidation of a NPPL, VFR and in communication with Kemble. The visibility was >10km in VMC. The PF joined O/H for RW08 from the W at 2000ft QFE 1014mb and at the midpoint made a gentle turn 30° R starting a descent. On realising his mistake the PF straightened out, climbed back to 2000ft and correctly turned L with the cct pattern, first over the live-side - where they encountered a Cessna inbound from the NW about 200ft higher - before then crossing the RW08 numbers as per CAA recommendation and starting a descent at 80kt. Their lookout to the W was into sun but in any event they did not see the Sirocco until it passed; it was almost certainly in a blind spot under their starboard wing. Looking up at the Cessna above to see how it was going to join they saw the Sirocco as it flashed past about 100ft below and a little behind their ac on a heading of 060°, close enough to give them a fright. At the time they were about 1500ft QFE in a gentle L turn descending deadside to cross the RW26 threshold numbers at cct height. He reported the 'Airmiss' to Tower. The Sirocco appeared to climb to 2000ft and proceeded to fly a wide LH cct outside the ATZ, for as they approached the end of the downwind leg the Sirocco was so far away he thought it was flying away. Afterwards, on reflection, both he and his student thought at the time that the Sirocco was a large ac (he commented that it looks like a Space Shuttle); perhaps this was a trick of the bright sunlight, so that his perception of the Sirocco's wide cct was a misjudgement. He thought the Sirocco pilot went straight into a large LH pattern after going through the O/H, intending to join at cct height 1000ft. He opined that he emphasised in training the importance of accurate flying in the ATZ, a FREDAH check on approach, confirmation of the QFE and joining O/H at 2000ft or in line with this and other standard procedures. Also a greater emphasis on listening out on the radio for the position of other traffic and on lookout for this and any other traffic.

THE KEMBLE FISO reports on duty in the VCR when an Airprox was reported at 1515Z by the pilot of an EV97 Eurostar against a Jurca Sirocco. Both ac were joining via the O/H for RW 08LH in good VMC conditions (+10km, FEW 040, QFE 1014 [actually 1008mb]). Aerodrome traffic levels were light with 3 ac joining, 1 outbound VFR SE'ly and 1 pending departure. The Sirocco was the third of the 3 ac to request join and was given relevant TI on cct and joining traffic. At the time the Airprox was reported the EV97 was over the RW heading S and descending crosswind towards the deadside. The Sirocco was seen to join straight down the RW (heading 080°) at a level slightly below the EV97. The Airprox was witnessed by the second FISO (on duty as VCR Assistant) who mentioned, a few moments before the Airprox was reported, that separation appeared to be compromised.

The pilot of the Sirocco was later interviewed by the Operations Manager later in the day who confirmed that he had not seen the Eurostar until after they had passed. The pilot of the EV97 confirmed that he was submitting an occurrence report to the CAA for investigation. Both pilots were reminded of the need for care to be taken whilst flying in the cct and in particular to joining at the correct heights.

Cause: Effectively, non-sightings by the pilots of both ac.

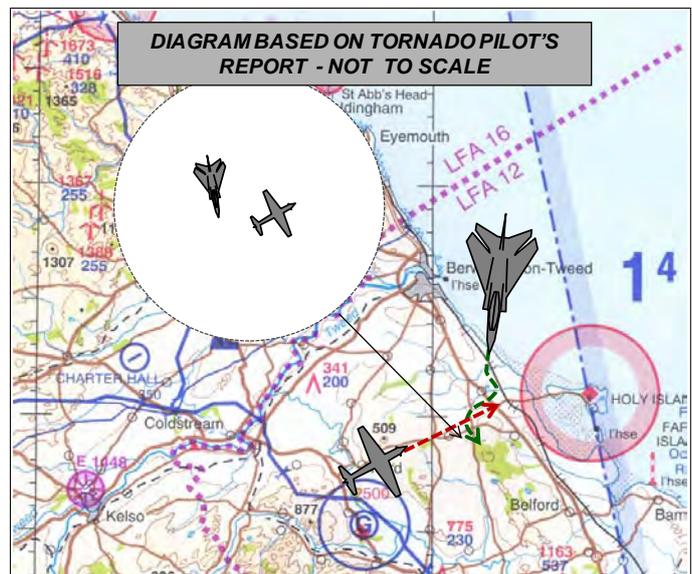
THE TORNADO GR4 PILOT reports flying a grey ac with all lights switched on, squawking 7001 with Mode C, as No 2 of a pair of Tornado GR4 ac conducting evasion training with a Hawk. They were heading 185° at 430kt and at 360ft and following a bounce by the Hawk they were separated from the flight lead by about 5nm, when the pilot saw a small ac in 1.30 position at about one mile range and slightly high. He instinctively manoeuvred to the L but after about 15° of turn, he quickly realised the ac was tracking from R to L. A further L turn would have put the Tornado belly-up to the ac and exacerbated the chance of a collision, so he reversed to the R and descended to 260ft agl. They passed below and slightly behind the ac, which was by then clearly identifiable as a Tucano (black with yellow sunburst on wings) and he assessed that they passed within 1000ft [H] of it. The Tucano was initially in straight and level flight but just before they passed it turned R (belly-up) to them. The time from initially sighting the Tucano to passing it was 7sec.
