ASSESSMENT SUMMARY SHEET FOR UKAB MEETING ON 20 JUN 2012

AIRPROX REPORT No 2012009

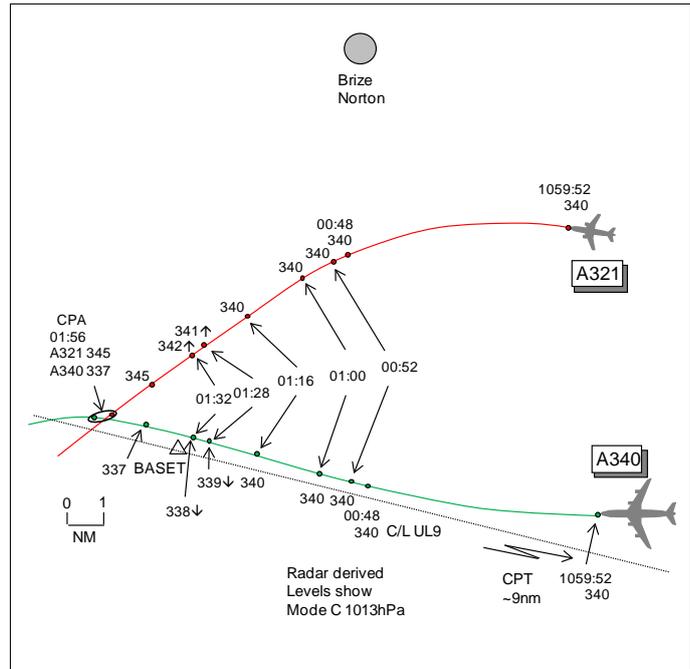
THE A321 PILOT reports cruising at FL340 heading 270° at 450kt near BASET intersection and in communication with London on 135.255MHz, squawking with Modes S and C. Behind them, also at FL340, was an A340. Both flights reported light to severe turbulence and since Met conditions were similar at both higher and lower levels they needed frequent heading changes for about 15min (Wx avoidance). They were cleared BASET – LIPGO, he thought, when the FO came back to the flightdeck after a short absence; the Capt had been alone for some minutes. The clearance read back was not challenged by the controller, the read back was supposedly correct. The crew were about to confirm the turn to BASET when ATC changed the clearance to another waypoint followed by heading changes to them and the A340. Before the turn could be performed a TCAS RA 'climb' was received and this was executed; the A340 received a TCAS RA 'descend'. At the CPA there was 500ft vertical and 0.5nm horizontal separation and he assessed the risk as high.

The A321 crew was instructed to, "*route direct to BADSI then LIPGO*", but gave an incorrect read back "*direct BASET er after to er LIPGO.*" This was not detected by the S35(T) controller and resulted in the A321 commencing a L turn to intercept the UAR C/L at BASET, bringing it into conflict with the A340. A number of contributory factors may have caused the pilot to mistake BASET for BADSI and the S35(T) controller to miss the incorrect read back:

The A321 was cleared to route direct BADSI-LIPGO when coincidentally BASET was the next waypoint in the FMS. This may have caused the A321 pilot’s misperception and response, ‘BASET-LIPGO.’ It is considered likely that neither of the reporting points BASET or BADSI would have been familiar to the pilot.

The A321 pilot’s accented read back, together with the controller’s bias to hear what he was expecting to hear, caused the controller to accept the read back as being correct.

Cause: The S35T controller did not detect the A321 pilot's incorrect read back.

CAA ATSI recommends that NATS Swanwick ATSU include this or a similar scenario, together with lessons learned in controllers' Training in Unusual Circumstances and Emergencies (TRUCE) module.

Recommendation: The CAA is recommended to review the 5-letter name-code designators in this area to avoid potential confusion between BASET, BADSI and BAKUR.

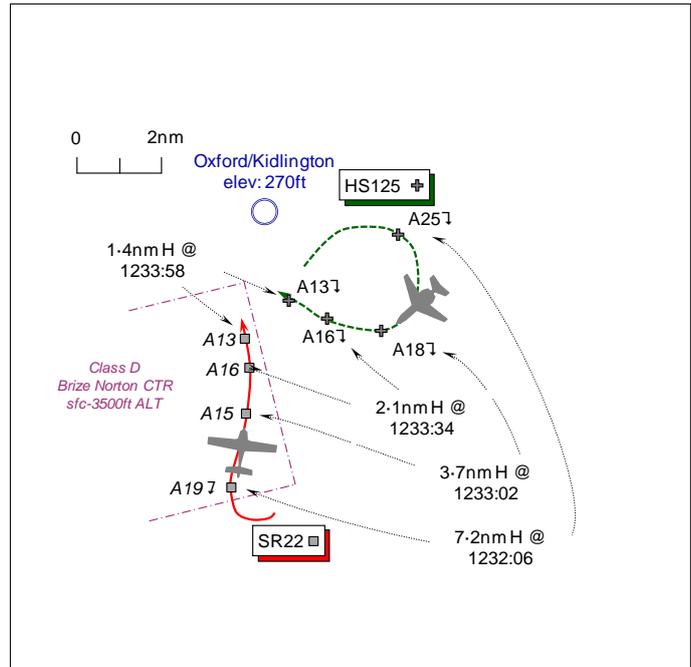
THE RAYTHEON HAWKER 800XP (HS125) PILOT reports that they were on a short VFR positioning flight from Farnborough to Oxford/Kidlington following a charter flight that had terminated at Farnborough. The in-flight weather was good and reported at Oxford as: visibility 10km+, with FEW clouds at 2900ft. They had opted for a visual join and the 1st Officer was the PF at the time of the Airprox. Oxford TOWER was providing a PS/BS on 125.325MHz. A squawk of A7000 was selected with Modes C and S on; TCAS II is fitted.

As she watched the HS125 on final for RW01 an ac was observed about half a mile behind it, which by checking the DF and pilot report she established was the SR22. A 4DME report had not been passed by the SR22 pilot, who had flown the wrong procedure and flown the NDB RW01 procedure not the 100° procedure for which they had been cleared.

Cause: The SR22 pilot did not fly the cleared procedure and flew into conflict with the HS125.

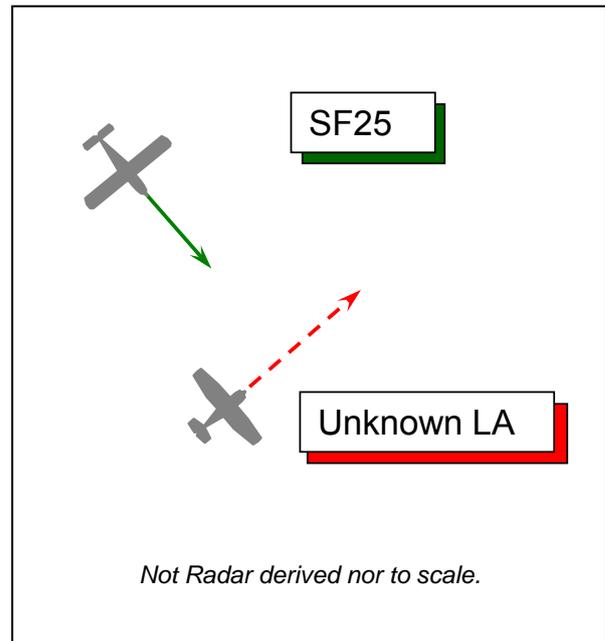
THE FALKE SF25 SELF LAUNCHING MOTOR GLIDER (SF25 MG) PILOT reports he was airborne to establish the prevailing cloud base for the club's duty officer-in-charge of gliding operations, but also to practise bad weather ccts at 500ft QFE. He was in communication with Sutton Bank on the A/G Station frequency of 129.975MHz. SSR is fitted, but selected 'off' and the Mode C was unserviceable. His SF25 MG is coloured green and white; a HISL is not fitted.

Cause: The untraced light aircraft flew over an active glider launching site (below the maximum promulgated height of the winch cable) and into conflict with the Falke SF25 MG.

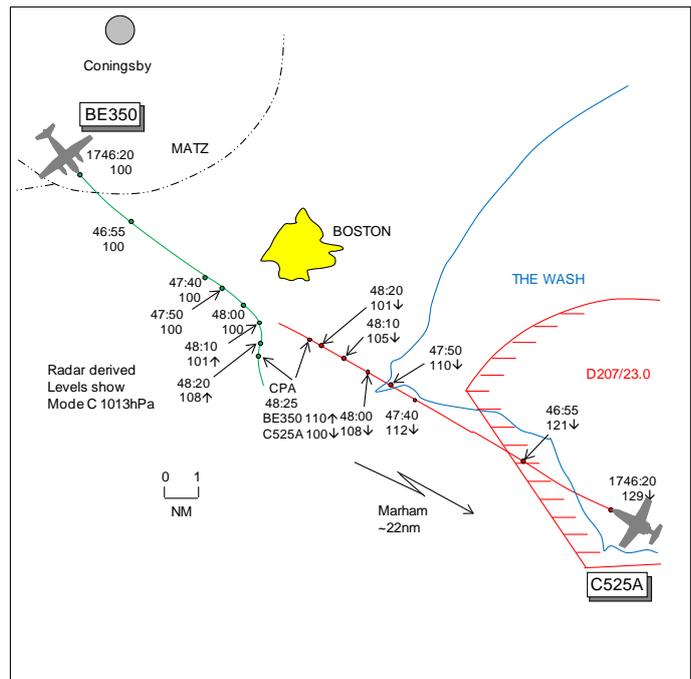
THE BE350 PILOT reports en-route to Marham and in receipt of a TS from Marham Approach on 233-075MHz, squawking 3660 with Modes S and C. The visibility was 30km flying clear above cloud in VMC and the ac was coloured grey with HISLs, nav, anti-collision and recognition lights all switched on. The flight was transiting to Marham for a PD and instrument approach heading 130° at 220kt and at FL100. A TCAS contact was observed by the PF at range 6nm and both pilots commenced an intensified visual scan. ATC subsequently reported “traffic 12 o'clock 5nm” but the conflicting ac was not visually acquired. They commenced a R turn to deconflict and a TCAS TA was generated with the conflicting traffic seen on TCAS on a reciprocal track 900ft above and descending. A TCAS RA was received when the conflicting traffic was about 300-400ft above descending. They turned R 90° and climbed 1000ft in accordance with the RA instruction to ‘climb, climb’. The L wing was then dropped and the conflicting ac was visually acquired by the PF passing approximately 800ft below on a reciprocal track 0.75nm laterally displaced to their L. The PF was unable to positively identify the other ac type. The Marham controller later passed the crew the details of the other ac involved. He assessed the risk as medium.

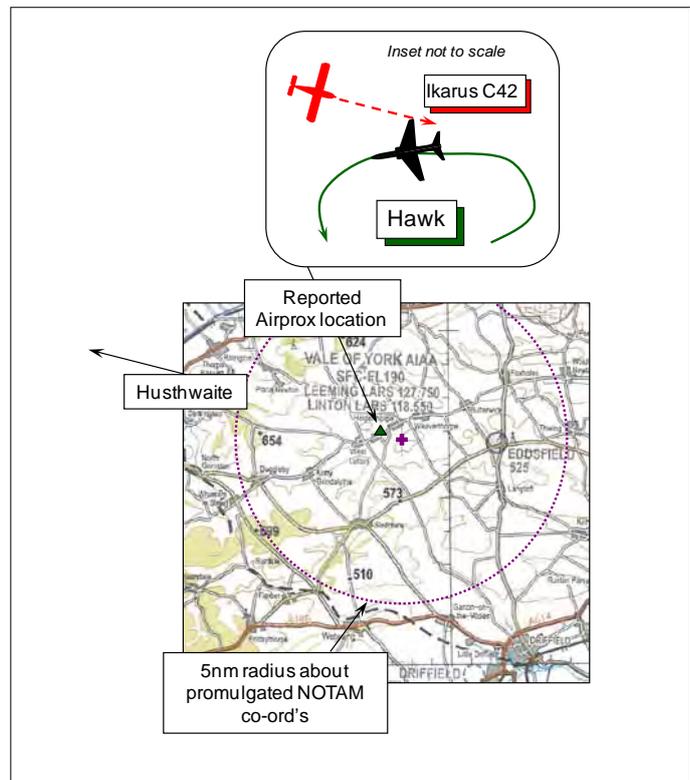
THE BAe HAWK T Mk1 PILOT reports he was flying a dual training sortie for the Joint Forward Air Control (FAC) Training Support Unit (JFACTSU) under VFR in VMC, clear of cloud with an in-flight visibility of 10km. He was not in receipt of an ATS, but in communication with the FAC on 280.725MHz and 137.600MHz.

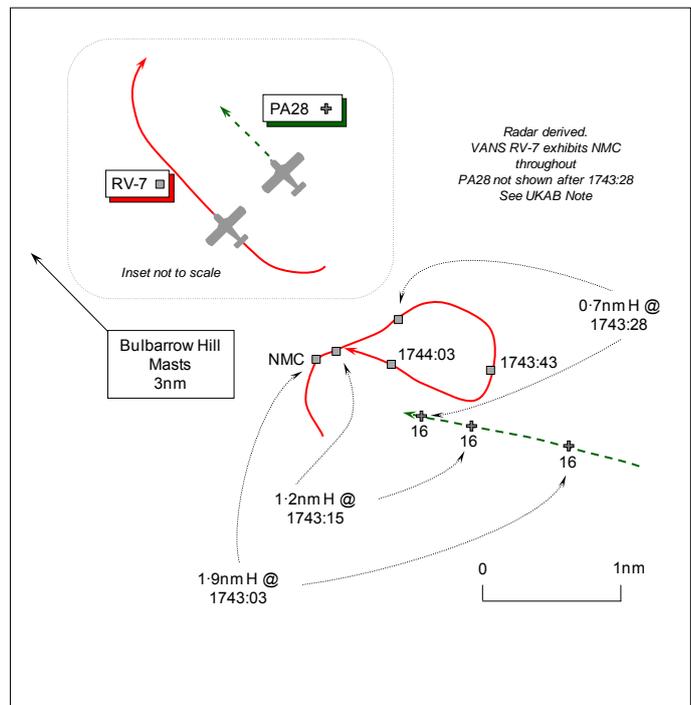
THE PIPER PA28-151 PILOT reports he was the co-pilot and PNF during a dual local flight originating from Yeovilton. The PF was navigating, whilst he as the PNF was operating the RT and acting as safety pilot. Bournemouth RADAR was providing a BS on 119.475MHz, that had been downgraded by ATC from a TS prior to the Airprox because of radar coverage. A squawk of A7000 was selected with Mode C initially and then the code changed to A7365 at the request of Bournemouth ATC; neither TCAS nor Mode S is fitted.

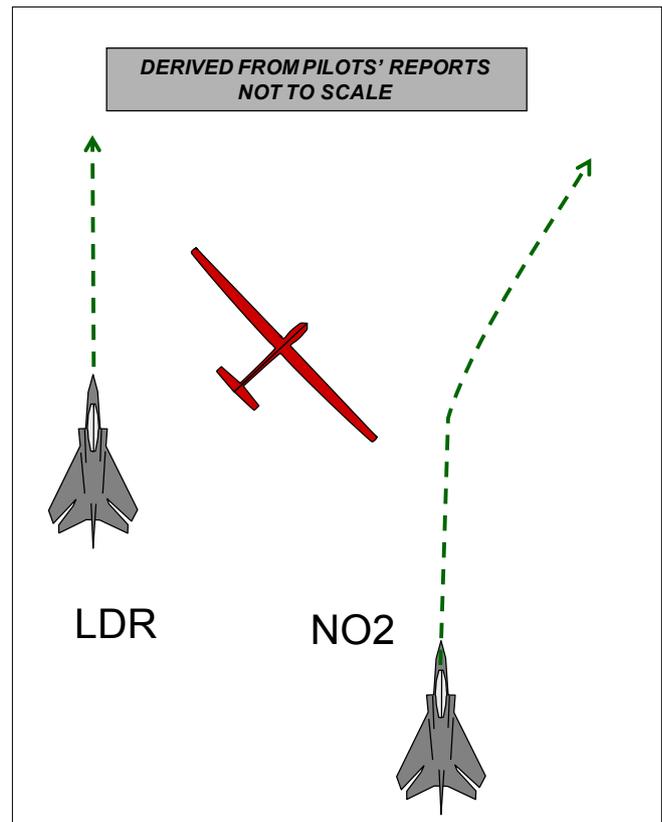
THE TORNADO GR4 PILOT reports flying a grey ac as No 2 of a pair on a tactical low-level sortie, squawking 7001 with Mode C. While heading 061° at 430kt conducting a rejoin after a simulated attack, they were flying at about 1500ft agl, in a 'sanctuary level', with much of their lookout focussed on regaining visual contact with their leader in the 30sec up to the CPA; they became visual with him as his ac passed below and in front of them. Upon looking out to turn L for the rejoin, the pilot saw a white glider in level flight about 400m away in their 12 o'clock position, co-height and flying from their L to R. He took immediate avoiding action by bunting and rolling to the R.

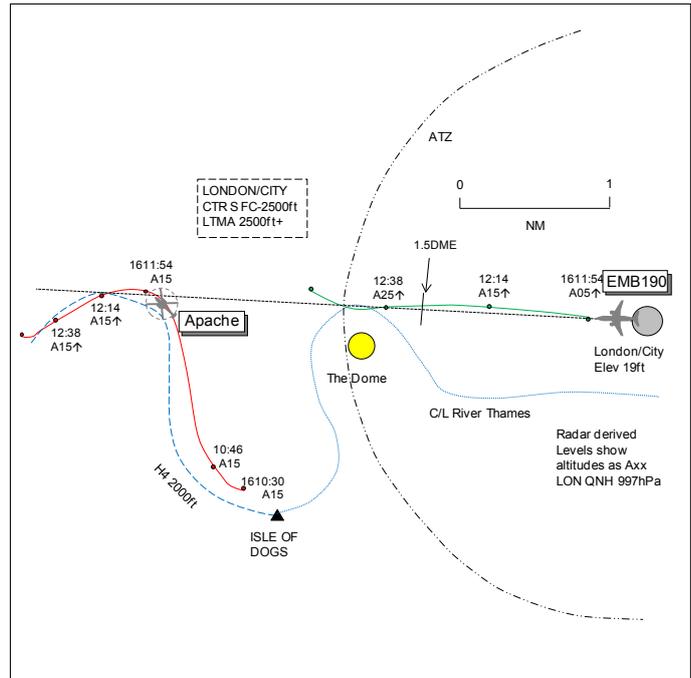
THE EMB190 PILOT reports on departure from London/City, IFR, and in communication with City Tower on 118.075MHz squawking with Modes S and C. While lining-up RW27 ATC informed them of an army helicopter holding at the Isle of Dogs VFR not above 1500ft. ATC then informed them this traffic would be routing directly W'bound staying S of the C/L. They confirmed the traffic in sight over the Isle of Dogs well S of the climb-out and they could also see it on their TCAS display showing 1400ft. They were cleared for take-off and as they rotated the Capt, PNF, noted the traffic was not tracking directly W but NW, still at 1400ft. The Capt reported this to ATC as they passed through 500ft however ATC did not speak to the helicopter flight. The helicopter continued closer to the RW27 C//L at 1400ft and the FO, PF, followed the departure flight guidance while the Capt searched for a visual reference; both crew monitored the TCAS display. Heading 274° at 128 kt the FO called for 'climb sequence' at 1000ft aal however the Capt announced that the intention was to delay acceleration owing to the proximity of the traffic. The FO confirmed he had the traffic on TCAS and both crew agreed the safest course of action was to continue at V2+10kt to out-climb the helicopter. The climb sequence/acceleration was completed at 2000ft aal with all other SOPs adhered to. He estimated the helicopter was within 1nm and 300ft below as they followed the SID passing 1500ft climbing straight ahead to the 1.5nm turn point on the CLN departure. No TCAS TA or RA was generated and he assessed the risk as high.
