ASSESSMENT SUMMARY SHEET FOR UKAB MEETING ON 21 MAR 2012

AIRPROX REPORT No 2011147

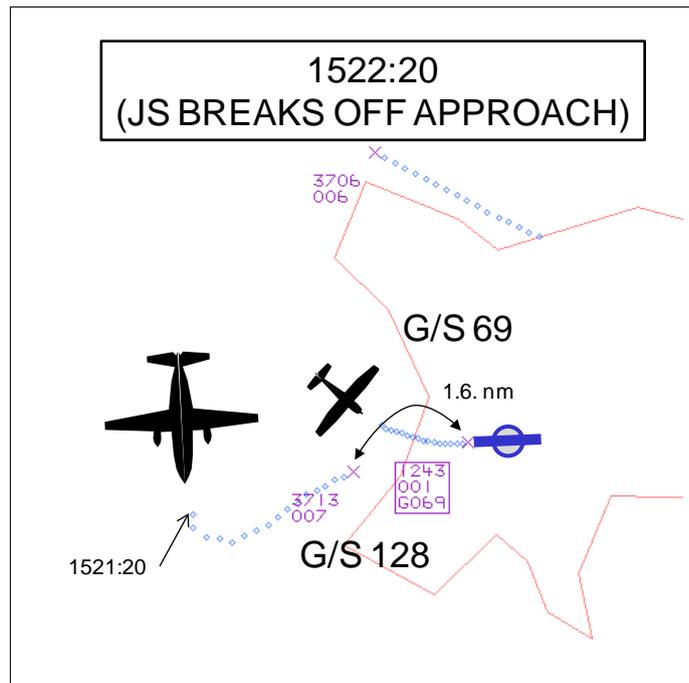
THE JS32 PILOT reports flying a passenger flight under IFR, inbound to Jersey squawking as directed with Modes C and S under the Control of Jersey APR then TWR; TCAS was fitted. While on L base for RW09 at 210kts and 2000ft they were informed that they were number 2 to a light ac; they were passed TI on the ac but nothing was seen. The crew were then instructed to take up a heading of 180° and maintain 2000ft and APR continued to pass TI. The pilot assumed that this was so he could transfer them to TWR and separation from the light ac would then be his responsibility. They were then requested to reduce speed so they reduced to 150kt. They continued on the heading of 180° until they had flown through the LOC and they were then cleared to descend at their discretion so they descended to 1000ft. When they were 1.5 miles through the C/L they were instructed to turn back onto finals and contact TWR. As they turned back (the short way round) they configured the ac and reduced the speed to 130kt. As they came onto final at 750ft, 3-4nm out they called TWR and saw the light ac that was still on L base and at 250ft above the RW. At that point TCAS triggered a "traffic traffic" (it would have been an RA in his view if it was not for the fact they were below 1100ft Rad Alt). At that point he decided that there was risk of a collision if things progressed any further so initiated a go-around and informed TWR. He tried to manoeuvre so that he did not fly directly above the ac but due to the RT loading from TWR he did not think he was very successful and he thought that they overflew other ac with less than 500ft separation. A MOR was raised about other [ATC] aspects of this event.

Cause: A large disparity in groundspeeds caused the JS32 crew to fly a go-around.

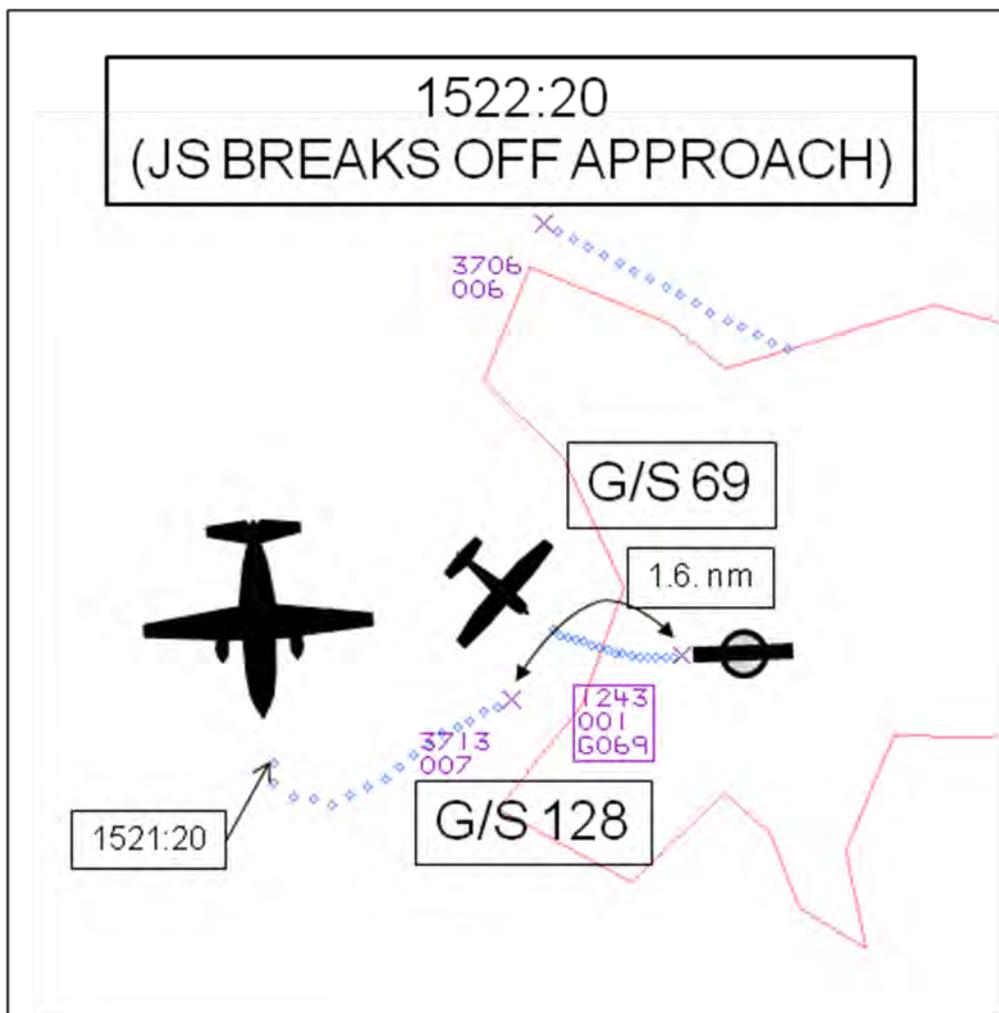
1521:10 The JS32, heading 180 degrees, was instructed to turn in towards the field, position approximately 0.5nm south of a 4nm final: C172 on an approximate 1.5nm final.

1521:30 The JS32 was advised shortly number one and instructed to call the TWR. At no point did the JS32 report visual contact with C172.

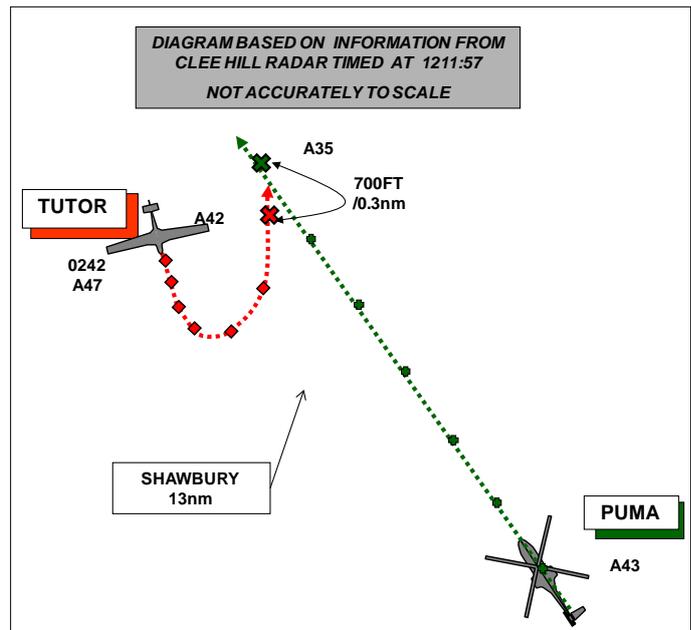
THE PUMA PILOT reports that they were flying an IFR transit leg from Benson, through Brize Norton's O/H and inbound for an ILS to RW18 at Shawbury. They had nav lights and white strobes switched on and were squawking 0220 with Modes C and S but TCAS was not fitted. At about 35nm from Shawbury, while heading 330° at 130kt, they called Shawbury APP [RAD] establishing two-way comms and requesting a TS. At about 15nm from Shawbury they were alerted to a contact at 5nm in their 11 o'clock (300° from them, in the vicinity of The Wrekin), which was reported to be a Tutor conducting aerobatics training, but they could not see the ac. Just inside a range of 14nm from Shawbury, they were updated on this traffic as being on the same bearing but then at 3nm. Within 10sec of this call from ATC, the ac was spotted on a reciprocal heading, judged to be about 1nm away and it appeared that it would pass down their port side. It was not known if the other ac was visual with them so to aid deconfliction the HP commenced a descent at about 600fpm. As soon as the descent was commenced the other ac was seen to start a descending LH turn; it kept the same alt as the Puma and barely moved from its position in the windscreen as it turned towards them. Still unsure as to whether the other ac was visual, the HP 'lowered the lever' and achieved greater than 2500fpm ROD in order to remove the conflict. The other ac passed about 150m behind them at the same level. The speed and rate of descent were maintained and after about 1min the crew turned the Puma to the L to ensure that the other ac was clear as it was unsighted in their 6 o'clock. The ac was recovered to 2500ft on the RPS, heading 360° towards Shawbury, and they completed the ILS without further incident.

Cause: The Tutor pilot flew close enough to the Puma to cause its crew concern.

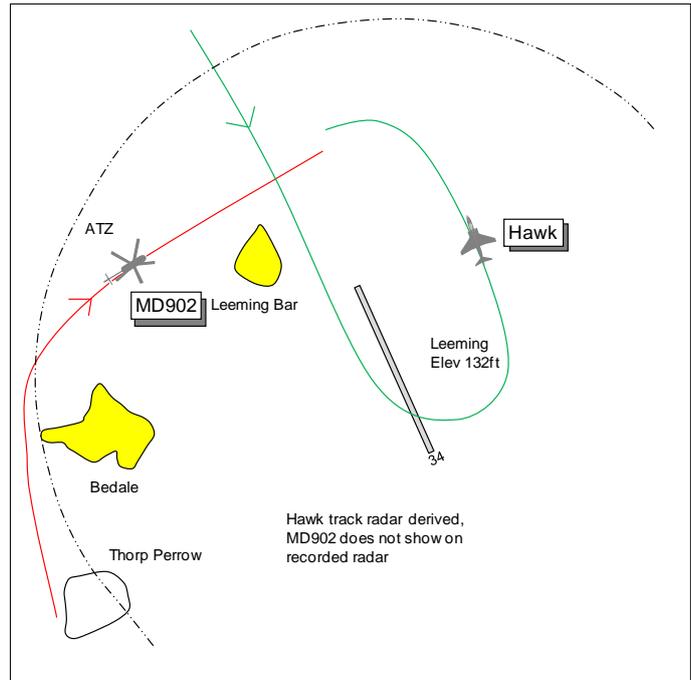
THE HAWK T MK1A PILOT reports on a visual recovery to Leeming and in communication with Leeming Tower, squawking 0424 with Mode C. The visibility was 25km flying clear below cloud in VMC and the ac was coloured black with nose landing light and HISLs switched on. He called "initial" for RW16 with Tower and was told the cct was clear but there was a Helimed at Bedale (3km in his 2 o'clock) not above 500ft N'bound. He became visual with the Helimed in a hover and commencing departure, assessing it as no factor as a N'y departure would deconflict from his intended cct RW16. He broke into the cct LH, turning away from the Helimed and he lost sight of the helicopter. He flew a standard pattern tipping in at the normal point. His attention was divided between the threshold and the cockpit parameters. At approximately halfway round final heading 240° at 140kt descending through 600ft QFE 1003mb he saw the helicopter in his 1130 position range 400m flying in the opposite direction and just below, assessing it was on his intended final approach path. He had time to roll off the bank to break the collision and pull gently, owing to the stall risk, and watched the helicopter pass 50m to his L and 150ft below. He reported the Airprox on the RT to Tower. At no time did Tower inform him of the Helimed's change of track. He assessed the risk as medium.

Cause: Zone released the MD902 own navigation resulting in a conflict with the Hawk on final.

- a. Review RAF ATM Force Orders 100.130 to determine whether paras 100.130.2 and 100.130.3 are applicable to ATCO ICs.
- b. Direct RAF ATM Terminal units to review local orders permitting the use of an ATCO IC, in lieu of a dedicated Sup, in a rostered control position, during core opening hours.

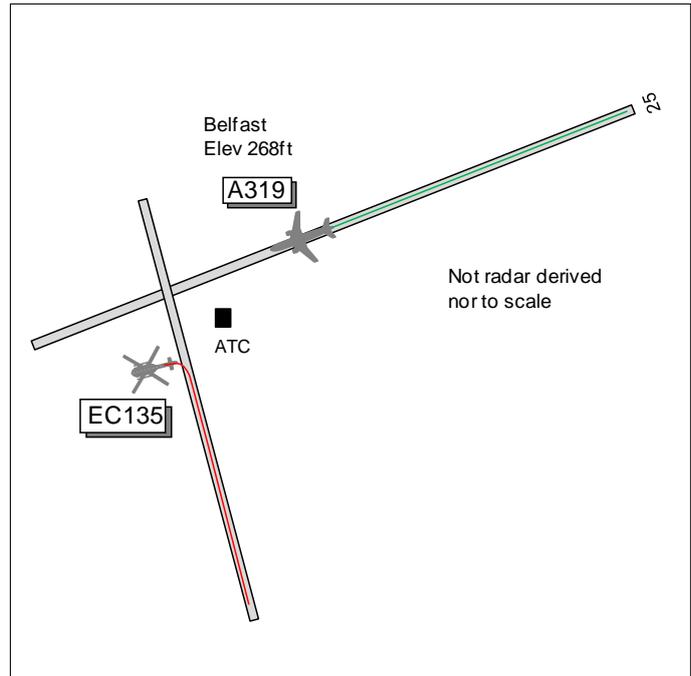
THE A319 PILOT reports departing Belfast under IFR and in receipt of an Aerodrome Control Service (ACS) from Belfast Tower on 118.3MHz, squawking 7025 with Modes S and C. The visibility was 10km in VMC and the ac's anti-collision, nav and strobe lights were all switched on. They were cleared to line-up RW25, take-off clearance received and after departure a L turn to PEPOD. During the early stages of the take-off roll ATC advised them to climb straight ahead after departure, which they acknowledged. At a late stage of the take-off roll they saw traffic moving from S to N O/H the aerodrome approaching the RW. Concerned once airborne climbing through 300ft QNH at 180kt and to maintain separation, they made a 30° R turn. They asked ATC for information on the traffic who acknowledged that the traffic was turning S. At one point vertical separation of 200ft was seen on TCAS; however, the lateral separation was difficult to gauge as it was dark. He assessed the risk as high.

Cause: In the absence of TI, the A319 crew was concerned by the proximity of the EC135.

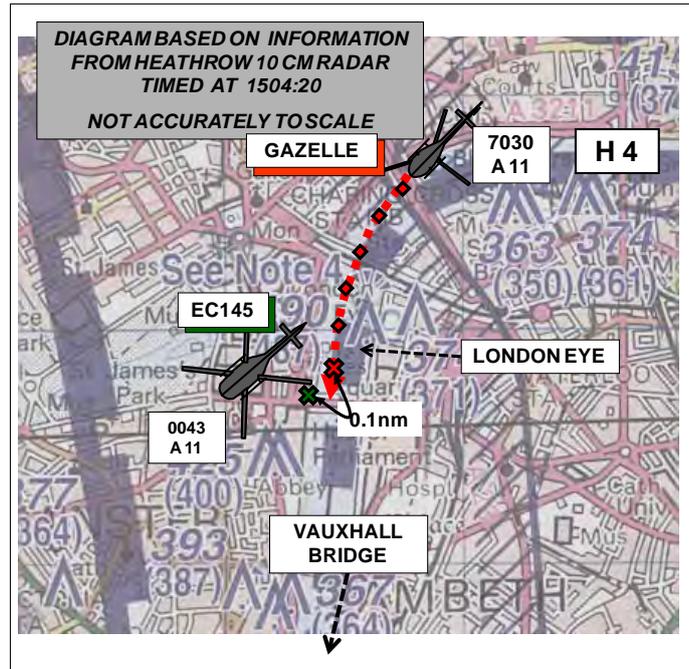
THE EC145 PILOT reports flying a CAT B Police task in a TCAS equipped helicopter with 2 observers, in the hover (into wind heading 210°) at 1200ft over Central London. Heathrow Special VFR passed him TI on 2 helicopters heading along the river Westbound to the London Eye. He acknowledged the call and repeated that he was on the N side of the river. He was initially visual with the 2 helicopters through his rear window but became unsighted as they moved into his 6 o'clock position. Shortly afterwards he received a TA on the TCAS at which stage he yawed his ac right and saw the Gazelle at the same altitude about 1nm away and heading straight towards him. He initiated avoiding action by transitioning into forward flight on a W'yly heading as the Gazelle began a left hand turn to orbit the London Eye. He estimates that the Gazelle came within 100 – 150m of his position at the same alt.

Cause: The Gazelle pilot flew close enough to the EC145 to cause its pilot concern.

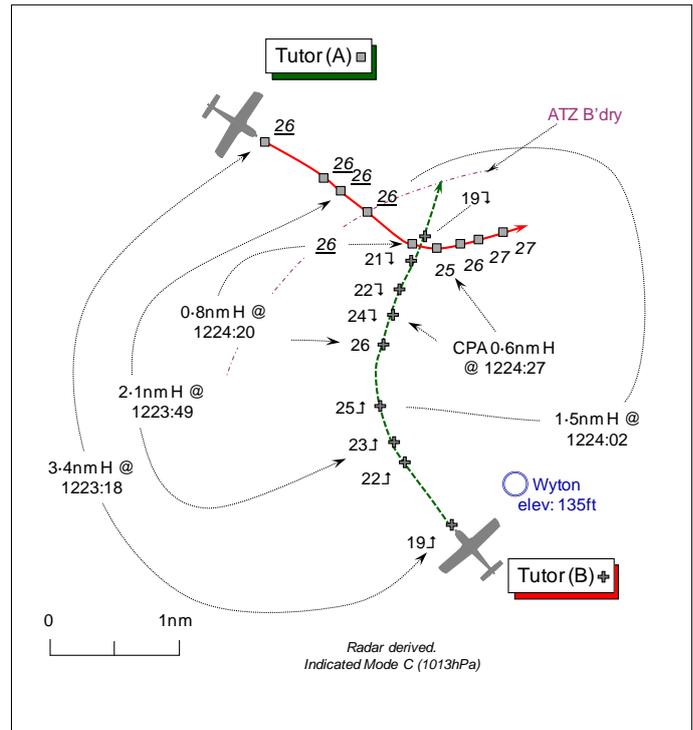
Tutor(B) turned off the 310° track and climbed above the 2000ft height requirement of the SID-1B departure route. This resulted in the two ac flying into conflict and caused the pilot of Tutor(A) to be concerned about the close proximity of Tutor(B).

Cause: The pilot of Tutor B climbed above the height prescribed for SID-1B.

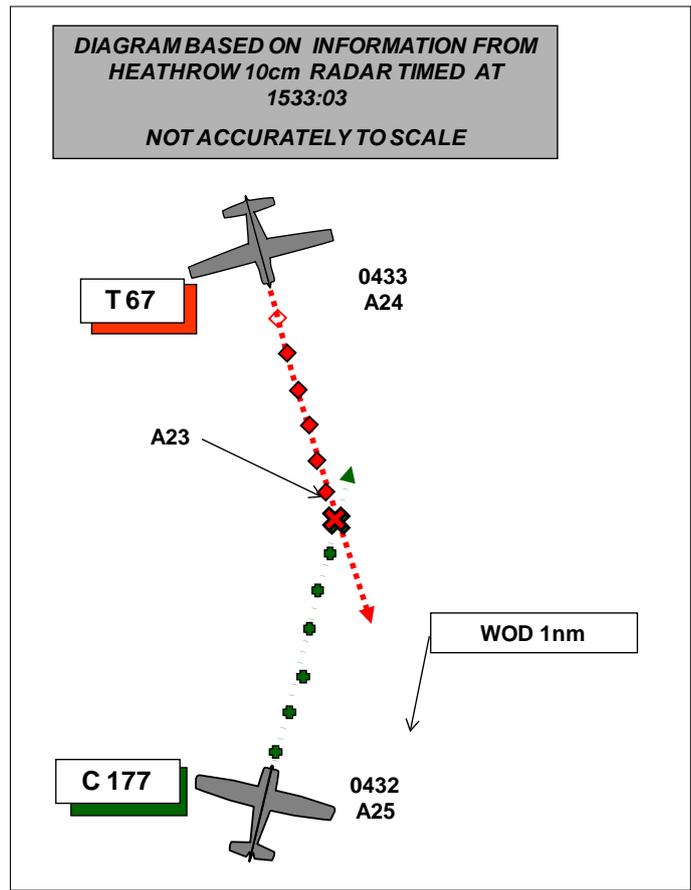
THE C177 RG PILOT reports flying a private flight under VFR from Cherbourg to Denham in a blue and white ac, squawking as directed with Modes C and S. At the time of the incident they were in a level cruise, heading 015° at 130kt and his co-pilot was talking on the radio with Farnborough Radar who were providing a BS; Farnborough asked them to confirm their alt then asked them to descend to remain below the London TMA. As pilot in command, he was maintaining level flight and had not commenced a descent when the incident occurred. He recalls looking to the E towards White Waltham and Heathrow and then glancing down at the GPS to confirm his position and that he was on track. On looking straight ahead again, he saw another ac very late, in front and slightly to the R and below him (a yellow low-wing single-engine type). By the time he had seen the other ac it was too late to take any avoiding action and it was only by chance that a collision was avoided and he assessed the risk as being high.

THE T67M PILOT reports that he was informed of the incident late and he could not recall the detail. He was flying a private VFR flight from Leicester to Redhill in a yellow and black ac with no TCAS fitted and was in the area of the WOD NDB at the time, cruising at 110kt at 2500ft [see below]; he was in receipt of a BS from Farnborough W LARS. He saw a high-wing white single-engine ac 400yd away in his right (1 o'clock) at about the same alt but it was too late to take any avoiding action. He reported the incident on the RT and assessed the risk as being medium-high.

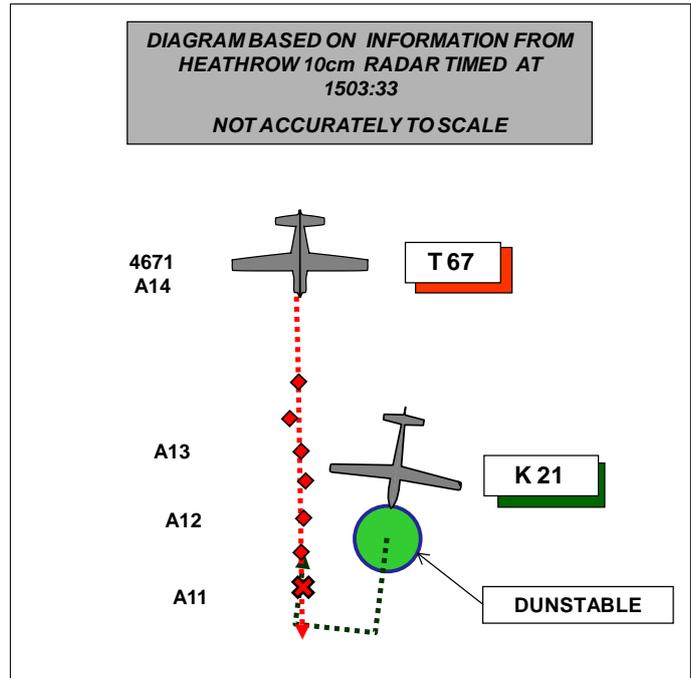
THE ASK21 GLIDER PILOT reports flying a white glider with no SSR fitted but listening out on Dunstable Radio located in a mobile tower. He had just completed a winch to 1100ft and about 30sec after cable release turned R then R again to position for a normal cct. After the second turn at 950ft agl then heading 010° at 55kt he saw a white low-wing single-engine light ac with a large bubble type single piece canopy 1-200ft away and head-on to him; the ac passed 100-150ft below him. An observer on the ground stated the ac was initially at same height as his glider and dived underneath it.

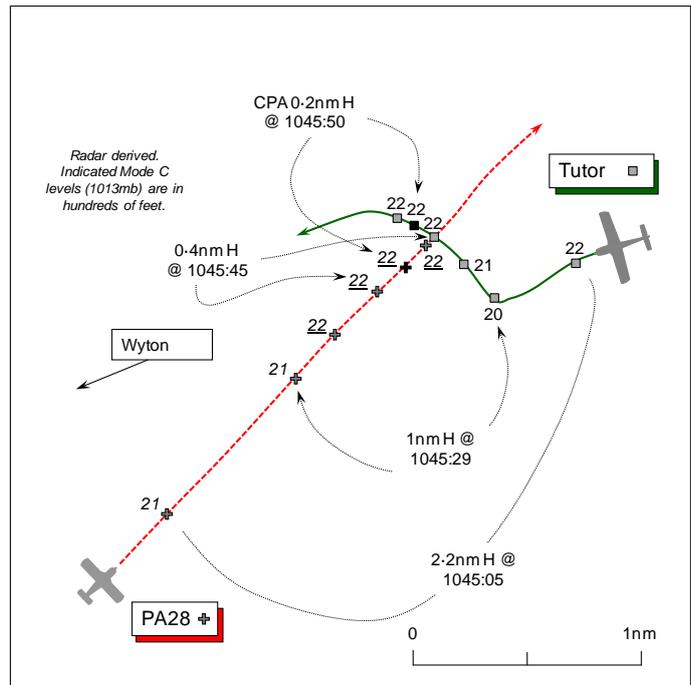
THE GROB TUTOR TMK1 PILOT reports he was conducting a local VFR solo continuation training sortie from Wyton, whilst in receipt of a reduced TS from Marham ZONE on 124.15MHz. A squawk of A3662 was selected with Mode C; elementary Mode S and TAS are fitted.

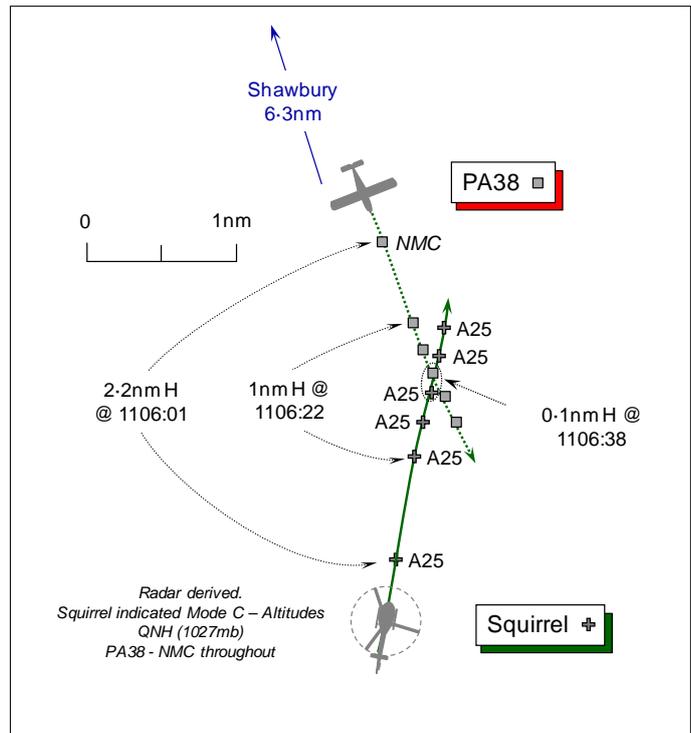
THE SQUIRREL HT Mk1 HELICOPTER PILOT reports he was conducting an instrument training sortie from Shawbury; the PF in the RH seat was using an IF training visor. After departing 'Box 'C', which is part of the Shawbury instrument flying training area, the Squirrel was descended from 3000ft to 2200ft QFE under a TS from Shawbury APP on 282.00MHz. A squawk of A0237 was selected with Mode C; neither TCAS nor Mode S is fitted.

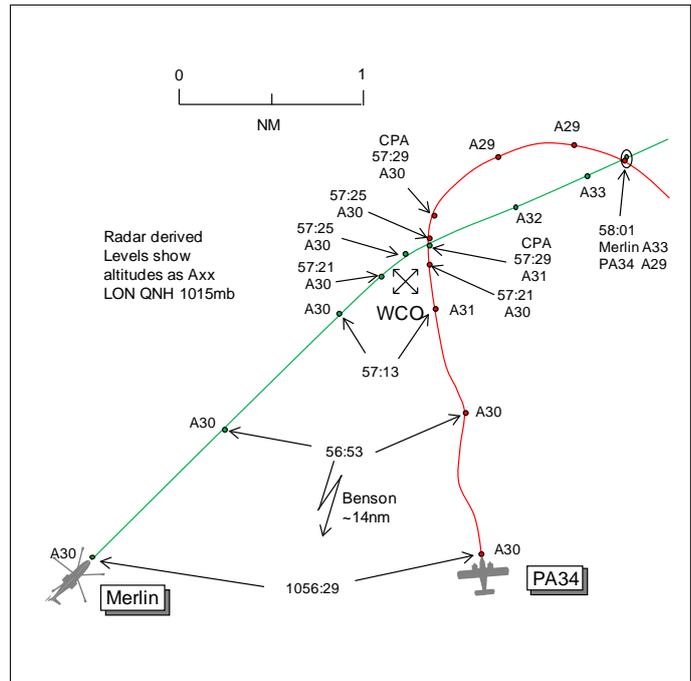
THE MERLIN PILOT reports en-route to Cranfield under IFR on an IRT and in receipt of a TS from Benson on 376.65MHz, squawking an assigned code with Modes S and C. The visibility was 20km flying 2000ft below cloud in VMC and the helicopter was coloured green with nav, both landing lights and HISLs all switched on. They had completed IF GH to the W of Benson and were routing to Cranfield via WCO NDB. Heading 060° at 120kt and level at 3000ft QNH 1015mb with approximately 1nm to run to WCO the Capt saw a white and blue coloured light, twin-engine ac 100m away converging from their R at an identical altitude. The HP, seated on the RHS, took avoiding action to the L, although this was after the ac had passed 50-100m in front, before it banked hard L and then around to the R and departed to the NE. He assessed the risk as very high.

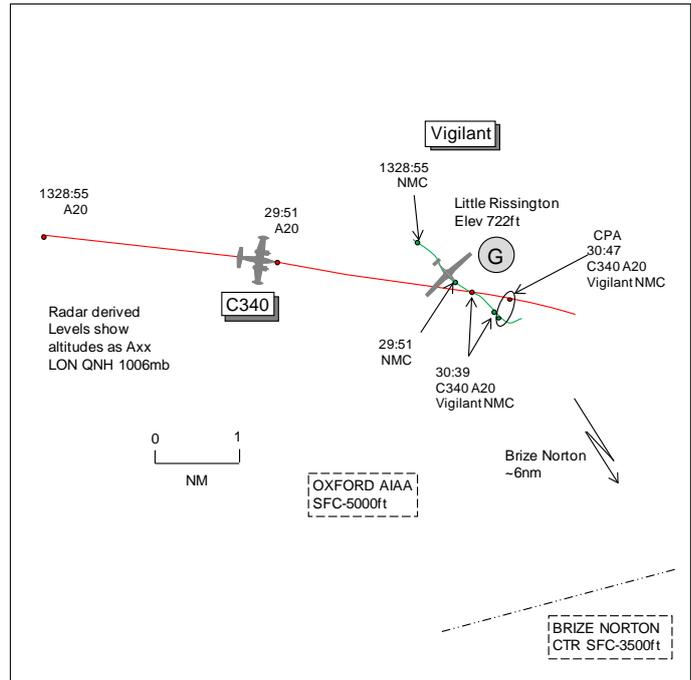
THE VIGILANT PILOT reports flying a local dual training sortie, VFR and in receipt of an A/G service from Little Rissington on 124.1MHz, squawking 7000 with NMC. The visibility was 10km flying clear below cloud in VMC and the ac was coloured white/day-glo with landing, nav and strobe lights all switched on. Heading 175° at 60kt, level at 800ft QFE 979hPa, as he was commencing a crosswind join for RW22, a light twin engine ac was seen to his L and behind at range 0.25nm approaching from the NW on a SE'ly heading at an estimated height of 1000ft aal. This ac was then seen to fly through the established cct pattern, passing 200ft above and 0.25nm away laterally behind his ac. He maintained straight and level on the crosswind leg, delaying his turn onto downwind. The other ac was observed to continue SE'ly and then commence a climb before disappearing into a cloud layer. TI was given to him by the Duty Instructor, which assisted him to visually acquire the twin-engine as it passed. He assessed the risk as medium. Brize were contacted by telephone in order to attempt tracing action and a controller stated that he was not working the traffic but saw a 7000 squawk tracking SE at about 180kt indicating 2000ft.

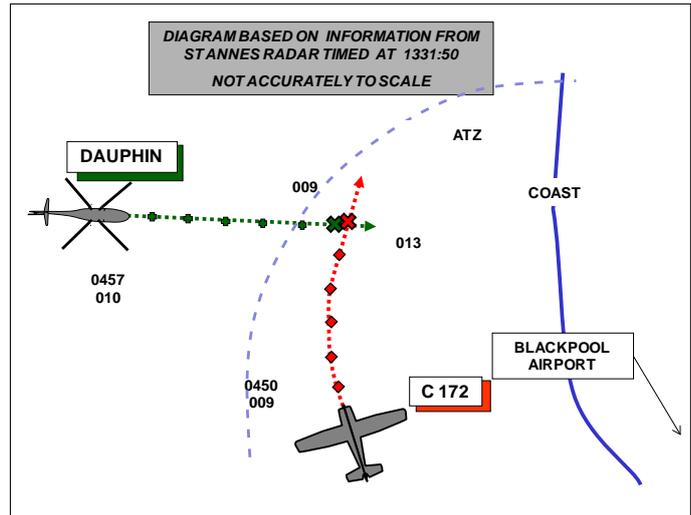
THE DAUPHIN 365N3 PILOT reports flying a commercial VFR flight inbound to Blackpool in receipt of a BS [ACS, See ATSI report] from them, while squawking with Mode C and TCAS was fitted. They were heading 090° at 120kt, were cleared by ATC to join the cct from the W, were informed of a C172 on climb out and that its intention was to turn N towards them. ATC then asked them if they were visual; he replied that they were not and the C172 was instructed to pass behind them. The Cessna replied they had the Dauphin visual and would pass behind it as instructed, he thought [see ATSI report] and would climb to 1000ft. They had a TCAS indication of close proximity, but it was not accurate enough at the very close range to establish the exact position of the contact.
