**ASSESSMENT SUMMARY SHEET FOR UKAB MEETING ON 18 May 2011**

## AIRPROX REPORT No 2010144

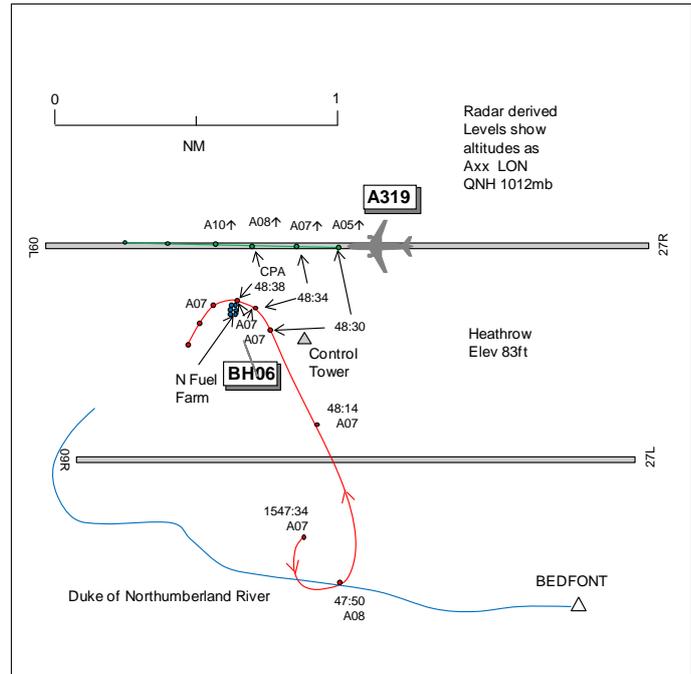
**THE A319 PILOT** reports outbound from Heathrow RW27R, IFR and in communication with Heathrow Tower, squawking with Modes S and C. Just after rotation, heading 271° at 140kt, Tower advised of a helicopter operating to the S of the aerodrome. As they climbed through 300ft the Capt visually acquired a black helicopter approx 300m to the forward/L of their ac at about 600ft moving towards the extended C/L of RW27R. Both pilots were ready to take avoiding action if required. The helicopter made a very sharp L turn by which time they were approximately 300ft higher than it. Neither a TCAS TA nor RA warning was received at any time and he assessed the risk as medium.

The ATSU written report indicated that AIR N observed the helicopter leaving the BA Cargo shed and was surprised at the speed the helicopter carried out the crossing. At 1548:03, because the A319 had already commenced the take off roll, AIR N elected to make a general broadcast, "all stations helicopter approaching er f-from the south will remain south of two seven left." (This was a slip and should have been transmitted as 27R.)

The ATSU written report indicated that both AIR S and N considered that the helicopter appeared to be fast as it disappeared O/H the Tower. There was no prior coordination between AIR S and AIR N regarding the management of departures, the passing of TI, the responsibility for applying visual separation or the wake turbulence requirements. The BH06 was next observed in a sharp L turn adjacent to the departing A319.

The missing electronic copy of the Tower NSF notice caused a delay in the operational assessment and appropriate plan and briefing. The faxed black and white copy was considered to be poor.

There was a lack of awareness amongst the VCR controllers regarding the precise requirement of the BH06 and the impact on Heathrow operations. Neither of the AIR controllers on duty at the time of the Airprox had previously seen a pipeline helicopter operating between the dual RWs at Heathrow; and therefore a lack of familiarisation and awareness of the operation caused a misunderstanding.

Because the A319 flight had commenced take-off, AIR N considered that the passing of TI would be distracting and therefore elected to pass a general broadcast. However the controller made a slip and stated the helicopter would remain S of RW27L instead of 27R. This may have resulted in the crew of the A319 being unaware of the helicopters intentions and being suprised when the helicopter was observed just S of RW27R.

Cause: Following an inaccurate broadcast from Air N, the A319 crew was concerned by the proximity of the BH06.

Suggested that in future, pipeline or other similar details should call the VCR Supervisor before departing in order for the Supervisor to fully understand what they want to do, so the Supervisor can brief the helicopter pilot on current operations/conditions and subsequently there would be ample time then for the Supervisor to appropriately brief all controllers who would be involved. He stated that this would also allow them to plan their flight better instead of being turned away due to the met conditions not being appropriate.

It is recommended that NATS procedures are amended to ensure that the Heathrow Tower Supervisor is involved in the approval process for the flight before the flight gets airborne when the detail involves activity within 4nm of Heathrow.

It is recommended that Heathrow Operations work with Terminal Control Operations to revise the assessment process for NSF approvals, including the assessment of the impact on the Heathrow Tower operation.

It is recommended that the Heathrow Safety Department raise awareness on the unit of incidents that have occurred at, or close to, the time of handing over of positions.

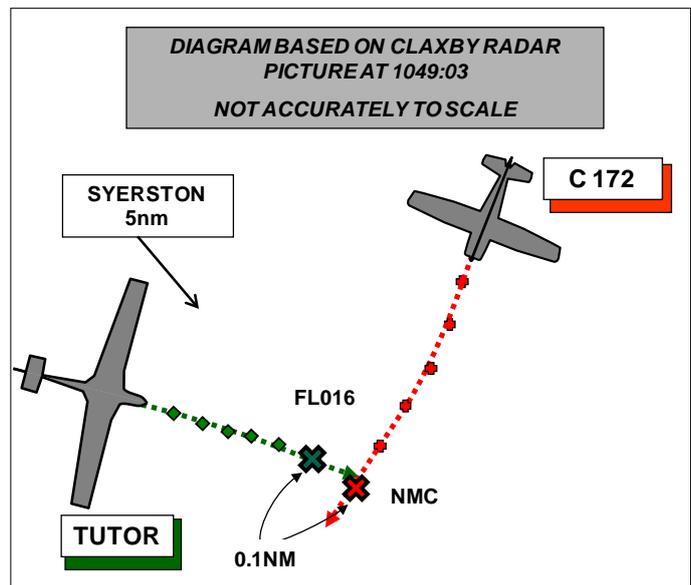
**THE TUTOR PILOT** reports flying an instructional sortie in a white ac with all lights switched on, initially in receipt of a BS from Waddington ZONE, with the student as handling pilot. They were 5nm NW of Syerston, heading 100° in the climb out from a PFL and passing 1300ft when he (the instructor) cancelled the BS and changed freq to Cranwell APP. Passing 1700ft and before gaining contact with Cranwell, the student pilot pushed forward abruptly and reported an ac above, he gained visual contact with the ac, 400ft away, by moving his head forward and right to clear the area obscured by the canopy arch then took control, noting the height as being 1650ft. The conflicting ac was a white high-wing Cessna with a blue registration mark and was in straight and level flight heading about 195° and he assessed the vertical separation to be 150ft.

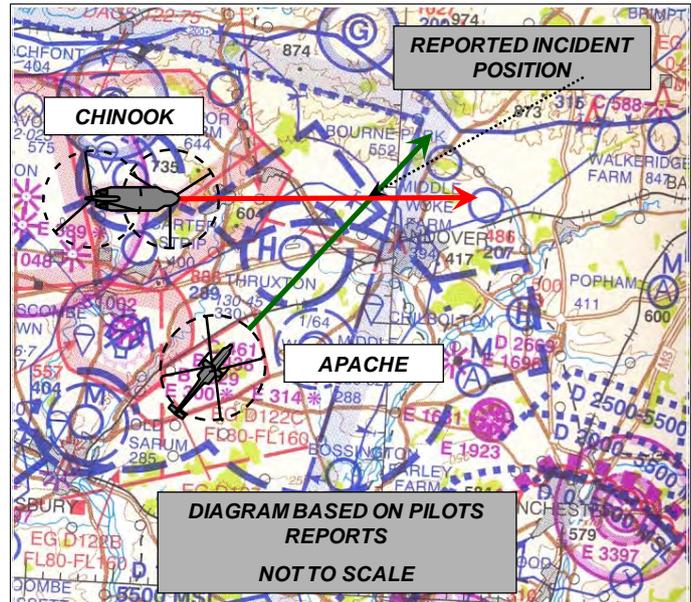
**THE CHINOOK PILOT** reports that they were Reversionary Night Flying (RNF) [not on NVGs], transiting in the Night Rotary Region 1 from Lugershall to Odiham at 800ft on the Cotswold RPS [1024mb], routing to the A34 before climbing for a radar pickup for an approach at Odiham. They had all lights switched on and were heading 090° at 130kt approaching Andover and had reselected the radios and IFF [squawking 3646] from SPTA in preparation for the climb and approach to Odiham. The NHP called "break" and at the same time he saw an Apache helicopter crossing from right to left in level flight about 50ft below and 100ft in front of them. He cyclically climbed the ac to avoid the Apache which disappeared under their nose. The No1 crewman picked up the Apache as it cleared to their 9 o'clock and saw it continue away without manoeuvring. RT calls were made to try and establish comms with the Apache on Middle Wallop Approach, low level common and Guard UHF but there was no response.

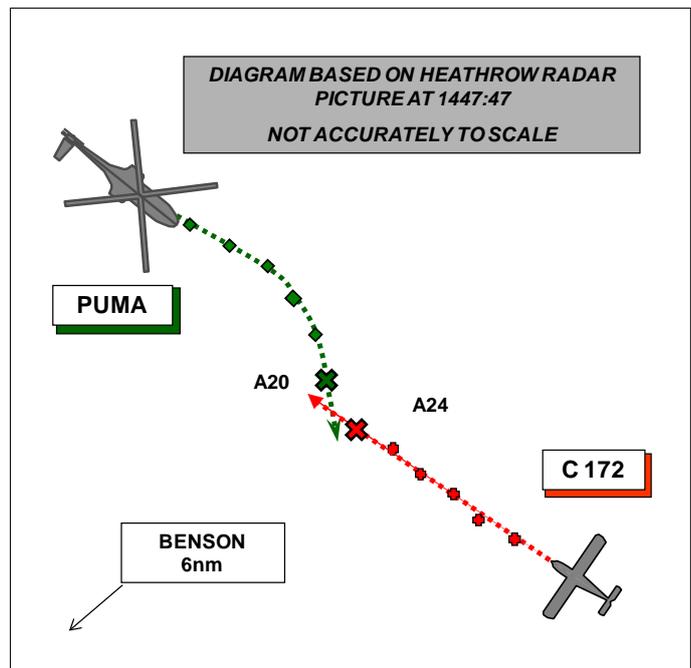
**THE PUMA PILOT** reports flying a camouflage green helicopter with no TCAS fitted but with strobes and nav lights switched on, on a GH sortie, in receipt of a BS from Benson APP, squawking as directed with Modes C and S. While he (the LHS QHI) was positioning the ac for a PFL near Stokenchurch, in straight and level flight at 2000ft on the RPS, heading 170° (he reported out of sun) at 120kt, the RHS pilot called 'break left' for a light ac that was a possible confliction. The ac was a white, high-wing, single-engine Cessna type, 100-200ft above them, also in a straight and level flight and was crossing them from the 11 o'clock to the 4 o'clock position. He started the break but quickly acquired the light ac visually and determined that there was no direct confliction and so he remained straight and level and allowed the light ac to pass overhead.

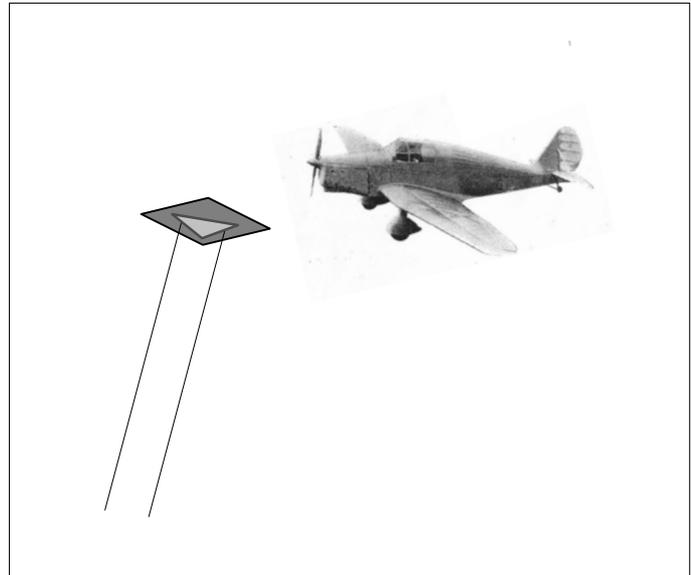
**THE TIPSY BELFAIR PILOT** reports that he was en-route to Turweston on a pleasure flight, heading 250° in the cruise at 95kt in hazy weather and he kept his alt low to aid forward visibility. He was navigating by map, stop watch and compass without GPS or other nav aids.
