ASSESSMENT SUMMARY SHEET FOR UKAB MEETING 22 September 2010

AIRPROX REPORT No 2010001

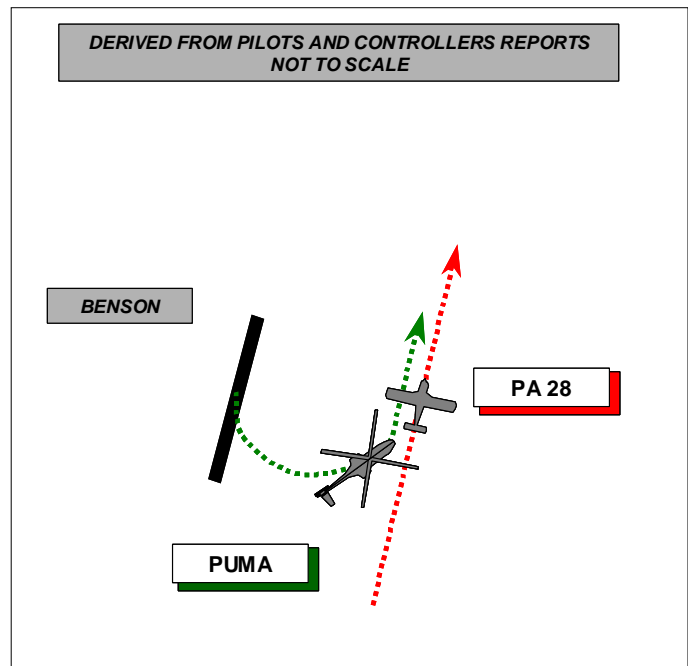
THE PUMA PILOT reports flying a training sortie in the Benson Circuit for RW19LH, in communication with Benson TWR. While levelling downwind at 1000ft QFE, passing through heading 060° at 100kt, another ac called to join the Benson circuit downwind and a blue and white low-wing light ac was seen simultaneously, 50-75m ahead and at the same height virtually in the circuit. He decelerated to increase the separation and assessed the risk as being medium.

HQ JHC comments that the actions of the Puma in the build-up to the incident were far from satisfactory. By flying non-standard circuits and, in particular, remaining on the RW during a Touch and Go, the Puma caused an unnecessary increase in workload for the controller. This Airprox highlights the importance of timely radio calls - both by the controller and joining traffic - but it could have been wholly prevented by better airmanship on the part of the Puma.

Members agreed that in this high-workload situation, the ADC had become distracted to such an extent by the Puma's non-standard circuits, that he had temporarily overlooked the approaching PA28. Had the ADC not been distracted, Members agreed that he would most likely have paid more attention to the PA28, of which he was previously aware having agreed with ZONE that it could join downwind and noted it on the HiBrite on 2 occasions; he could then have prompted the ZONE Controller to transfer it to him in an unrushed and timely manner. The ZONE Controller too, Members agreed, had contributed to the incident by not instructing the PA28 pilot to report 'visual' with the airfield, as is normal procedure, and then to call TWR before entering the circuit area; Controller Members agreed that although civil and military procedures differed, in this situation such a call would have been best practice and might have prevented the incident. It was also unanimously agreed that if a controller does not instigate a handover to TWR, then the pilot should take the initiative and request it before nearing the airfield, for example by saying 'would you like me to contact TWR?'

Cause: Unaware that the PA28 had joined the circuit downwind, the Puma crew turned into conflict with it.

OIC Flying Club has briefed members of the importance of being conversant with local procedures; in addition the unit is reviewing the Flying Club Orders. Best practice remains for Supervisors to roster a GRD Controller when busy periods are expected in TWR, thus reducing the workload on ADCs.

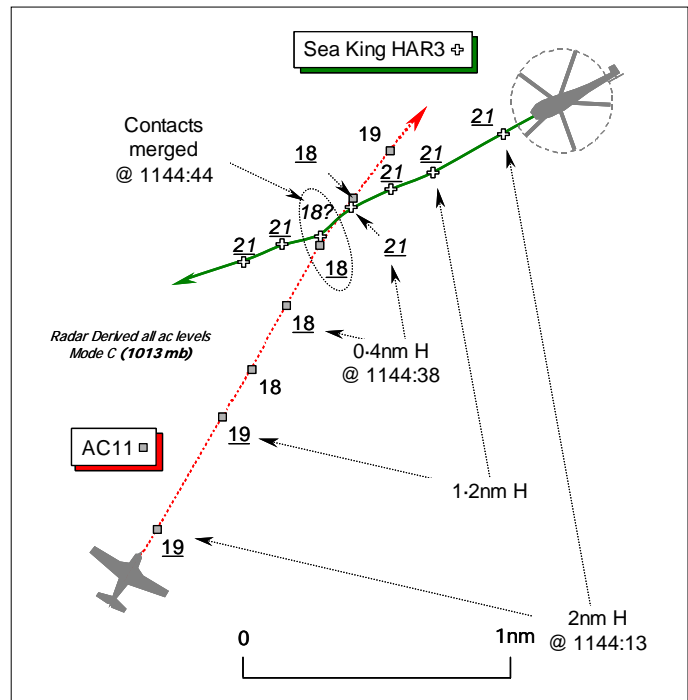
PART A: SUMMARY OF INFORMATION REPORTED TO UKAB

In determining the primary cause of the Airprox, one Member considered that 300ft vertical separation did not pose a definite hazard and this Airprox had stemmed from the late sighting of the AC11 by the Sea King crew, who had not assimilated the TI provided. However, it was clear from his own account that the AC11 pilot had seen the helicopter from a good distance away and had watched it as the two ac converged. He was therefore, able to give the Sea King a wider berth if he chose to do so, and the Board routinely recommends pilots to avoid other aircraft both laterally and vertically. The Board concluded, therefore, that the cause of this Airprox was that the AC11 pilot flew close enough to the Sea King to cause its crew concern. However, as the AC11 had the Sea King continually in sight and could have manoeuvred if necessary, the Board agreed that no risk of a collision had existed.

Cause: The AC11 pilot flew close enough to the Sea King to cause its crew concern.

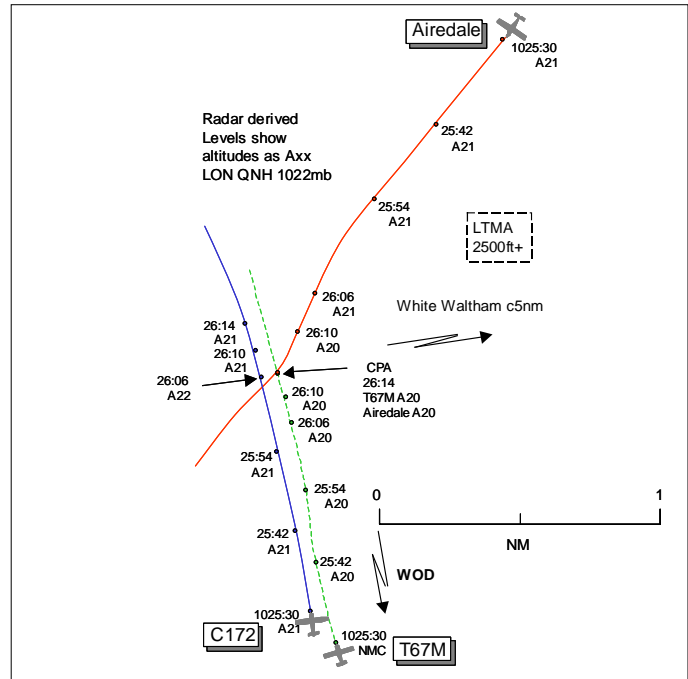
C172 v Airedale 50-100ft V/0-2nm H

T67M v Airedale Nil V>Returns merge

THE C172 PILOT reports en route to Wellesbourne VFR and in loose formation with a T67M whilst under a BS from Farnborough W on 125.25MHz, squawking an assigned code with Modes S and C. The visibility was >30km flying 1000ft below cloud in VMC and the ac was coloured white/blue with strobe lights switched on. The route flown was via Guildford, WOD NDB and then on towards WCO whilst the T67M was flying slightly behind and to starboard. In the vicinity of WOD heading 355° at 100kt and 2200ft he saw another ac, a high-wing single-engine type coloured white/blue, about 200m away to his R and 50-100ft below on a near collision course. The other ac was very close to his R windscreen pillar, so he thought it had been concealed behind it previously, which would have contributed to his late sighting. He quickly determined that the other ac, although close, would pass behind him with no risk of collision which it did about 2sec later about 50-100ft below and 100m laterally. His attention turned immediately to the T67M which was going to get much closer to it. He considered whether he could alert the T67M pilot to the other ac by making an RT call but there was too little time to say anything that could have helped without making things worse. It was difficult to see exactly how the other ac would appear to the T67M pilot – below/above or relative position. The T67M did have 2 pilots onboard so he hoped 1 of them would see the conflicting ac; however, they did not until they were very close. With the visibility being excellent and having a pax who was new to light ac flying, he had not wanted too much radio work so did not consider a higher level of service. However, he later realised that he had omitted to tell Farnborough that he had another ac in formation. The T67M pilot then reported the Airprox to Farnborough a few minutes later. He assessed the risk of collision as low.

THE T67M FIREFLY reports en route to Wellesbourne in two-ship loose formation with a C172 and listening out on the Farnborough W frequency, squawking 7000 with Modes S and C. The visibility was unlimited flying 1000ft below cloud in VMC and the ac was coloured yellow/black with strobe lights switched on. The C172 was responsible for navigation whilst he concentrated on holding formation 300m R echelon with his co-pilot providing a general lookout for traffic and handling the radio. The C172 flight was in communication with Farnborough; however, he missed the C172 pilot's

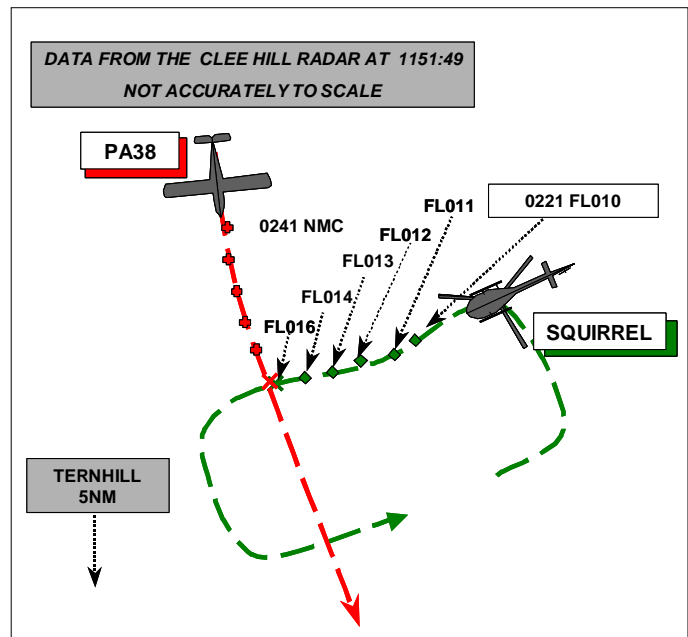
THE SQUIRREL PILOT reports flying a yellow and black helicopter with nav lights and strobes switched on, on a training flight, squawking a Shawbury conspicuity code with Mode C and operating on a Shawbury monitored quiet frequency and booked into the LFS. Half an hour into a sortie of advanced autorotations, using the canal north of Market Drayton as a line feature entry point for comparison, the ac was being repositioned at 70kt in a left-hand racetrack to re-cross the canal on a notional into-wind heading of 070° for a further autorotation. Climbing through 1900ft with about 30° to go and the ac starting to level off, the NHP student became aware of a light ac in close proximity through the overhead window and warned the HP [instructor] who levelled off. Having levelled off and rolled 'wings level' the HP then also saw the ac, a white coloured, light fixed-wing ac similar to a Grob Tutor, continuing along the right-hand side of the canal towards the S. The fixed wing ac had made no apparent attempt to take evasive action and appeared to be following the line feature of the canal into sun. At the closest point the ac was assessed to have been about 50ft above and five 'spans' clear. The student noted that the white ac had a blue flash down the side, was being flown by a single pilot and carried a registration that they only partly noted.

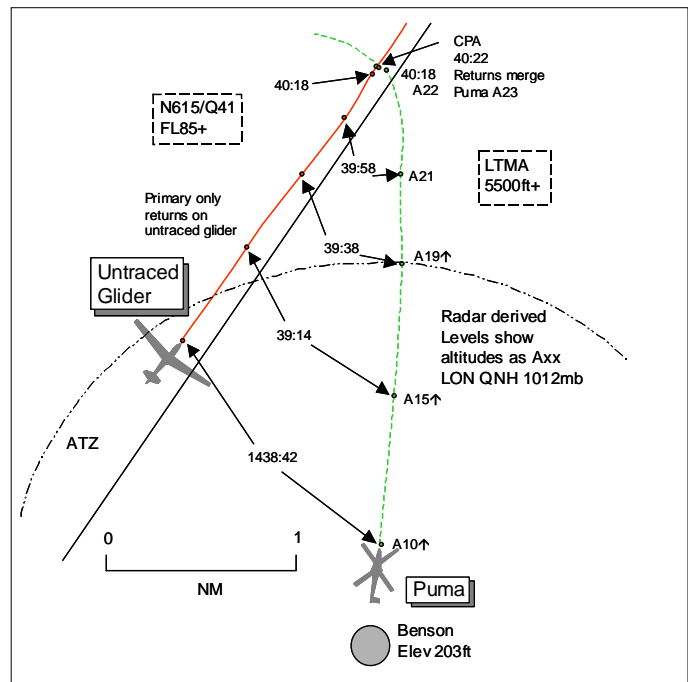
THE PUMA PILOT reports flying a local sortie from Benson and in receipt of a DS, he thought, from Benson Director, squawking 3610 with Mode C. The visibility was 30km flying 2500ft below cloud in VMC and the ac was camouflaged green with HISLs, nav and landing lights all switched on. After completing an overshoot from a PAR RW01 they were being re-positioned for a further approach, an ILS RW19. When commencing a level L turn on to heading 290° [actually 310°] at 1900ft QFE 1006mb and 100kt about 3nm N of Benson, iaw ATC instructions, the handling pilot in the LH seat spotted a glider out of the corner of his eye approaching from the LHS at the same level. He immediately initiated a rapid climb to avoid the glider which was seen to pass about 100-200ft below. He informed ATC that the glider was at 1900ft and 3nm on the extended C/L of RW01. He assessed the risk as high.

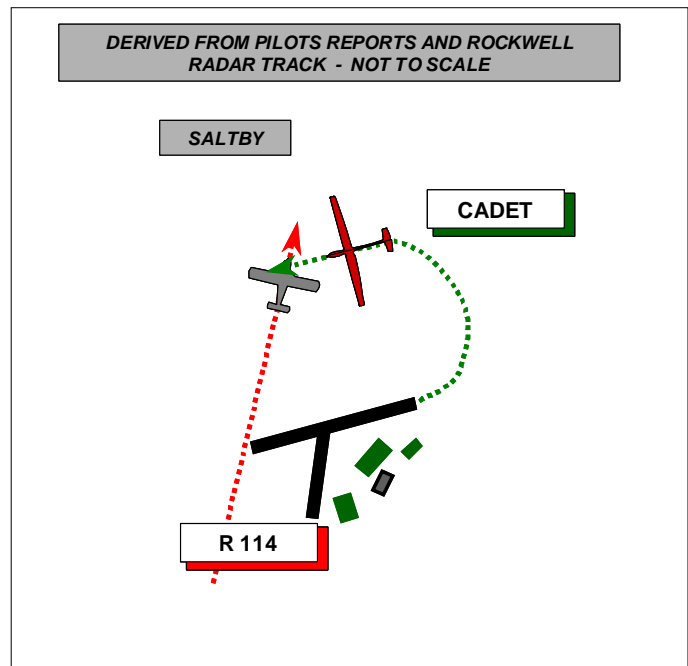
THE SLINGSBY CADET PILOT reports that he had completed a normal glider winch launch to a height of 1200ft AAL at Saltby airfield in a silver ac with no SSR, radio or lights. Turning crosswind into the cct (RWY08 LH cct) he noticed a white low wing, single-engined, ac with a green stripe on a heading of about 300° about 3-4nm away, approaching the airfield, very slightly above the horizon. Initially, he believed the ac to be the glider tug returning to the airfield. On turning downwind, however, heading 260° at 30kt, he remained visual with the ac and assessed that there was a risk of collision so he commenced a shallow descent to increase the vertical separation and completed a normal landing. The ac passed about 500m in front of him, from left to right and about 150ft above, while he was descending through 1000ft AAL. The ac flightpath did not deviate and it flew directly through the airfield overhead.

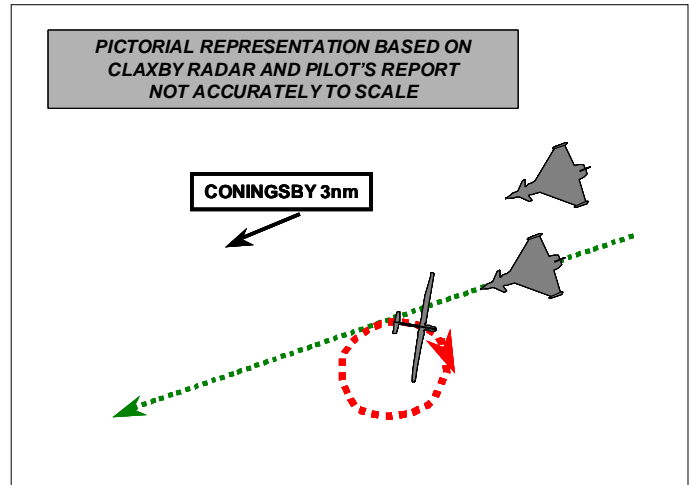
THE TYPHOON PILOT reports flying dual, leading a pair of Typhoons recovering visually to Coningsby RW27 (L) in echelon formation, from a routine training sortie in contact with Coningsby TWR squawking as directed with Mode C. As the formation approached initials [070°/3nm@2000ft QFE] the No2 pilot called 'Bunt, Bunt, Bunt' in order avoid a [white] glider [which he saw 0.25nm away]. The lead Typhoon bunted aggressively and the No2 subsequently called that the collision risk had been averted. The lead Typhoon pilot did not see the glider at any stage.
