ASSESSMENT SUMMARY SHEET FOR UKAB MEETING ON 14 SEPTEMBER 2011

AIRPROX REPORT No 2011024

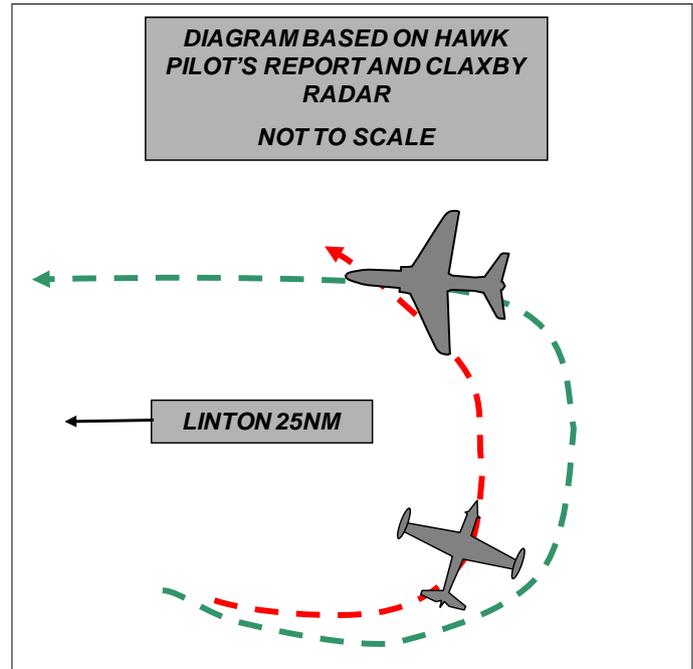
THE HAWK T MK1 PILOT reports flying a dual Forward Air Controller (FAC) training sortie in a NOTAMed area in the Yorkshire Wolds [see UKAB Note (2)] in a black ac with all lights switched on, squawking 7001 with Mode C; TCAS and Mode S were not fitted. Following the completion of a simulated ground-directed target attack profile at low level, the ac was repositioned overhead the target area in a steady level left turn at 2000ft amsl and 300kt in order to complete a high workload RT debrief for the student FAC. After one orbit the rear seat pilot made the captain aware of a white light ac with 'podded wingtips' and displaying white strobes, 1000ft away, co-altitude and maintaining a constant 'nose on' attitude towards them. He attempted to change the geometry between the two ac but it had no effect and he thought that the ac was deliberately following their flight profile.

In order to terminate the conflict he was forced to level the wings and accelerate his ac away from the following ac and, once safe separation between the two ac was established, the debrief was continued. The light ac was then seen to depart to the NW whereupon a waggle of the wings was observed.

It was unfortunate that the second ac (ac 2) could not be traced as a pilot's report would have facilitated a fuller investigation of this incident. Members opined that there are not many ac types (with tip tanks/pods and a bubble canopy) that fit the reported description of the untraced ac as amplified by the Hawk pilot by telephone to the UKAB; further in order to fly the profile reported the ac 2 must have been capable of fairly high performance. Members also noted that the ac had not been squawking, which most likely excluded military ac; also that it did not even show as a primary contact in an area where radar performance is fairly good, thus also probably excluding ac such as a (red and white) Jet Provost which is otherwise similar to the description. There is one fairly high performance light training ac on the UK register with a colour scheme that matches that reported but it is based well away from Yorkshire and it was established that it was not airborne on the day of the incident.

Cause: Sighting report.

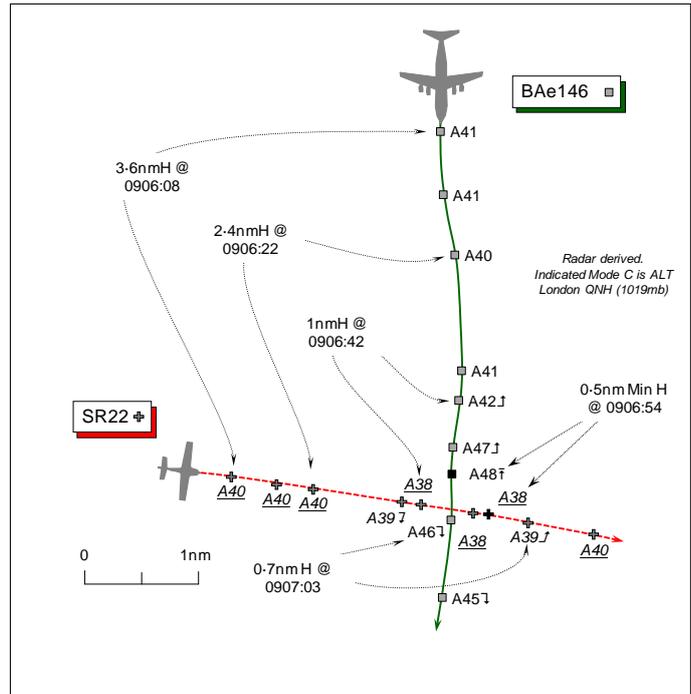
THE BAe146 PILOT reports he was in transit to Northolt on an IFR flight, routing SIVDA to BARKWAY (BKY), and had descended wings level at 230kt from FL100 to 4000ft London QNH (1018mb) into cloud with London MILITARY [LJAO E-TACTICAL] under a TS. A squawk of A4671 was selected following a handover to Luton RADAR, but before two-way RT was established with the Luton controller, heading 200° 10nm N of BARKWAY (BKY), TCAS showed traffic at the same altitude of 4000ft moving R to L. Flying in between cloud layers with FEW at 5000ft, TCAS enunciated a CLIMB RA and the guidance was followed, ascending to an altitude of about 4600ft, before returning to their previously 'cleared' level. The other ac – a white civilian low-wing single-engine propeller driven aeroplane - passed less than 1nm in front and 400ft below their ac with a 'high' Risk of collision. No TI had been given by London MIL. Once they had established RT comms, Luton RADAR asked whether details of the other ac had been passed to them on handover. Luton stated they would complete a report on the incident. The recovery to Northolt was completed without further incident.

NATS LTD reports that the BAe146, had been operating outside CAS under the control of London MILITARY (LJAO E-TAC) and at 0858 was pre-noted to Luton RADAR for a 'Charlie' arrival inbound to Northolt. Luton RADAR was being operated by a trainee monitored by an instructor. At this time the BAe146 was outside the range at which Luton RADAR was operating so the controller asked for the ac to be handed over later, when it was within 30nm of Luton.

On completion of an air test, the BAe146 began to route towards BKY via SIVDA descending to 4000ft London QNH and, at 0859:00, was pre-noted by E-TAC to Luton RADAR. E-TAC was under training with two other ac pre-noted to them but only the BAe146 was on frequency at the time of the occurrence.

Cause: In the absence of specific TI, a conflict in Class G airspace resolved by the BAe 146 crew using TCAS.

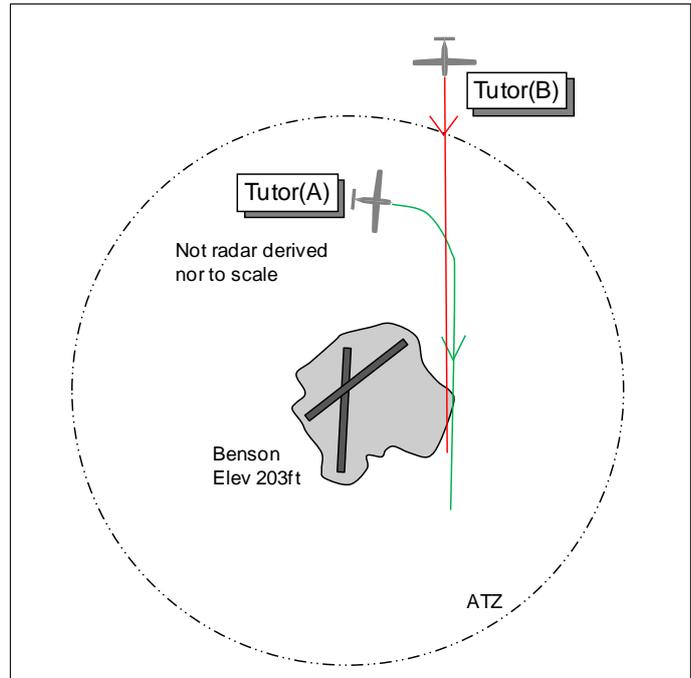
THE TUTOR(A) PILOT reports flying a solo cct consolidation exercise at Benson, VFR and in communication with Benson Tower on 127.15MHz; the ac's transponder was switched off. The visibility was 10km below cloud in VMC and the ac was coloured white with HISLs and nav lights switched on. He was late making a downwind call on RW01 because when he was ready, about a third of the way down the RW, he was unable to call owing to other traffic communicating with ATC. Heading 190° at 800ft QFE and 80kt he made a routine lookout to the R, by now he was two-thirds of the way down the RW, he noticed another Tutor, Tutor(B), about 100ft higher and 150ft away in his 4 o'clock. He believed that both he and the Tutor(B)'s pilot saw each other at the same time because the other Tutor initially broke R as its pilot called ATC before then conducting a LH orbit. During this period he maintained straight and level flight and watched to see what Tutor(B) was doing. Once Tutor(B) was clear he was able to call "downwind" and was cleared for a touch and go after another Tutor, Tutor(C) that was already on final. He assessed the risk as high.

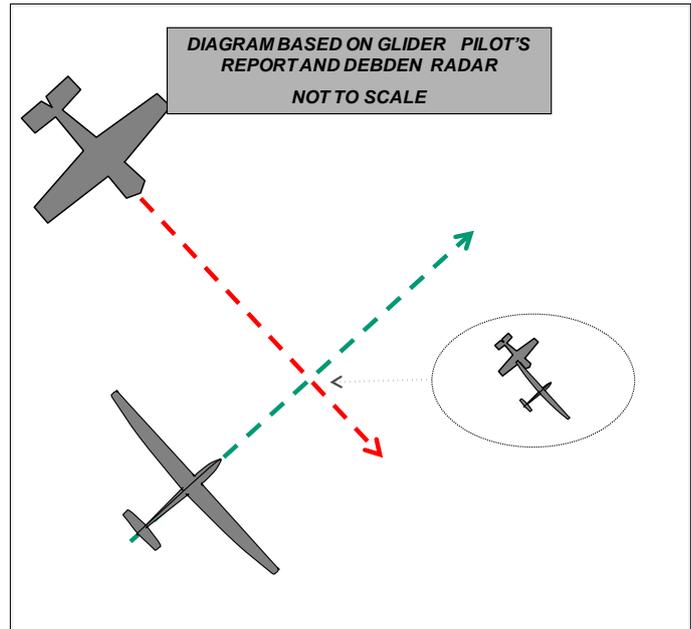
THE DISCUS 15M GLIDER PILOT reports soaring at 70kt in a white single-seat glider with orange hi-visibility flashes on the wings and fin. He was 7nm SW of Sywell and listening out on a gliding common frequency when he had a close encounter at 4300ft (QNH) with a single-engine GA ac, believed to be low wing or mid-wing configuration, mostly white with some blue and possibly a yellow flash [actually silver with a yellow band]; the registration was not seen. He was not equipped with SSR or TCAS; FLARM was fitted and serviceable but did not indicate any contacts.

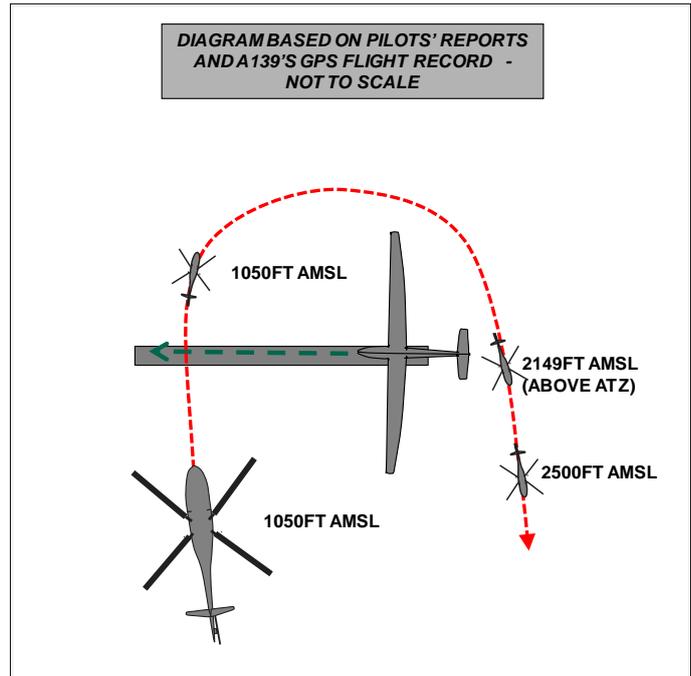
THE PUCHACZ GLIDER PILOT reports flying the second of two check flights for the handling pilot in a white glider listening out on the [unmanned] TWR VHF frequency [120.8]. The ac was launched by wire auto-tow from RW27 and they were in the initial climb at about 300ft and 55kt when the instructor aborted the launch to simulate a launch failure/cable break. As the handling pilot lowered the nose of the glider a red and white helicopter was seen in their 11 o'clock position heading slightly towards them, crossing from L to R. The instructor took control and commenced a descent to land straight ahead. The helicopter maintained its height of about 1500ft and turned about 030° left crossing ahead of them before turning R on the N side of airfield over the technical site. Thereafter, the helicopter turned R and flew away from the airfield to the SE.

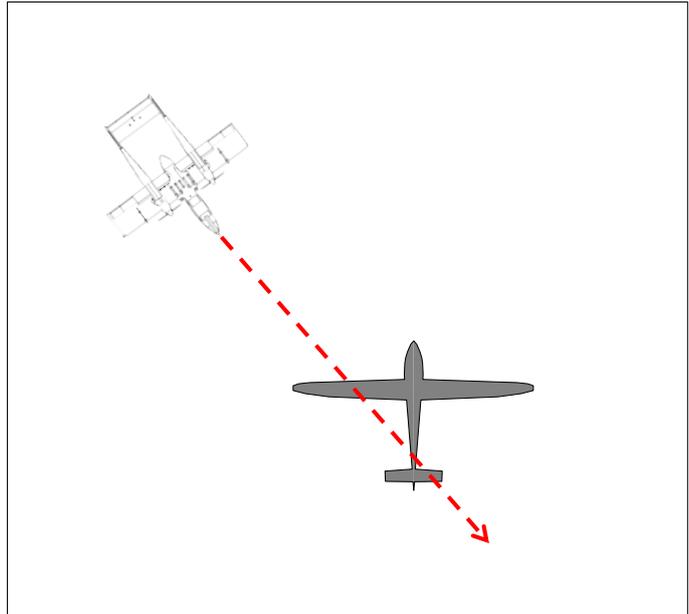
THE VENTUS GLIDER PILOT reports soaring at 50kt on the Marham QFE of 1020mb [see UKAB Note (1)] in dark, overcast conditions in a white glider with no SSR fitted but listening out on Marham Ground when he saw a dark camouflage green, twin tail boom Bronco type ac with day glo panels, ½ nm away and approaching him. He rocked the wings of his ac to attract attention of the other pilot and then flew away from the other ac.

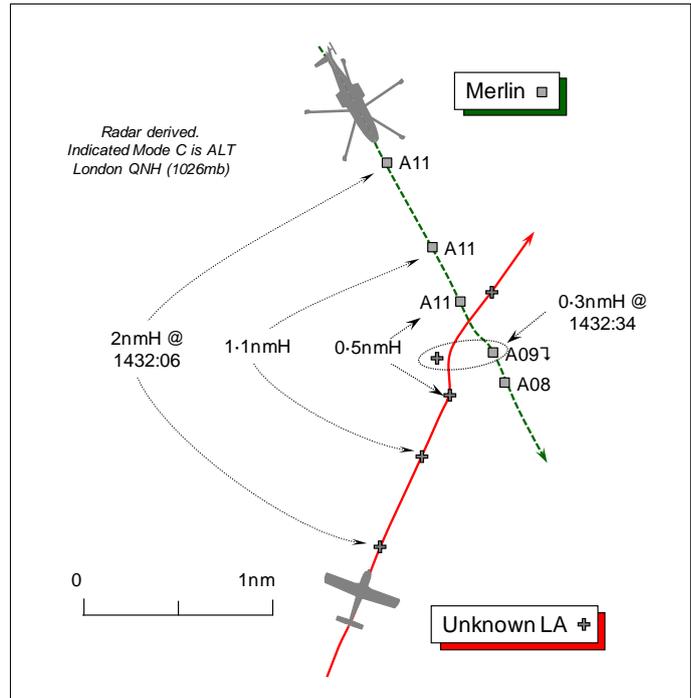
THE MERLIN HC3 HELICOPTER PILOT, a QHI, reports he was conducting a conversion training sortie and was in transit under VFR from Linton-on-Ouse to Benson, whilst monitoring the LFS frequency. He was not under an ATIS; a squawk of A7000 was selected with Mode C; neither TCAS nor Mode S is fitted.

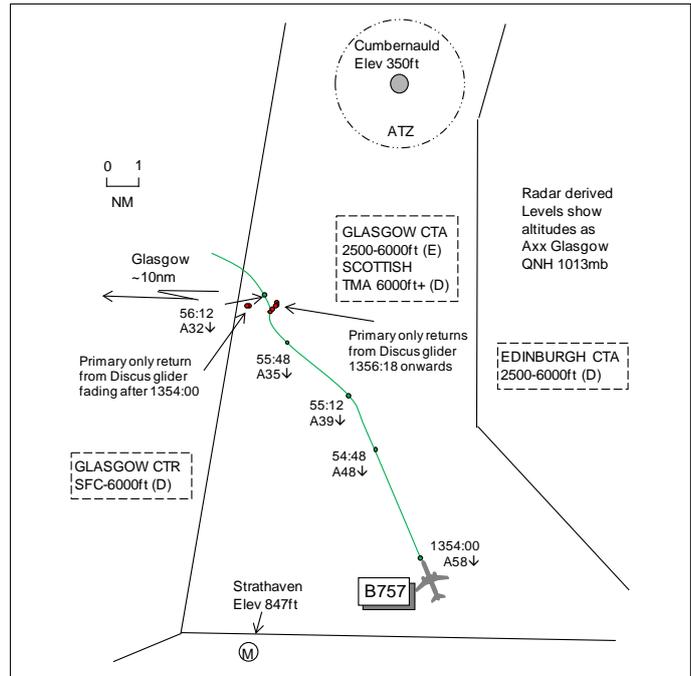
THE B757 PILOT reports inbound to Glasgow IFR and in receipt of a RCS from Glasgow Approach on 128.75MHz, squawking 2746 with Modes S and C. They were operating in excellent visibility below scattered cloud and had requested and received clearance for a visual approach but not to descend below 3000ft. Radar had advised that a primary return had been seen in the area previously but had now disappeared, having believed that the ac had descended below radar cover. About 12nm SE Glasgow heading 300° at 230kt, level at 3000ft, he thought, he saw a glider directly ahead range 1.5nm and at the same level. The A/P was disconnected and a R turn was commenced. The glider appeared to fly straight and level in the opposite direction passing 100m to their L at the CPA. ATC was informed and the approach was continued normally. He assessed the risk as high.
