## AIRPROX REPORT No 2010145

Date/Time: 16 Sep 2010 2255Z (night)

Position: 5314N 00430W (Final  
RW31 Valley - elev 36ft)

Type: Hawk Lynx

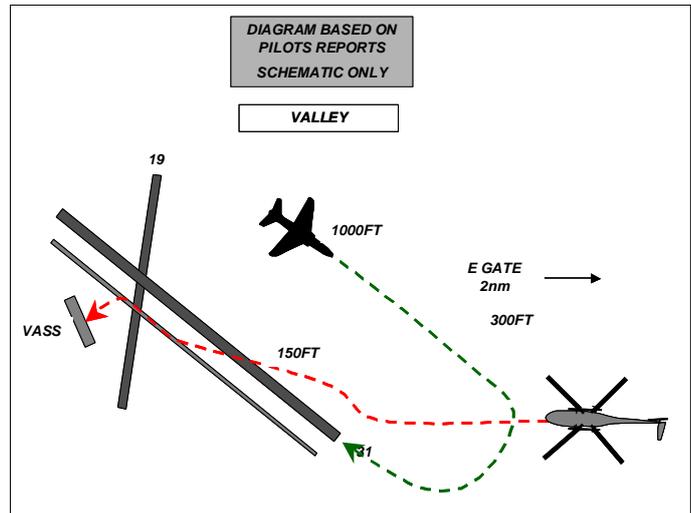
**THE HAWK PILOT** reports that he was in the [night] cct for RW31 (RH) with his (red) strobe and nav lights switched on and was in receipt of a BS on UHF, from the Valley ADC on his first night solo on Hawks; TCAS was not fitted. While descending and turning through about 500ft QFE on the final turn at 140kt, while looking into the turn towards the threshold, he saw the red strobe of an ac passing below them. He rolled wings level to line up with the RW and then saw the red strobe level with his ac, on the horizon in his 4 o'clock; at that time he was at 300ft QFE. He called TWR to confirm whether or not there was any traffic on short final and was informed that a Lynx helicopter holding short of RW31. The angle-rate geometry of his observation of the strobe enabled him to accurately assess that the separation between the helicopter and his ac to have been between 100 and 200ft.

It appears that the height of the Lynx and its proximity to the RW31 threshold caused concern to the Hawk pilot and moreover, if the heights reported by the respective pilots are accurate, then only about 200ft vertical separation might have existed, supporting the Hawk pilot’s assessment of the separation. However, the Lynx crew was visual with the Hawk from early in their recovery, they remained so throughout and were content that adequate separation existed at all times.

finals turn. The Hawk's height here would have been 700 – 800ft which, coincidentally, equates to the 400 – 500ft separation noted by the Lynx pilot. This, and the fact that the Lynx crew reports being visual throughout reduces the level of concern over this incident, but the fact remains that the Lynx reduced the separation unnecessarily. HQ Air is content that the RAF Valley procedures are robust.

Cause: The Lack of TI led the Hawk pilot to believe there was a conflict with the Lynx

Recommendation: 1. It is recommended that RAF Valley reviews its procedures for co-ordinating helicopter movements under fixed-wing circuit traffic.
