## AIRPROX REPORT No 2011057

Date/Time: 4 Jun 2011 1035Z (Saturday)

Position: 5545N 00213W (10nm S of ST ABBS VOR)

Airspace: Scottish FIR (Class: C)

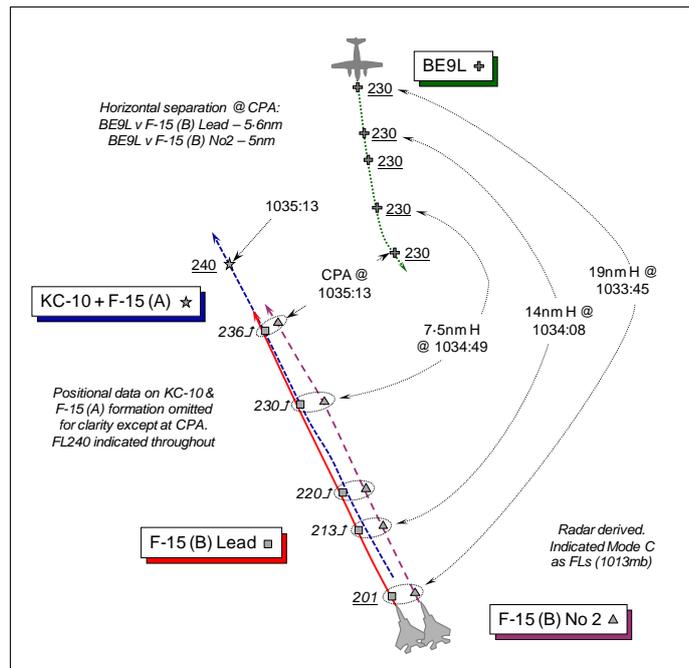
BE9L v F-15 (B) Lead: 600ft V/5.6nm H

BE9L v F-15 (B) No2: N/K V/5nm H

It is clear that F-15 (B) flight climbed above their assigned level of FL210, thereby breaking the coordination agreement between ScATCC (Mil) and ScACC TAY SC. Although the instruction to climb to FL210 was clear, F-15 (B) flight leader did not acknowledge this instruction. Moreover, it has not been possible to determine whether the flight leader mis-heard the instruction or whether they suffered a cognitive failure, where their desire to join the Coronet formation intruded on their response execution such that they omitted to level-off at FL210.
