AIRPROX REPORT No 2012065

Date/Time: 14 May 2012 2135Z (Night)

Position: 5108N 00146W
(1km WSW RW35 THLD
Boscombe Down
- elev 407ft)

Airspace: ATZ (Class: G)

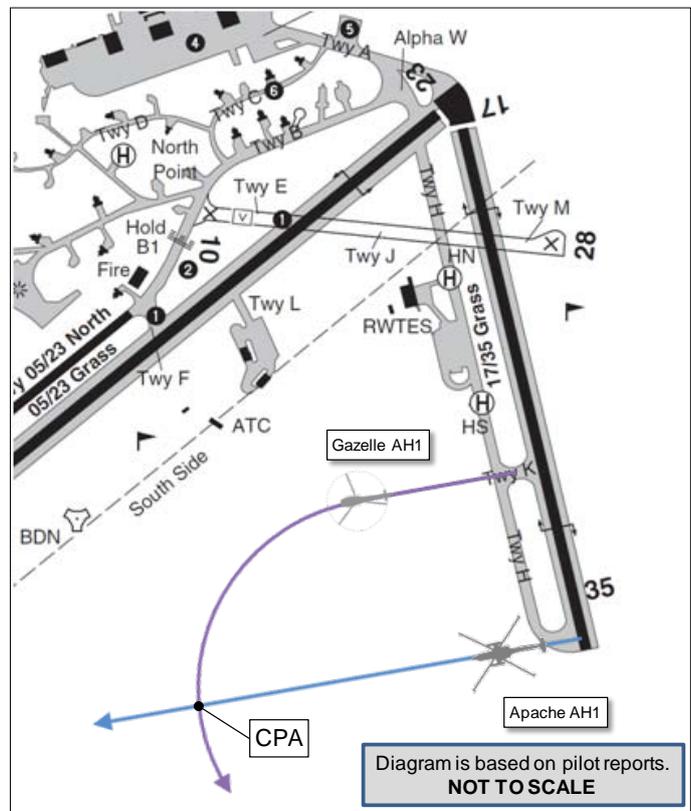
THE APACHE PILOT reports flying a local night advanced training sortie using NVS and operating RW23 LHC 'South Side', with navigation and red anti-collision lights selected 'on'. The SSR transponder modes 3/A, C and S were selected on but TCAS was not fitted. In the hover over the RW35 threshold he conducted a lookout turn in order to obtain visual contact with a Gazelle helicopter he believed to be late DW or on L base; red lights were seen in that area. He completed the lookout turn, transitioned into forward flight into wind heading 260° and accelerated to 70kts. 'At circa [hgt] 250ft ...' [Boscombe Down QFE 1000hPa] the Gazelle appeared in his 5 o'clock position approximately 100-200ft above him and turning over the top. He stopped climbing and extended into wind to achieve greater separation. The Gazelle then moved to operate RHC to the N of RW23.

He observed that the Gazelle's anti-collision lights did not appear to be functioning, that its navigation lights blended into the clutter of other lights on the airfield, that it did not stand out from the backdrop of a very well lit up area around Boscombe Down and that operations on the South Side were being conducted 'negative R/T'.

2. Immediately prior to the incident, the crew of the Gazelle conducted a visual lookout turn, whilst in the hover on runway 35 main, and positively identified the Apache, hovering, on the threshold of runway 35. The Gazelle then transitioned on an approximate heading of 260° accelerated to 90 kts IAS and planned to level at 500ft QFE. A short time later, the Apache crew also conducted a lookout turn whilst on the threshold of runway 35 main and, believing that the Gazelle was late downwind/base leg, identified red lights towards that position. No further hazards were detected visually, on the aircraft radar or NVS and the Apache transitioned on an approx heading of 260° accelerated to 70 kts and planned to level at 300ft QFE. As the Gazelle approached 450ft the handling pilot (HP-right seat) called for the non-handling pilot (NHP) to clear him left which he did. The HP commenced a left turn and after approximately 20° of turn he saw the Apache approaching from the left rear of his aircraft, called it and instinctively commenced a gentle climb levelling at 600ft QFE. Simultaneously, as the Apache crew approached 250ft QFE they saw the Gazelle appearing from, what they perceived to be, their 5 o'clock position turning over the top as the Apache pilot started to level off. Both crews estimated the distance between both aircraft was between 100-200ft with little time for effective avoiding action.
