AIRPROX REPORT No 2012096

Date/Time: 7 Jul 2012 1047Z (Saturday)

Position: 5202N 00056W (3½nm
SE of Silverstone Heliport
– elev: 502ft)

Airspace: Silverstone RA(T) (Class: G)

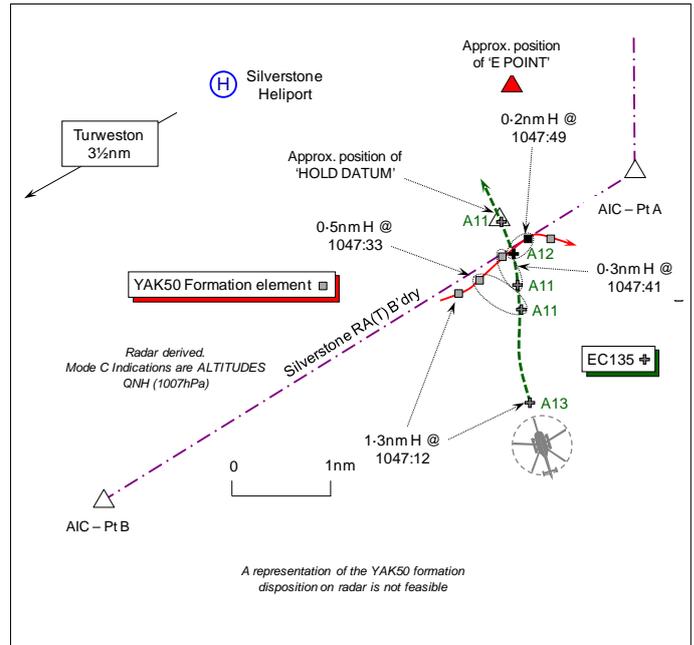
Nil V/30m H Not seen

Not feasible

Cause: A non-sighting by the YAK50 formation on the boundary of the Silverstone RA(T).

1. The Silverstone operator is recommended to review the AIC, in concert with CAA AUS, to provide additional guidance to pilots flying in the vicinity of the RA(T) and to review the briefing requirements for display crews.
2. The YAK50 formation display team is recommended to review its operating procedures.
