AIRPROX REPORT No 2012148

Date/Time: 31 Aug 2012 1015Z

Position: 5218N 00047W
(RW21L Sywell A/D
- elev 400ft)

Type: Corby Starlet A109E

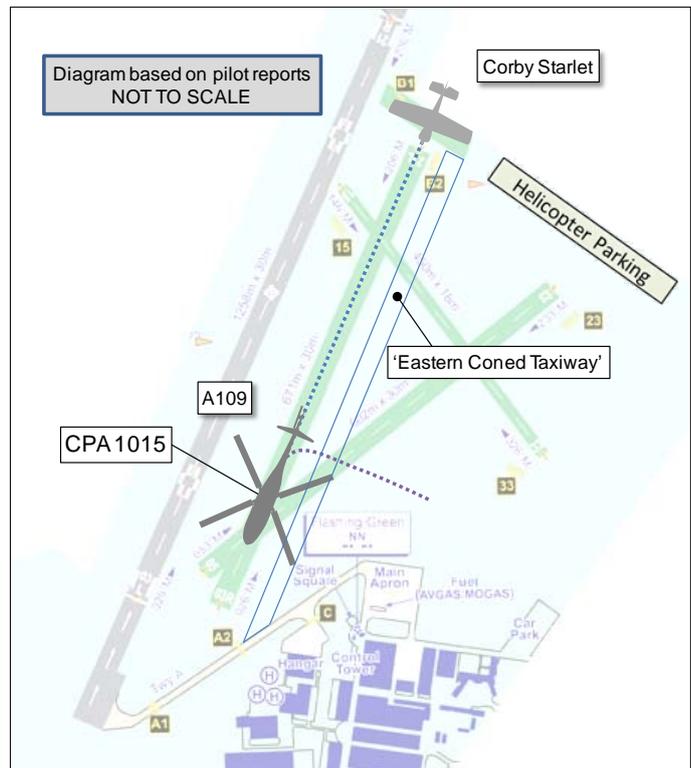
The Starlet pilot observed that the A109 did not cross the RW as expected but instead hovered over the RW. He became unsure as to the A109 pilot's intentions and, reluctant to go around over the top of the helicopter, landed on RW21L/Grass.

The Starlet pilot slowed to exit L and applied L rudder. The ac then swung through approximately 90° to the R. The pilot initially believed that the tailwheel steering had failed and looked up, into the cockpit of the A109 directly O/H. The Starlet pilot continued to apply L rudder and eventually the ac responded. He moved to the L and vacated the RW.

Cause: The Starlet pilot landed while the runway was occupied by the A109.
