## **AIRPROX REPORT No 2012158**

Date/Time: 10 Oct 2012 1359Z

Position: 5133N 00009W  
(North Weald Base Leg  
RW02 LH - elev 321ft)

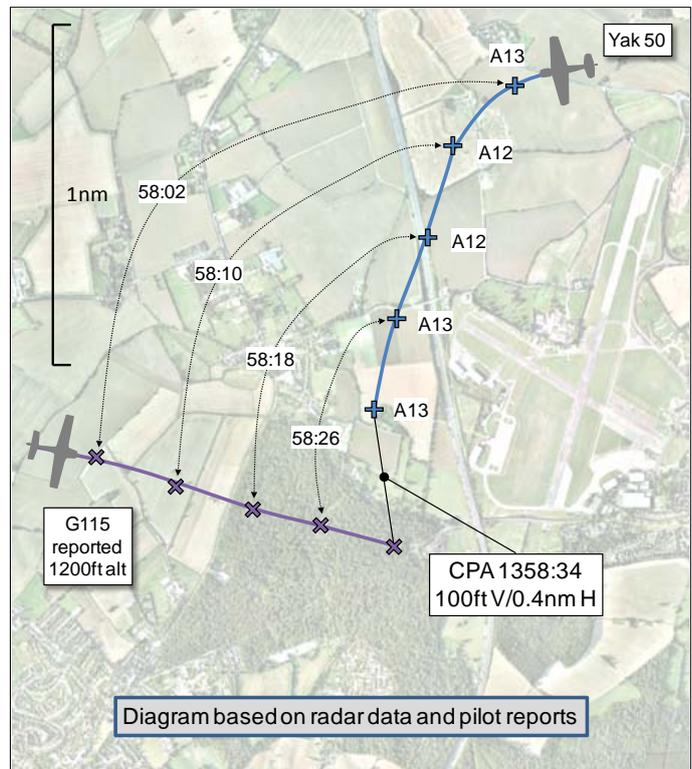
At 1358:00 the Yak 50 pilot advised North Weald Radio of his intention to simulate an engine failure and to overfly the A/D without undercarriage. At 1358:25 the Yak 50 was shown midpoint downwind, indicating 1300ft, with the Grob 115 in the Yak 50 pilot’s 12 o’clock at a range of 0.5nm, crossing from R to L towards the RW02 threshold. The Yak 50 pilot reported traffic ‘just going crosswind’. The A/G operator replied that the other traffic had not identified itself to North Weald. The Grob 115 pilot’s written report indicated being visual with the Yak 50 at approximately the same level.

At 1359:03, the Yak 50 pilot cancelled the simulated engine failure and reported heading E to ‘come back in a few minutes’. Radar recording showed the Yak 50 pilot turning towards the Grob 115 at a range of 0.9nm. The Yak 50 is shown to follow the Grob 115 on an E’ly track at 1000ft. The Yak 50 pilot continued to follow and manoeuvred behind the Grob 115. At 1401:48, the Yak 50 was shown 0.1nm NW of the Grob 115 at 900ft. The Yak 50 pilot continued to fly parallel to the Grob 115 and at 1402:00 was shown in the Grob 115 pilot’s 3 o’clock position at 0.1nm. The two ac continued converging and, at 1402:06, the distance between them reduced to less than 0.1nm. At 1402:14 the radar contacts merge with the Yak 50 indicating 800ft. The Grob 115 pilot’s written report indicated his being surprised to see the Yak 50 in close formation, within 10-15m of his ac for 20sec before breaking away behind and below.
