## **AIRPROX REPORT No 2013179**

Date/Time: 20 Dec 2013 0929Z

Position: 5301N 00412W  
(Lleyn Peninsular)

Type: Hawk T1(A)              Hawk T1(B)

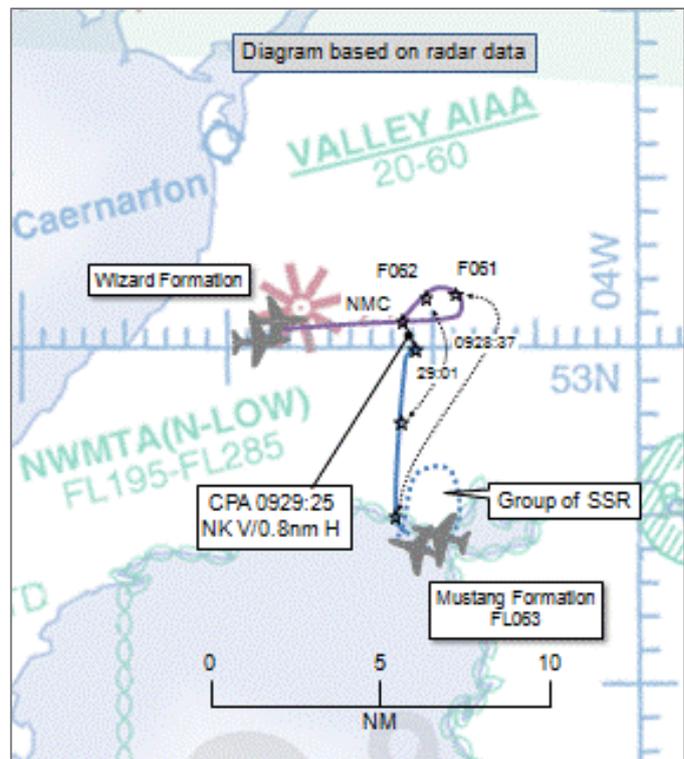
NK V/0.8nm H<sup>1</sup>

<sup>1</sup> CPA is derived from surveillance tracks but some aircraft in the formations were not transponding. Actual CPA could therefore have been less than that recorded.
