AIRPROX REPORT No 2013014

Date/Time: 14 Mar 2013 1059Z

Position: 5114N 00048W (2.5nm SSW
Farnborough - elev 238ft)

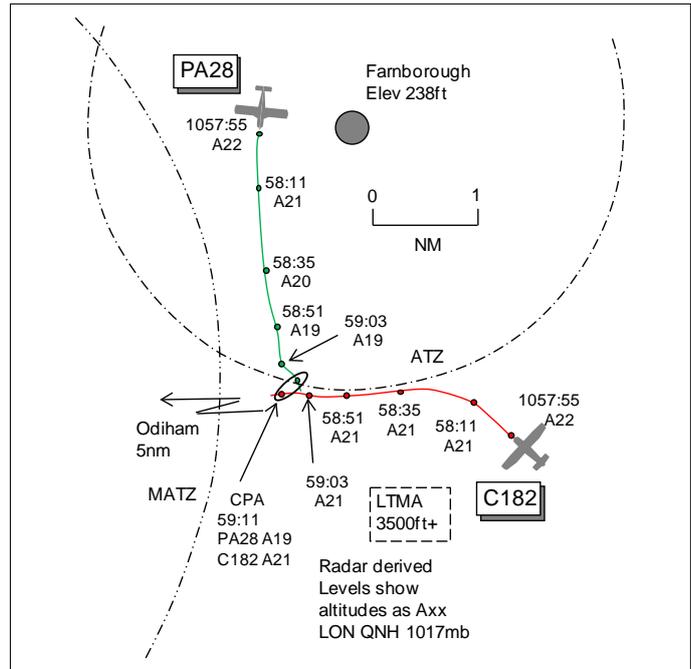
200ft V/0.2nm H

behind, well clear.” The radar replay shows that at this point the PA28 was 0.3nm NW of the C182, maintaining a SSE’y track indicating 1900ft. The PA28 can then be observed making a hard turn to port at 1059:10, passing 0.2nm NE of the C182 and indicating 200ft below. This point represents the CPA, 5.6nm E of Odiham.

Based upon the PA28 pilot's report, they sighted the C182 immediately prior to initiating the L turn observed on the radar replay at 1059:10, with the radar separation according with the pilot's assessment of less than 0.5nm.
