## AIRPROX REPORT No 2013037

Date/Time: 16 May 2013 1550Z

Position: 5358N 00014W  
(9nm NE of Leconfield)

Type: Jetstream JS41 F15E

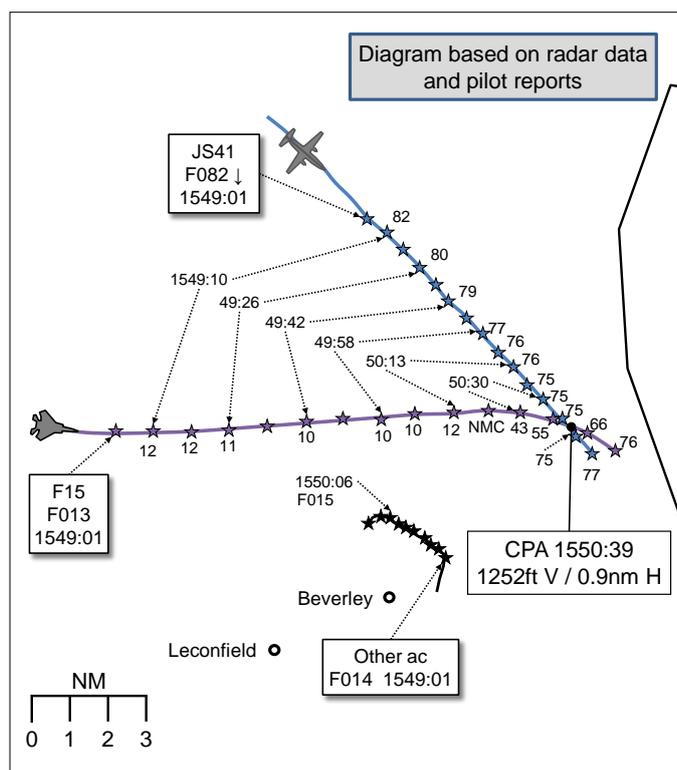
Recorded Separation:  
1200ft V/>0.1nm H

Cause: The F15E pilot climbed into conflict with the JS41, which he did not see.
