## **AIRPROX REPORT No 2013108**

Date/Time: 9 Aug 2013 1450Z

Position: 5154N 00210W  
(1.3nm E Gloucestershire A/D  
- elevation 101ft)

Type: Merlin HC3 Mooney M20C

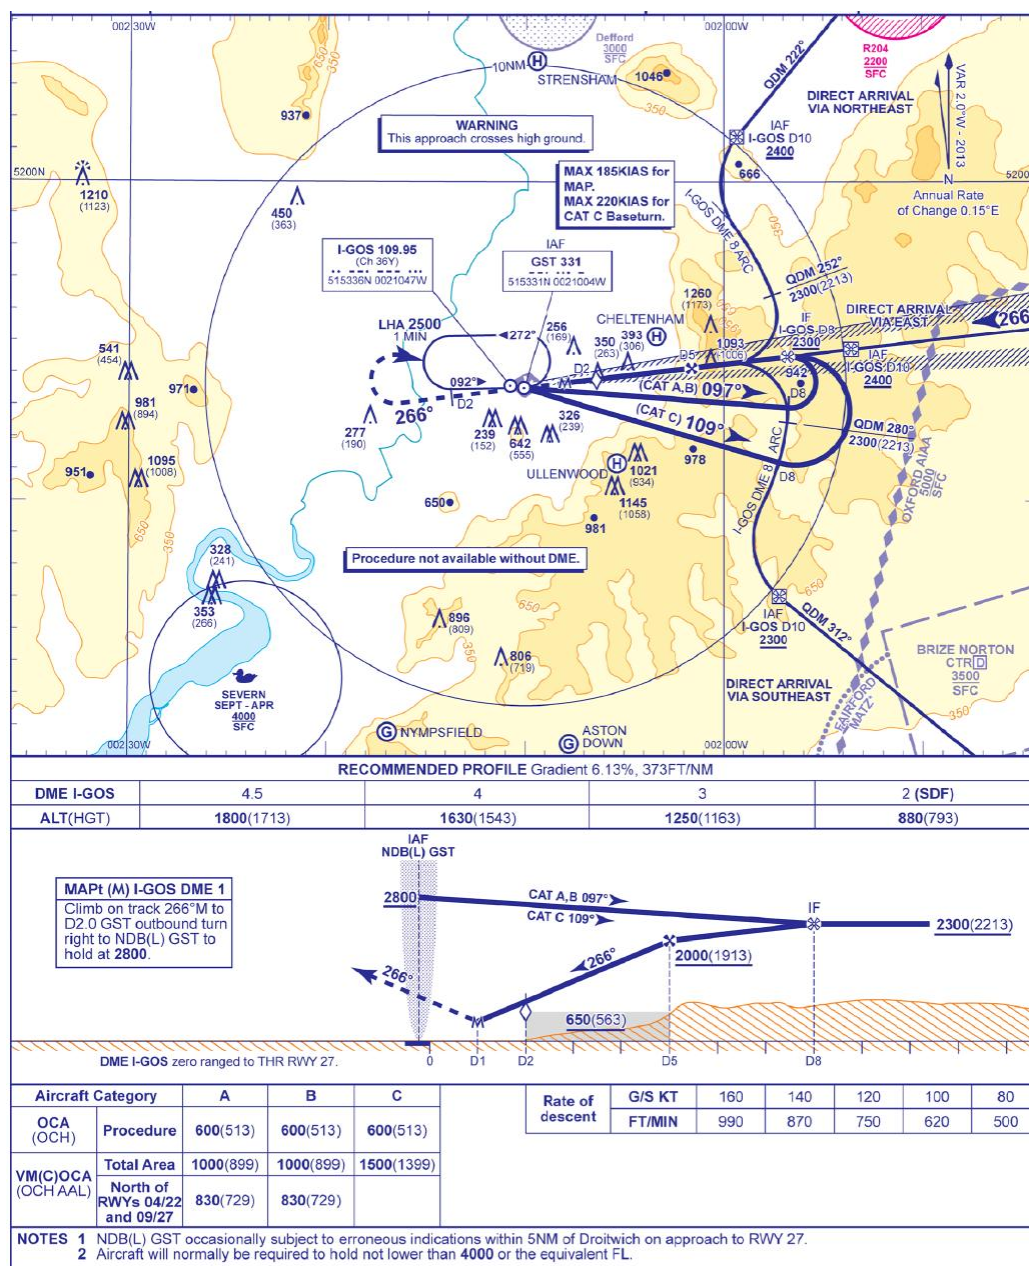
Figure 1 – Extract from the IAP – NDB/DME RW27

carry out an NDB/DME approach to RW27. An extract from the Instrument Approach Plate (IAP) taken from the UK AIP page AD 2-EGBJ-8-8 (30 May 13) is shown below Figure 1.
