AIRPROX REPORT No 2013156

Date/Time: 5 Nov 2013 1202Z

Position: 5138N 00039W
(Bovingdon hold)

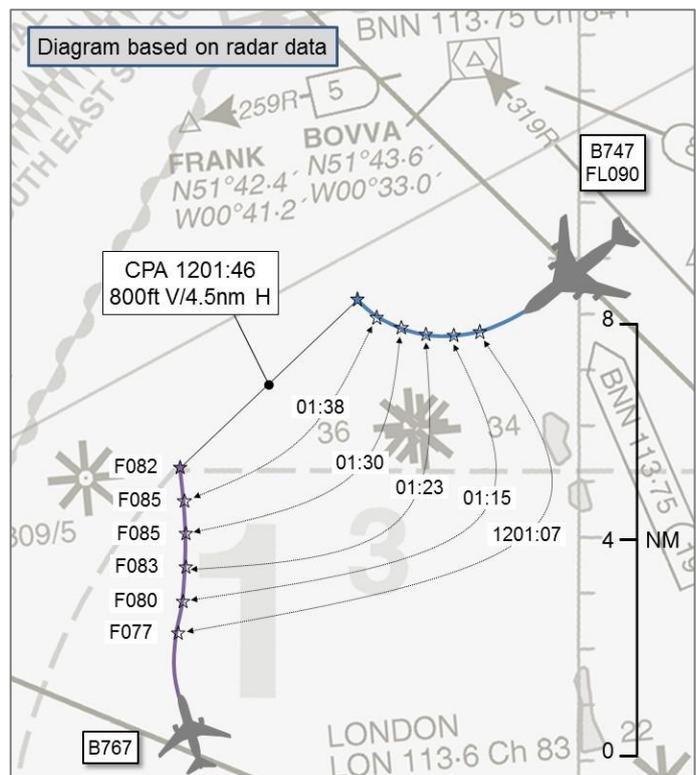
Recorded Separation:
800ft V/4.5nm H

The Board noted that, from the radar replay information, it was apparent that the B767 pilot had had the QNH set instead of the Standard Altimeter Setting. This had caused the pilot to climb above his cleared level (FL80) and into conflict with the B747 at FL90. The Board quickly and unanimously considered that this was the cause of the Airprox.

Cause: By not selecting the Standard Altimeter Setting in time, the B767 pilot climbed above his cleared level and into conflict with the B747.
