AIRPROX REPORT No 2014025

Date/Time: 24 Mar 2014 1537Z

Position: 5142N 00038W
(3.5nm SW of Bovington)

Airspace: London FIR (Class: G)

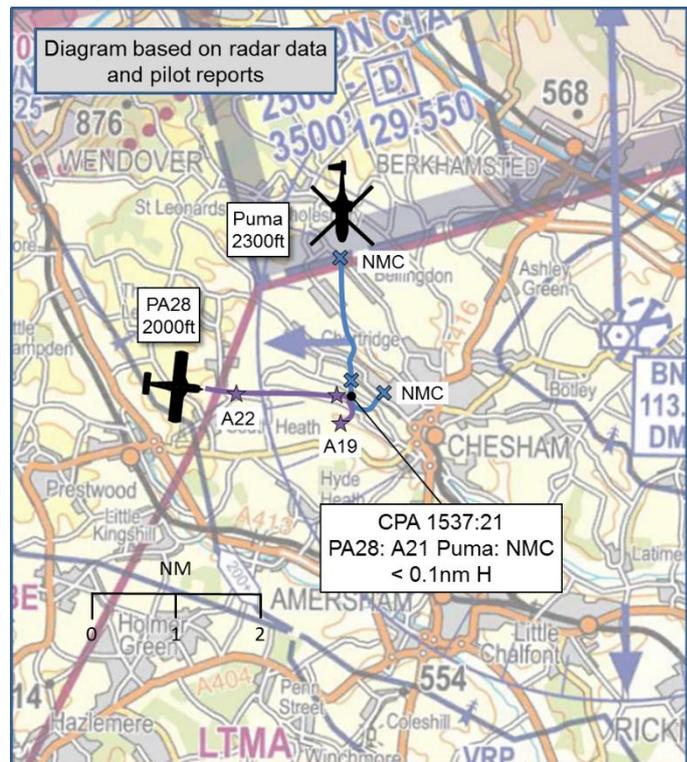
NK V/<0.1nm H

Cause: A late sighting by both pilots.

Recommendation(s): JHC consider investigating Puma SSR and NATS radar compatibility.
