AIRPROX REPORT No 2014199

Date/Time: 7 Oct 2014 1338Z

Position: 5115N 00103W
(2nm ESE Basingstoke)

Type: Chinook Duo Discus

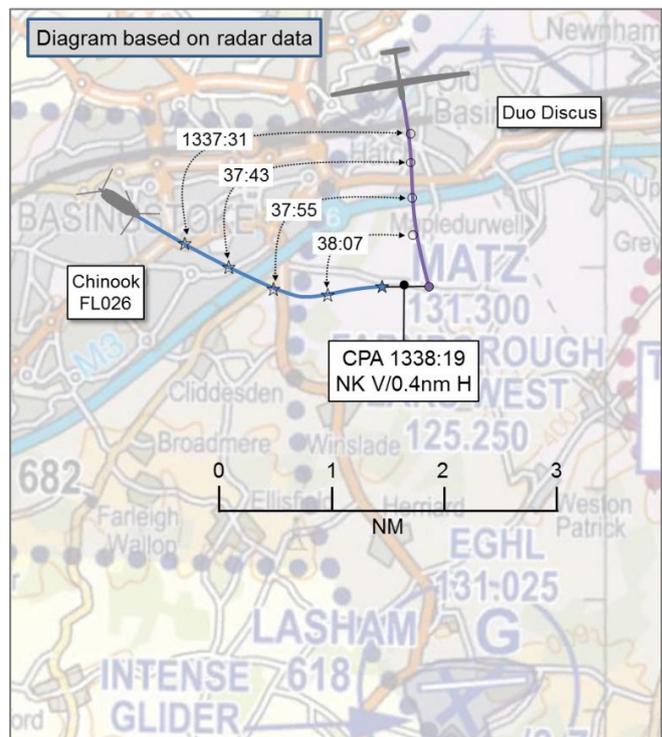
Recorded Separation: NK V/0.4nm H

THE ODIHAM APPROACH CONTROLLER reports the Chinook pilot called for a radar pickup at Odiham for an ILS. He was identified and given a reduced Traffic Service. When transiting 1nm south of Basingstoke Hospital, a contact was called to him in the left 10 o'clock, range 5 miles, crossing left-right with no height information. The pilot called not visual. The traffic was then called again as left 11 o'clock, 3 miles, crossing left-right, no height information, possibly a glider from Lasham. The Chinook was just to the south east of Basingstoke Hospital by 1nm and was still not visual. A suggested turn of left 080° from the original 130° heading was given to pass behind the traffic. The traffic was then called again at 2nm and the pilot called visual. This was 2nm east-southeast of Basingstoke hospital.
