AIRPROX REPORT No 2014212

Date/Time: 10 Nov 2014 1813Z (Night)

Position: 5556N 00026W
(60nm E of St Abbs Head)

Type: Falcon 20 Tornado GR4

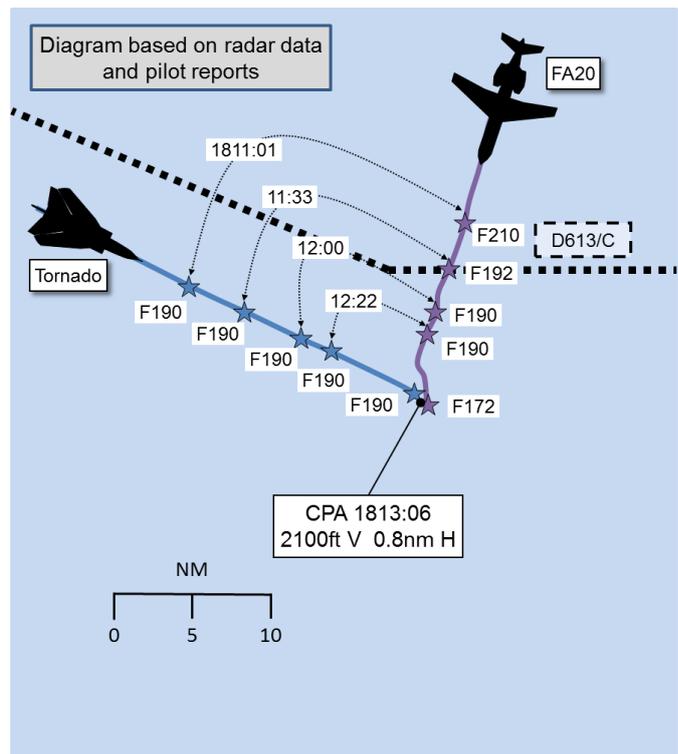
Recorded Separation:

2100ft V/0.8nm H

THE FALCON 20 (FA20) PILOT reports flying a blue aircraft with HISLs and navigation lights illuminated, under IFR in VMC, squawking transponder Modes 3/A, C and S, with TCAS II operating, and in contact with a 1ACC controller. On completion of a military training sortie in D613, a descent from FL260 to FL190 was requested from 1ACC, along with a radar handover to Swanwick(Mil) for transit to the south-west. The descent to FL190 was completed, and the squawk and frequency for Swanwick(Mil) were received, acknowledged and set just prior to exiting D613C on a heading of approximately 200°. When they transferred to the Swanwick(Mil) frequency, the FA20 crew could not check in because there was a 'high comm intensity' between 'Psycho' formation and Swanwick(Mil). The crew noted a 'pop-up TCAS track' on their display, indicating approximately 5nm away in their 2 o'clock, co-altitude at FL190. The TCAS track then rapidly indicated a TA, and appeared to be on 'an apparent collision course'. The crew made an immediate decision to take avoiding-action, turning left through 30°, with an immediate descent of approximately 4000fpm through FL180, continuing until they levelled off at FL160. During the initial descent (prior to passing FL180) the TA upgraded to an RA with a 'DESCEND, DESCEND' command. The RA command was 'immediately adhered to' and the crew estimated from the TCAS track position that the horizontal flight paths of both aircraft crossed with the aircraft separated by approximately 1000ft.

Turning to the Tornado crew, the Board noted that they had seen the FA20's lights but had found it difficult at night to judge its position and closure accurately; without the benefit of TCAS or Traffic Information, the Board considered that they had been unable to take any effective avoiding action.
