AIRPROX REPORT No 2014054

Date/Time: 7 Apr 2014 0915Z

Position: 5434N 00102W
(6nm NW RIKUD)

Airspace: UAR UL602 (Class: C)
Scottish UIR

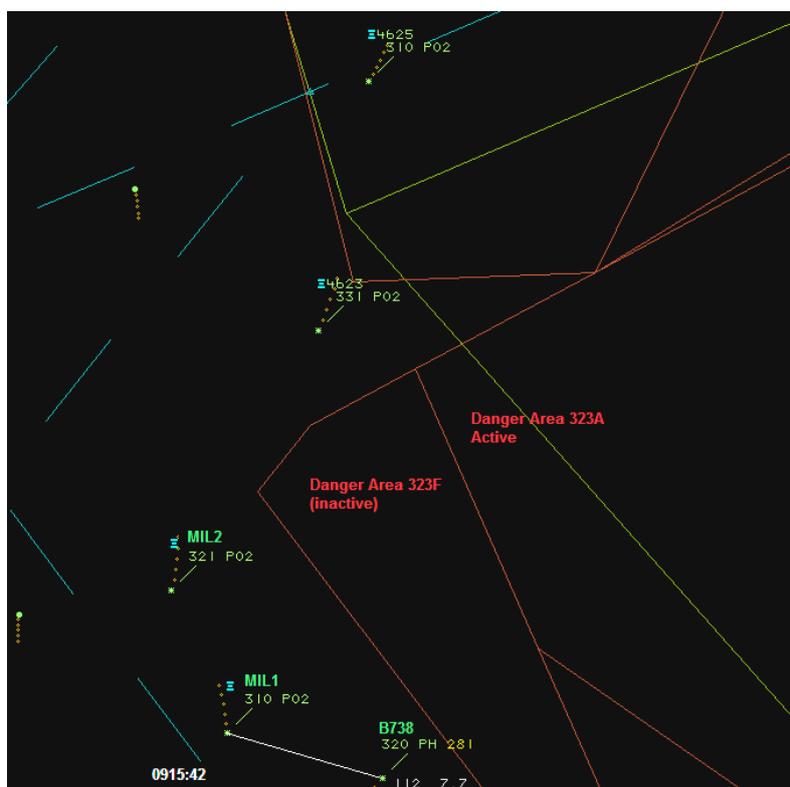
Figure 8.

The Montrose Planner managed to contact the Swanwick NE Mil controller to ask if they were working PNTHR 21; he was informed that the aircraft was with Scottish control; the Montrose Planner asked the Swanwick NE Mil controller to transfer the telephone call. At 0915:42 (Figure 8) the Planner was still trying to co-ordinate PNTHR 21 and could be heard on the open line stating that no-one was picking up. The Montrose Tactical controller had instructed the B737 pilot to descend to FL280. The B737 pilot was tracking away from PNTHR 21 and TREK 31 but towards an active Danger Area (D323A). Two other non-RVSM approved aircraft (squawking 4623 and 4625) could be seen as potential conflicts with the B737 (2000ft vertical separation was required). At 0915:49 the B737 pilot was instructed to turn north but was still heading towards the Danger Area. At 0916:05, the Montrose Tactical controller instructed the B737 pilot to squawk 7700 and advised the crew that they were entering an active Danger Area. The B737 pilot was instructed to resume his own navigation to OTBUN. The B737 penetrated D323A for approximately 20 seconds. Once clear of the conflicts with the military traffic and the Danger Area, the B737 pilot was instructed to re-select his previous SSR code and he was transferred to the next sector.
