AIRPROX REPORT No 2014059

Date/Time: 7 May 2014 0834Z

Position: 5056N 00009W
(Hurstpierpoint)

Type: DA42 DA40

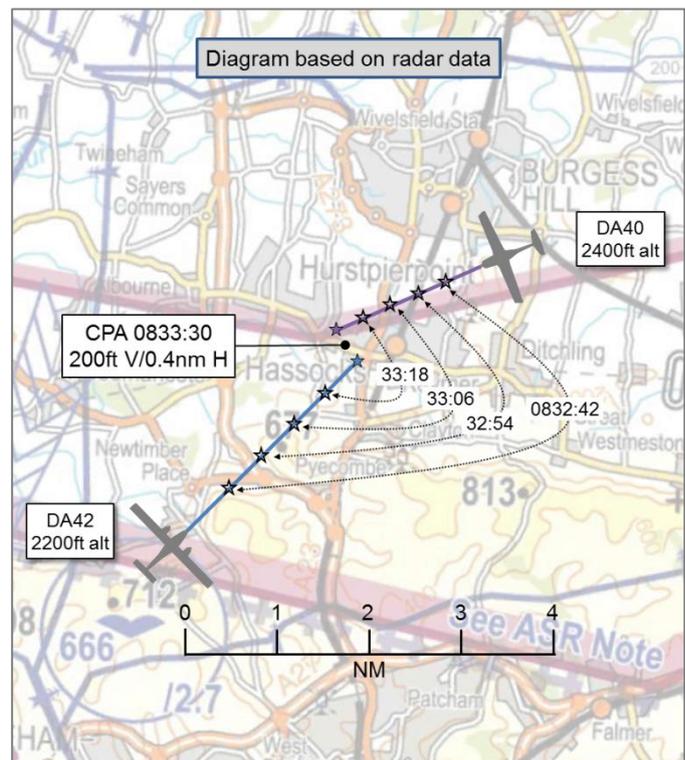
0ft V/300m H Not Seen

200ft V/0.4nm H

The Board agreed that the cause of the Airprox was a non-sighting by both pilots, and that, despite the separation of 0.4nm, safety margins had been much reduced because of the procedural nature of the DA42 pilot's approach under IFR.

<u>Cause:</u>	A non-sighting by both pilots.
<u>Degree of Risk:</u>	B
<u>ERC Score</u> ⁵ :	20
<u>Recommendation:</u>	The DA42 Operating Company considers reviewing the use of IF screens.
