**AIRPROX REPORT No 2014074**

Date/Time: 31 May 2014 1150Z (Saturday)

Position: 5047N 00018W  
(Shoreham)

Airspace: Shoreham ATZ (Class: G)

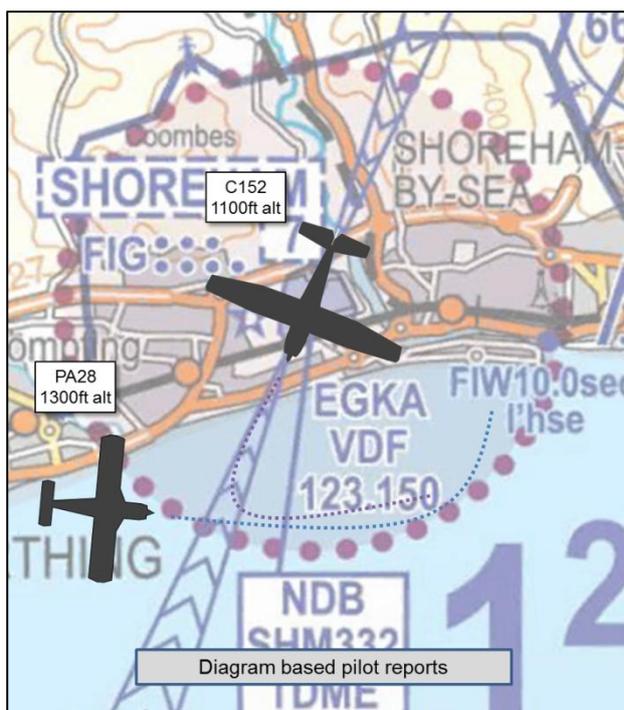
**THE C152 PILOT** reports flying in the Shoreham visual circuit with a student. Transponder Mode 3A and C were selected; he did not report which lights were illuminated. He was turning from crosswind to downwind when the other aircraft flew directly overhead at 1300ft. They kept a tight downwind circuit to avoid the other aircraft, but it flew beside them, and the other pilot made no attempt to avoid them until ATC told him to position behind.

At 1142:52, having followed the coastline, when 3.4nm southwest of Shoreham, the PA28 turned inland and commenced a left-hand orbit.
