AIRPROX REPORT No 2014077

Date/Time: 3 Jun 2014 1638Z

Position: 5101N 00301W
(15nm E MULIT)

Airspace: LON FIR (Class: G)

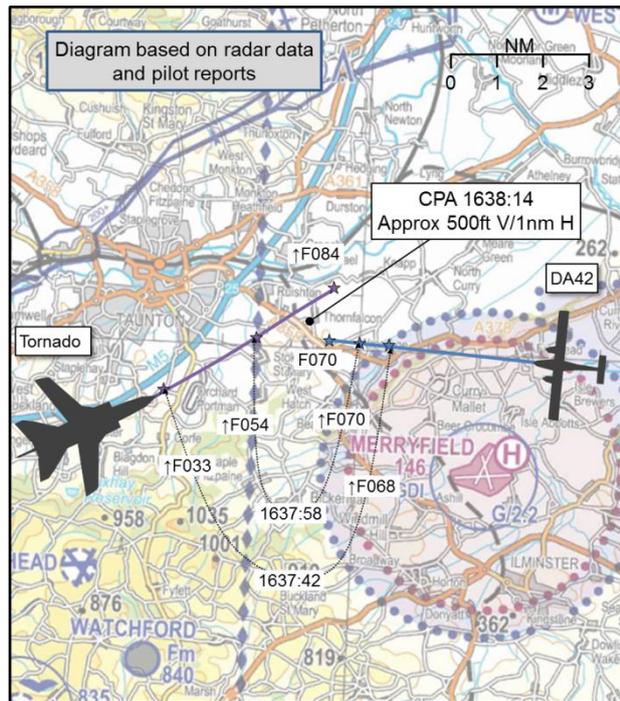
Reported Separation:

0ft V/0.5nm H NK

Recorded Separation:

500ft V/1nm H

In summarising the event, the Board determined the cause of the Airprox to be that the Tornado pilot had climbed into conflict with the DA42; they assessed the risk category as B; safety margins had been reduced much below the normal.
