AIRPROX REPORT No 2014143

Date/Time: 18 Aug 2014 1321Z

Position: 5137N 00109W
(2nm W Benson)

Airspace: Benson ATZ (Class: G)

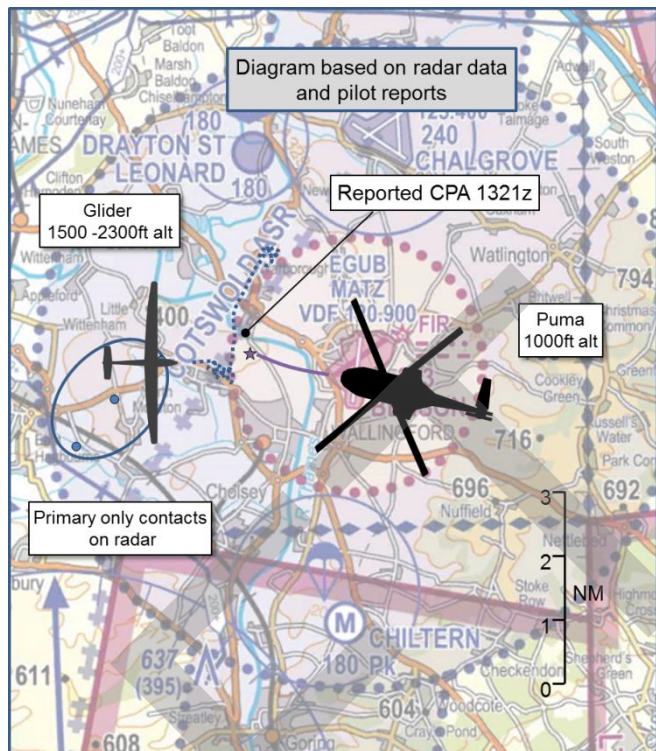
THE PUMA PILOT reports flying a green camouflaged helicopter with all lights illuminated and SSR transponder Mode 3A, C and S selected. The aircraft was not fitted with an ACAS or TAS. He was departing from Benson under VFR, passing altitude 1000ft, and about to speak to Benson Approach when the NHP saw a glider in the 9 o'clock position at the same level at a range of 0.5nm. Further scanning by the crew identified at least 4 other gliders circling between 500ft and 2000ft, all of which appeared to them to be within the Benson ATZ. Contact was made with Benson Approach, who could not see the gliders on radar due to the Watchman radar being unserviceable. Approach then relayed the information about the gliders to other departing and arriving traffic. On visual recovery, approximately 15min later, the crew was informed that the glider pilots had made contact with Benson Zone and had asked for permission to enter the ATZ. However, the gliders could still not be seen on radar and so the Puma pilot was led to believe they had been denied permission to enter the ATZ. He approached the airfield at 3000ft and could see the gliders to the southwest of the initials point for RW19, between 200 and 1000ft and still appeared to be within the ATZ. The pilot manoeuvred the aircraft at height to the south of the RW19 centreline and made an approach without further incident. The pilot believed that all 4 gliders infringed the Benson ATZ and, in attempting to gain lift, positioned themselves at the initials point, causing disturbance to Benson based traffic, including an NPAS helicopter. He wanted to highlight that although there were known websites publically available, which give glider information based on data gathered from FLARM, at present there was no way of accessing these websites through military computer systems.

THE NIMBUS PILOT reports that he was flying a FLARM equipped glider, in VMC in the vicinity of RAF Benson. Cockpit workload was high due to difficult soaring conditions. He did not see any other aircraft in the vicinity of RAF Benson, but at this point in the flight he had to start his engine (it was a self-sustaining glider) in order to avoid a field landing. He did this and then assumed a heading in the general direction of his home airfield, whilst avoiding rain showers along the way.

An Airprox was reported on 18th August 2014 when a Puma flew into proximity with up to 4 gliders. The Puma was receiving a Basic Service from Benson, but Benson was SSR only due to unserviceable radar and could not see the gliders on radar. The glider pilot most likely to be the one seen by the Puma pilot submitted a report, but with difficult gliding conditions, did not see the Puma.
