AIRPROX REPORT No 2014172**Date/Time:** 13 Sep 2014 1430Z (Saturday)**Position:** 5153N 00209W
(1nm SE of Gloucestershire Airport)**Airspace:** Gloucestershire ATZ (**Class:** G)**Aircraft 1** **Aircraft 2****Type:** Ikarus C42 Cessna C182**Operator:** Civ Trg Civ Pte**Alt/FL:** 1000ft 2000ft
QFE NK**Conditions:** VMC VMC**Visibility:** >10km NK**Reported Separation:**

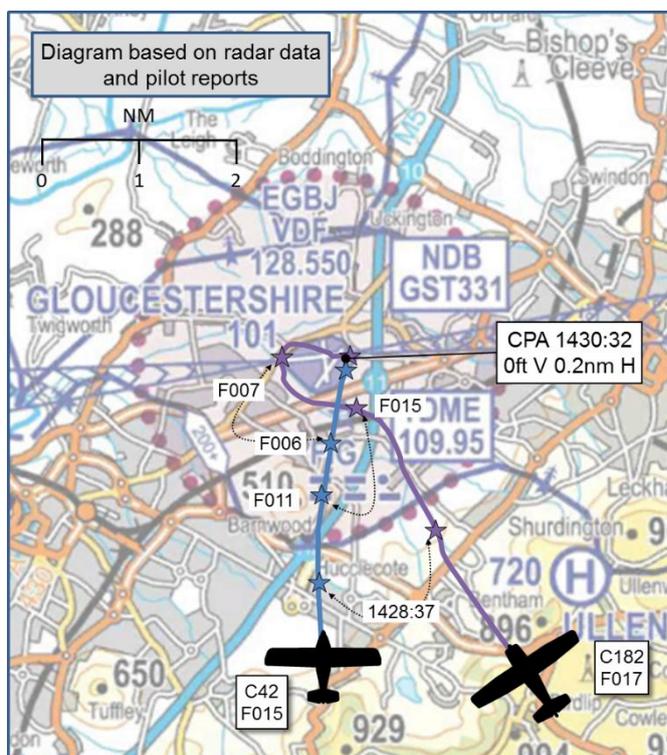
0ft V/300m H NK

0ft V/0.2nm H

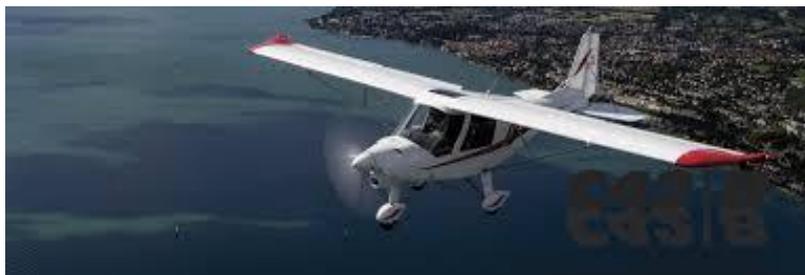
When the C42 pilot contacted the Tower, the controller agreed to allow the C42 to route direct to join crosswind, descending on the dead side. The C42 pilot then sighted the C182 descending ahead. The C182 pilot had acknowledged the instruction to join overhead for the left-hand traffic pattern on RW09. It was considered likely that the C182 pilot became disorientated as he descended early on the deadside, and failed to follow the overhead joining procedure for a left-hand pattern on RW09; this resulted in the C182 pilot descending into conflict with the C42, which was joining crosswind.

Cause: The C182 pilot flew into conflict with the C42 having mistakenly joined for the reciprocal runway.
