AIRPROX REPORT No 2015020

Date: 17 Feb 2015 Time: 1459Z Position: 5251N 00015W Location: 8nm SE Cranwell

PART A: SUMMARY OF INFORMATION REPORTED TO UKAB

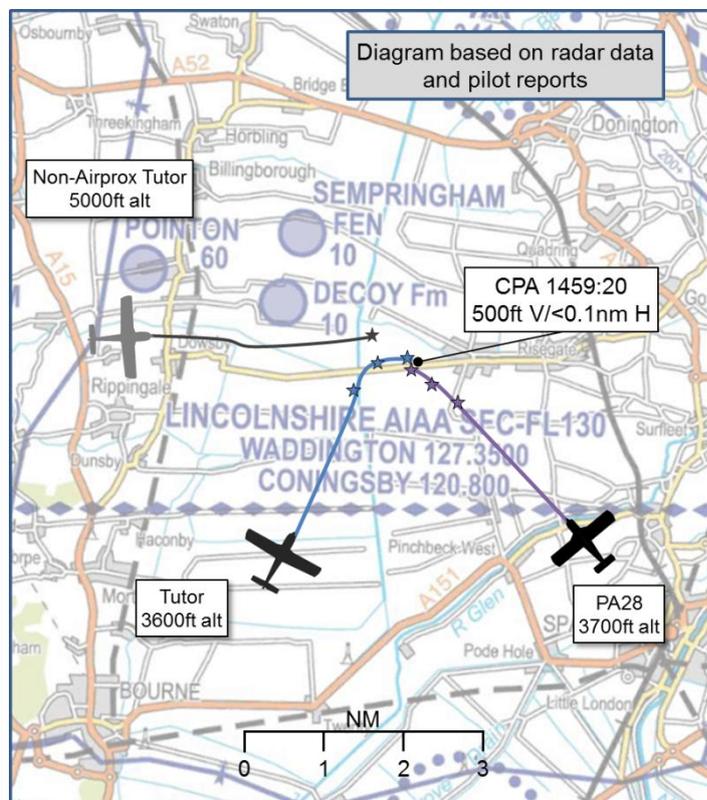
Recorded	Aircraft 1	Aircraft 2
Aircraft	Tutor	PA28
Operator	HQ Air (Trg)	Civ Trg
Airspace	Lincs AIAA	Lincs AIAA
Class	G	G
Rules	VFR	VFR
Service	Traffic	Basic
Provider	Cranwell Departures	Coningsby
Altitude/FL	4000ft	5000ft
ACAS/TAS	Other TAS	Not fitted
Alert	TA	N/A
Transponder	A,C,S	A,C,S
Reported		
Colours	White	White and Tan
Lighting	Strobes, Nav landing light.	NK
Conditions	VMC	VMC
Visibility	40km	50km
Altitude/FL	4000ft	5000ft
Altimeter	RPS (1030hPa)	RPS
Heading	090°	315°
Speed	80kt	105kt
Separation		
Reported	200ftV 200m H	200ftV 0.25nmH
Recorded	500ft V/0.1nm H

THE TUTOR PILOT reports that the student was flying a clearing/lookout turn to the right prior to conducting a stall. A TAS alert was received in the 1 o'clock position at +100ft and the Warrior was spotted by the instructor when in the 11:30 position. The instructor then took control and continued the right turn whilst initiating a descent. The cream-coloured Warrior passed down the port side 200ft above and 200m away. The pilot noted that at the time there was a fairly high volume of ATC information on frequency, so both pilots were looking out.

THE PA28 PILOT reports that he saw a Tutor in his 11 o'clock at 1nm entering a vertical climb, this continued until they were approximately 1000ft above when they appeared to carry out a stall-turn manoeuvre. In the second half of the manoeuvre, it became apparent to him that they had sighted his aircraft because they carried out a quarter roll to their right to position parallel, level and in the opposite direction. The Tutor then appeared to manoeuvre aggressively towards his aircraft from the 7 o'clock position, level, before breaking away; his estimate of the closest position was during this manoeuvre, but he believed they had seen his aircraft by then. Had they not seen each other, and the planned stall turn gone ahead, the risk of collision would have been much higher because his planned track would have gone through the Tutor's planned exit altitude and track.
