**AIRPROX REPORT No 2015088**

Date: 10 Jun 2015 Time: 1520Z Position: 5151N 00129W Location: 5nm W Oxford Airport

**PART A: SUMMARY OF INFORMATION REPORTED TO UKAB**

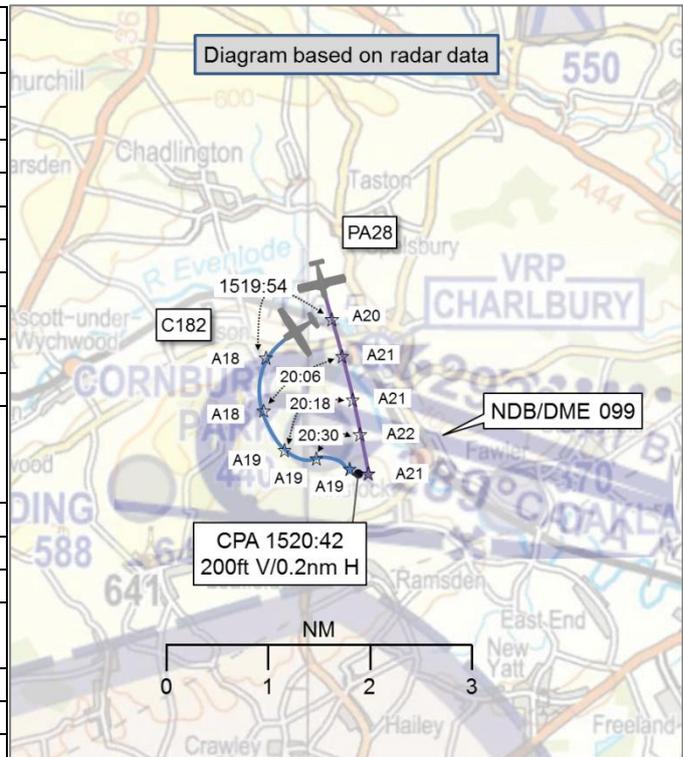
**THE CESSNA 182 PILOT** reports that he was performing an NDB DME 099 procedure at Oxford with an approach time of around 1515. They were in good VMC but under a Traffic Service for the instrument approach for RW01. The controllers were under a reasonably high workload vectoring an AirMed aircraft onto a final approach RW01 through Brize, and he found out later that they were also coordinating other instrument traffic from London. He had completed his base turn inbound on 099° and was just beginning the descent at around 1900ft on the QNH. It was at this point that they saw a PA28 in his 10 o'clock, 1nm, which flew straight across within 1nm of his path, at a very similar level, heading south into the Brize Zone. He did not report that he had taken any avoiding action, but he did comment that he passed just behind the other aircraft. He noted that he had just transferred from Radar to the Tower, which he opined was another possible reason why the controllers may not have been able to tell him about the other aircraft after they had switched frequency. They informed ATC of the aircraft, and they reported it to Radar. He had received no call that he could remember, and the radar controllers said they could not remember if they had given him the information due to the high workload and would have to listen to the RTF tapes to find out. They also mentioned that they had had no communication from Brize radar regarding the traffic. When they looked at the screen they believed the aircraft to be at 2000ft. The C182 pilot commented that there may have been a little confusion in the Oxford Controllers' minds about whether he was on a Traffic or a Basic service because they had departed initially on a Traffic Service then 'downgraded' this to a Basic Service for a general handling phase of the flight before requesting a further Traffic Service as they headed back towards the OX NDB at a time when the controllers were handing over. He recalled he was given a reduced Traffic Service on entering the radar overhead so this may also have added to the issue. However, at the time of the incident he recalled being about 5nm to the west of the airport.

**THE PIPER PA28 PILOT** reports that he was first alerted to the Airprox some 2 weeks after the event. He was flying more or less due south and routing via Popham's overhead. He was on autopilot, linked to GPS, and maintaining a steady heading. It was a busy flying day with lots of aircraft around but excellent visibility; his front-seat passenger and he were keeping a good look-out. There were several encounters with other traffic on the day, although he did not consider any of them significant. His GPS log showed he held a steady altitude of around 2200ft for most of the journey, with a straight track between waypoints. He was receiving a Basic Service from Brize Radar. He did recall a Cessna type aircraft coming in at a similar altitude, or perhaps a little lower, on a converging course from his left at about his 9 o'clock (i.e. from the direction of Oxford). Even as he saw it, the aircraft's pilot took avoiding action he thought, and turned sharply away. At the time he considered this was not an especially close encounter but was grateful for the positive avoiding response of the other pilot; he would have been ready to take action himself if necessary. He remembered thinking at the time that possibly this was a trainee pilot with an instructor out of Oxford, and that the instructor had taken control to make a positive response to the developing situation. He did not think anything more of it until he was advised about the Airprox. [UKAB Note: this sighting was in fact before the Airprox that was reported by the C182 pilot, and is likely to have been when they initially crossed over a minute or so prior.]
