AIRPROX REPORT No 2015090

Date: 4 Jun 2015 Time: 1009Z Position: 5155N 00209W Location: Gloucestershire

PART A: SUMMARY OF INFORMATION REPORTED TO UKAB

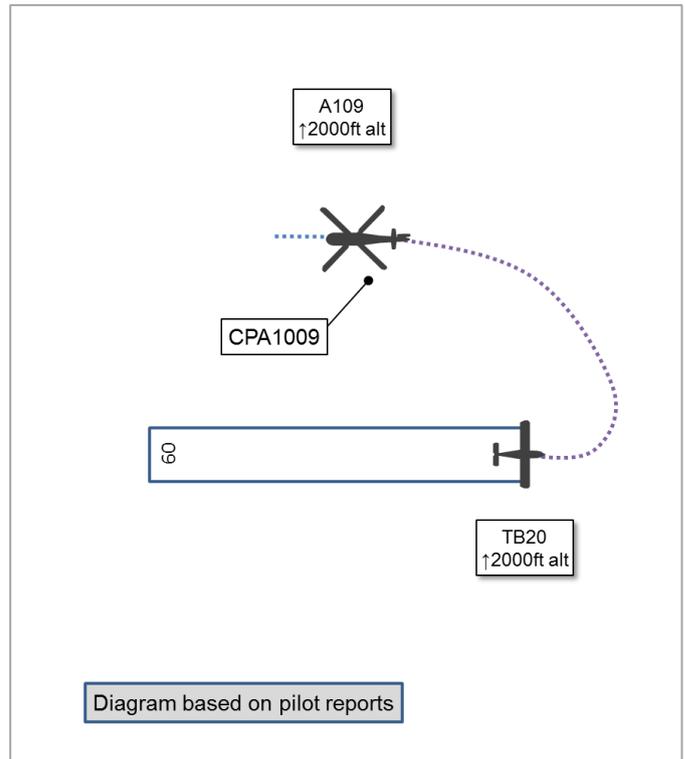
THE AW109 PILOT reports he was in the RW09 helicopter circuit and had received ATC approval to climb to 2000ft for a practice auto-rotation. He was maintaining a good look-out because there was a lot of traffic around, when an aircraft passed within 20ft vertically and “inside the disc diameter” overhead. It had come from their 7 o’clock, and the pilot opined that no amount of look-out would have seen it. It was seen when the sky above became completely blocked out, and he thought it likely that the other pilot hadn’t seen them because he didn’t see the other aircraft change direction at all. He noted that there was no time to react, and he thought that the 2 aircraft missed by pure luck.

THE TB20 PILOT reports departing from RW09 with the student under the IFR hood. He was aware that the helicopter circuit was active, but expected this to be at 750ft, and they were already passing 1500ft as they turned wide-downwind to depart. They were told to change to Approach frequency and, as they checked-in, they were downwind passing 2000ft. Almost simultaneously, ATC gave Traffic Information and the instructor saw the roof and rotor blades of a helicopter below and left. He took control and recalled wondering what the forward speed of a helicopter in the climb was. He started a right turn, but it was quickly apparent that they were overtaking and climbing away from it. The helicopter passed below and from left to right, but he was unable to meaningfully judge the distance. He didn’t think the risk of collision was high and therefore at the time didn’t consider it to be an Airprox. However, he noted that despite many years flying at Gloucestershire he did not realise that the helicopters could routinely climb up to 2000ft, especially considering that overhead joins were at this height. After landing, he called to discuss the incident with ATC. He opined that it was unfortunate that his unusual departure had coincided with the helicopter’s unusual operation, which, with hindsight, could have been easily deconflicted with a clearance not to turn west below 2000ft.

THE GLOSTER CONTROLLER reports that the TB20 departed from RW09 with a left turn to the west and was advised that the helicopter circuit was active. The AW109 in the helicopter circuit was climbing to 2000ft for an auto-rotation into the Heli North Training Area. The controller observed on the air traffic monitor that the two aircraft were parallel to each other and tracking west, so advised the pilot of the TB20 that the helicopter was at 2000ft.
