AIRPROX REPORT No 2015105

Date: 10 Jul 2015 Time: 0838Z Position: 5048N 0011W Location: Gosport

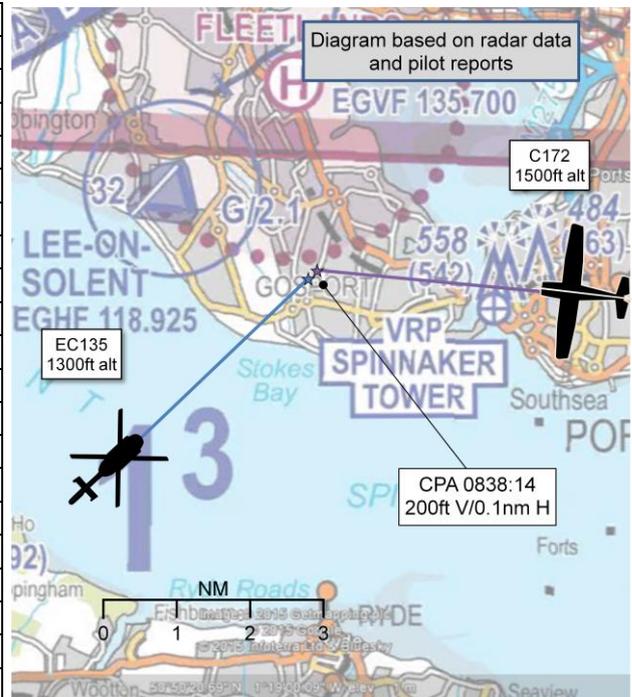
- At 0834:12 the pilot of the EC135 established communication with Solent Radar and a Basic Service was agreed. The aircraft had just left the Isle of Wight and was tracking northbound towards a Portsmouth hospital at 1300ft.
- At 0836:32 the pilot of the C172 established communication with Solent Radar, as he reported passing the Spinnaker Tower at Portsmouth. A Basic Service was agreed as the aircraft tracked westbound at 1500ft.
- At 0838:15 CPA occurred (Figure 1).

In determining the cause, the Board quickly agreed that it was simply a late sighting by both pilots. Regarding the assessment of risk, the Board concurred that effective and timely action had been taken to prevent a collision and that this was a Category C incident.

Cause: A late sighting by both pilots.
